# Imaging Australia's first naval loss

THE 2018 PHOTOGRAMMETRIC SURVEY OF SUBMARINE HMAS AE1

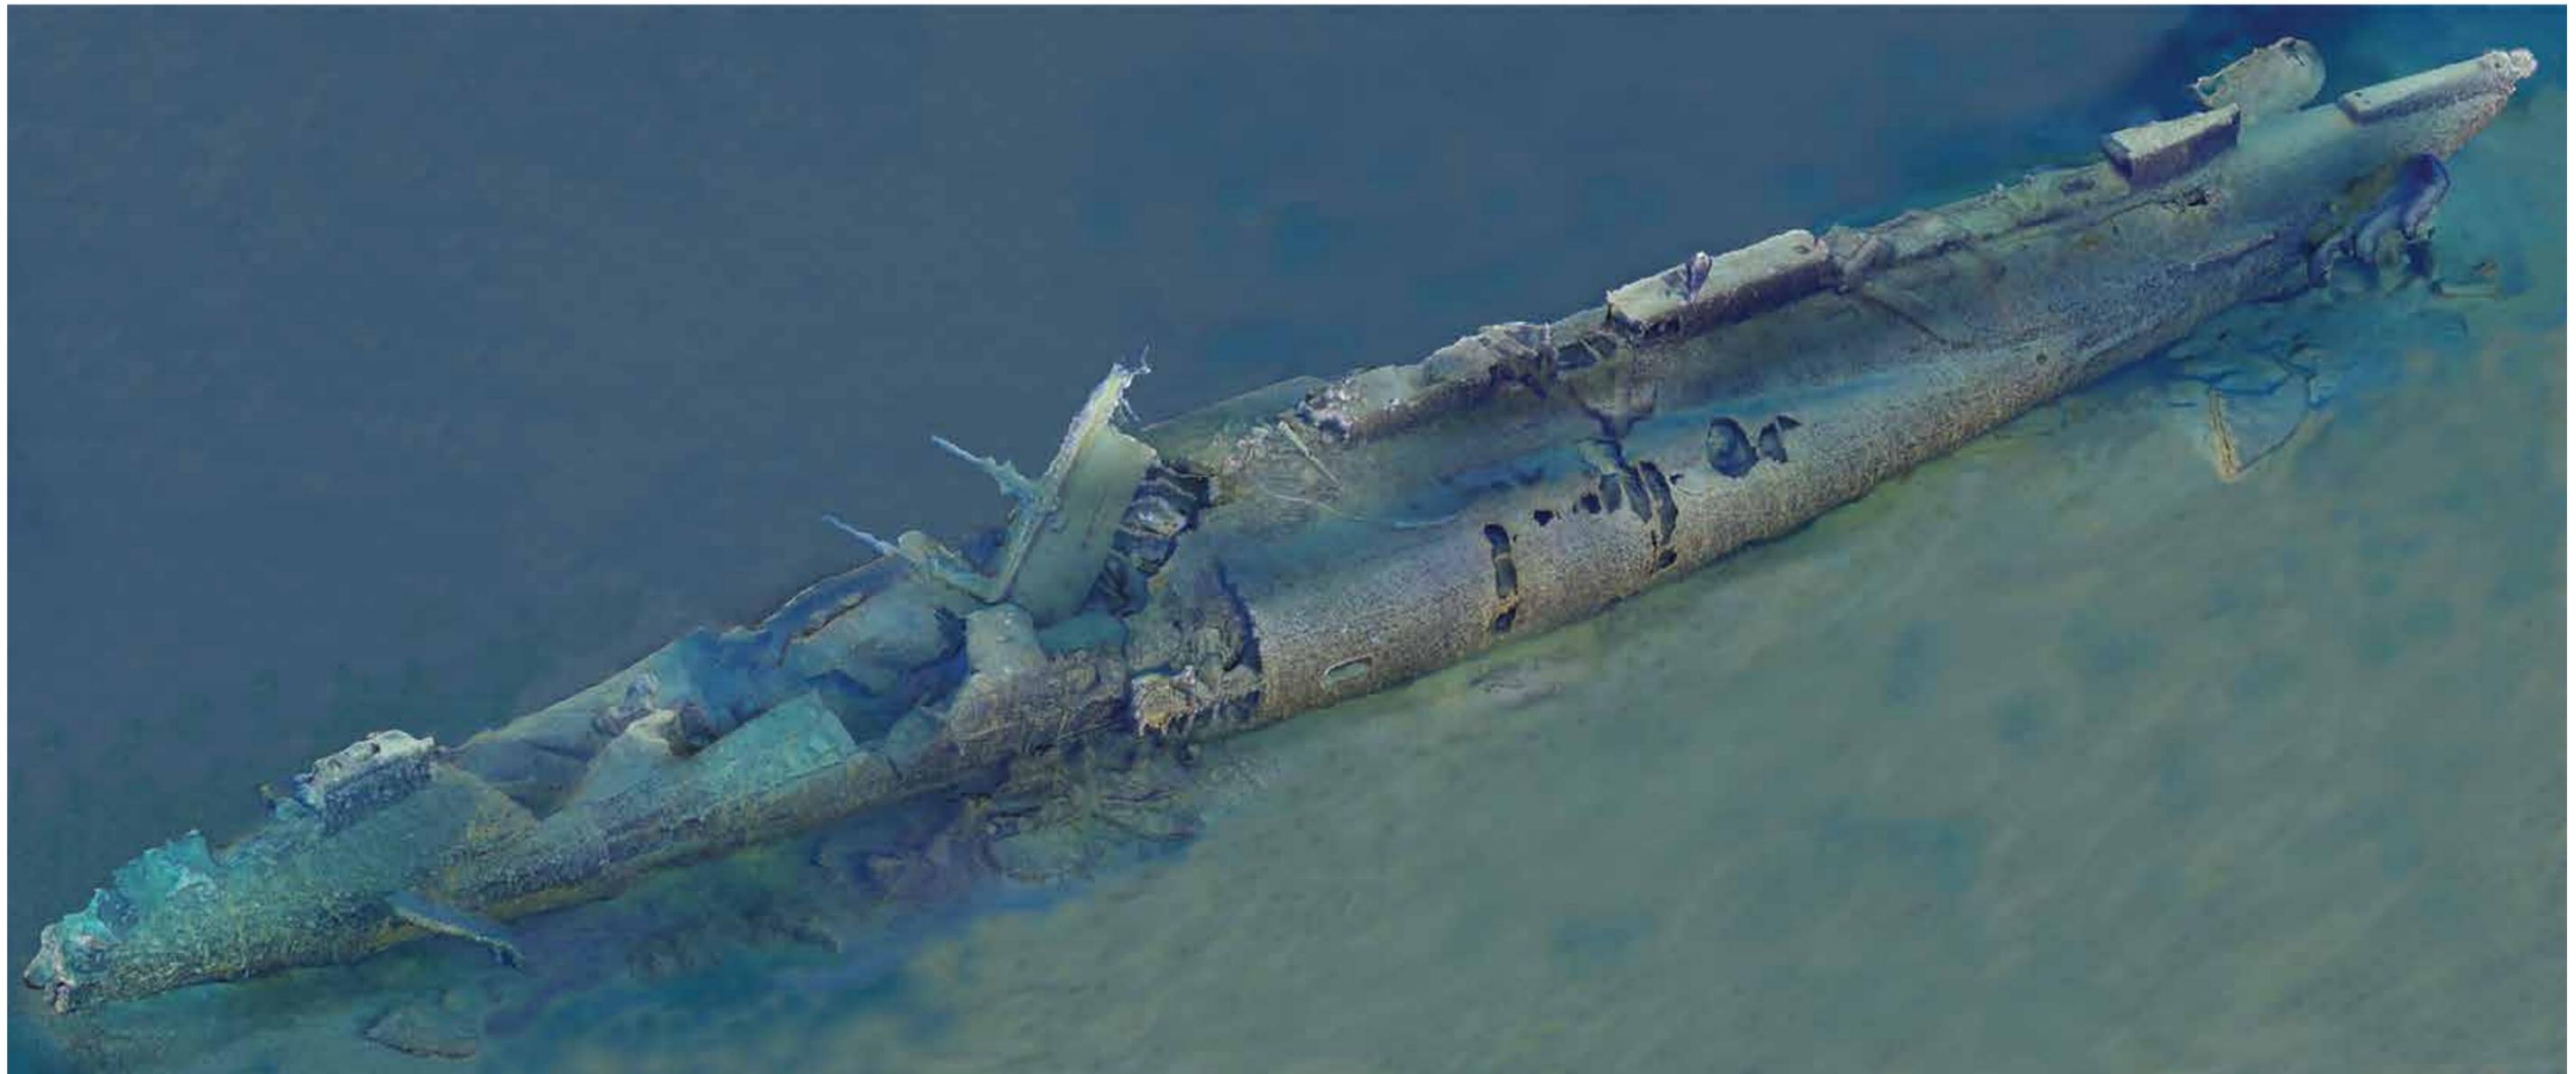
- 01 Pages 2–3 Port side view of the interim 3D photogrammetric model of HMAS *AE1*. A high-resolution 3D model is currently being generated from the 8,000-plus still images at Curtin University's HIVE (Hub for Immersive Visualisation and eResearch). 3D model by Curtin University from images courtesy of Paul G Allen, Find *AE1* Ltd, ANMM and Curtin University. © Curtin University
- 02 A Remotely-Operated Vehicle (ROV) deployed from RV *Petrel* uses a camera mounted on its manipulator arm to inspect the interior of *AE1*'s stern torpedo tube. Image Paul G Allen, Find *AE1* Ltd, ANMM and Curtin University. © Navigea Ltd
- 03 Implosion of *AE1*'s forward hull has caused the fin to collapse into the remains of the submarine's control room. Image Paul G Allen, Find *AE1* Ltd, ANMM and Curtin University. © Navigea Ltd

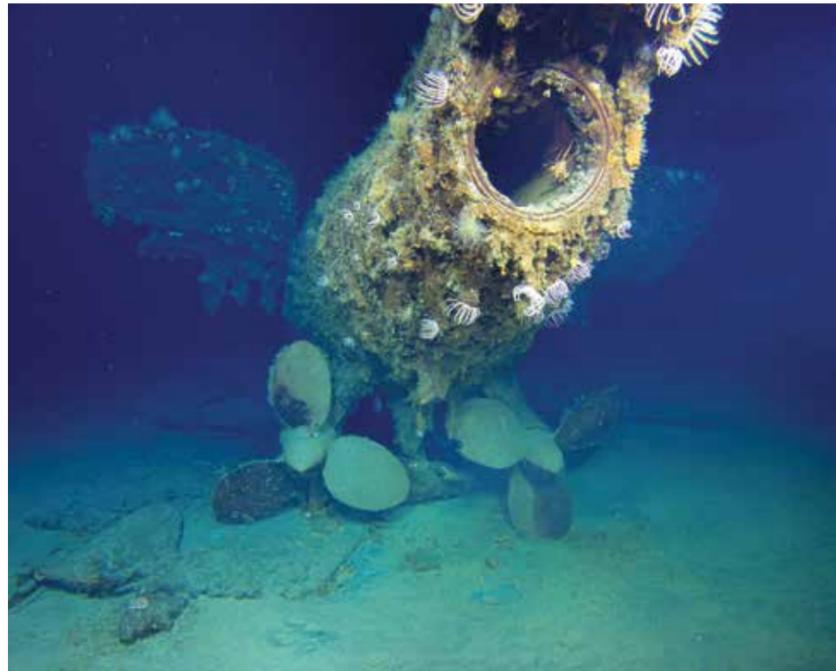
- 01 *AE1*'s disarticulated skeg and rudder lie on the seabed beneath the submarine's port propeller.
- 02 Since *AE1*'s discovery in December 2017, the fin has collapsed further into the remnants of the control room. This is evidenced by the forward periscope, which now rests directly atop the surviving starboard pressure hull plating.
- 03 Natural forces such as corrosion have caused most of *AE1*'s 'saddle' ballast tanks to disintegrate and collapse to the seabed. The opening for the submarine's port side amidships torpedo tube is visible at far right. Images Paul G Allen, Find *AE1* Ltd, ANMM and Curtin University. © Navigea Ltd

guards, rudder and skeg. All four guards are lying flat on the seabed, just beneath their respective hydroplanes. While natural processes such as corrosion could have caused them to fall away from the hull, it is more likely that they snapped off as *AE1* fell onto its keel after initially striking the seabed stern first and pitching forward. The 2018 survey confirmed that both fore and aft sets of hydroplanes were in the 'hard-to-rise' position, which indicates that the crew desperately attempted to recover from a dive and return to the surface. *AE1*'s rudder and skeg were found lying beneath the port side propeller. Both appear to have been broken off by the submarine striking the seabed stern first; however, the angle of the impact was shallow enough that it did not damage *AE1*'s propellers.

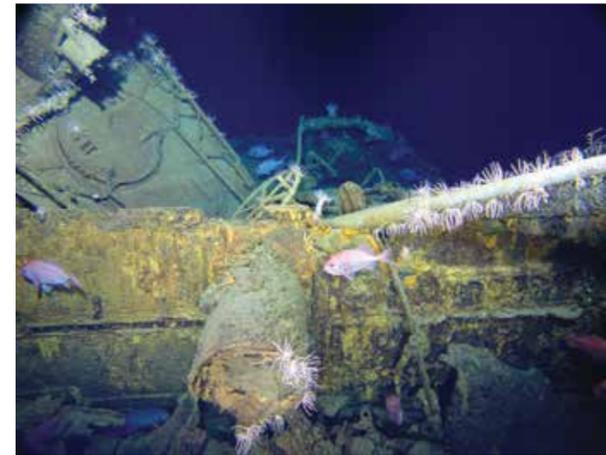
02

Specific hull components may also have deteriorated and disarticulated due to seismic and tectonic activity in the area. The fin, for example, has collapsed further into the control room since *AE1*'s discovery in December 2017 (and in the wake of large earthquakes and accompanying aftershocks in New Britain in March 2018). While there is clear damage to the submarine from natural processes, no evidence of human-manifested change (such as anchor or trawl damage) was noted. Indeed, unlike many historic shipwreck sites in shallow water and/or more developed areas, *AE1* appears to be relatively free of modern rubbish and debris.
