Wungong Catchment Trial

Tree deaths in native forests and rehabilitated minesites in the Wungong Catchment

Report on field visits in May and June 2011

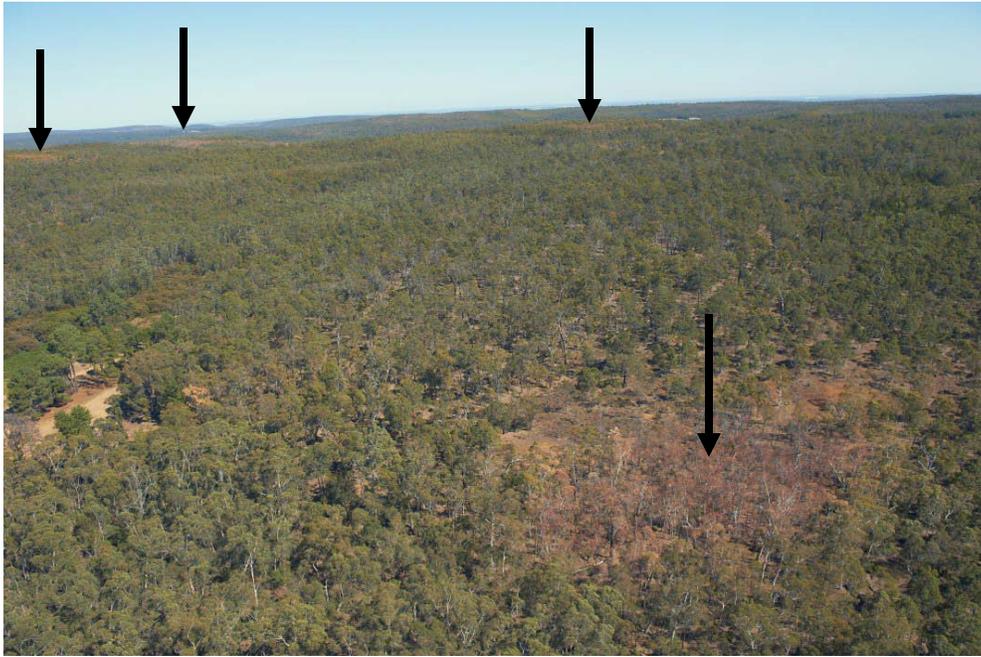
Aerial photography from 15 April 2011 shows that the patches of dead trees were not evenly distributed throughout the catchment. Many of these patches, but not all, were clustered, and were associated with rocky outcrops (Fig. 2 and 3). These deaths had occurred in both native forest and on the even aged stands on minesites that had been rehabilitated between 29 and 11 years earlier (Fig. 1), however the patches of dead trees in native forest appeared to be larger (up to 5 ha in area) than those on the rehabilitated minesites where the patches were less than 1 ha in extent. Few or no deaths have occurred on thinned sites (F. Batini pers. comm.).

Figure 2. Aerial photograph close to Site N2, looking south. Arrows indicate patches of recent deaths. Photo: courtesy of the Water Corporation.

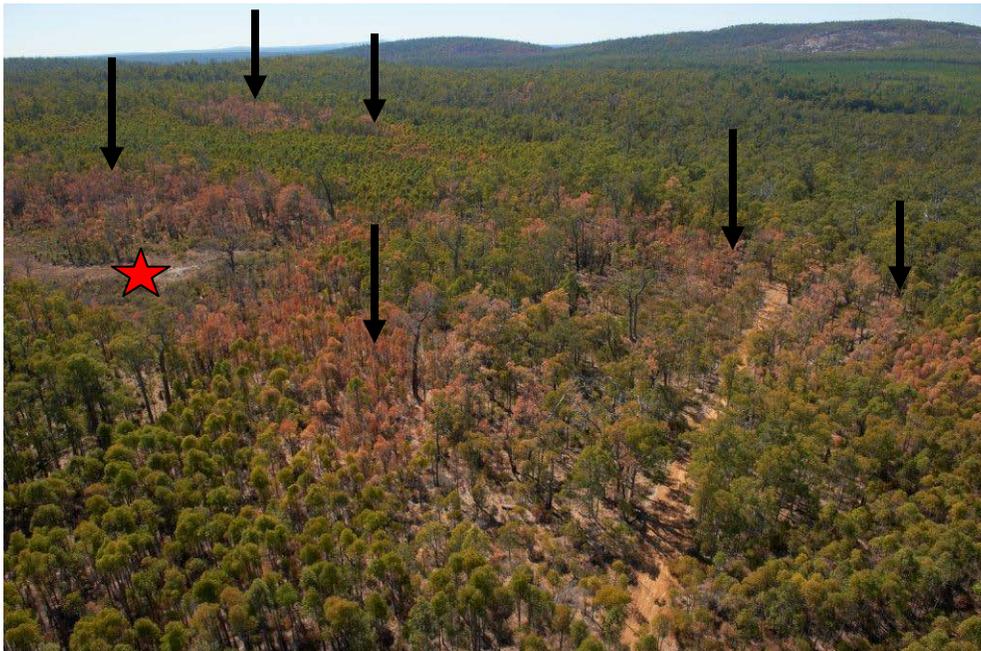
Figure 3. Aerial photograph close to Sites N7 and R1 and 2, looking north east. Arrows indicate patches of recent deaths, the star indicates a rocky outcrop. Photo: courtesy of the Water Corporation.

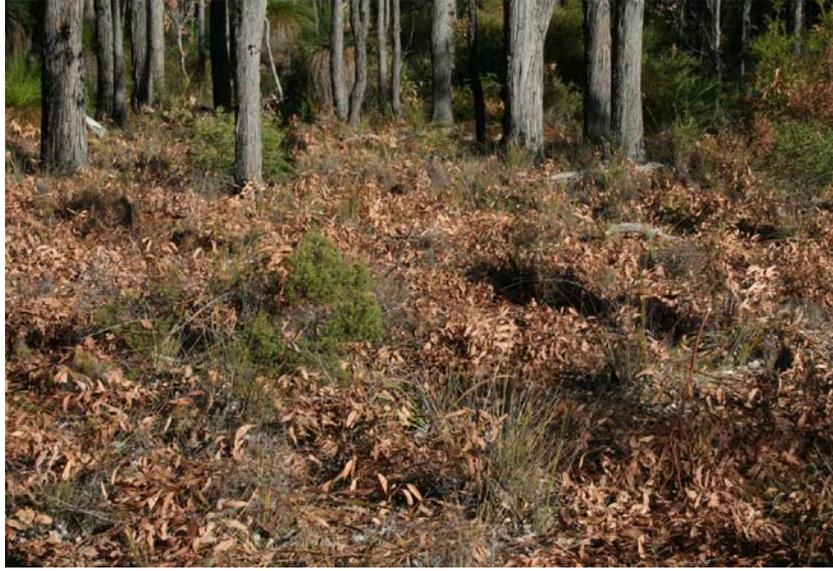
In many of the affected native forest stands there were a large number of dead leaves under the trees (Fig. 4), resulting from the clean abscission of crown units (Fig. 5). This was different from the situation on the rehabilitated minesites where abscission was mainly of leaves, rather than whole crown units (Fig. 6).

Figure 4. Abscised crown units under recently dead jarrah trees in native forest (Site N7).

On all the native forest sites the trees appear to have been under moisture stress for a prolonged period because many have prematurely abscised branches from their crowns (Fig. 4 and 5). Also a number have well developed borer larvae in the cambial area, and these borers will only attack drought stressed trees.

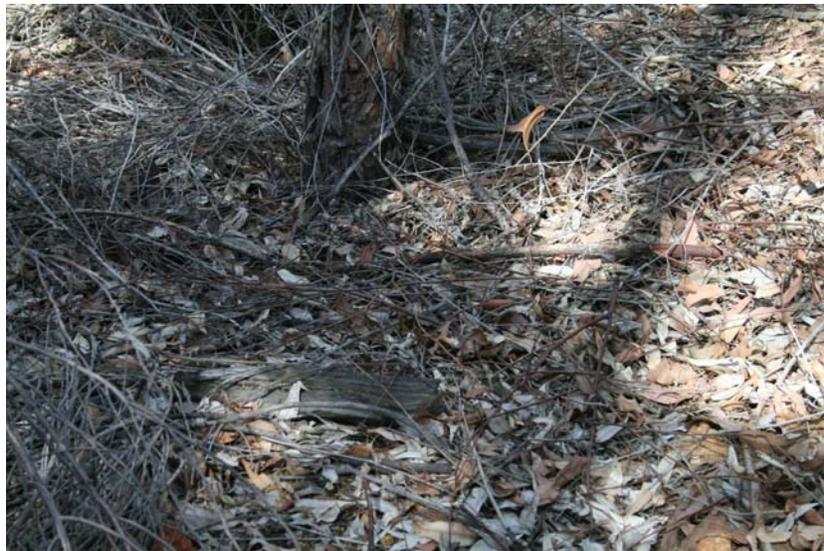
Figure 6. Leaf litter, rather than abscised crown units under recently dead jarrah on rehabilitated minesite (Site R3).

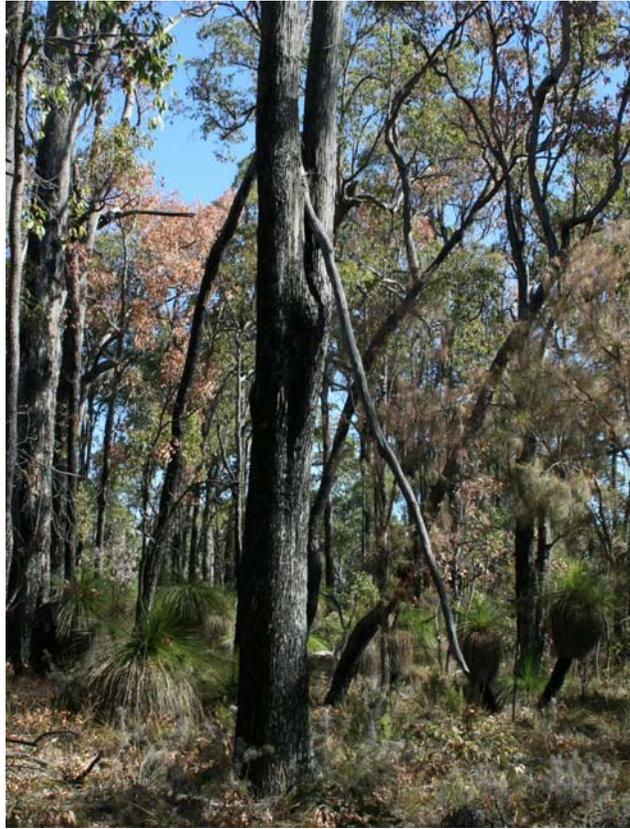
It was only the trees that appear to have been affected; in native forest stand there were no obvious deaths in the understorey (Fig. 7). On the rehabilitated minesites there were very few understorey plants (Fig. 8).

Figure 7. The understorey is unaffected in native forest even though many trees have died (Site N4).

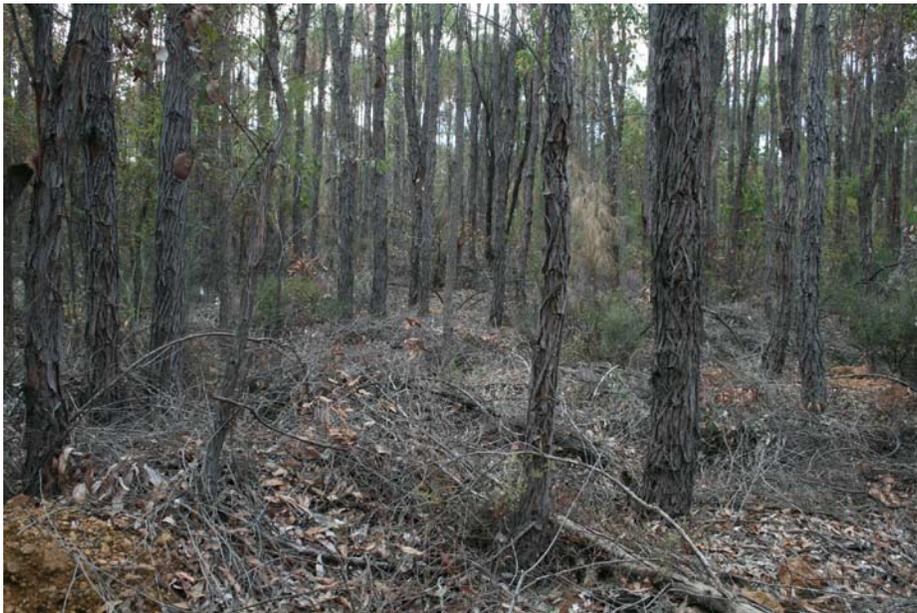
Figure 8. On rehabilitated minesites the understorey is almost completely lacking (Site R1).

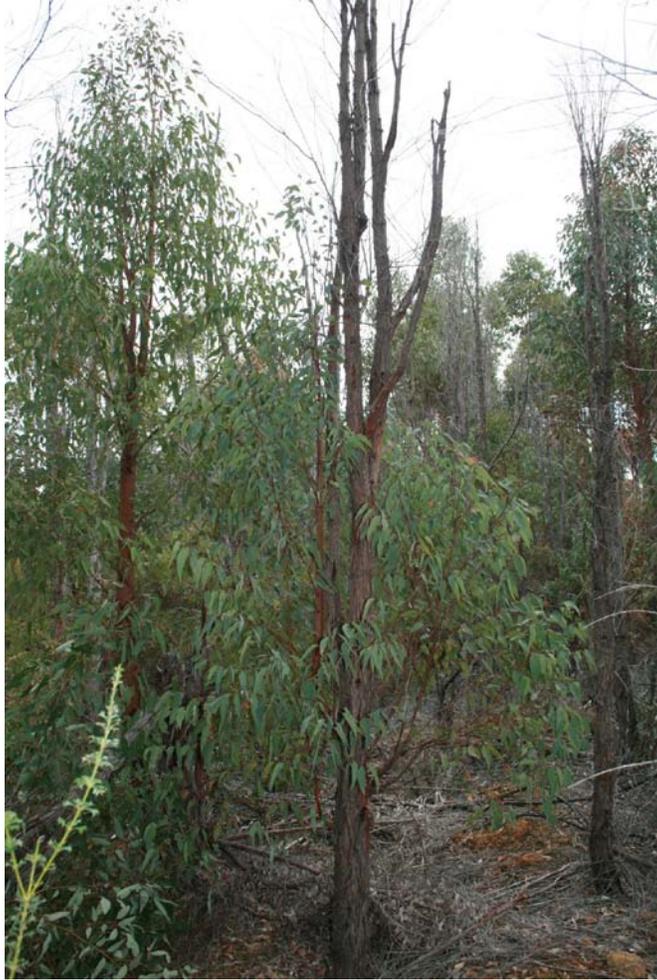
The sites where tree deaths have occurred in both native forest and on rehabilitated minesites are sites where deaths have occurred in the past, especially in 2007 (F. Batini, pers. comm.). In some cases the complete tree had died, in other cases the primary crown had died and the tree had regenerated by coppice and/or epicormic shoots at the stem base. This was particularly evident on the rehabilitated minesites (Fig. 9 and 10).

Figure 9. Jarrah tree where the primary crown has died but which has reshot from epicormic shoots at the base of the stem (Site R2).

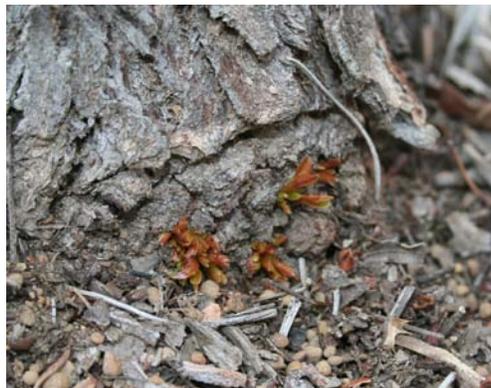
Figure 10. Coppice shoots developing at the base of a jarrah sapling with a dead crown (Site R3).

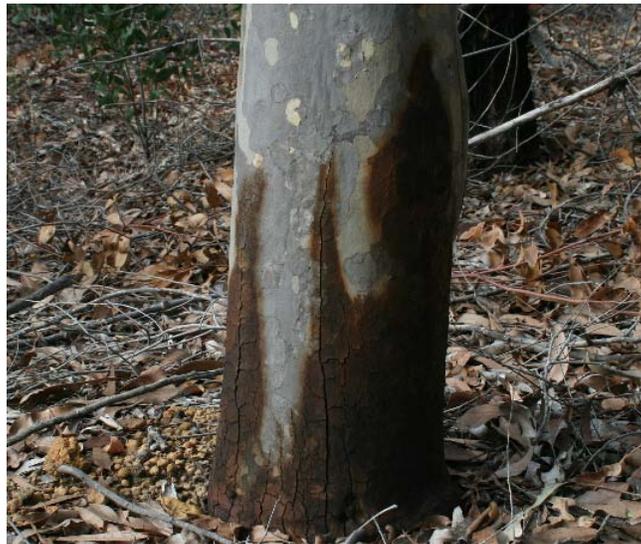
There was no indication of death being associated with pathogenic invasion in the native forest trees, or in the majority of trees on the rehabilitated minesites. On one minesite however, several trees had large, conspicuous basal cankers at the root collar (Fig. 11). The common fungal pathogens *Cytospora* and *Endothia* were isolated from these cankers. These fungi are pathogens of stressed trees.

Figure 11. Basal canker at the on spotted gum (Site R5).

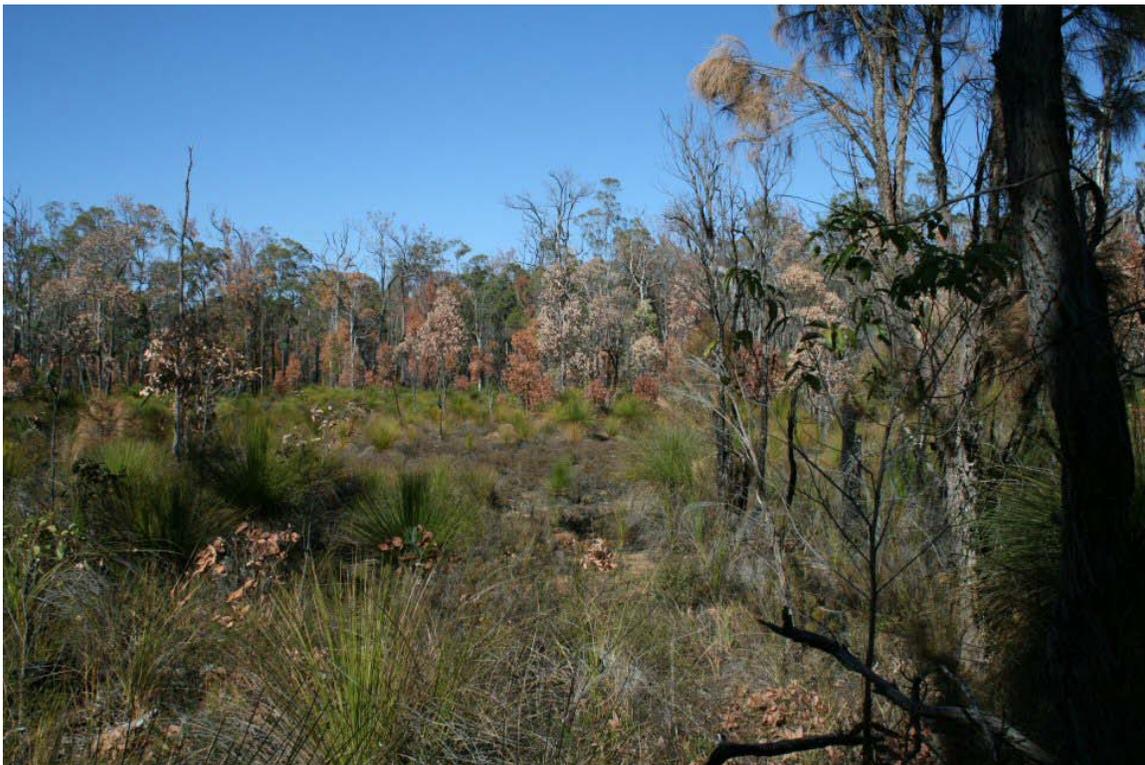
Health status: Highly stressed with many dead trees, however the mid- and understorey are unaffected (Fig. 12). Close to a large area of dead trees (Fig. 13). Tree deaths have occurred previously on this site, particularly in the summer of 2007 following a dry winter. Many of these apparent dead trees coppiced the following year, and have died in 2010/2011 (Batini pers. comm.).

Figure 12. Site N1. Recently dead trees around a rocky outcrop which is close to the surface.

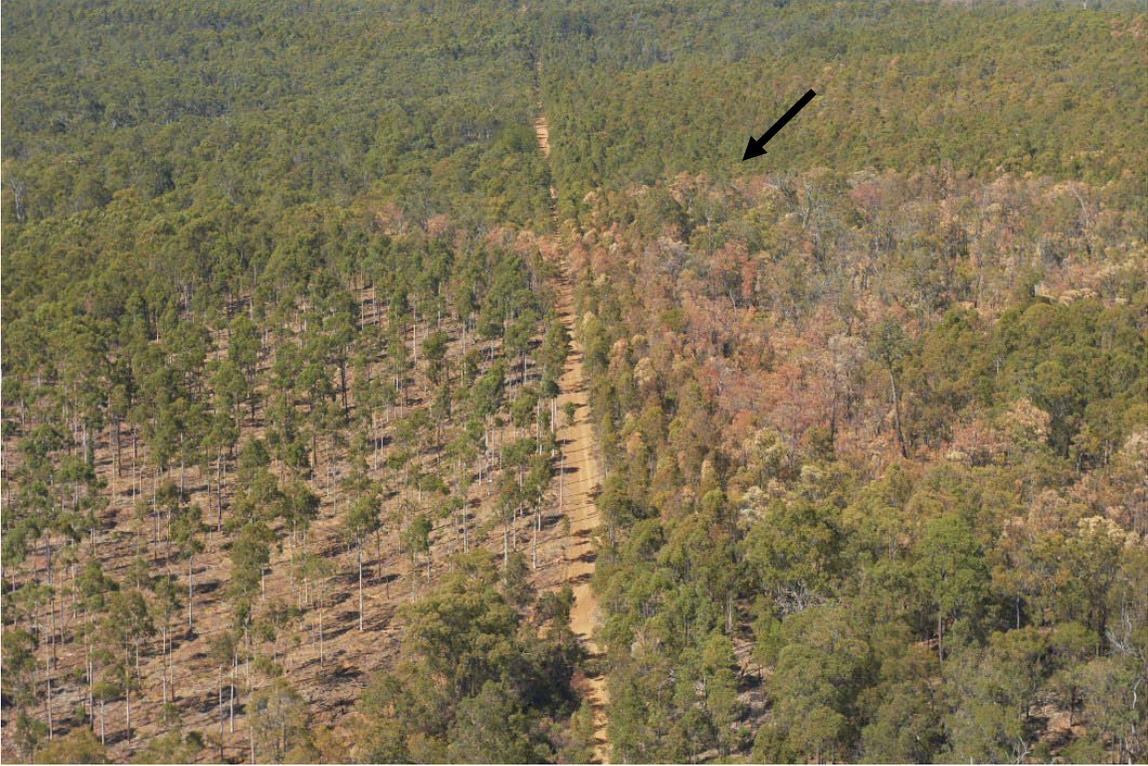
Figure 13. Aerial photograph showing the area close to Site N1, with extensive deaths in native forest and rehabilitated, unthinned forest on the right of the road. There are no deaths in the thinned area, on the left of the road. The location of Figure 4 (Site 1) is indicated by the arrow, the precise location is not apparent because of changes in slope and obliquity of the aerial photograph.

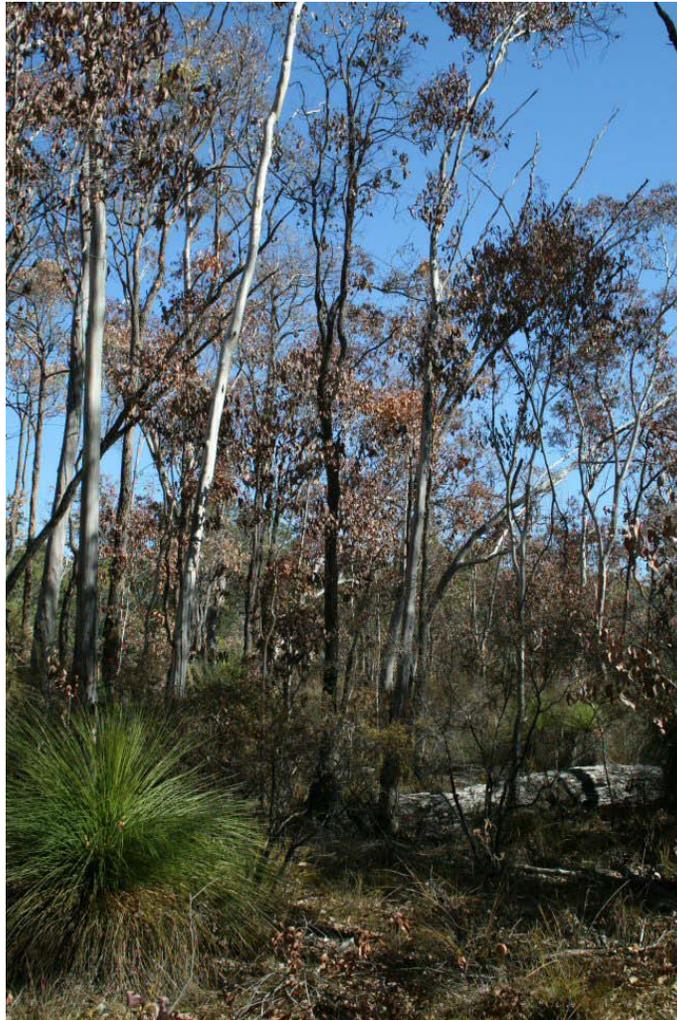
Health status: All of the trees have died (Fig. 14); the understorey is unaffected. Occasional deaths have occurred previously on this site.

Figure 14. Site N2, recent deaths in bullich stand, the understorey is unaffected.

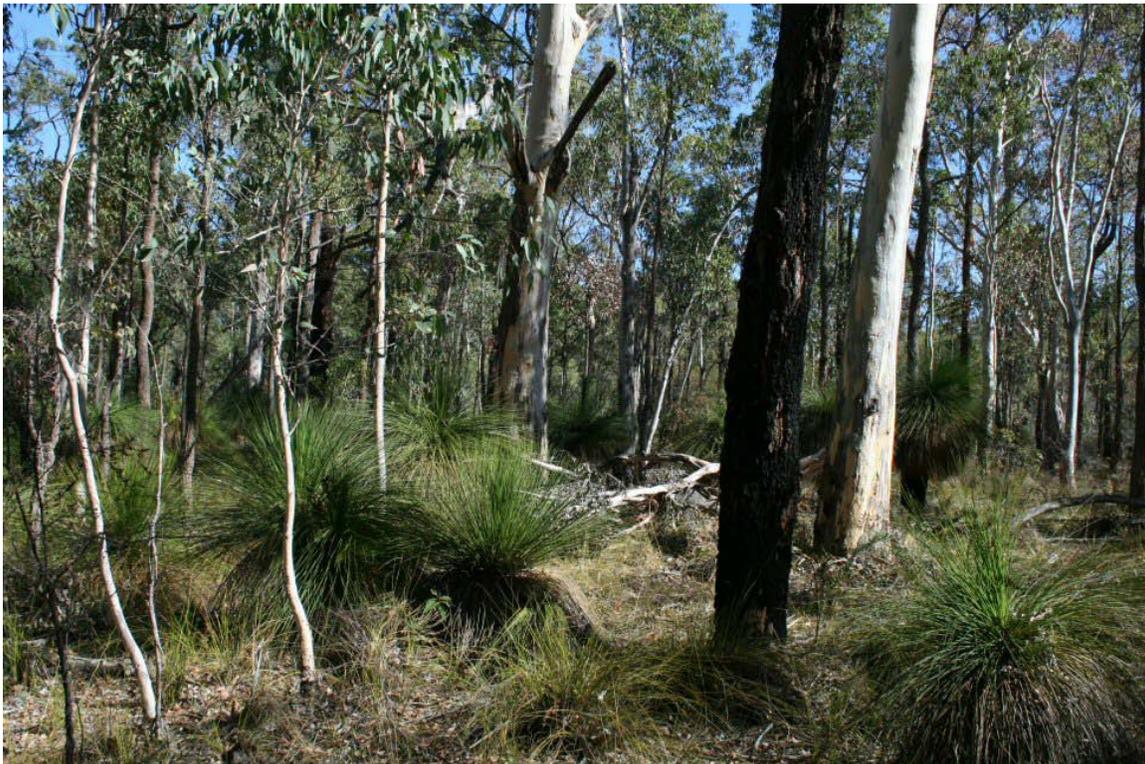
Health status: No dead trees (Fig. 15); the understorey is unaffected. No deaths have occurred previously.

Figure 15. Site N3, healthy bullich stand adjacent to the dead stand on Site N2.

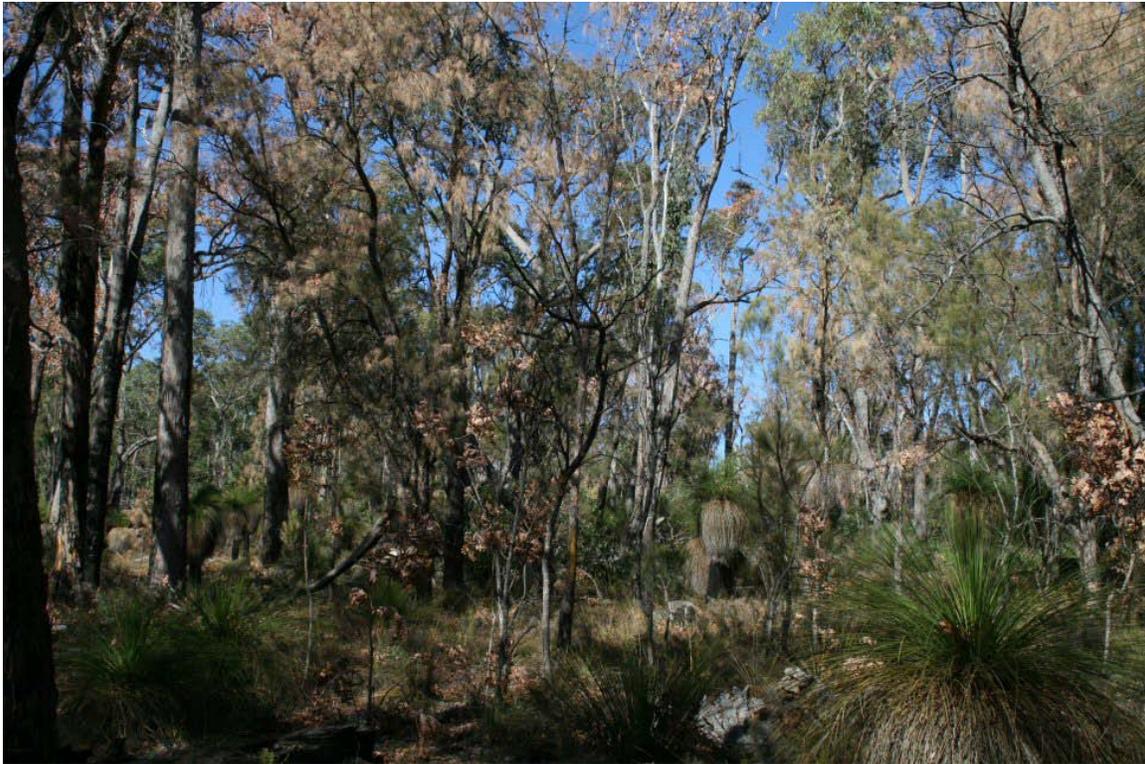
Health status: Very stressed with many dead trees; the mid- and understorey are unaffected (Fig. 16). No previous tree deaths on this site.

Pest or pathogen attack: borer larvae in some trees, no sign of pathogenic invasion

Figure 16. Site N4 showing deaths in the overstorey trees, with unaffected understorey.

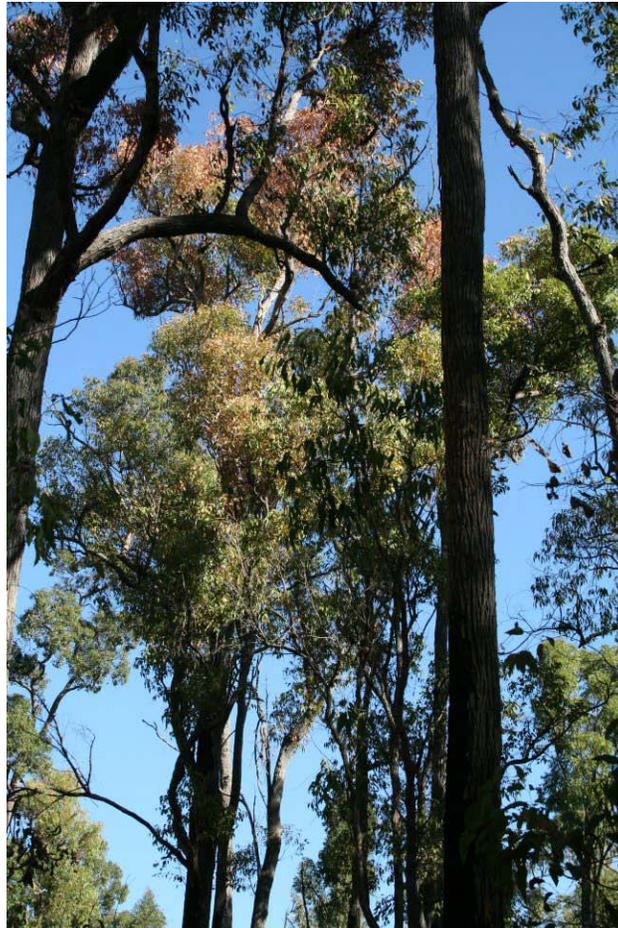
Health status: A few dead and dying jarrah trees; the understorey is unaffected (Fig. 17, 18).

Pest or pathogen attack: Possible Armillaria infection in a dead marri

Figure 17. Site N5, Demonstration plot 1, unthinned jarrah stand showing dying crowns.

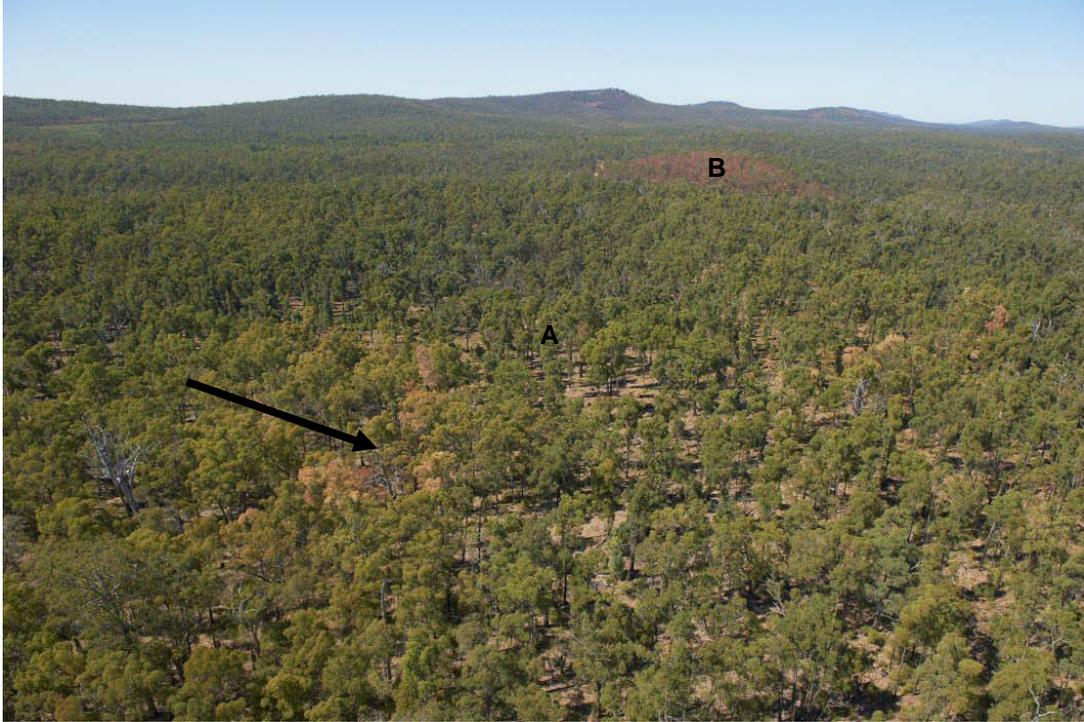
Figure 18. Aerial view of Site N5 (arrow), Demonstration plot 1, unthinned jarrah stand showing some dying crowns. A: adjacent thinned stand; B: wildfire damage in the background.

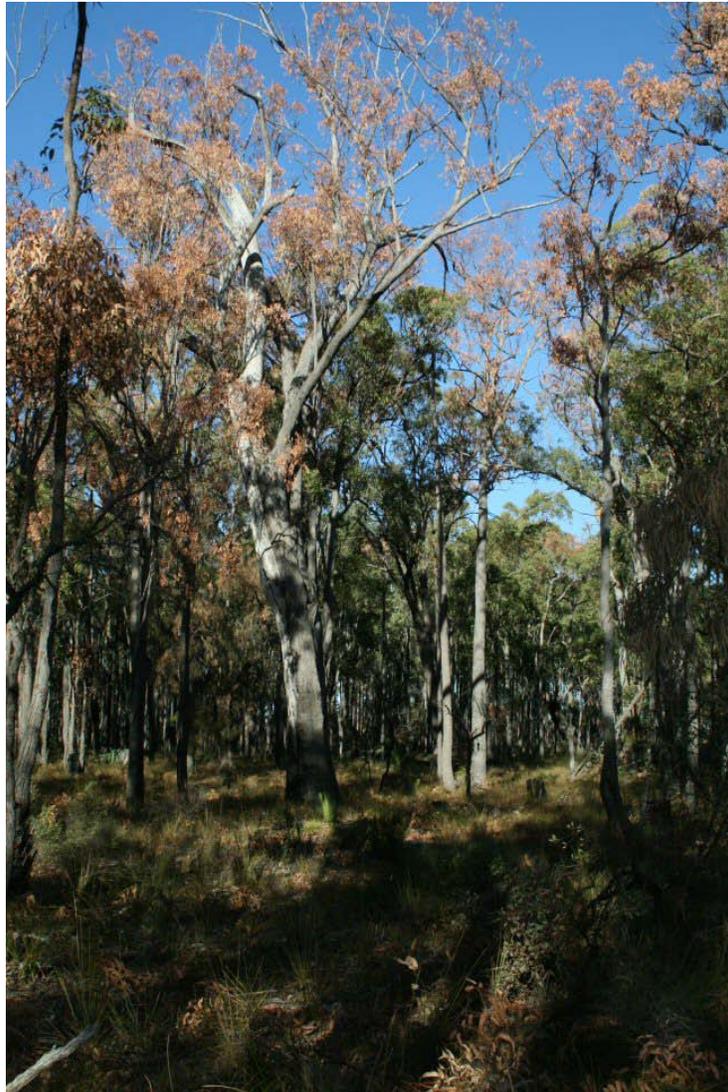
Health status: Many dying jarrah trees; the understorey is unaffected (Fig. 19). One previous death (more than 10 years ago) on this site.

Figure 19. Site N7, deaths of large jarrah trees, understorey unaffected.

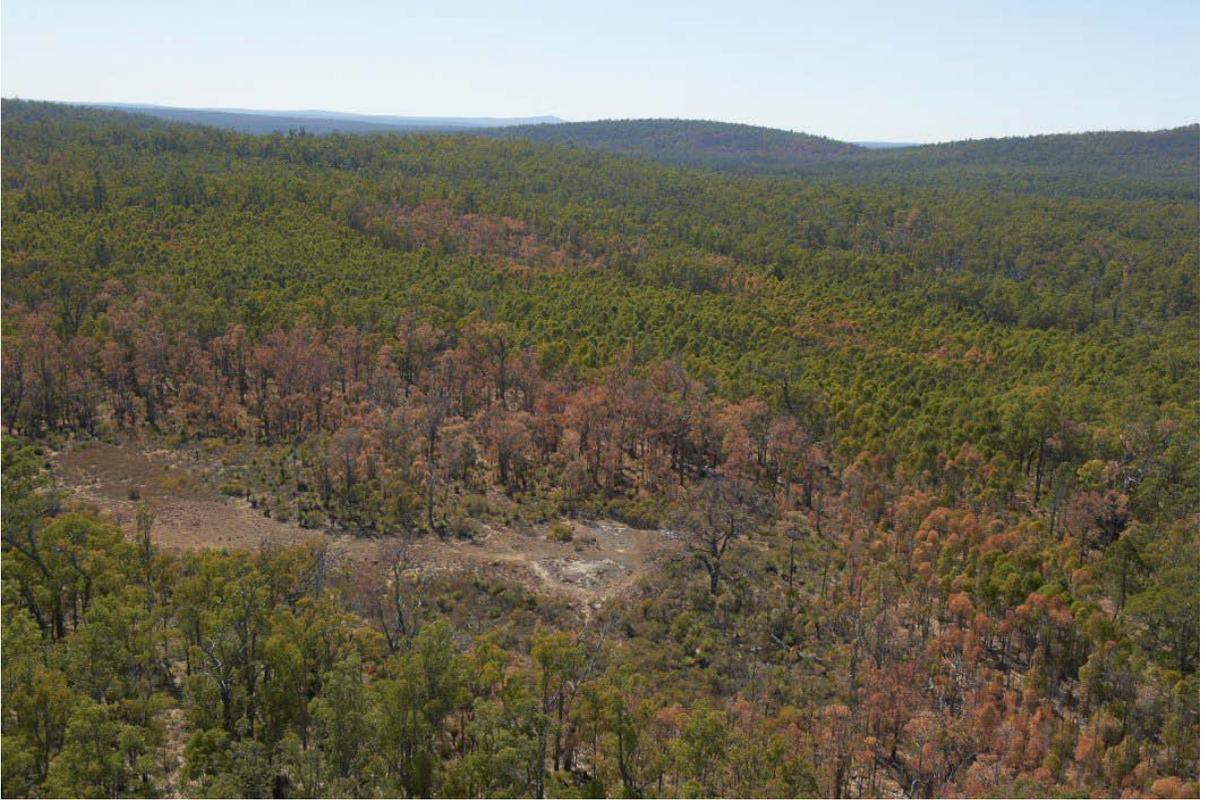
General site description: upper slope. Soil depth 30 cm; the soil is sandy gravel. General view Figure 20.

Figure 20. General aerial view close to Site N7, showing rocky outcrop in the foreground.

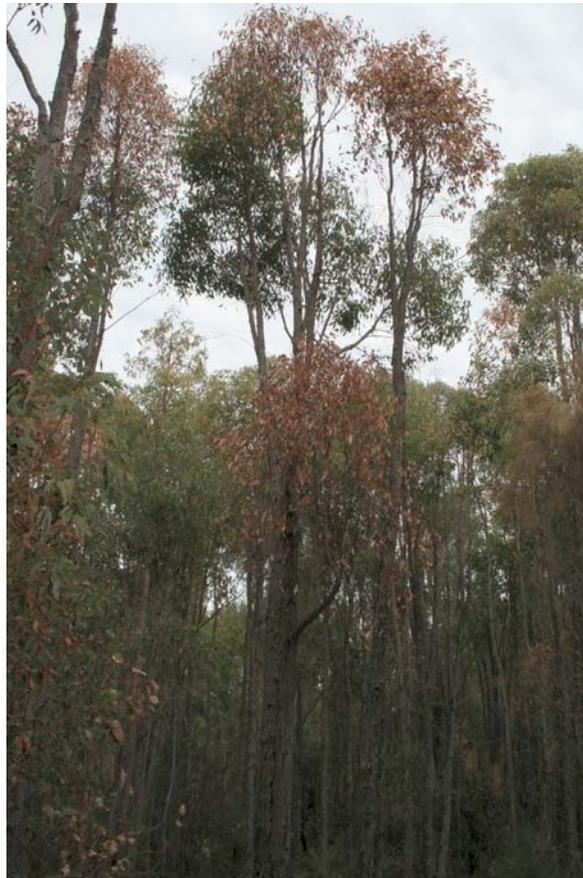
Health status: some dead jarrah (Fig. 21) and casuarinas trees, but the majority are healthy, although there were some past deaths in 2007 (F. Batini pers. comm.).

Pest or pathogen attack: borer larvae in some trees, no sign of pathogenic invasion

Figure 21. Site R1. Showing a small area of recent jarrah deaths.

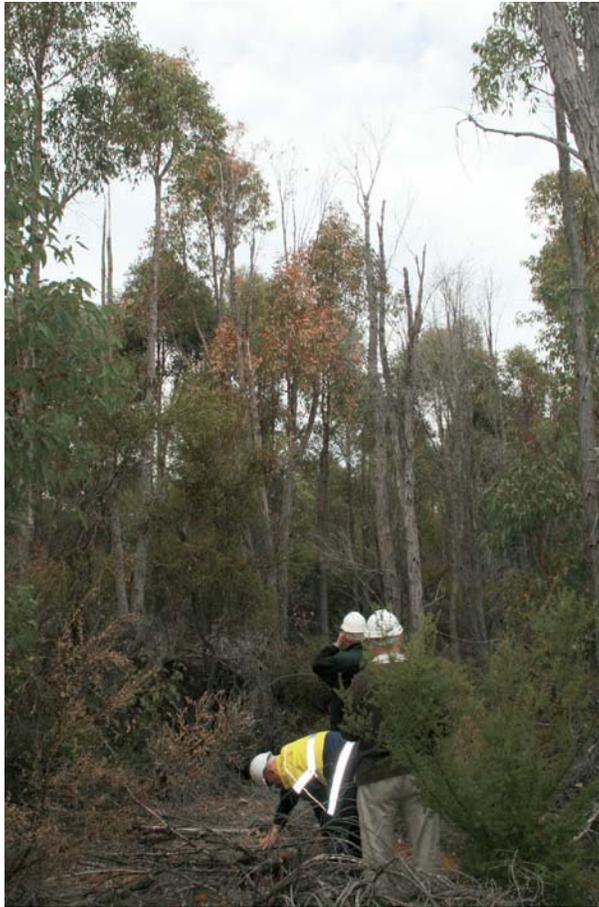
Health status: small patch of dead jarrah trees (Fig. 22), but the majority appear healthy, although there were past deaths in 2007 (F. Batini pers. comm.).

Figure 22. Site R2. Small area of dead jarrah crowns in an area where deaths had occurred in the past.

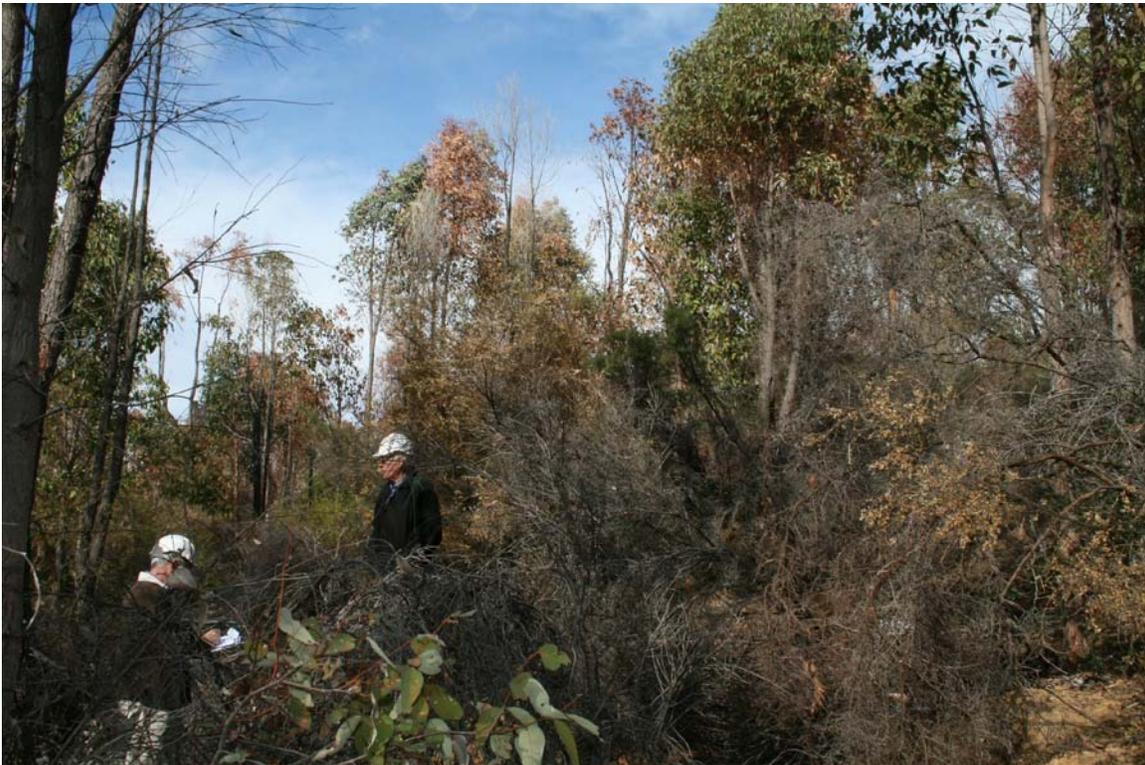
Health status: some dead jarrah trees (Fig. 23), but the majority are healthy, although there have been some past deaths.

Pest or pathogen attack: no borer larvae seen, no sign of pathogenic invasion. One tree reshooting at the base.

Figure 23. Site R3. Recent jarrah deaths.
