1 **Experimental Investigation of the Response of Precast Segmental Columns**
2 **Subjected to Impact Loading**

3 Xihong Zhang*, Hong Hao and Chao Li

9 **Abstract**

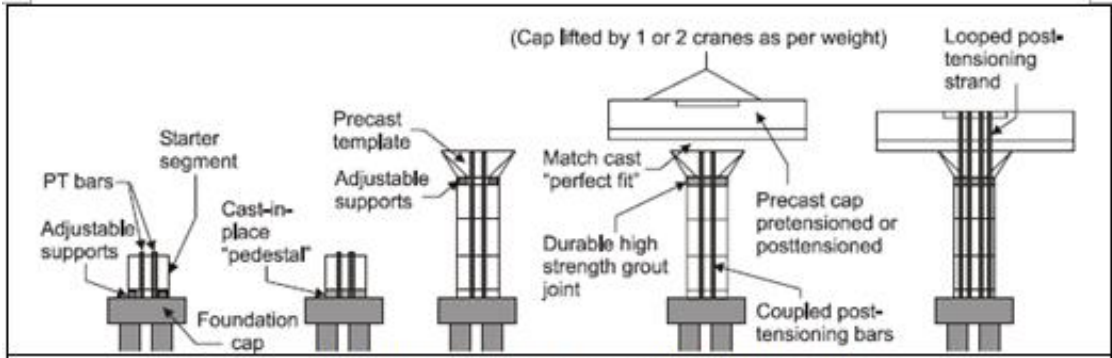
a) Erection sequence of a segmental column [4]

Figure 1 Ancient and modern constructions of segmental columns

41 Segmental columns have been popularly used in construction ever since ancient times.
42 Many iconic structures around the world today were built hundreds or even thousands of
43 years ago with segmental stone pillars, such as Brandenburg Gate, Germany built in 1788-
44 1791 (Figure 1b), Tempo in Rhodes island, Greece built around 7th Century B.C. (Figure 1c).
45 One of the earliest modern constructions that utilized precast segmental concrete elements
46 was Lavaca Bay Causeway, Texas, US in 1961 [1]. The application of precast segmental
47 columns has gained its popularity globally ever since. Numerous modern constructions have
48 successfully used precast segmental concrete columns. Examples of buildings and bridge
49 structures that employed segmental concrete columns can be found in reference [2, 3].
50 Despite all the above advantages, a major setback for precast segmental structures is that

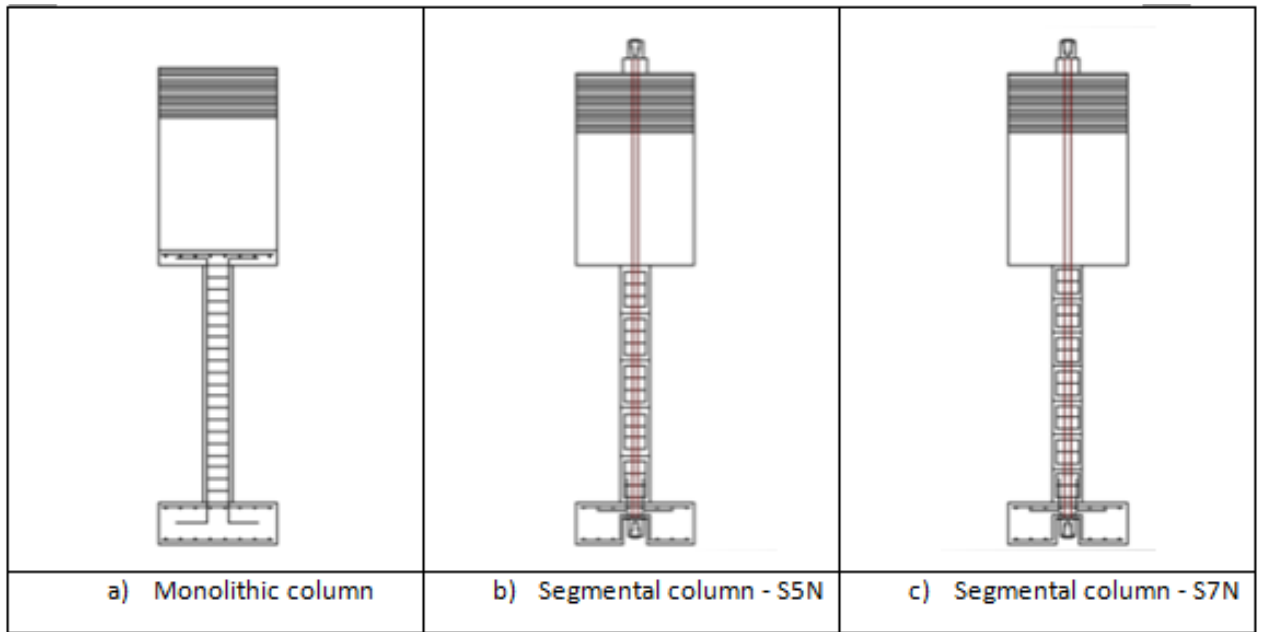
Figure 2 Schematic views of the test specimens

133 Figure 2 shows the schematic view of the three specimens. The columns were 800mm in
134 height and had squared cross-sections of 100mm x 100mm in dimension. The designated
135 dimension of the tested columns represented quarter-scale model of a 3.2m tall residential
136 column. The height of the tested columns was restricted by the dimension of the pendulum
137 impact testing system for the current experiment. Previous studies by Woodson and Baylot
138 [18, 19] have demonstrated the suitability of quarter-scale model for RC column with similar
139 dimensions subjected to blast loading. Column damage and response including load and
140 deflection were well measured in their tests. It is therefore believed the current adopted
141 scaled model could be able to properly represent the behaviour of segmental column under
142 impact loading. A footing of 140mm deep and 400mm x 400mm cross-sectional area was

143 built for each column to bolt them onto the strong floor. The monolithic column was cast
144 with a 400mm x 400mm x 50mm flanges at its top to support the added mass. A concrete
145 block of 400mm x 400mm x 450mm (L x W x H) in dimension together with 5 pieces of 23kg
146 steel plates was placed on top of the columns, which gave a total weight of about 288kg on
147 top of the column. The weight of the column itself is about 18kg. The ratio of the supported
148 weight to the column self-weight was therefore about 16. Due to the restraint of the testing
149 system, there was no space for additional mass to be placed on top of the columns. Also,
150 because of the nature of impact test, inertia force from the added mass cannot be replaced
151 by directly applying axial force. No axial force was applied in addition to the added mass. The
152 barrels and wedges on both ends of the prestress tendons were anchored inside the footing

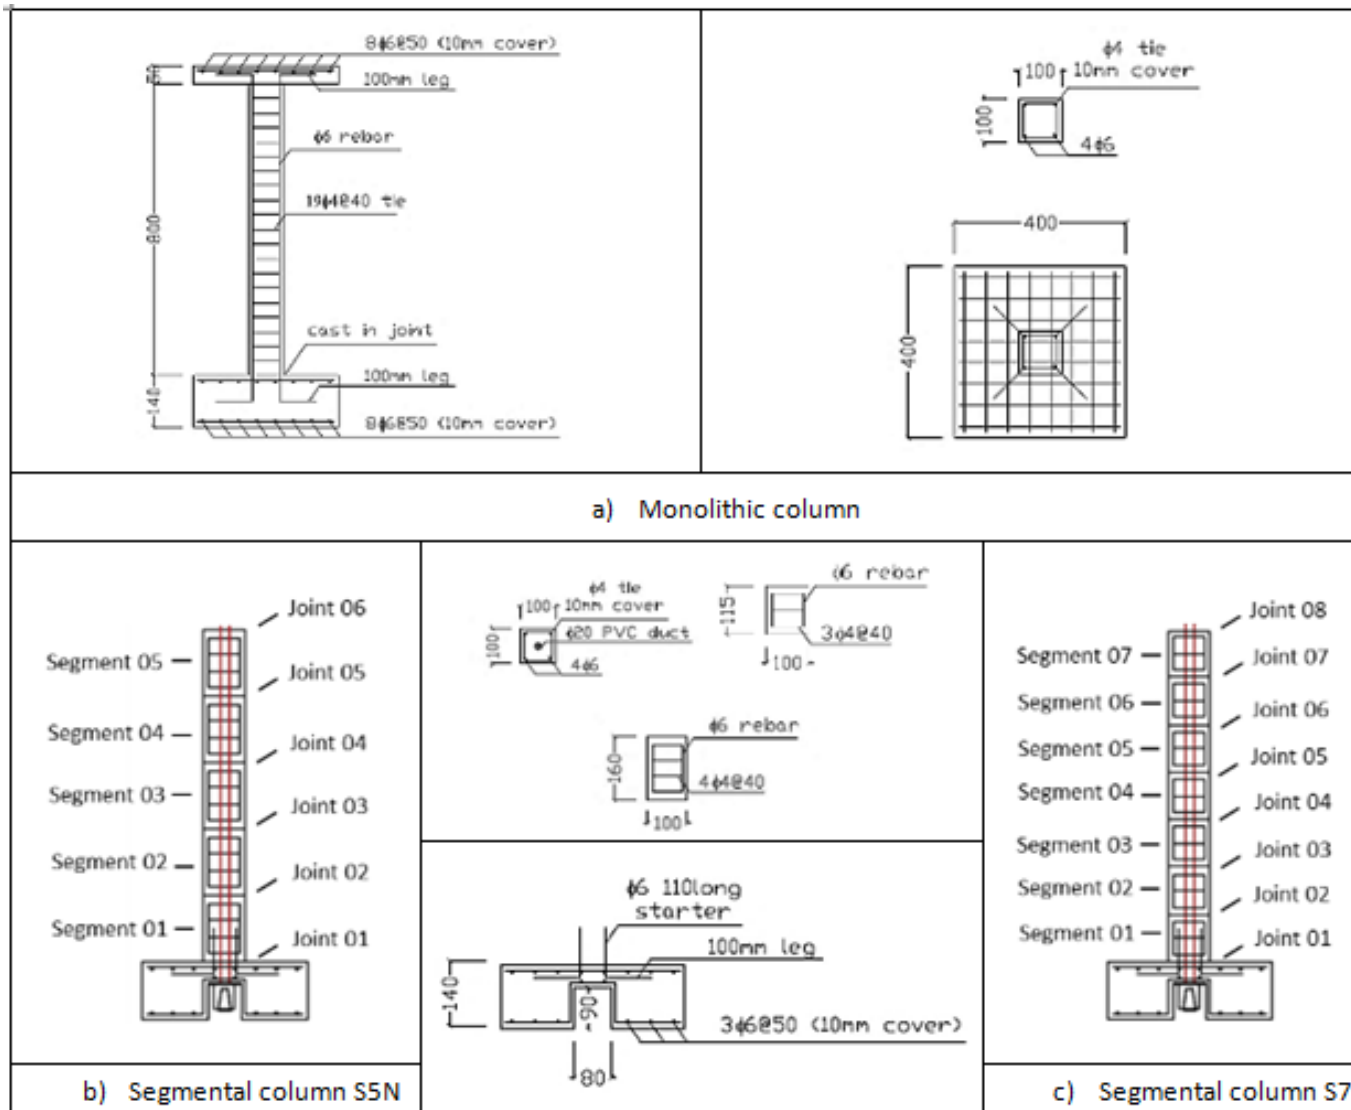
Figure 3 Details of the test specimens

154 Figure 3 depicts the details of the test specimens. For the monolithic column, 6mm
155 diameter longitudinal rebar was extended into the top flange and the bottom footing, which
156 created fully fixed boundary conditions for the monolithic column on both ends. The
157 segmental columns were connected to the footing using two 6mm diameter starter bars in
158 the direction of loading. No grout or epoxy was used to glue the base segment to the footing.
159 The top segment was left in direct contact with the concrete block above it. No
160 reinforcement or grout was used to connect the top segment and the concrete block. The
161 segmental column S5N included five pieces of 160mm tall reinforced concrete segments.
162 Four 4mm diameter ties at 40mm spacing were used to confine the concrete in each
163 segment. Column S7N comprised of seven segments of 115mm in height. 3 ties were
164 included in each segment. It is worth noting the previous studies on the seismic response of

229 group of five dots were glued to the same heights on the monolithic column. And similarly
230 seven tracking dots were used for column S7N. The high-speed camera images were post-
231 processed using digital image correlation software to derive the column displacement time
232 histories at these tracking dots. For easy interpreting the test results, the segments and
233 joints are numbered as Segment 01-07 and Joint 01-08 respectively (as depicted in Figure 3).

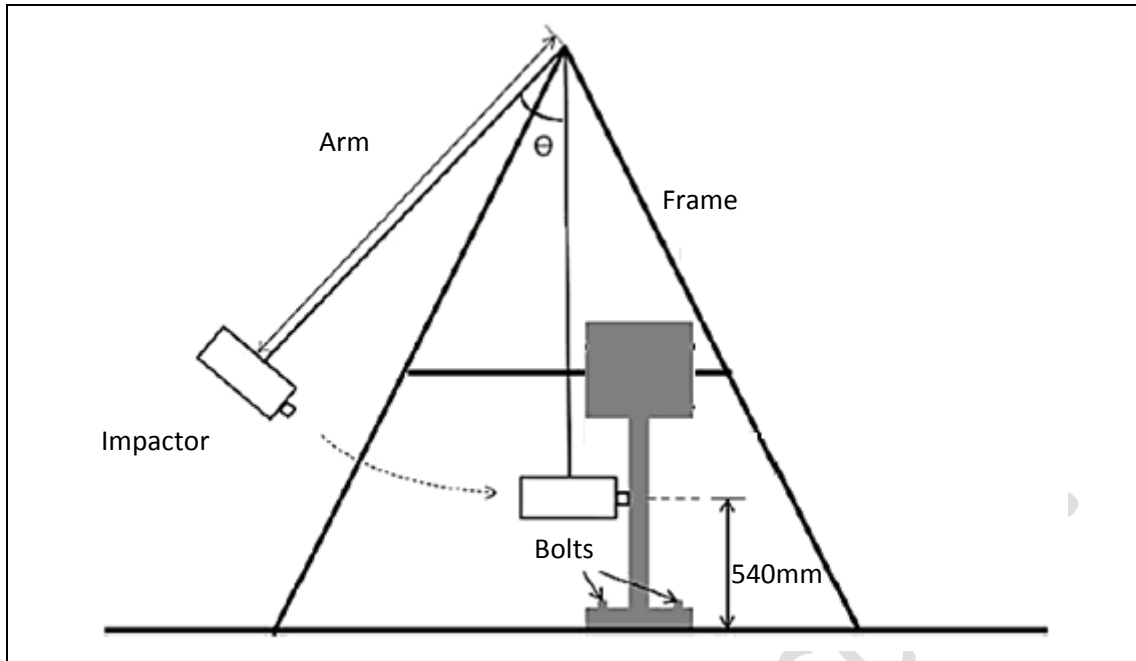
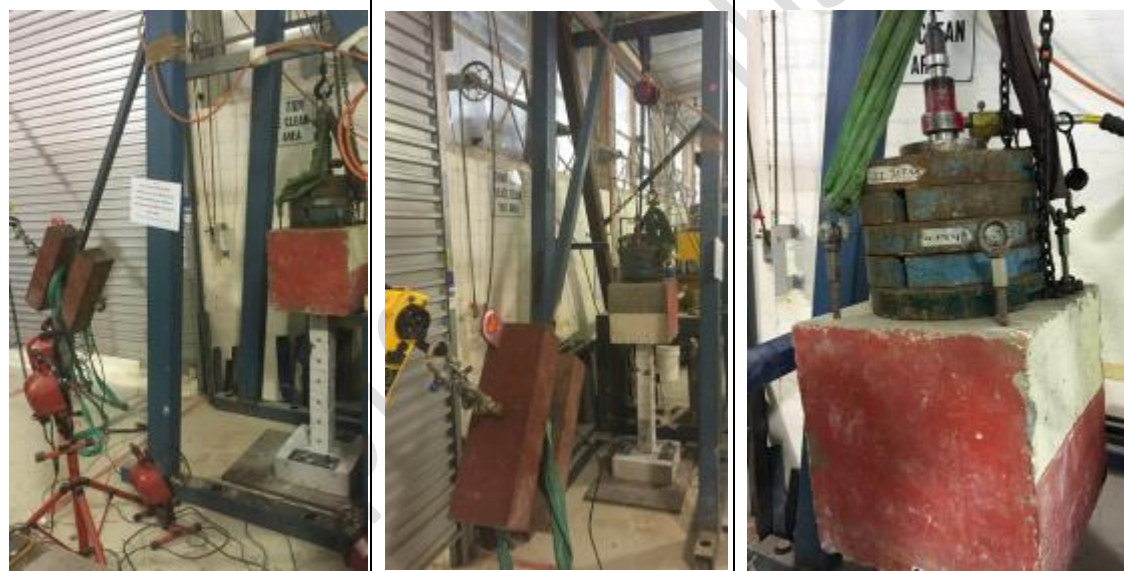
a) Schematic view of pendulum impact system

b) The ready-to-go impact system and setup details

Figure 5 Pendulum impact system and the test setup

210 Pendulum impact system was utilized in the current test. The pendulum impact system
211 consisted of a steel frame, a pendulum arm, an impactor, and an inclinometer. As shown in
212 Figure 5, the steel frame was fixed on the strong floor to support the entire test system. A
213 300kg steel impactor was connected to the frame through a 2.8m long pendulum arm. In
214 each test, the impactor could be lifted to a desired height (quantified through the lifting
215 angle) and then released to strike the mid-height of the column. After the impactor hit the
216 column and rebounded, the impactor was pulled back immediately to avoid a second impact
217 on the column.

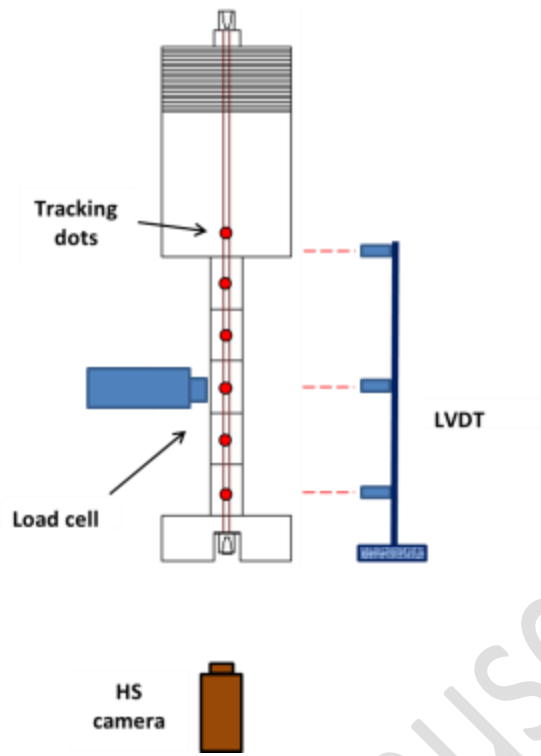
Figure 6 Measurement system for the pendulum impact test

218 Figure 6 illustrates the measurement system. To measure the applied impact load a 25t
219 load cell was fixed in front of the impactor. The load cell was calibrated on Baldwin universal
220 testing machine. Three laser Linear Voltage Displacement Transducers (LVDT made by
221 Keyence) were placed at column mid-height, column top and near column base behind the
222 test specimens. The LVDT has a measuring range –of 150 mm each direction. The sensors
223 were wired to a NI USB-9237 acquisition system and the data were captured at a sampling
224 frequency of 50 kHz. A high-speed camera (Photron SA-Z) was installed to monitor the
225 deformation-to-failure process of the columns. The filming rate of the high-speed camera
226 was set to 8000fps. The exposure time was set to balance with the aperture. Four halogen
227 lights were used to provide intensive light for high-speed filming. Five tracking dots were

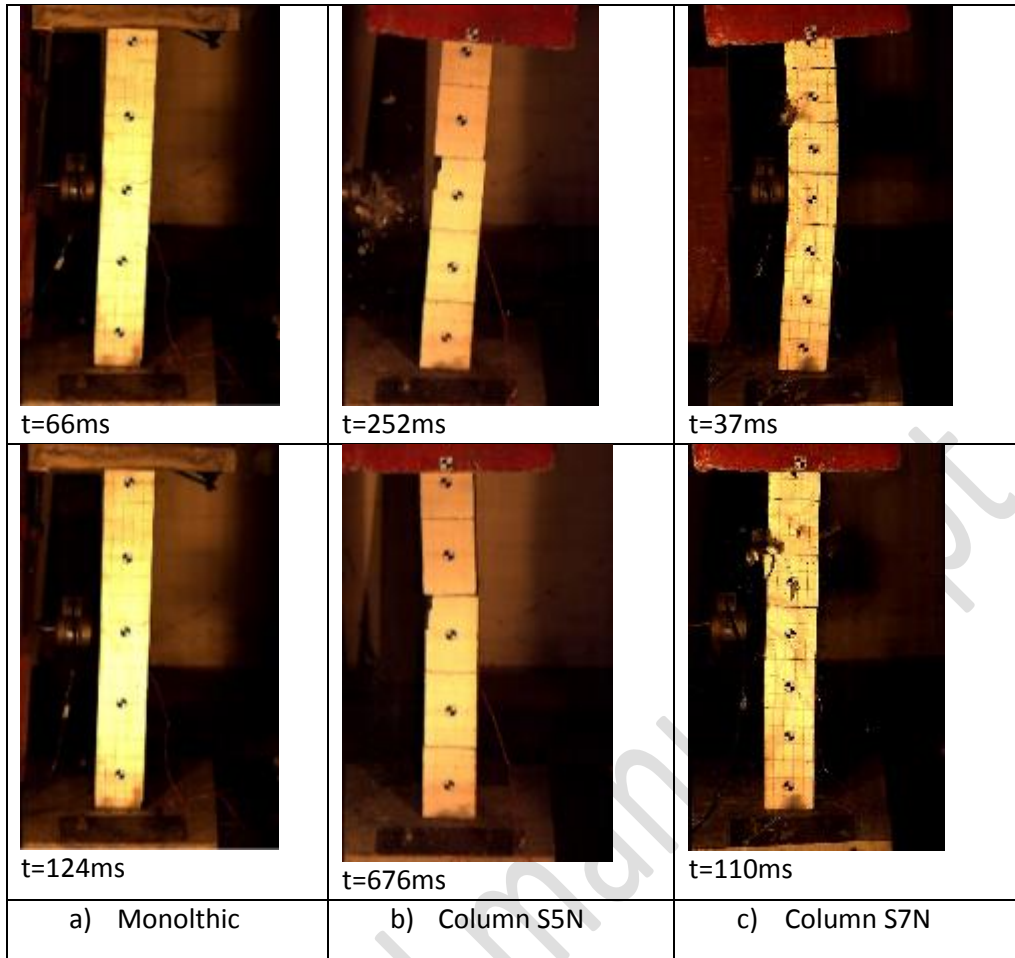
Figure 8 High-speed camera images of columns in Impact 03

250 The response of each column under the strike of the impactor was monitored by a high-
251 speed camera. Figure 8 and Figure 9 show the deformation-to-failure processes of the
252 columns under progressively increased impact loading. Since the impact loads were
253 relatively small in Impact 01 and 02 none of the columns experienced any significant

299 S5N in Impact 02. No apparent damage was found on this segmental column after Impact 02.
300 When the impactor was released at 15 degree, damage to the segmental column appeared.
301 As shown in Figure 8b, at $t=5\text{ms}$, as the flexural induced compressive stress in the concrete
302 exceeded its compressive strength, concrete crack was formed on the top left corner of
303 Segment 03. As the impactor forced the column to further deform and bend, the concrete
304 crack extended. At $t=45\text{ms}$, the top left corner of the segment failed due to compression. An
305 apparent joint opening was found between the Segment 03 and 04. The joint opening

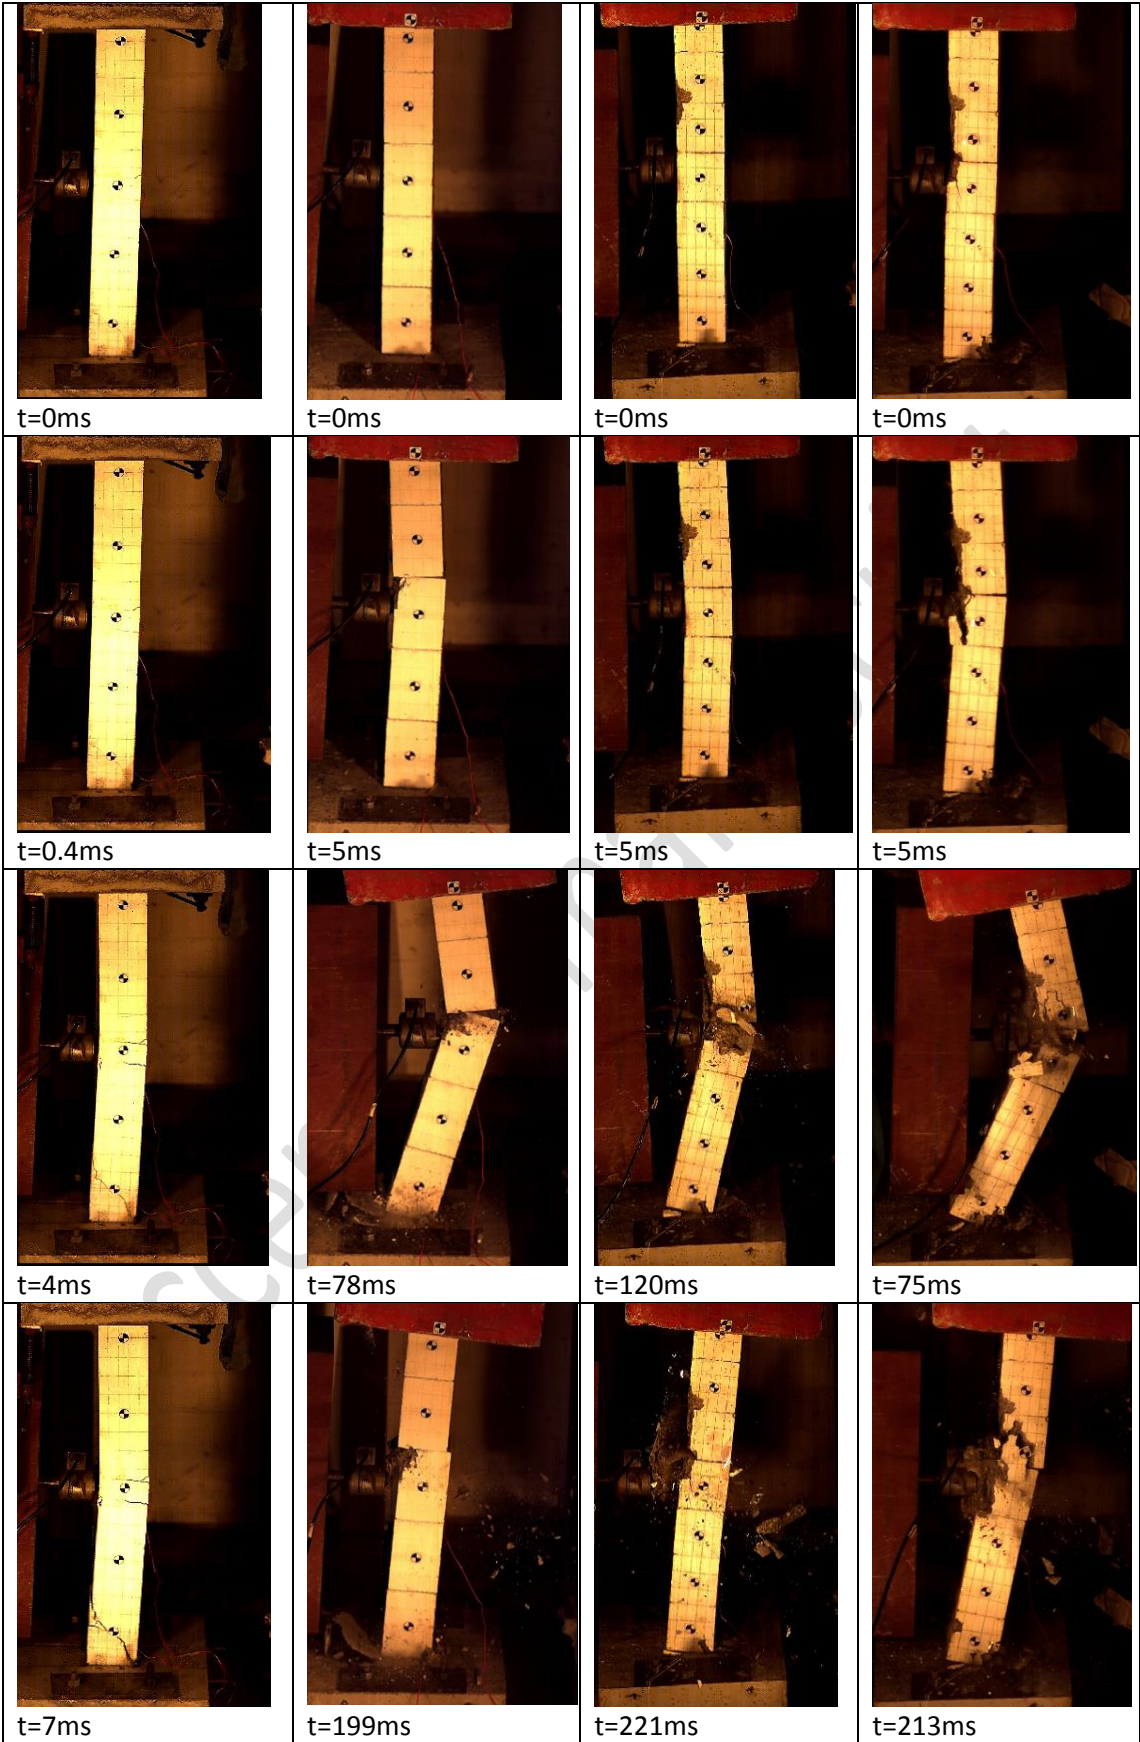
Figure 9 High-speed camera images of columns in Impact 04 and 05

280 Impact 04. As shown in Figure 9a, upon the impactor struck onto the column the existing
281 cracks around the mid-span opened and began to extend at $t=0.4\text{ms}$. As the impactor forced
282 the damaged column to further deform laterally, flexural cracks grew into major cracks and
283 quickly extended across the central part of the column, and concrete crush occurred on the
284 other side of the column ($t=4\text{ms}$). The significant lateral impact loading also widened the
285 existing shear crack near the column base. A complete concrete shear failure occurred at
286 $t=7\text{ms}$, and the shear force was merely resisted by the reinforcement. A total column
287 collapse was observed at $t=57\text{ms}$ with a flexural bending failure at the centre and base of
288 the column and also a thorough diagonal shear failure near the base of the column.

332 further increased impact load by releasing the impactor at 30 degree (Figure 9c), the centre
333 of the column was forced by the impactor to bend significantly. More severe concrete
334 crushing failure occurred on Segment 04 and 05 at $t=120\text{ms}$ because of the large flexural
335 induced compressive failure and also the large impact force from the impactor directly.
336 Some compressive damage on the base segment (Segment 01) was also found as the column
337 rotated against its base. An opening could be observed in the base joint (Joint 01) as the
338 column experienced large flexural bending. Despite the damage to concrete in some
339 segments, after free vibration column S7N still managed to survive the impact with obvious
340 residual deformation. A final impact (Impact 05) was then carried out on column S7N to
341 examine its ultimate impact resistance capability. Figure 9d shows the deformation-to-

342 failure process of the column. As can be seen, Segment 04 in the middle of the column was
343 badly smashed by the impactor. As the column bent, Segment 05 was seriously crushed due
344 to the extreme flexural bending. The base segment was also severely damaged in its
345 compressive surface as it rotated around the footing (Figure 11). Plastic deformation was
346 formed in the starter bar, and after Impact 05 column S7N was left with large residual
347 deformation. Because the compressive damage extended to the neutral axis in Segment 05,
348 the segments and the added mass above Joint 05 lost its stability and the column was
349 considered failed completely.

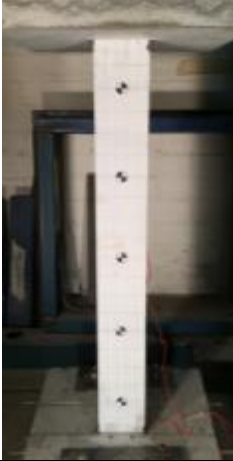
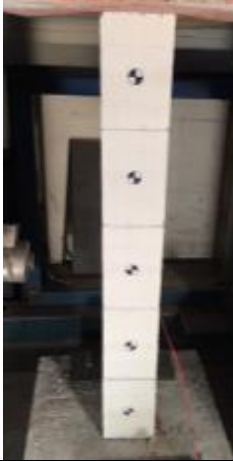
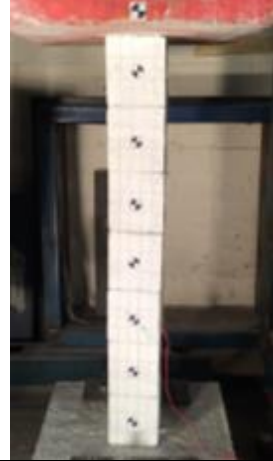
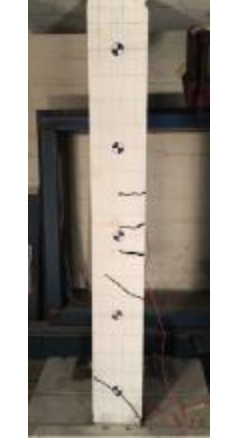
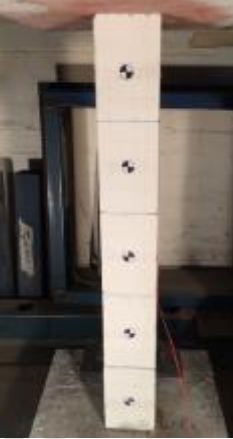
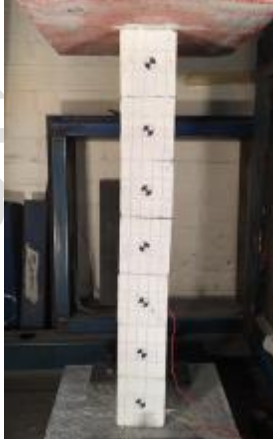
Monolithic	Column S5N	Column S7N
a) Post-impact status of columns after Impact 01

Monolithic	Column S5N	Column S7N
b) Damage to columns after Impact 02

Monolithic	Column S5N	Column S7N
c) Damage to columns after Impact 03

Figure 11 Post-impact status of columns

279 widened under the impact loading (Figure 11a). Catastrophic column failure was resulted in

351 The failure of the monolithic column was governed by flexural failure and shear failure.
352 As the level of impact load increased, flexural tensile damage to concrete in the rear face of
353 the monolithic column was observed in Impact 02 (Figure 11b), which grew into major
354 critical cracks (Figure 11a). The tensile cracks led to the flexural failure of the column (Figure
355 11d) when the impact load was further increased. Diagonal shear failure near column base
356 was also found in the monolithic column which also initiated in Impact 02 (Figure 11b). As

369 concrete segment take the compressive force. When starter bars were used to connect the
370 base segment and the footing, which was quite commonly adopted in seismic design so as to
371 improve energy dissipation capability, the force transferred to the footing would increase.
372 Damage to footing was therefore more likely to occur (Figure 11d).

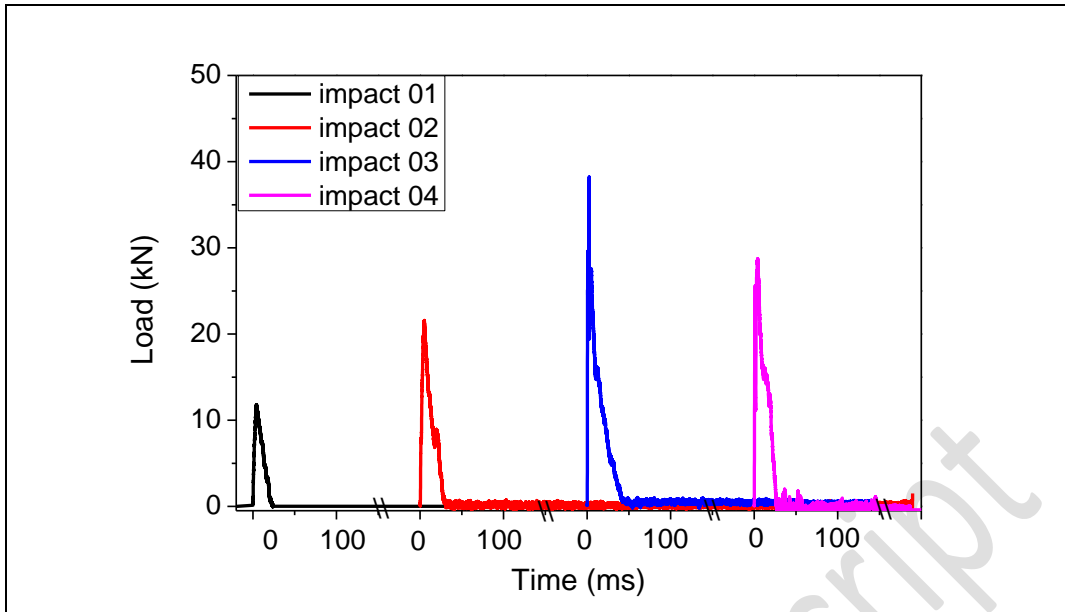
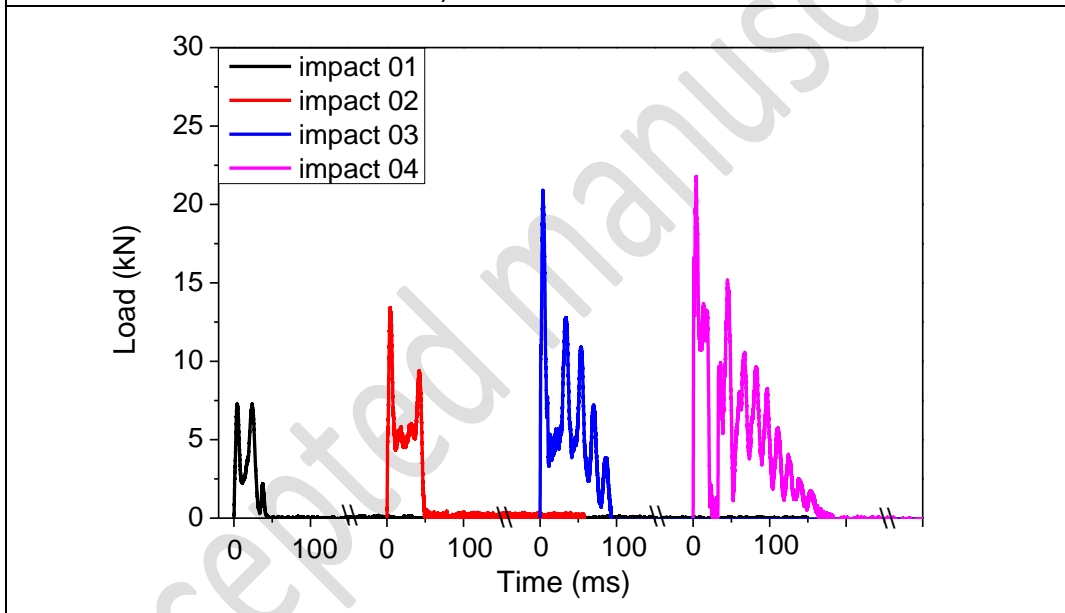
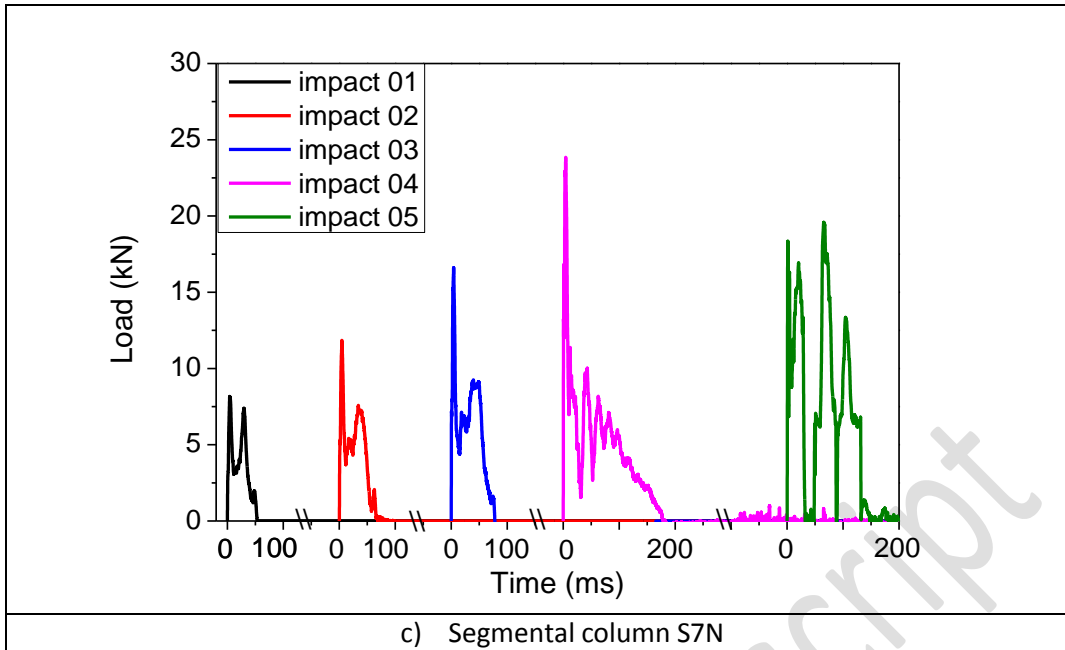
a) Monolithic column

b) Segmental column S5N

c) Segmental column S7N

Figure 12 Load time histories

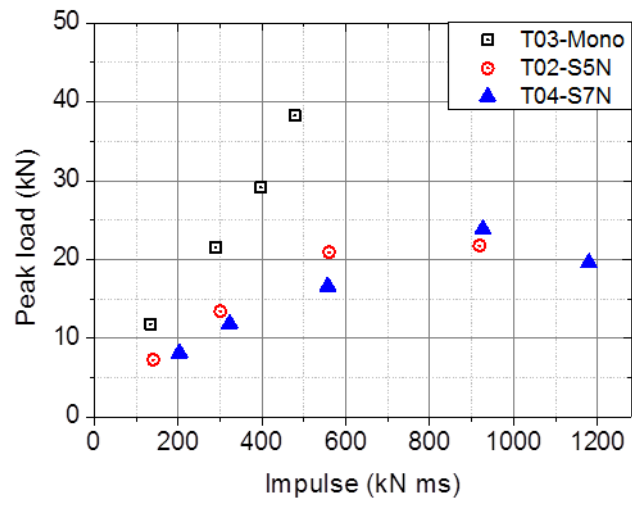
Figure 15 Peak impact loads vs. impulses

569 The recorded peak forces and the derived impulses are summarized and plotted in Figure
570 15. As shown, when the impactor of the same weight struck with the same impact velocity
571 (same releasing angle), higher peak forces were always observed on the monolithic column
572 than that on the segmental columns. But similar or even larger impulses were always found
573 on the segmental columns because of longer impact duration. The peak forces on the
574 segmental column with five segments were slightly higher than that on the one with seven
575 segments. This is because the stiffness of column S5N was relatively higher than that of
576 column S7N with more joints.

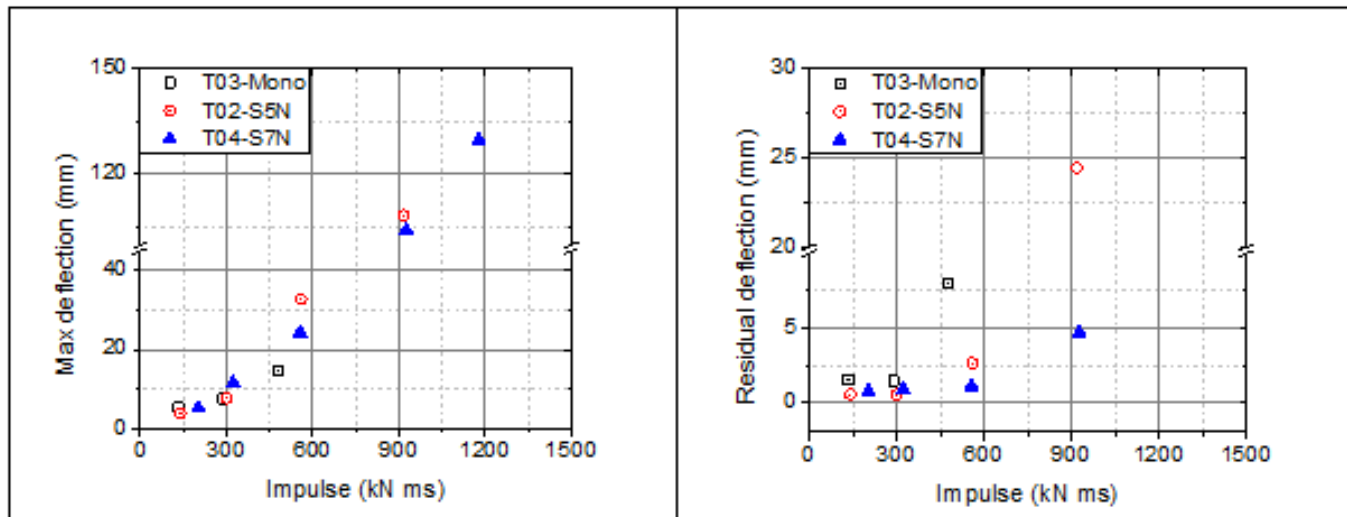
Figure 17 Maximum central deflection and residual deflection versus impulse

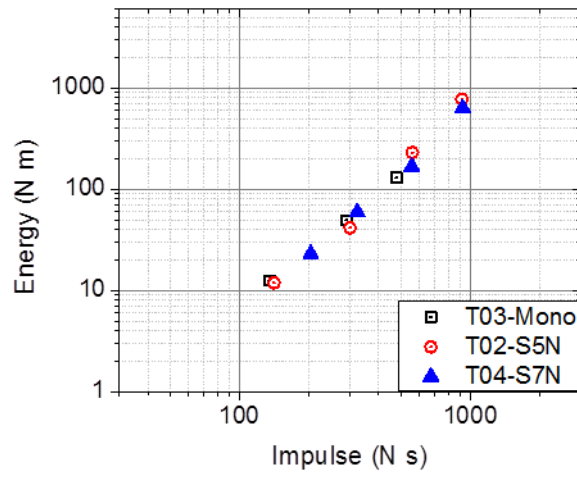
648 Energy absorption is another important parameter in evaluating column impact
649 resistance capability. The energy absorption depends on the load and deformation history
650 rather than the permanent deformation. Figure 18 shows the impact load versus column
651 central deflection for the three columns in each impact. The enclosed area by the load and
652 deflection curve represents the energy dissipated through column deformation and damage.
653 According to Figure 18, the impact loads on the monolithic column are in general higher
654 than those on the segmental columns. But the deformations of the segmental columns are
655 always larger. It is therefore not straightforward to directly assess the energy dissipation
656 capabilities of the columns. The dissipated energy derived from the enclosed area of the
657 load-deflection curves are plotted against the impulses. As shown in Figure 19 when the

658 applied impulses were relatively low, very similar levels of the energy were dissipated by the
659 monolithic column and the segmental column. The monolithic column failed at the impact
660 with an impulse of about 480kN ms, but the two segmental columns were still capable of
661 resisting impact loads and dissipating more energy. The monolithic column dissipated the
662 impact energy mainly through plastic deformation of reinforcement and damage of concrete.
