Comparative study between wear of uncoated and TiAlN coated carbide tools in milling of Ti6Al4V

Abstract:

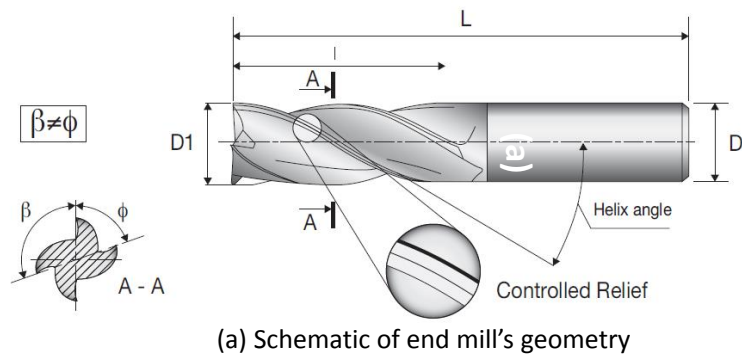
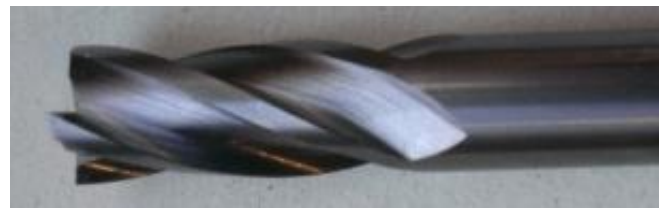
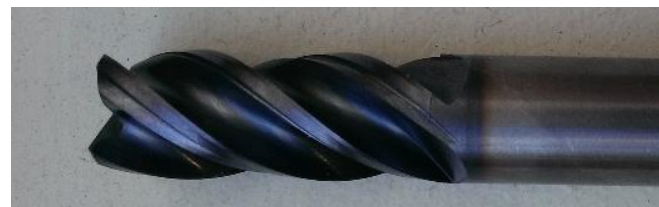
Fig. 1 Tungsten carbide end mills used in the tests

As cutters, two types of tungsten carbide end mills are used. One is uncoated (Hanita D014 supplied by Wahida Inc. Japan) and the other coated with TiAlN by physical vapour deposition method (KCPM 15 supplied by Kennametal Inc. USA). The geometric dimension of both cutters is as follow: diameter $D_1 = 12$ mm, no of flutes = 4, total length, $L = 83$ mm, working length, $l = 26$ mm, helix angle = 30° , axial rake angle = 6° and secondary clearance angle = 15° . Figure 1 shows photographs of both coated and uncoated carbide cutters used. The physical and mechanical properties of the tungsten carbide and TiAlN coated tools are summarized in Tables 3 and 4. Before actual cutting tests, the edges of the cutters are observed to be sharp and clean without any dirt and contaminants.

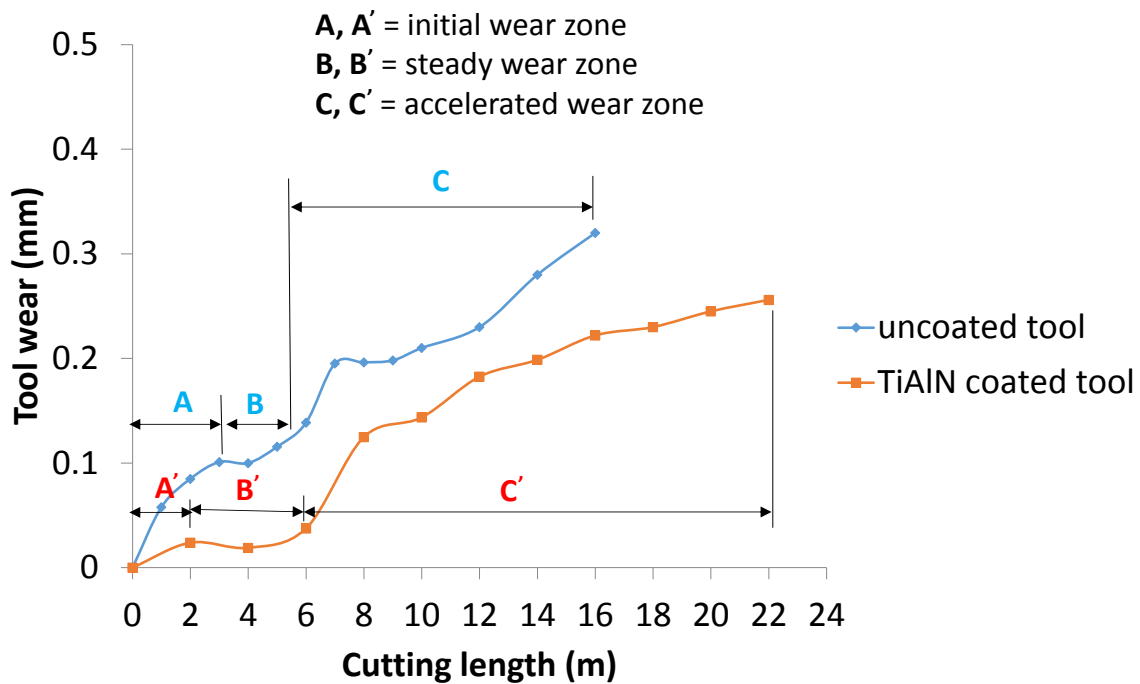
Fig. 3 Comparison of uncoated and TiAlN coated tool wear progress as a function of cutting length

The main focus is to investigate tool wear and wear mechanism associated when machining of titanium alloy. In general, cutting tests continue until the tool reaches a standard failure criterion (i.e. average flank wear = 0.3 mm for carbide tool). Figure 3 depicts a comparison of tool flank wear progression with respect to the cutting length for uncoated and coated tools. It can be seen from Fig. 3 that, as the cutting length increases, TiAlN coated carbide tool

exhibits a lower wear than the uncoated tool. For instance, after cutting of about 10 m, the coated tool reaches wear value of 0.1436 mm, which is about 32% smaller than that of uncoated tool (wear = 0.21 mm). The coated tool can cut up to 22 m in length with wear progression of about 0.23 mm, while the uncoated tool reaches wear of about 0.321 mm (i.e. failure criterion) at a shorter cutting distance of 16 m. In other words, overall the coated tool, after cutting of 16 m, shows an enhancement of tool life by about 44% over its counterpart. Further, generally a cutting tool follows a three region wear characteristics – (1) initial wear zone with relatively high wear, (2) steady state wear region and (3) accelerated wear region leading to failure [20]. As shown in Fig. 3, both uncoated and coated tools show approximately three wear zones as indicated by **A-B-C** and **A'-B'-C'** areas, respectively. Initial wear rate of the uncoated tool is larger than that of the coated tool as the slope of curve in 'A' zone is shown to be relatively high. Further, the steady state wear region for the uncoated tool starts after about cutting distance of 3.5 m, while for the coated tool it starts after cutting of 2 m and the stability of the region is longer as compared to that of the uncoated one. This indicates that the TiAlN coated tool exhibits a better tool life or wear resistance and can be safely used for more cutting length in machining of titanium alloys. Moreover, the findings are quite consistent with those of other researchers, e.g. [21], [22].

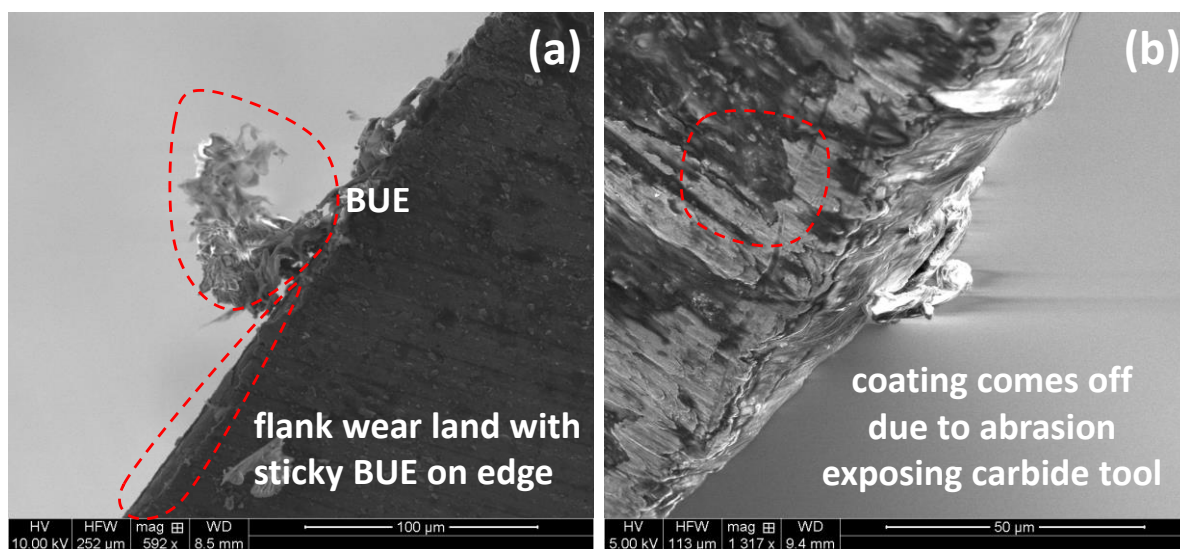
Fig. 5 Wear land and mechanism of TiAlN coated carbide tool at a cutting length of 16 m

16
17 At the same cutting distance, interestingly the cutting edge of the coated tool appears to be
18 very smooth with very small or minor wear marks on the flank land, as shown in Fig. 5(a).
19 Observed gradual flank wear can be due to the increased wear resistance of the TiAlN
20 coating during continuous abrasion of the tool with the workpiece. Similar progressive wear
21 on flank land for the coated tool in cutting of titanium was reported by Dhar et al. [21]. No
22 significant chipping and fracture on the cutting edge were observed; but, similar to uncoated
23 one, sticky BUEs are noticed on the cutting edge. However, it is to be noted that the coating
24 on the cutting edge appears to come off due to the continuous abrasion between workpiece
25 (including BUE) and tool (Fig. 5(b)). As reported by Konig et al. [23], accelerated adhesion
26 takes place after the coating has been removed due to prolonged cutting. In such case, the

7
8
9 As seen in Fig. 5(b), TiAlN coating is potentially expected to be diffused and taken away
10 from the cutting edge, and the part of the tool which is engaged with the workpiece thus
11 becomes uncoated, causing the tungsten carbide being exposed to the cutting zone. This can
12 be further supported by the presence of fairly large amount of Ti on the tool edge detected by
13 EDX, as illustrated in Fig. 6. Diffusion of coating materials into workpiece/chips resulting in
14 tool failure is reported by researchers. In an extensive study by Odelros and Stina [25], EDX
15 analysis revealed a high content of Ti in particles adhered to the cutting tool, indicating the
16 detected Ti content is due to the underlying chemical reaction between the coating material
17 and titanium alloy. It is to be noted that these adhered layer of materials (often termed as
18 BUE) further cause abrasion between the tool and cutting chips/workpiece, hence resulting in

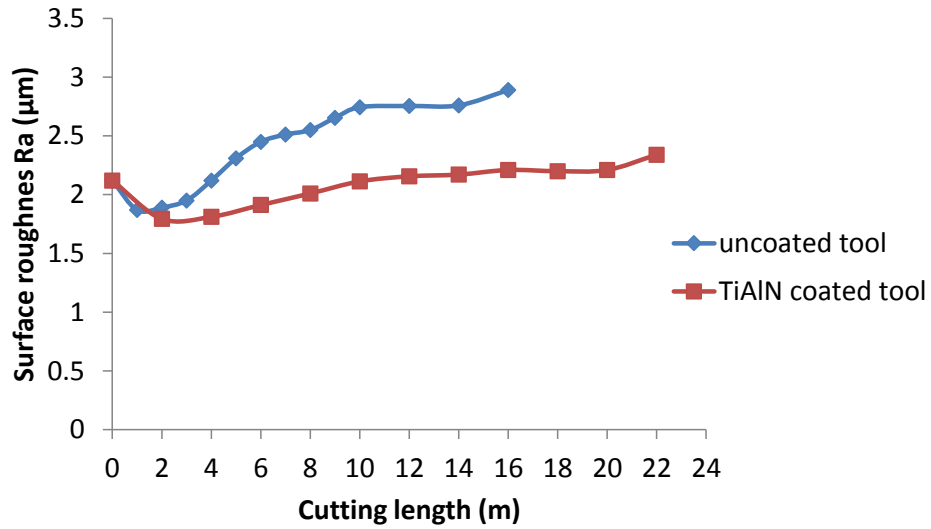
Fig. 7 Comparison of surface roughness between uncoated and TiAlN coated tools

- The TiAlN coated tool generates smooth machined surface with a 31% lower roughness (R_a) over the uncoated tool. As is expected, both tools generate the serrated chips; however, burnt chips with blue colour are noticed for the uncoated tool as the cutting continues further.

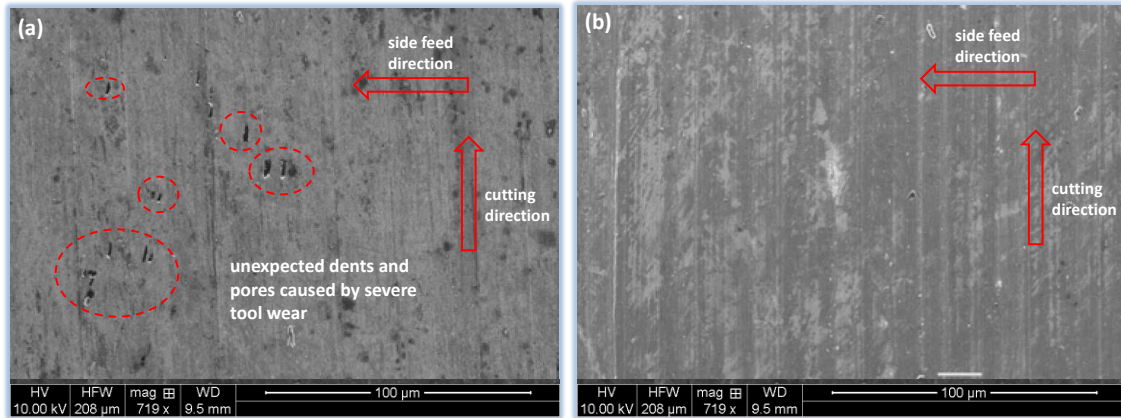
Fig.8 SEM photos of machined surface topology at a cutting distance of 16 m for (a) uncoated tool and (b) TiAlN coated tool

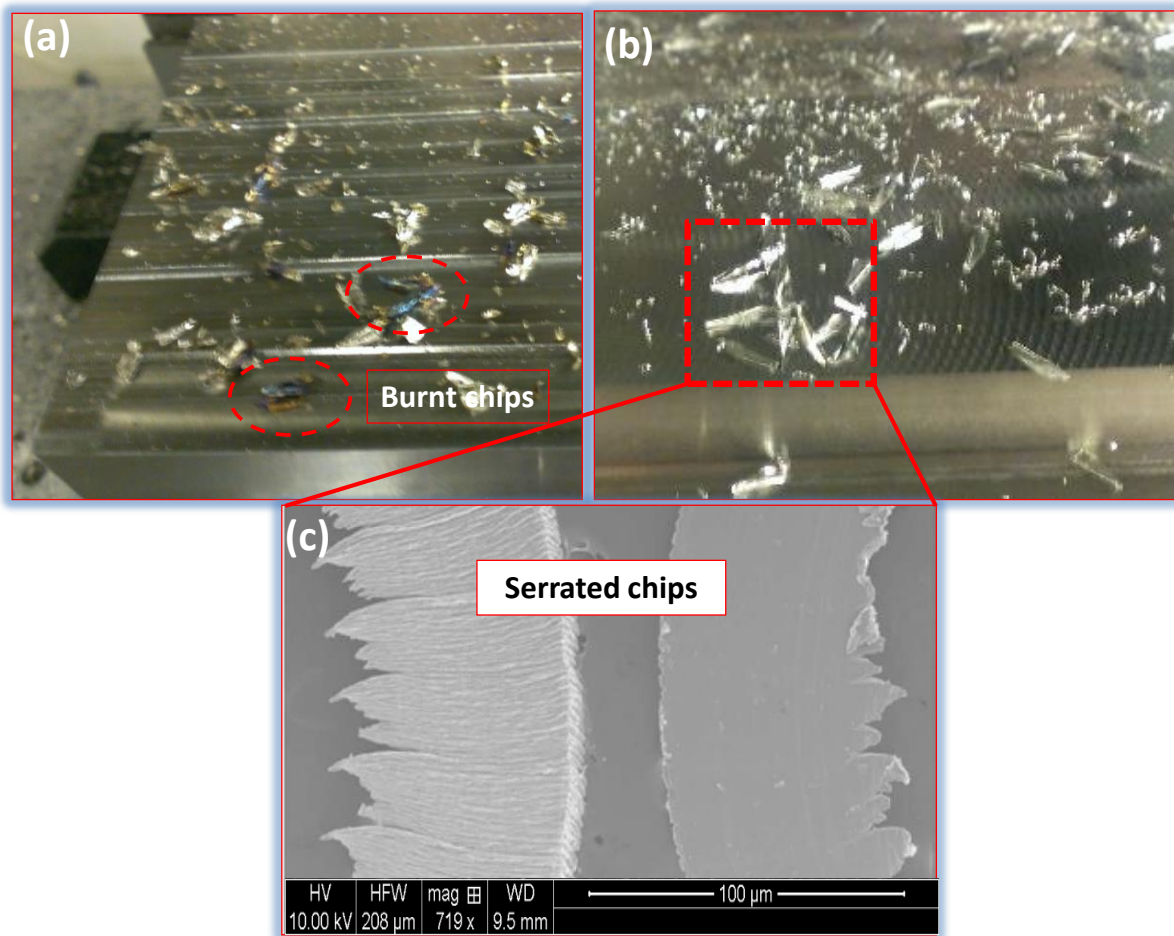
Fig. 9 Optical microscopic photos of chips formed by (a) uncoated tool, (b) TiAlN coated tool at a cutting length of 16 m and (c) magnified SEM photo of the chips

Further, cutting chips or swarf generated at the cutting zone were collected and observed by the optical microscope. **Figure 9** shows the chips generated by uncoated and TiAlN coated tools at a cutting distance of 16. More discontinuous and fracture chips are noticed for the uncoated tool (**Fig. 9(a)**). Further, burnt chips with blue colour are observed. This can be due to the heat generated at the cutting zone of the blunted tool due to wear. On the other hand, the coated tool generates fairly continuous and unbroken chips (**Fig. 9(b)**). Interestingly, chips generated by both tools appear to be saw tooth or serrated type, as can be seen in **Fig. 9(c)**. Mechanisms and modelling of serrated chips generated during cutting of titanium alloys were widely well reported and confirmed by many research works in literature [28]–[31]. It is shown that the small initial chip thickness and large rake angle affects the generation and

1 geometry of regular serrated chips [32]. While the initial thickness is related to the feed rate
2 to be chosen, the actual chip thickness during the cutting can be affected by the cutting edge
3 of the tool associated. Therefore, it is possible that the severe tool wear at the cutting edge
4 may influence the geometry of serrated chips. Hence, in order to minimize the serrated
5 chipping, tool wear must be regulated to the acceptable level without sacrificing the
6 machining productivity. With this aim, one possible solution is to develop prediction model
7 of energy efficient machining of titanium alloys by controlling inherent cutting temperature
8 and vibration generated [33], which will allow choosing the optimum machining conditions
9 including cutting parameters to enhance the tool life.
10
11
12
13
14
15
