Western Australian School of Mines

Corrosion of Rock Reinforcement in Underground Excavations

**This thesis is presented for the Degree of
Doctor of Philosophy
of Curtin University of Technology**

February 2008

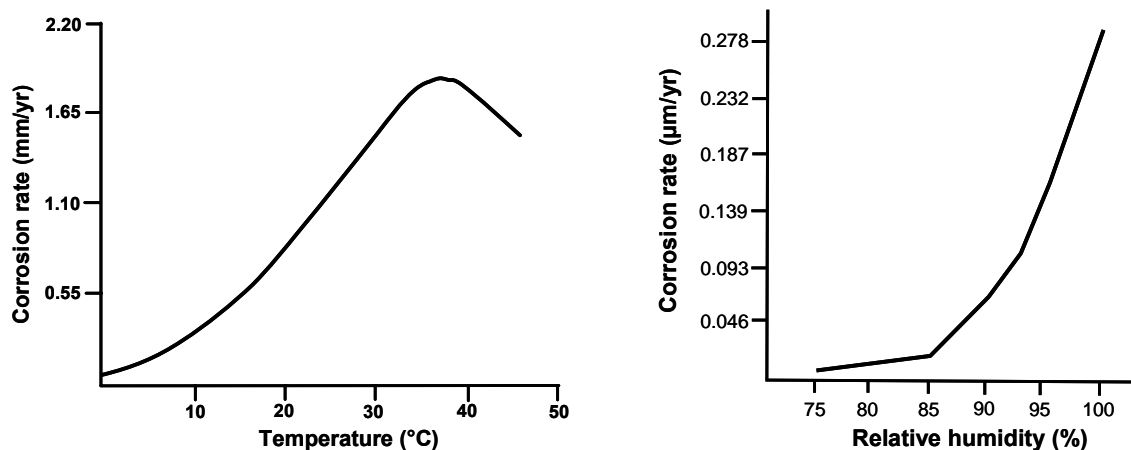
For iron, the critical humidity appears to be about 60%; at this level, rust slowly begins to form. At 75 to 80% relative humidity, there is a sharp increase in corrosion rate that is speculated to occur because of the capillary condensation of moisture within the rust corrosion product layer. At 90% relative humidity, there is another increase in the corrosion rate corresponding to the vapour pressure of ferrous sulphate. The critical relative humidity for zinc appears to be between 50 and 70%.

Figure 2.3 The influence of temperature and relative humidity on atmospheric corrosion (Roberge 2000).

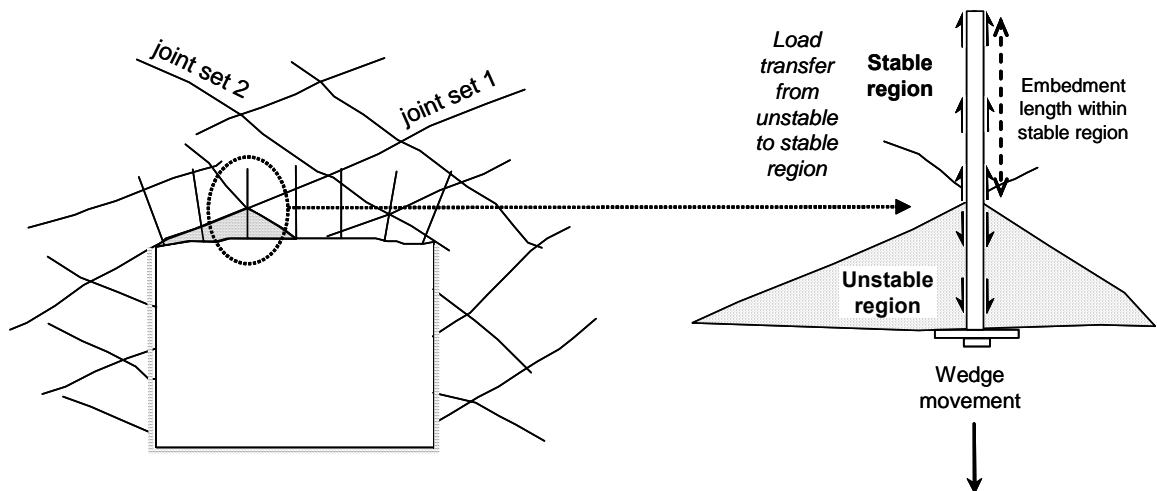
A supported rock block may fall due to failure of any of the three separate components of load transfer due to insufficient steel capacity (rupture of the reinforcing element) or inadequate load transfer (slippage). The critical embedment length is the minimum length of reinforcement that is needed to mobilise the full capacity or strength of the bolt.

Figure 2.8 Load transfer and embedment length concepts (Villaescusa & Wright 1997).

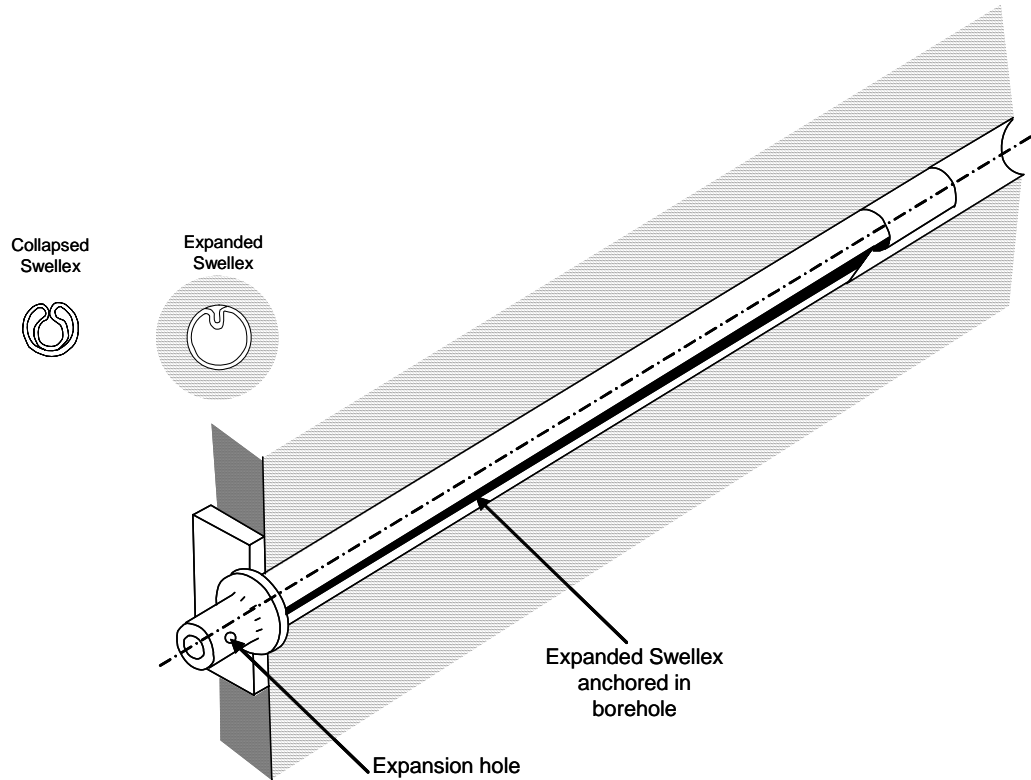
Figure 2.11 The components of the Swellex bolt (Hoek, Kaiser & Bawden 1995).

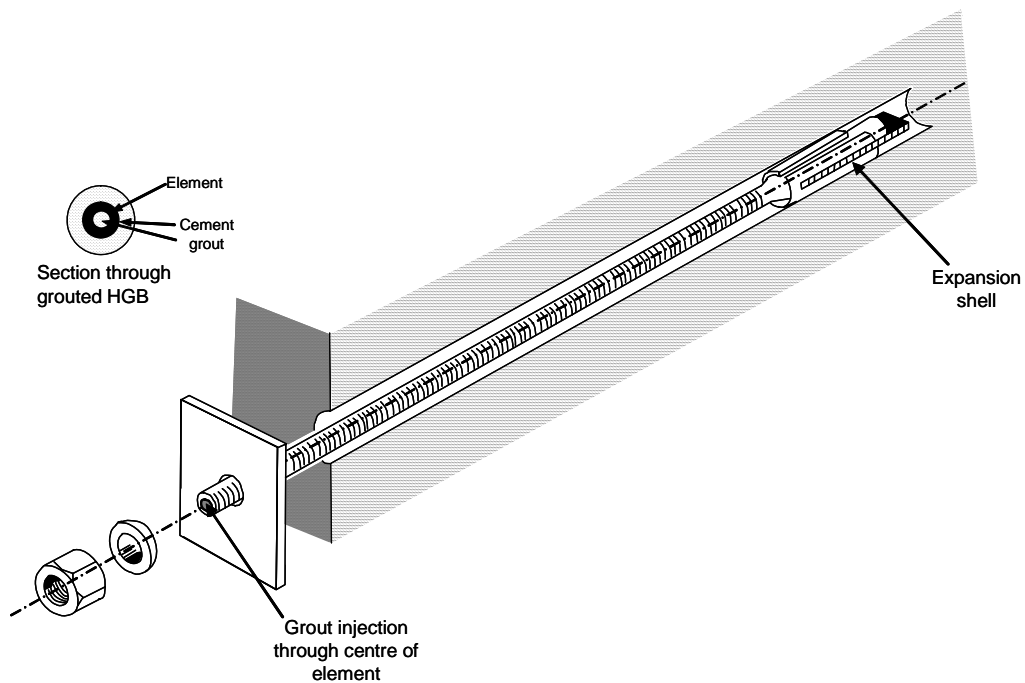
Figure 2.15 The components of the Hollow Groutable Bolt (HGB) (Hoek, Kaiser & Bawden 1995).

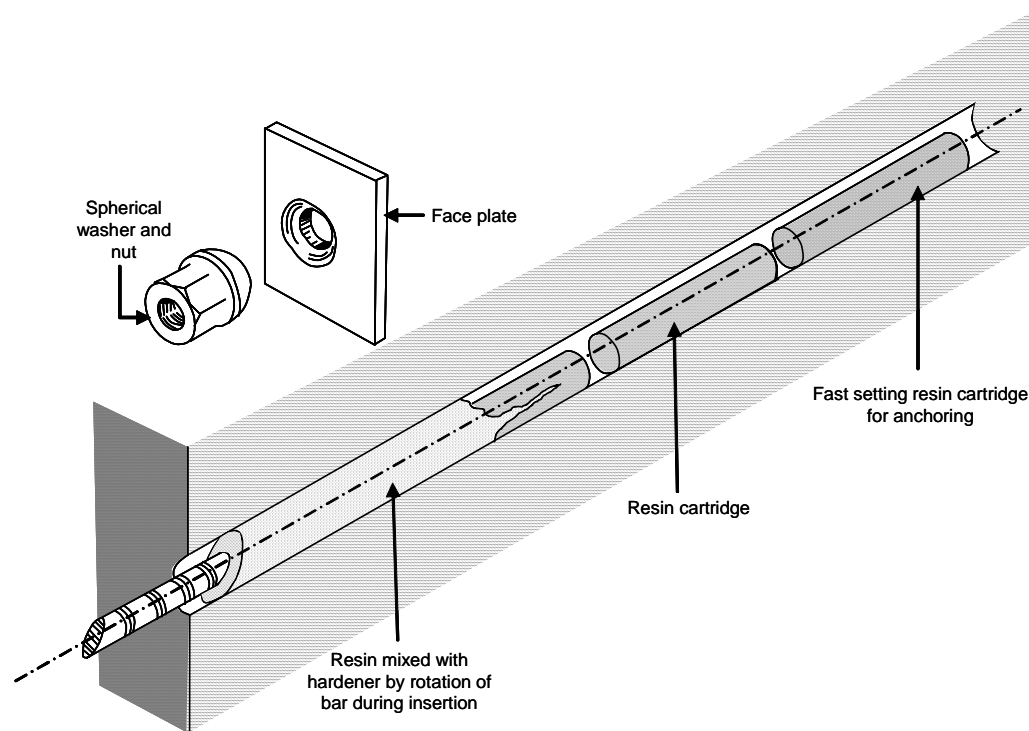
Resin grouted elements may be tensioned or non-tensioned. Tensioning fully encapsulated resin rock bolts is achieved by placing a quick set resin at the toe of the borehole with slow setting resin cartridges inserted behind. Tensioning can be completed after a few minutes once the quick set resin has hardened. Resin grout provides a physical barrier protecting the element from the corrosive environment; however, there is some uncertainty about the long-term corrosion protection offered by resin grouts and also about the reaction of some resins with aggressive groundwaters (Hoek, Kaiser & Bawden 1995).

Figure 2.16 The components of a resin grouted rock bolt using threaded bar (Hoek, Kaiser & Bawden 1995).

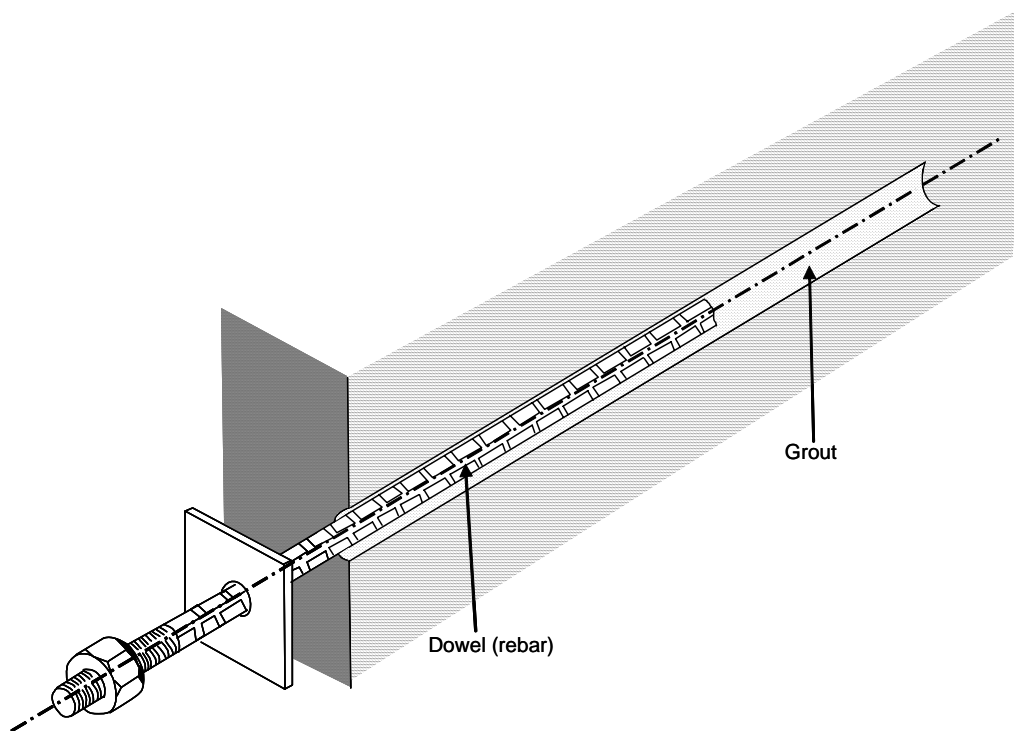
Figure 2.17 Grouted dowel using reinforcement bar inserted into a grout-filled hole (Hoek, Kaiser & Bawden 1995).

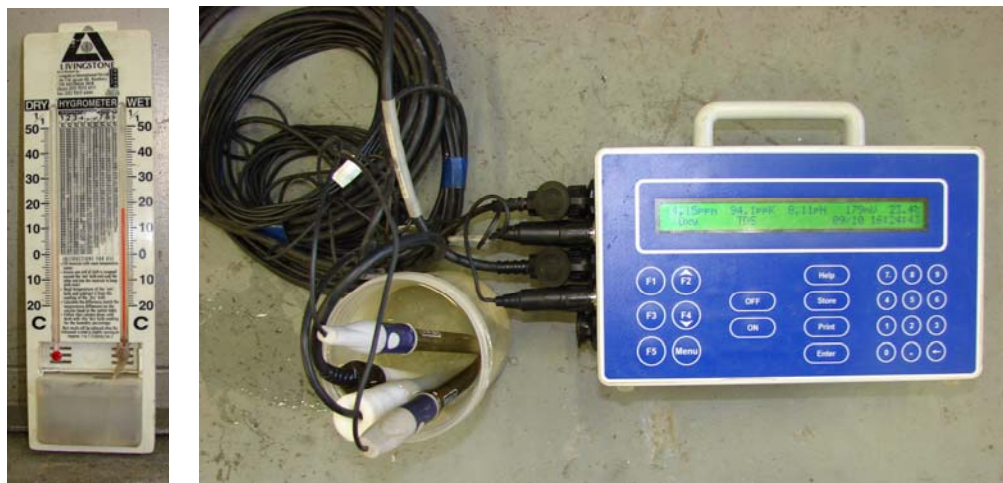
Figure 3.1 Hygrometer (left) and portable TPS 90-FMLV field lab (right) used to collect environmental information.

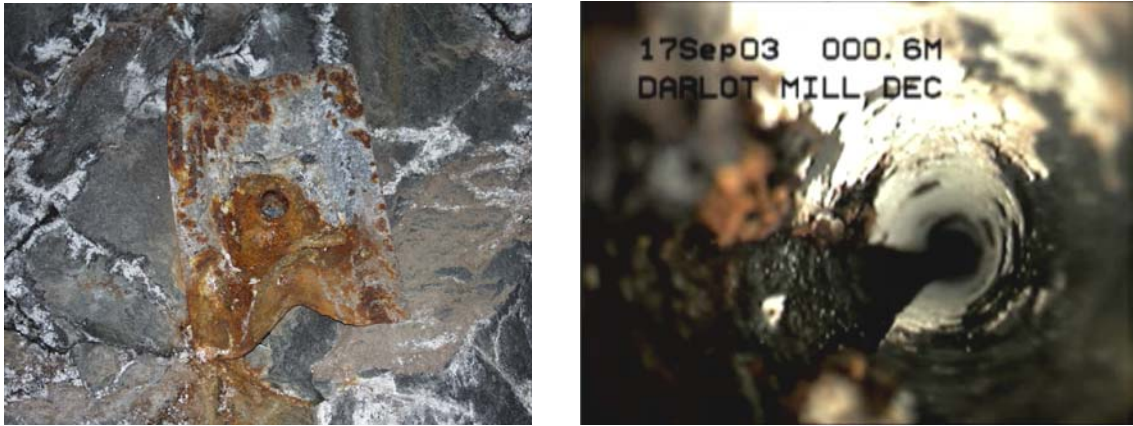
Figure 3.10 External (left) and internal (right) view of corrosion damage to a galvanised FRS that has been affected by earlier groundwater flow.

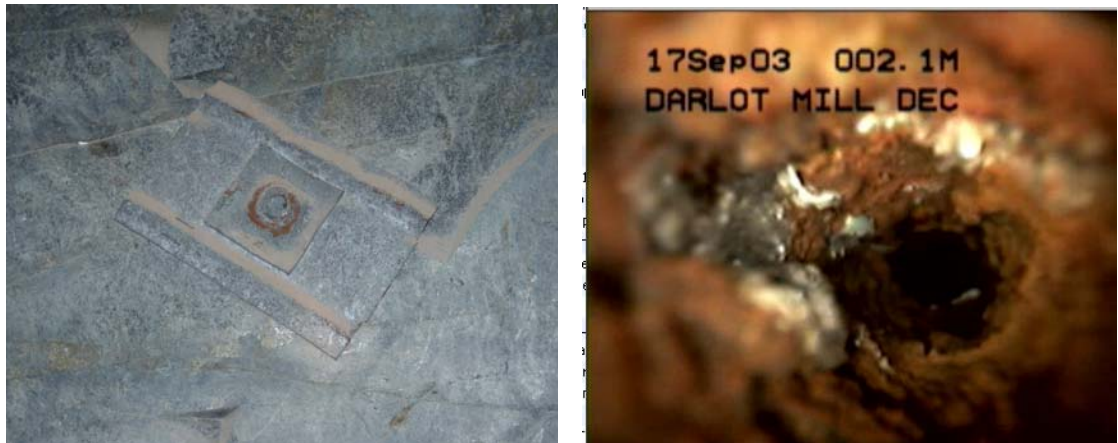
Figure 3.11 No corrosion of the plate (left), but strong corrosion of the FRS reinforcement (rights) at 2.1m depth.

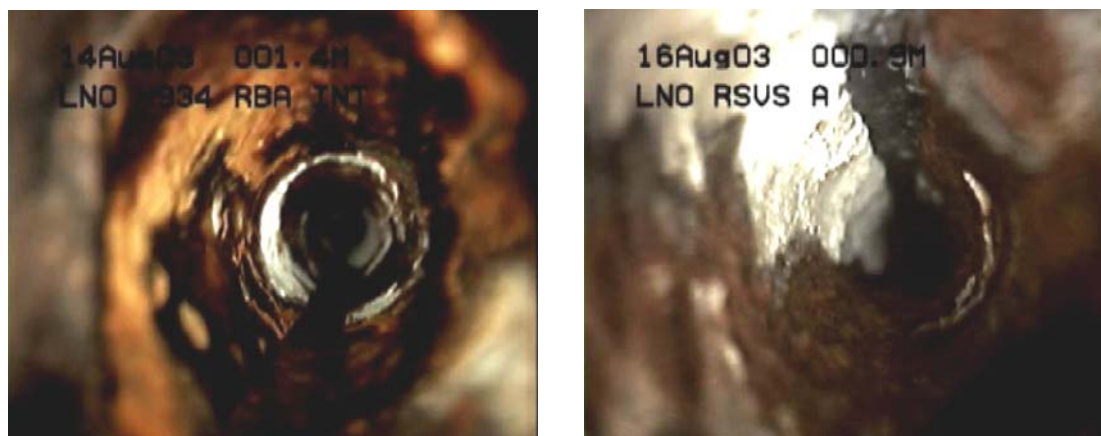
Corrosion damage was observed on a number of galvanised FRS that are affected by groundwater in the ore drives and the return airway. Figure 3.19 shows the level of damage which is high, indicating the corrosiveness of both groundwater types. Groundwater originating in the shaft also affects the first few metres of level shaft platforms. Some corrosion of friction bolts was detected, but generally was only mild to moderate. However, the extended life of the shaft access excavations means that problematic corrosion may occur over time.

Figure 3.19 Corrosion damage to galvanised FRS in the hanging wall development (left) and ore drive (right).

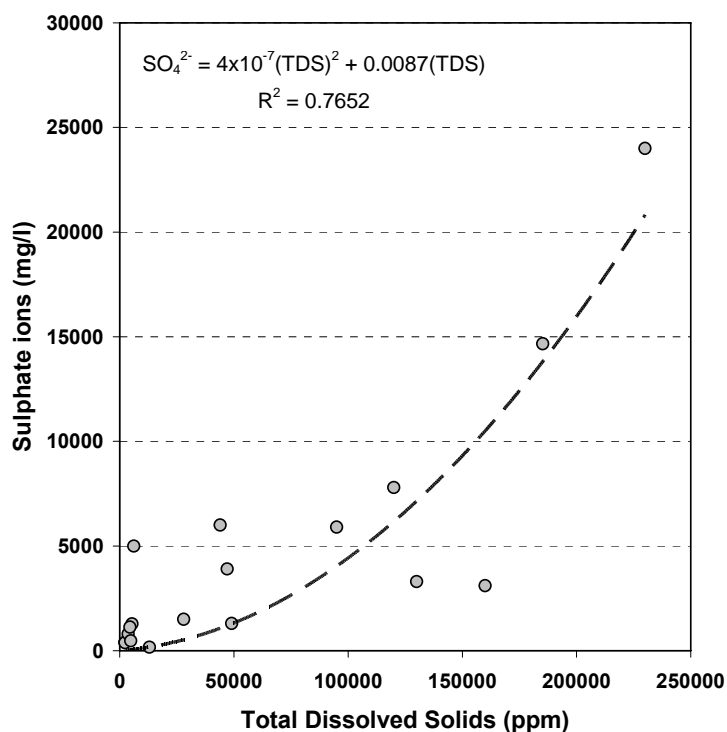
Figure 3.25 A weak correlation between the TDS and sulphate ion concentrations.

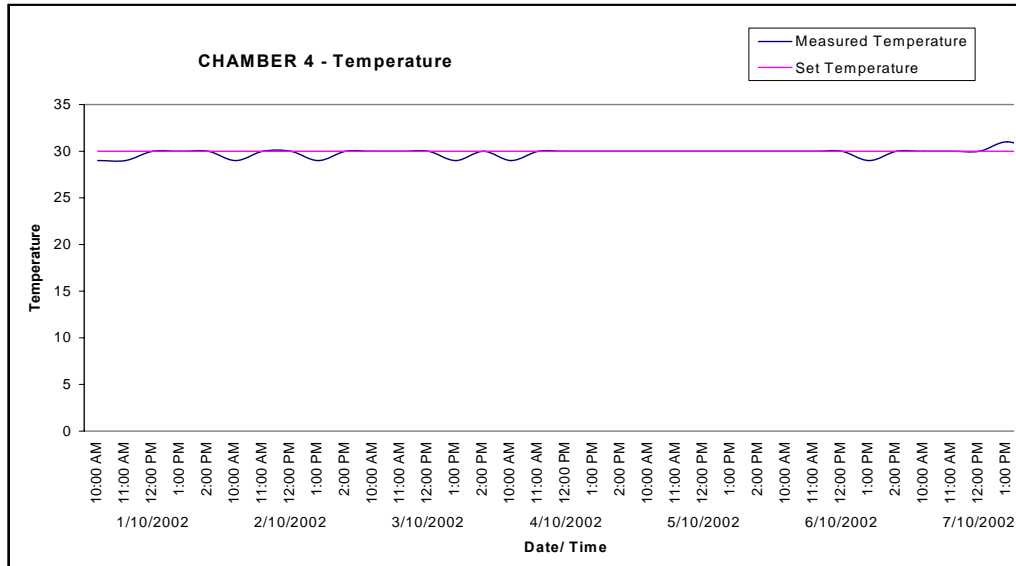
Figure 4.2 Monitoring of temperature in the corrosion chambers.

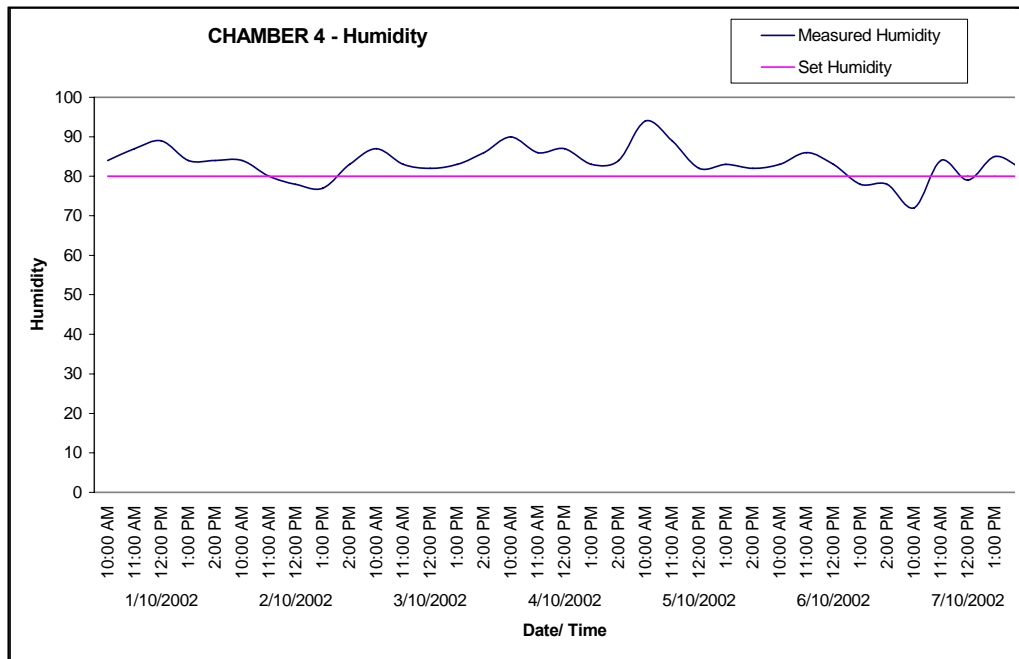
Figure 4.3 Monitoring of humidity in the corrosion chambers.

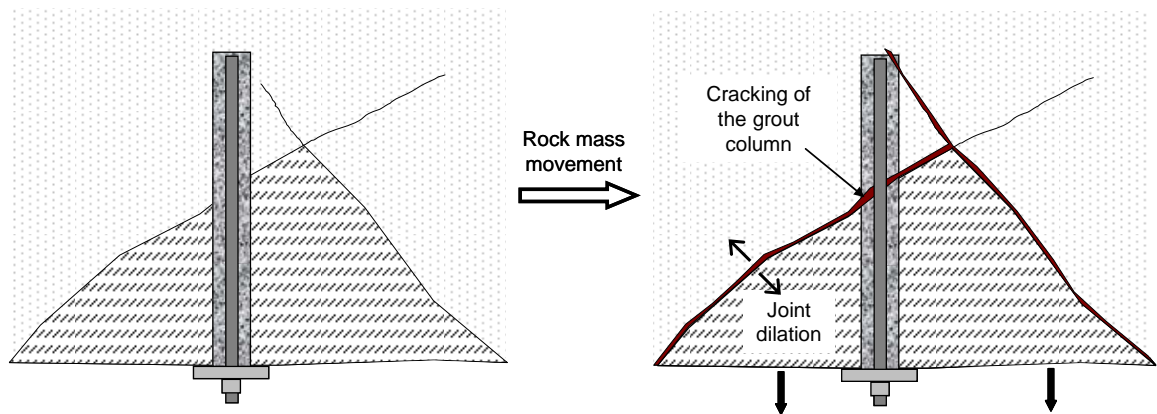
Cracks within the grout column provide a pathway for gravity assisted water flow to interact with the steel element. Cracking preferentially occurs along geological discontinuities, which are also the conduit for groundwater flow in hard rock aquifers. Without the protection reinforcement elements will undergo corrosion damage. There is currently no commercial non-destructive testing method able to determine if cracking of the grout column has occurred and whether it has resulted in corrosion damage to the element. Overcoring of the element is the only way to ascertain this.

Figure 4.4 Cracking of the grout column due to joint dilation.

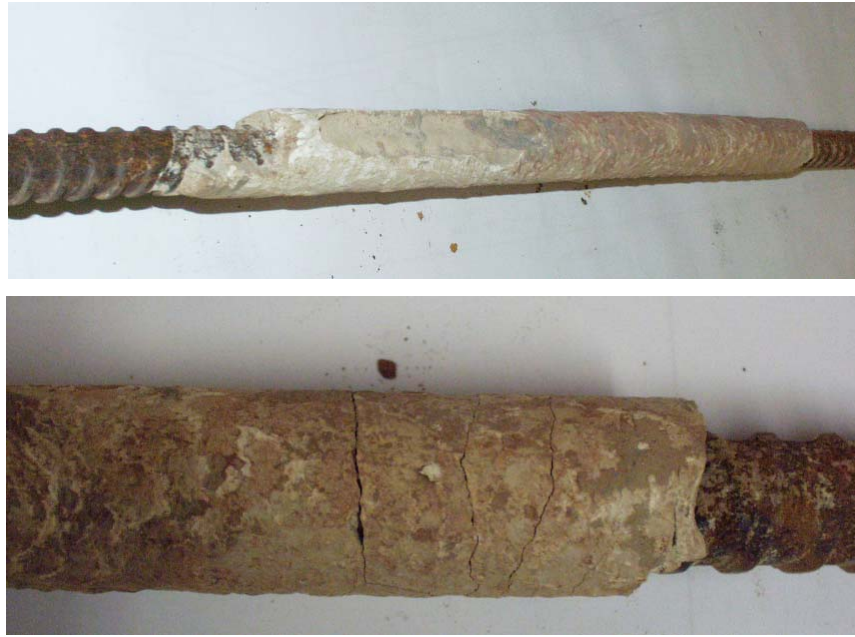
Figure 4.5 Cracking within a resin grouted column, these cracks present a path for the surrounding environment to interact with the reinforcement.

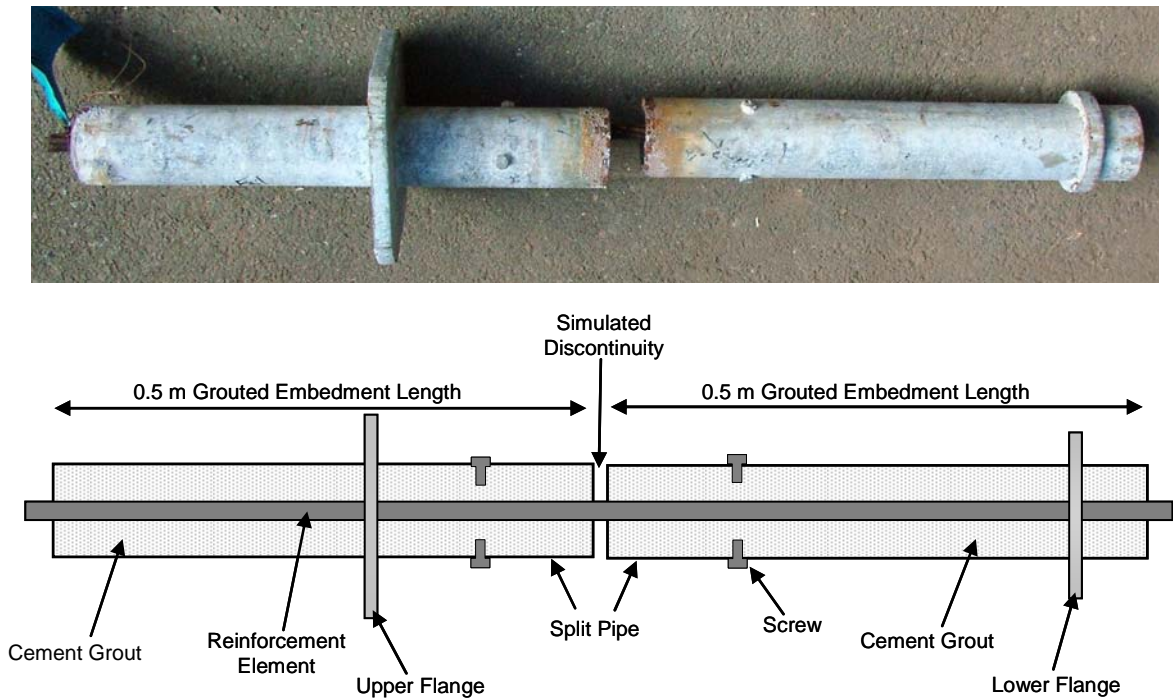
Figure 4.8 The split pipe testing system.

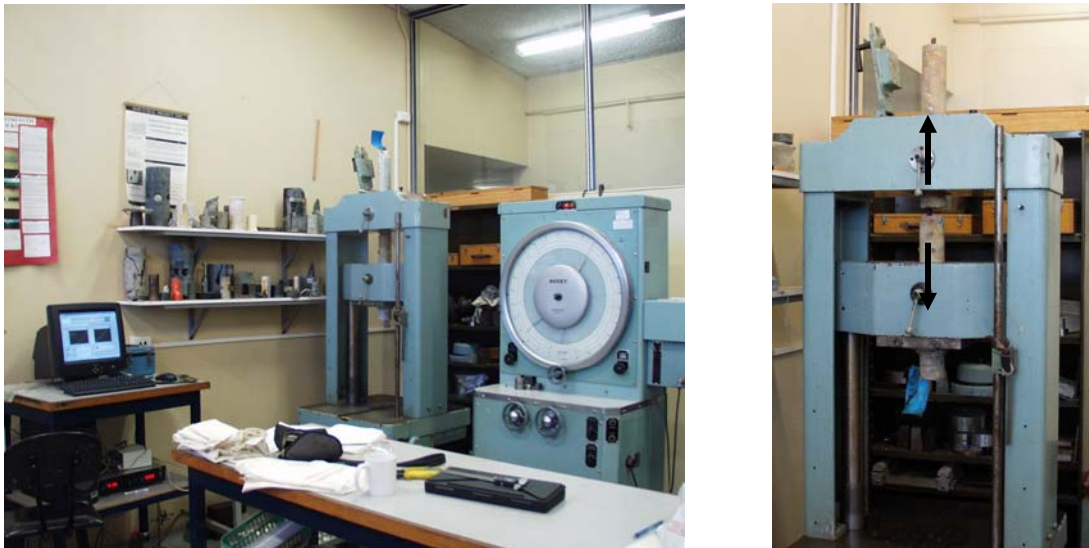
Figure 4.9 The testing set up showing the Avery machine in the background and the PC and analogue data collector to the left. A closer view of the split pipe is shown on the right.

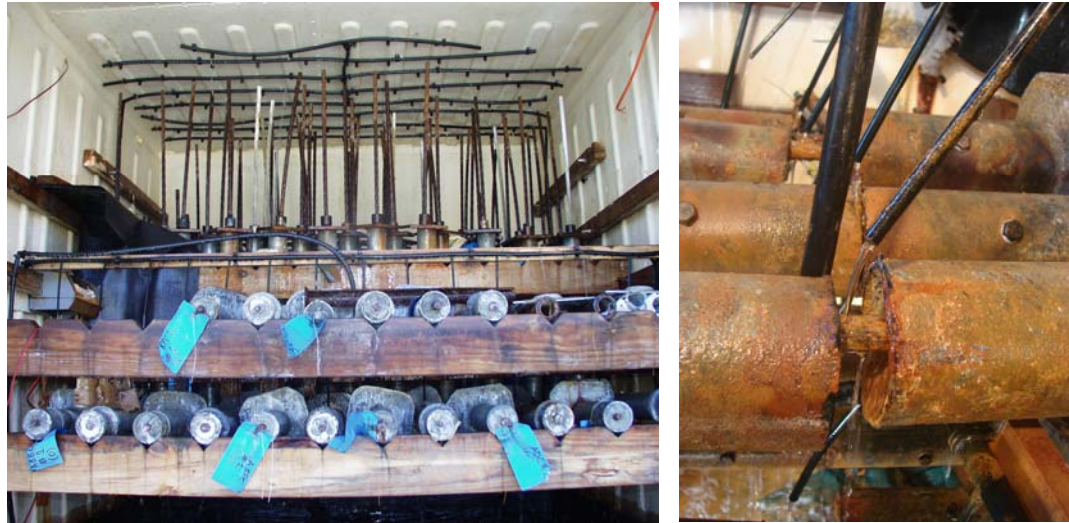
Figure 4.10 A typical WASM corrosion chamber (left) and water flow through simulated geological discontinuity (right).

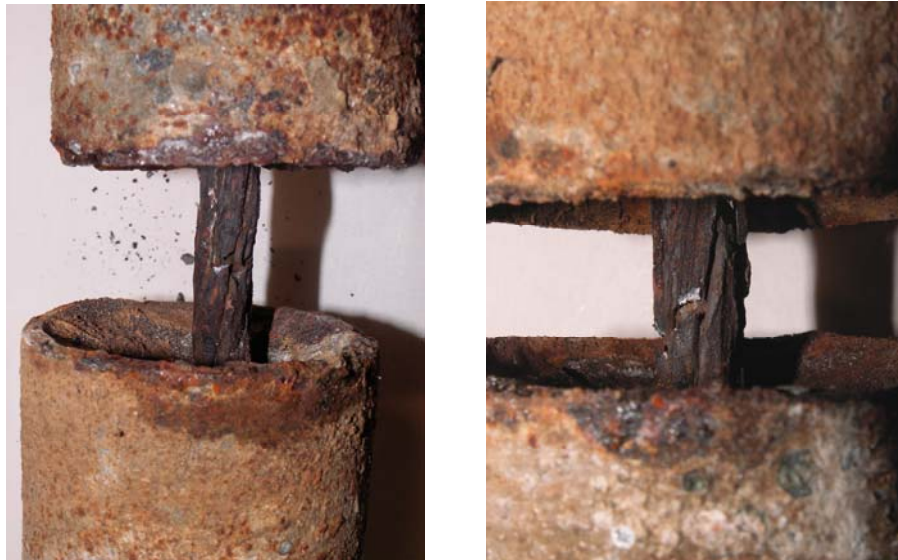
Figure 4.11 Typical failure of the strand elements with plain strand (left) and bulbed strand (right).

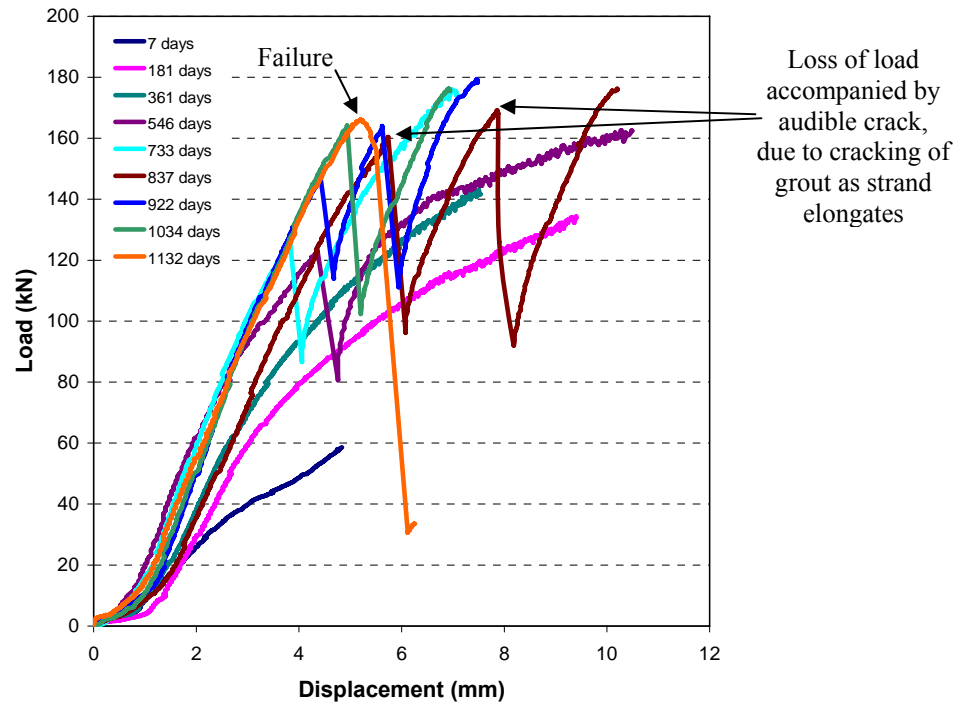
Figure 4.14 Typical load-displacement plot of single plain strand with MCI additive (0.5 m embedment length)

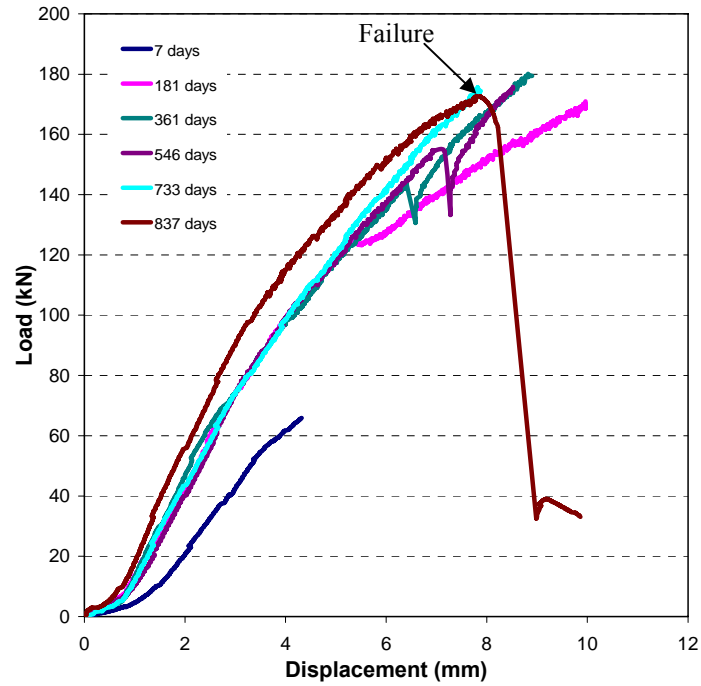
Figure 4.15 Typical load-displacement plot of single bulbed strand with methocel additive (0.5 m embedment length).

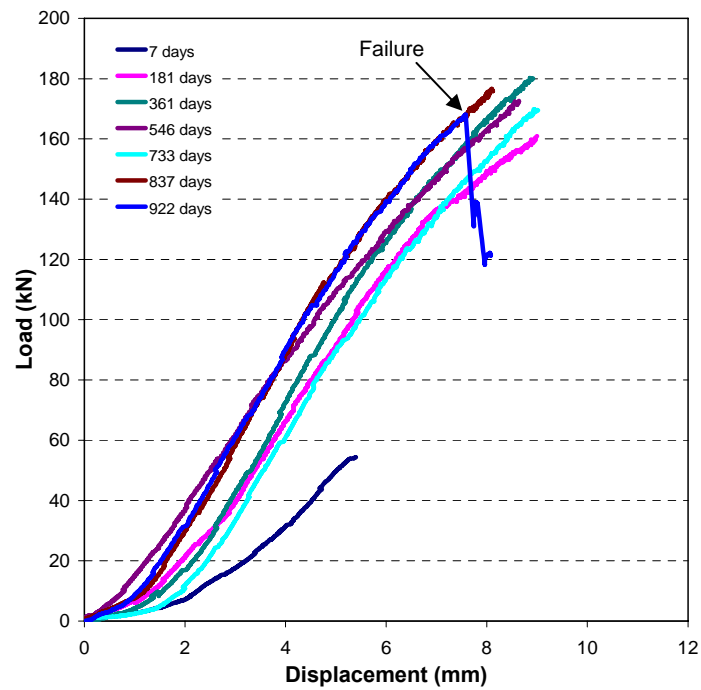
Figure 4.16 Typical load-displacement plot of single bulbed strand with MCI additive (0.5 m embedment length).

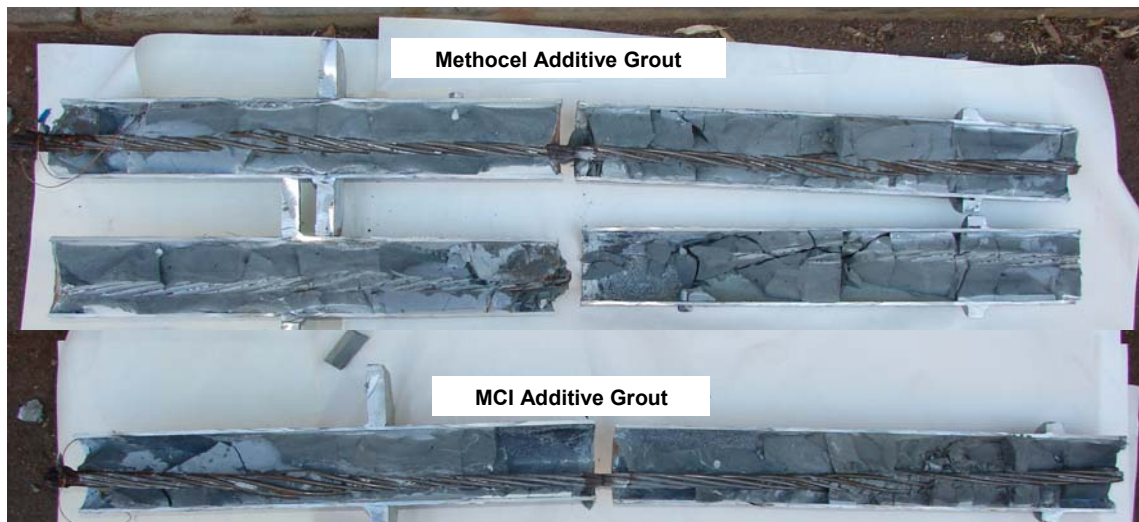
Figure 4.18 Good quality grout was observed for all horizontally placed samples inspected.

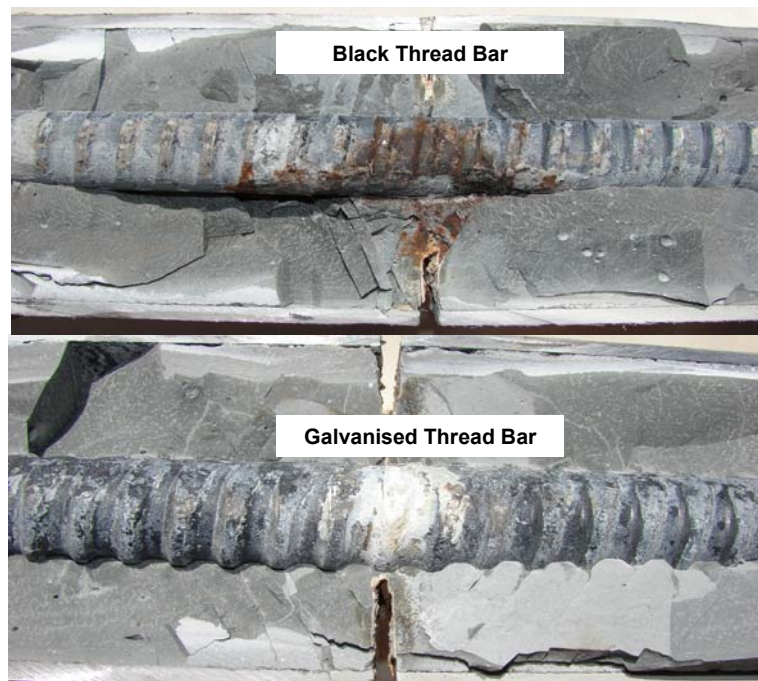
Figure 4.24 Corrosion of the thread bar elements of same age.

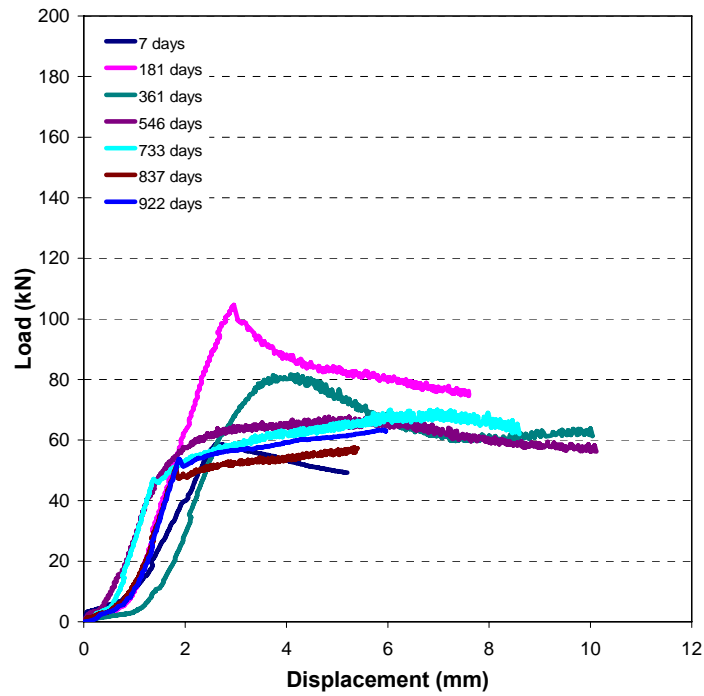
Figure 4.25 Load-displacement plot of black thread bar element with MCI additive that experienced slippage at low loads.

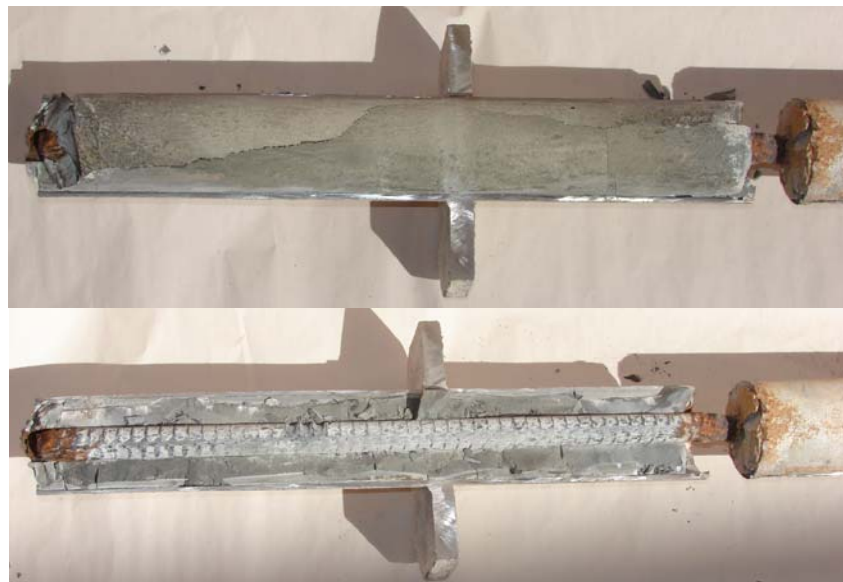
Figure 4.26 A cut section of a black thread bar with MCI additive sample that pulled through the top 0.5 m embedment length.

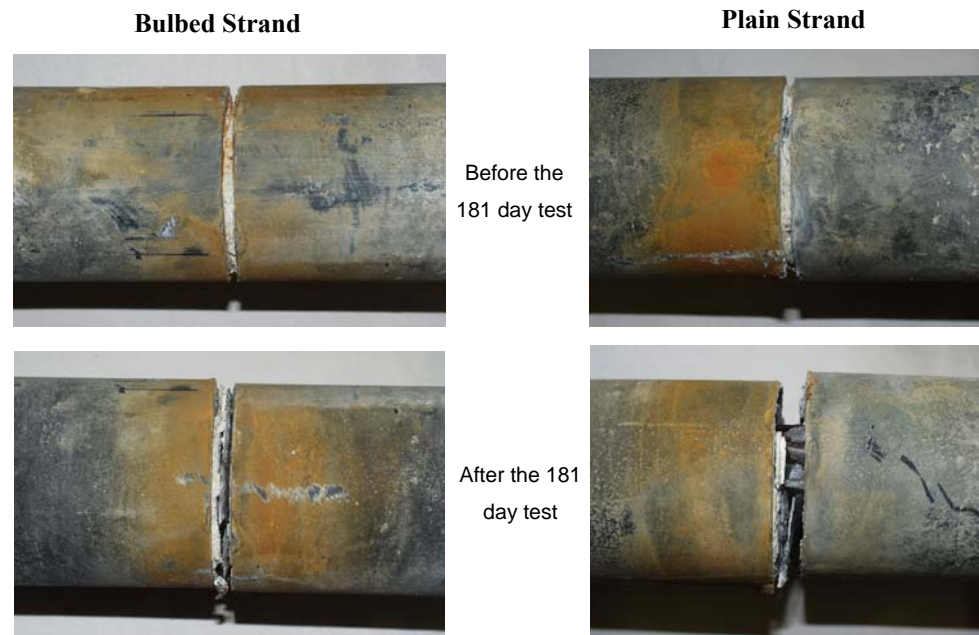
Figure 4.27 Sufficient opening of crack width to allow for corrosion did not take place until after the 181 day test.

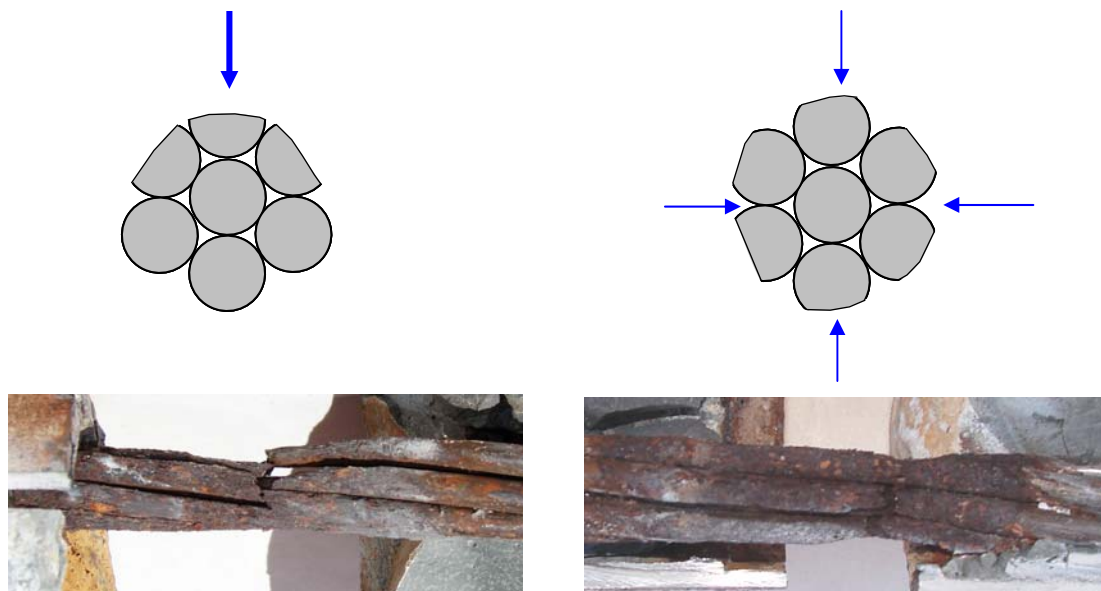
Figure 4.28 Variations in time of failure due to water flow being concentrated in one area (left) or spread around the circumference of strand (right).

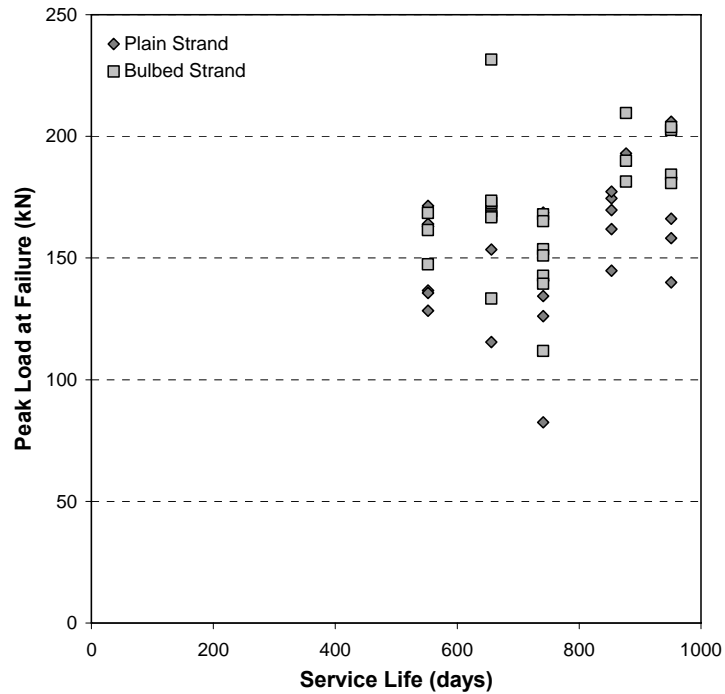
Figure 4.29 Comparison of results between plain and bulbed strand (0.5m embedment length).

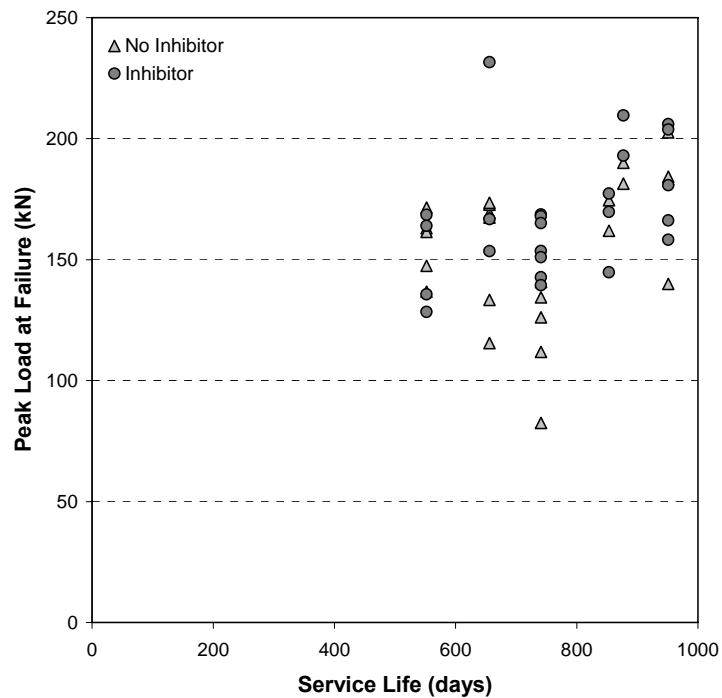
in total) experiencing the same problem. While not exhaustive the laboratory evidence from this experiment points towards some problems with the overall strength of the MCI additive grout mix.

Figure 4.30 Comparison of all strand results between the non-inhibitor and inhibitor grout mixes (0.5m embedment length).

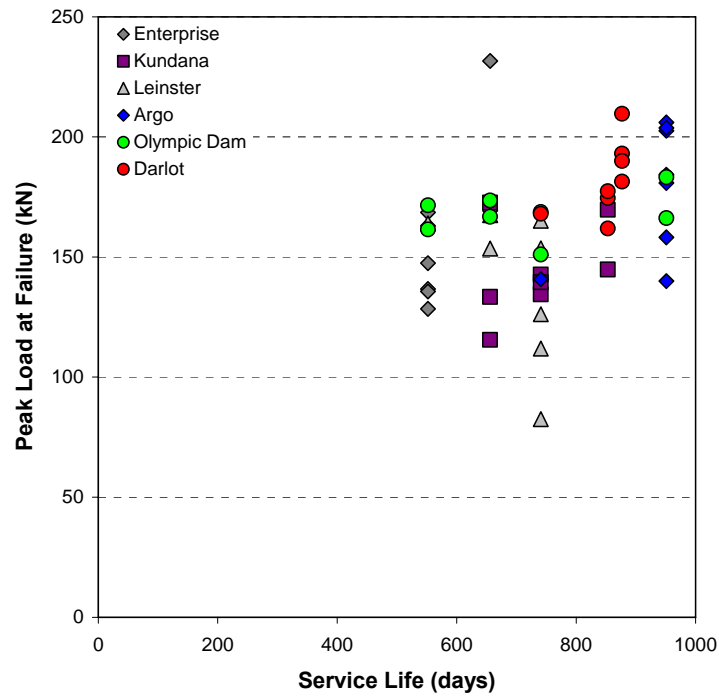
Figure 4.31 Summary of strand results by corrosion chamber (0.5m embedment length).

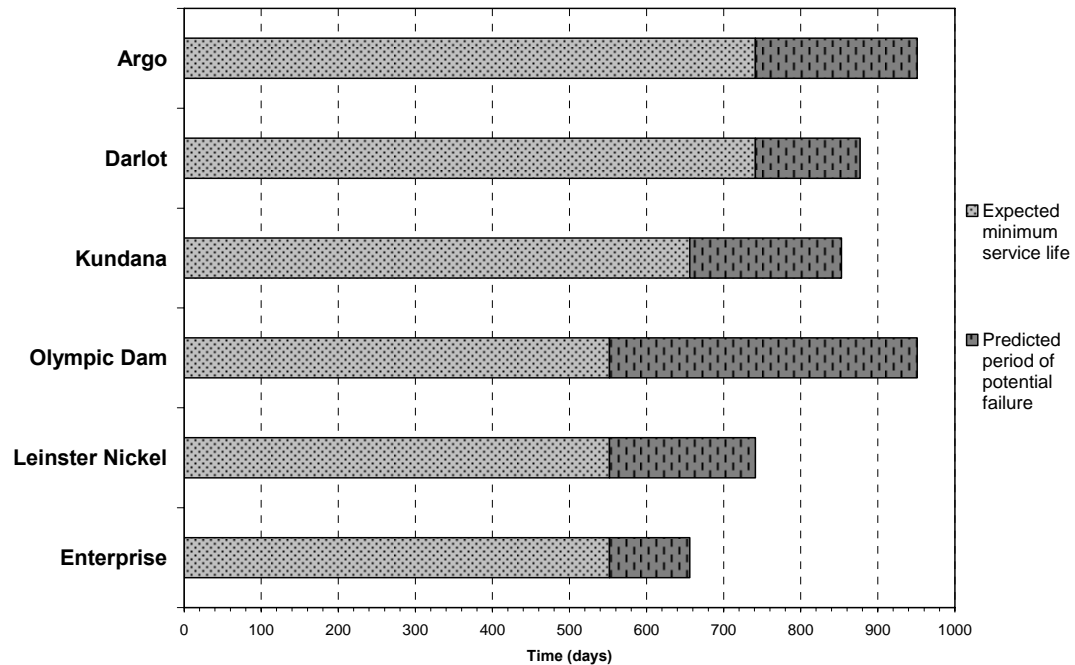
Figure 4.32 The expected service life of cable strand in the corrosion chamber environments.

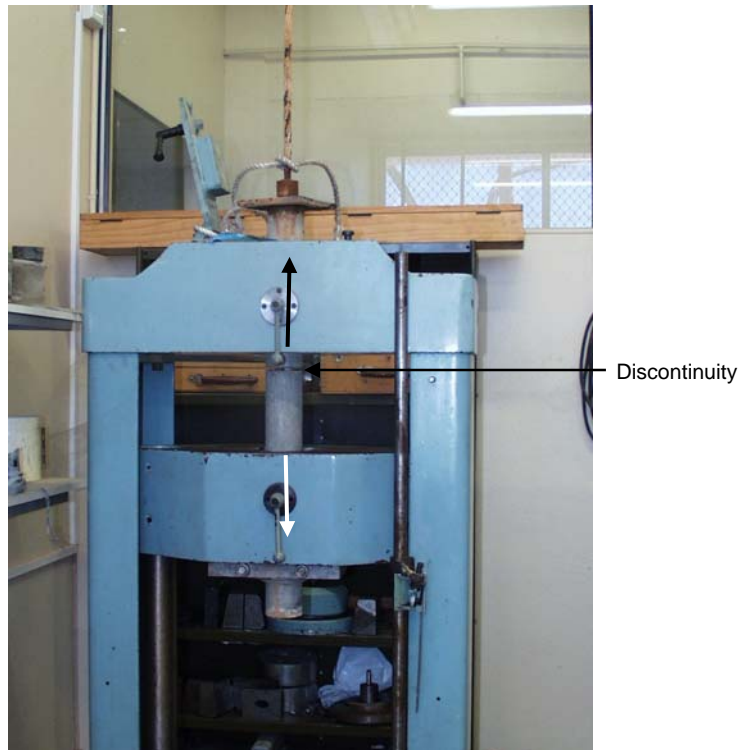
Figure 4.38 Laboratory testing of the barrel and wedge anchors.

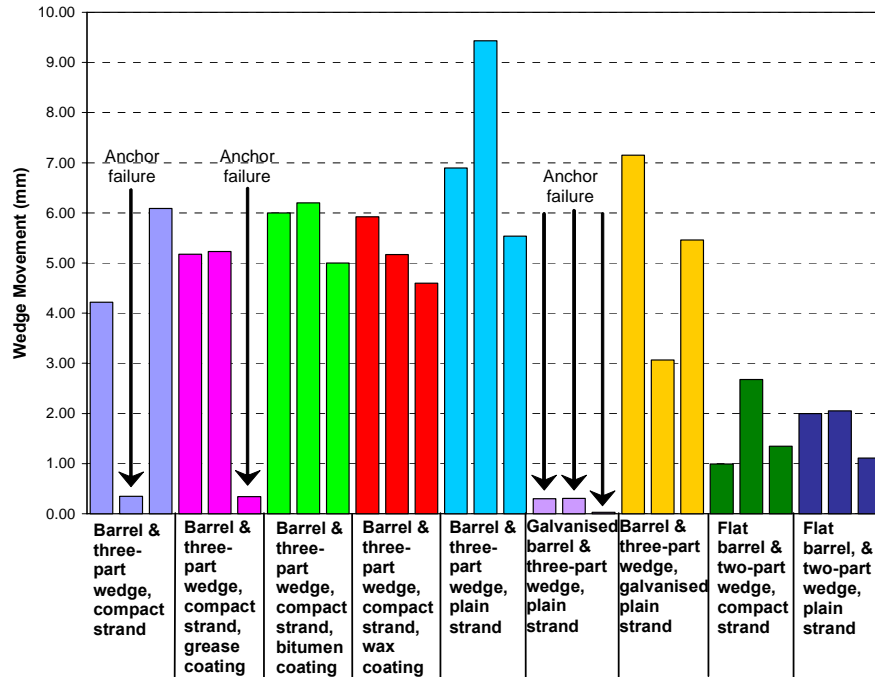
Figure 4.47 Total wedge movement of anchors after 297 days in the corrosion chamber.

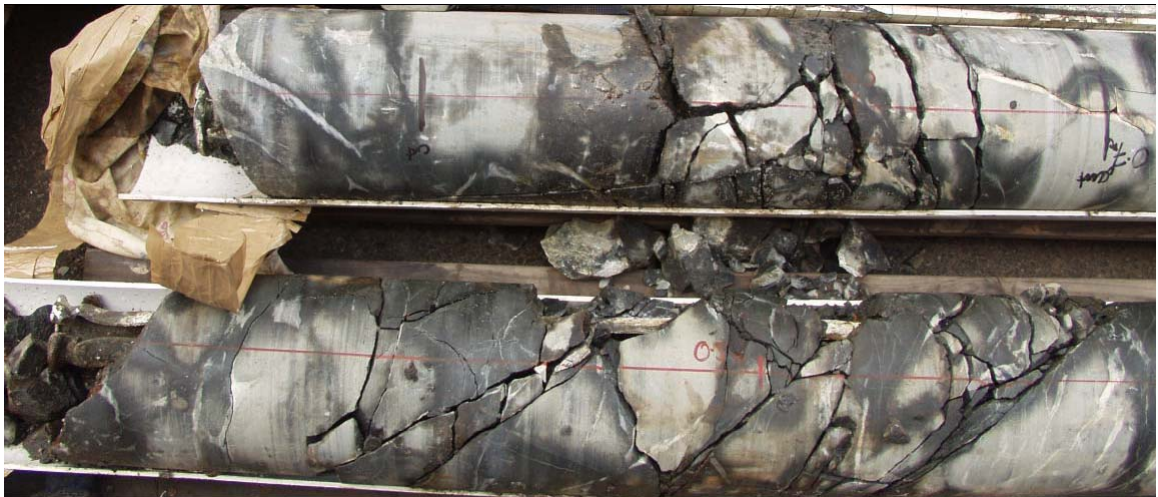
Figure 5.3 Full recovery from overcoring friction rock stabiliser collars in very poor rock mass.

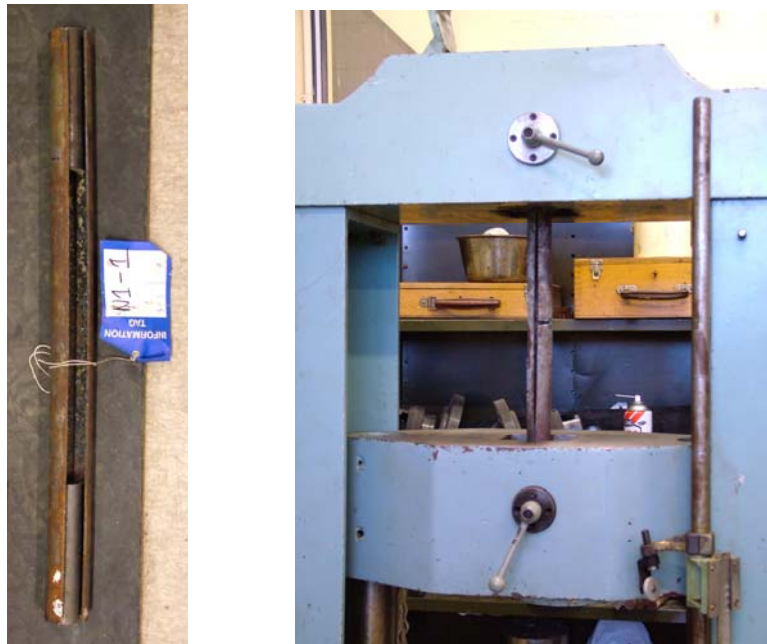
Figure 5.8 Friction bolt is prepared for tensile strength testing (left), and tensile testing of friction bolt (right).
