Western Australian School of Mines

Corrosion of Rock Reinforcement in Underground Excavations

**This thesis is presented for the Degree of
Doctor of Philosophy
of Curtin University of Technology**

February 2008

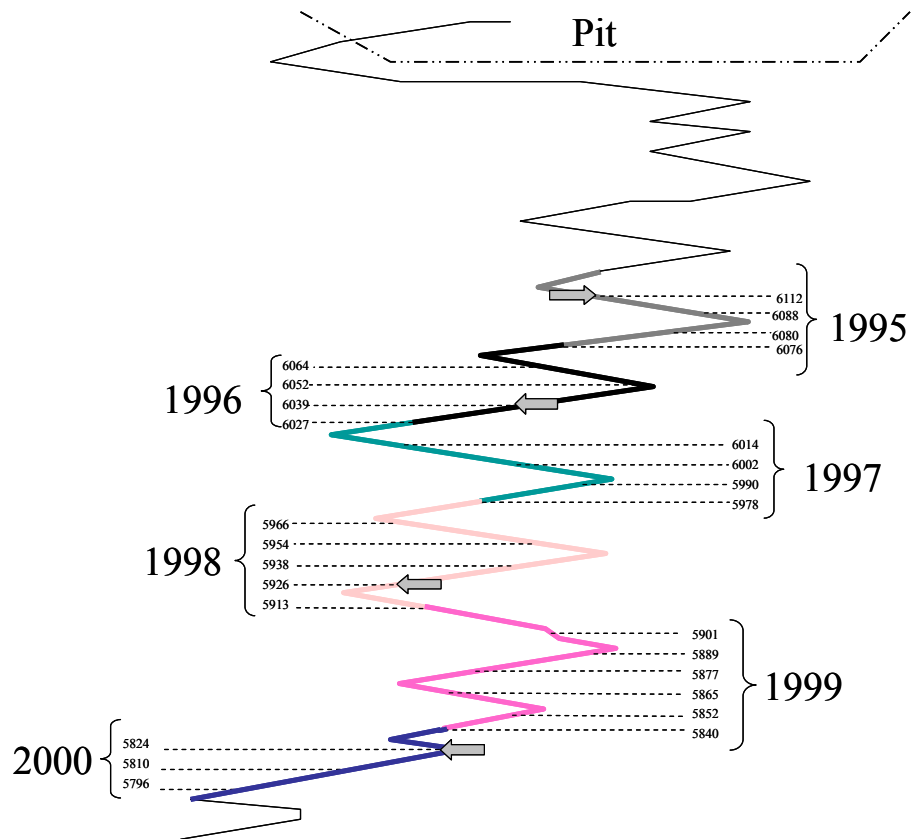
Figure 5.9 Schematic diagram of the Strzelecki Decline with overcore locations marked by grey arrows.

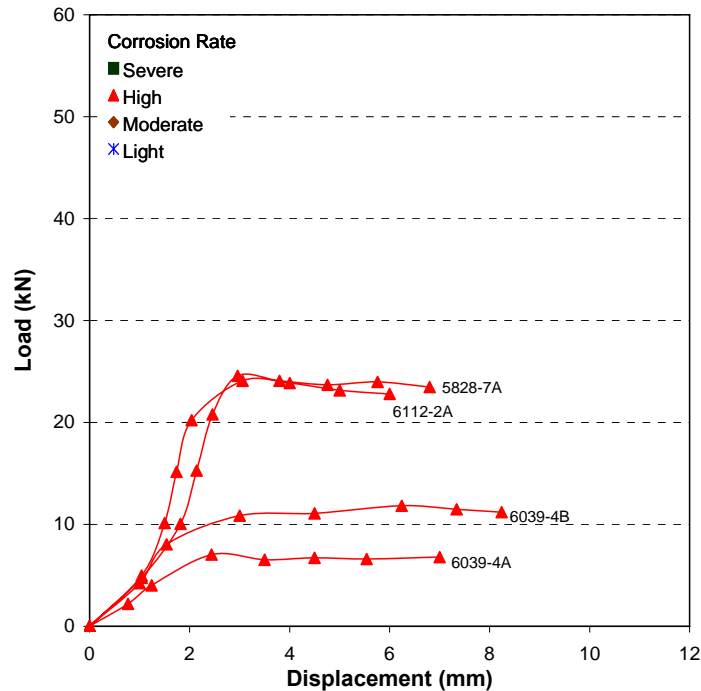
Figure 5.11 Load displacement plot of galvanised 47 mm diameter friction bolts (250-300 mm embedment lengths).

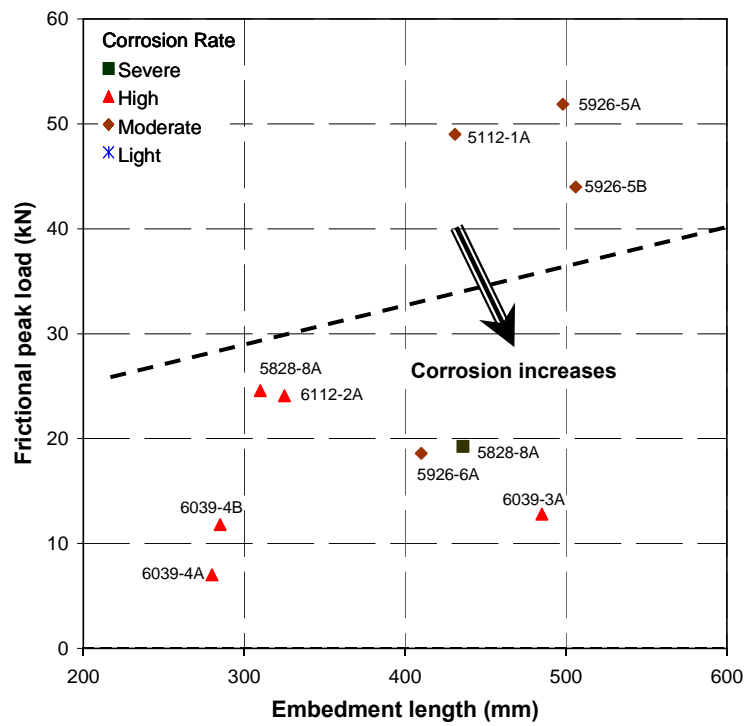
Figure 5.13 Relationship between the peak frictional strength and the embedment length for galvanised 47 mm diameter friction bolts.

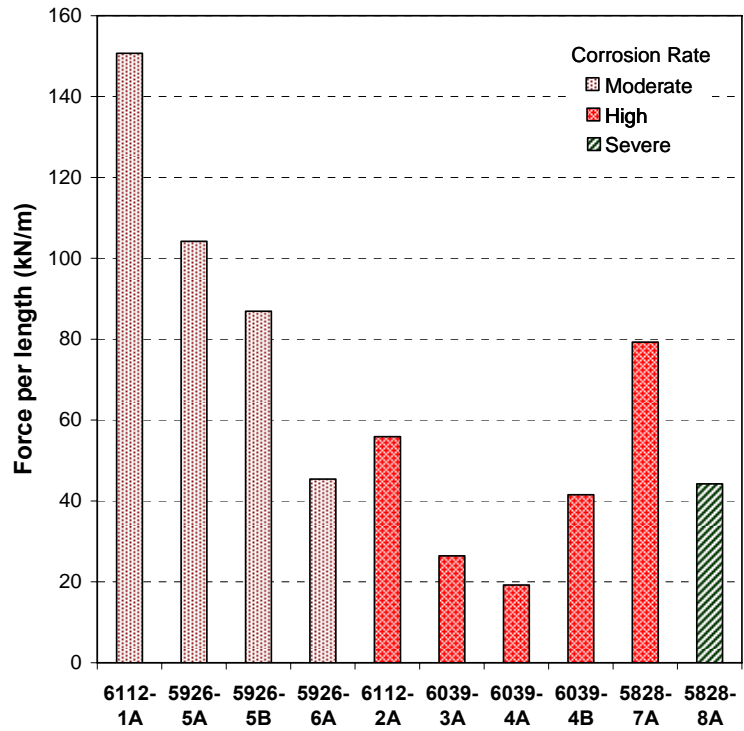
Figure 5.14 Normalised results of pull tests.

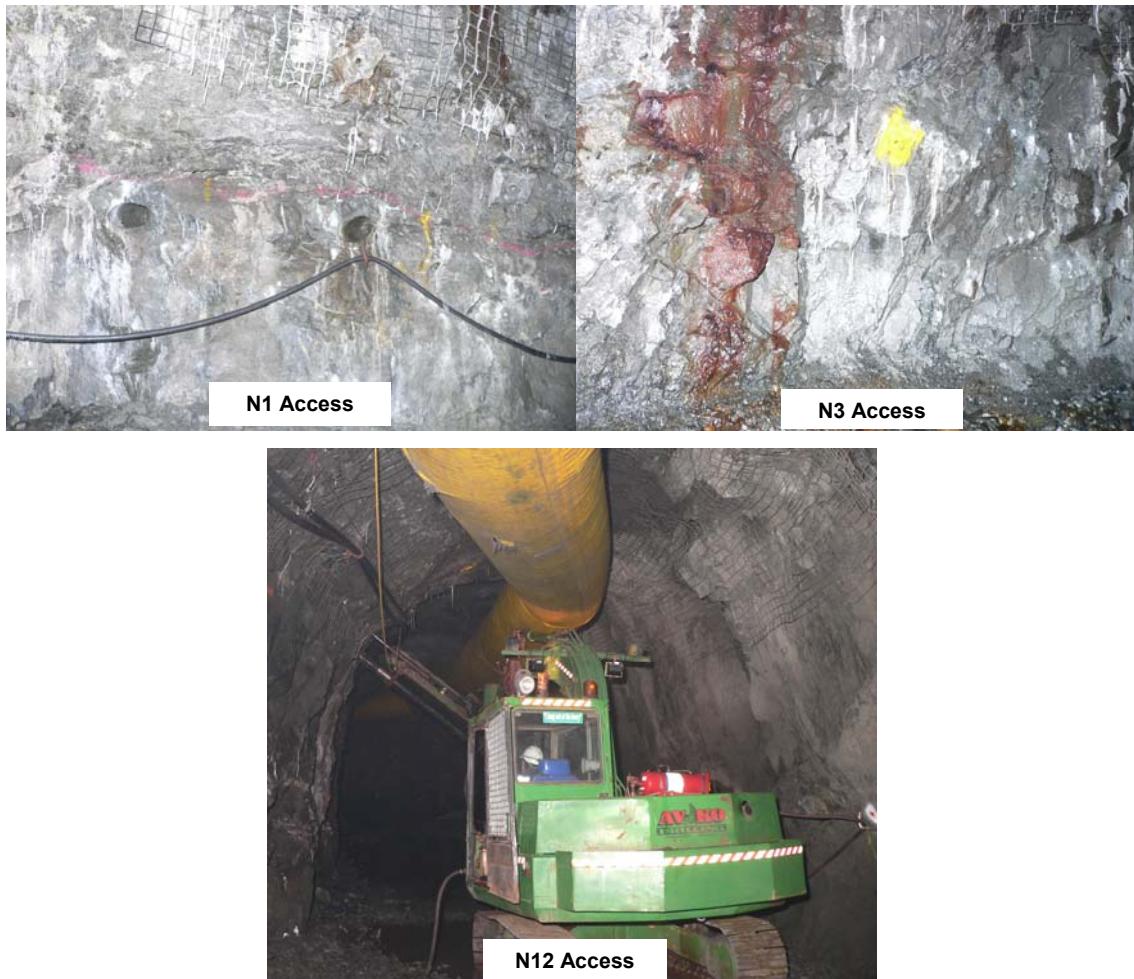
Figure 5.19 Overcoring conditions at the N1 Access Dive (top left), N3 Access Drive (top right) and N12 Access Drive (below centre).

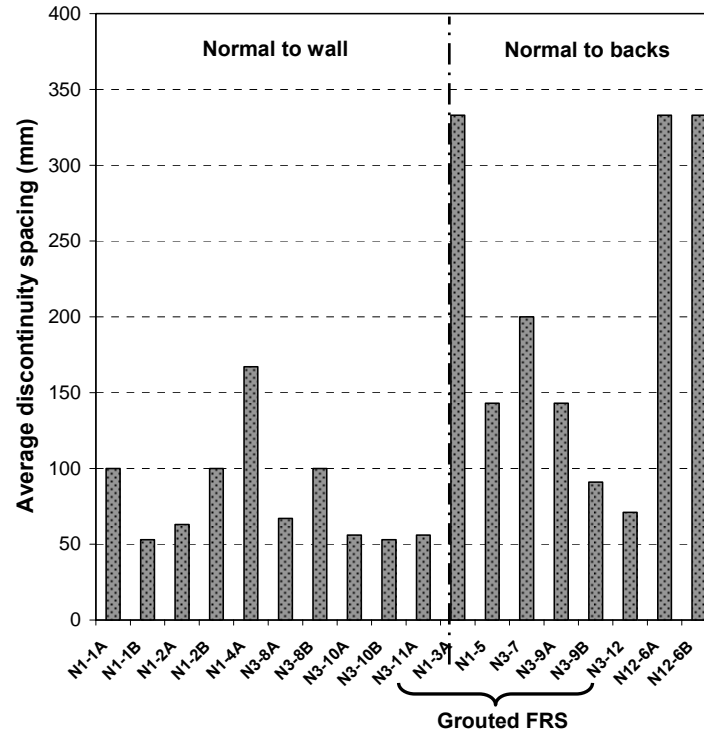
Figure 5.20 Graph of the average discontinuity spacing showing the differences between the rock mass in the walls and the backs.

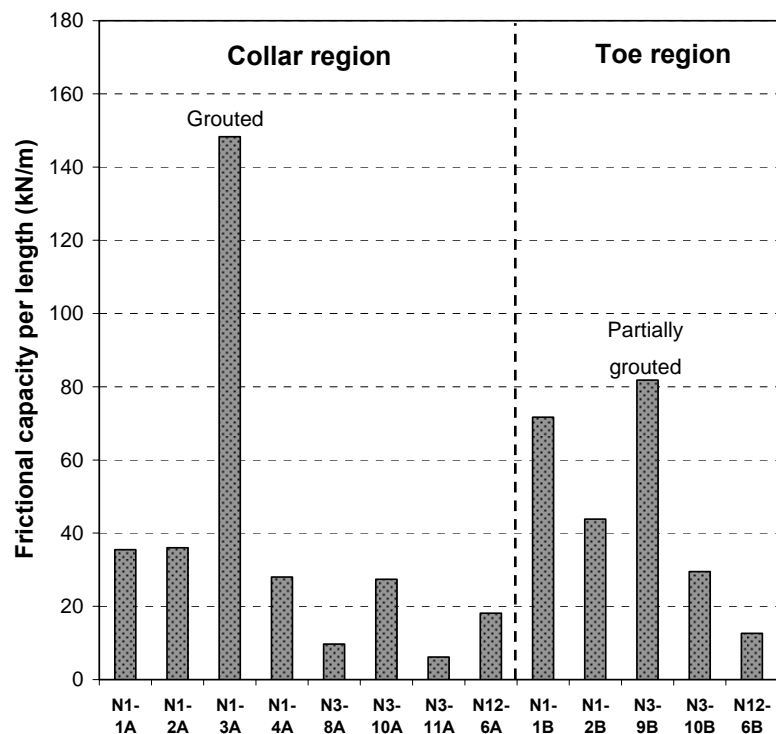
Figure 5.26 Frictional capacity per metre of embedment length of collar (A) and toe (B) samples normalised from pull tests of 300 mm embedment length.

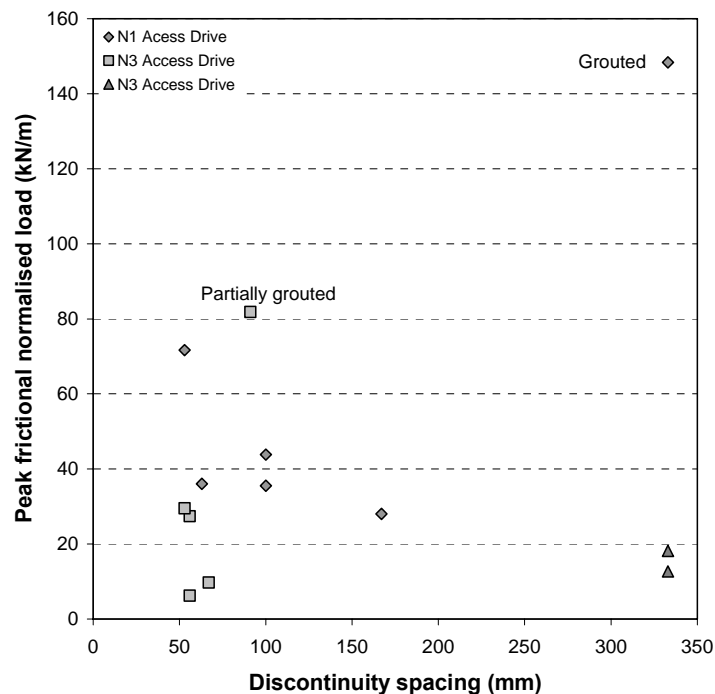
Figure 5.29 Comparison between the discontinuity spacing and the peak frictional load from pull testing.

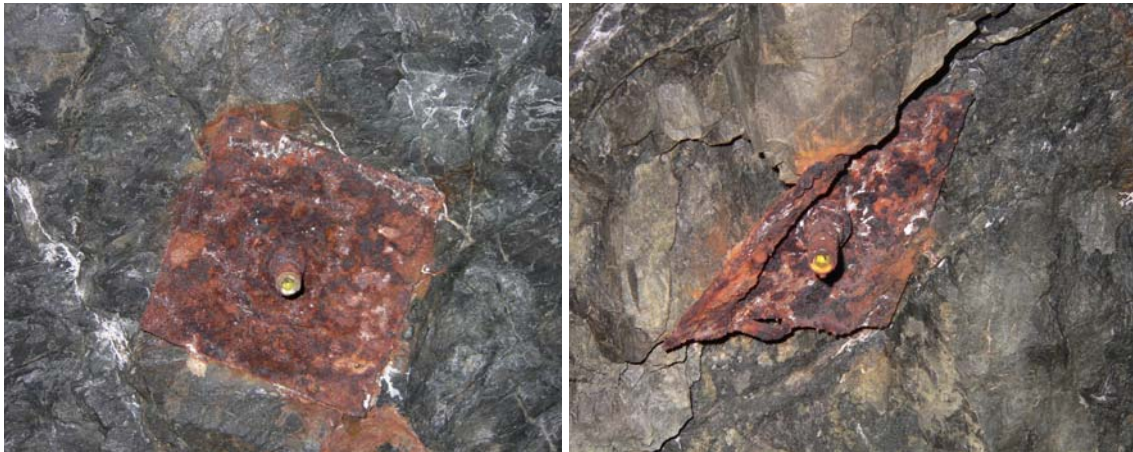
Figure 5.33 Severe corrosion of a HGB face plates due to flooding of mine workings.

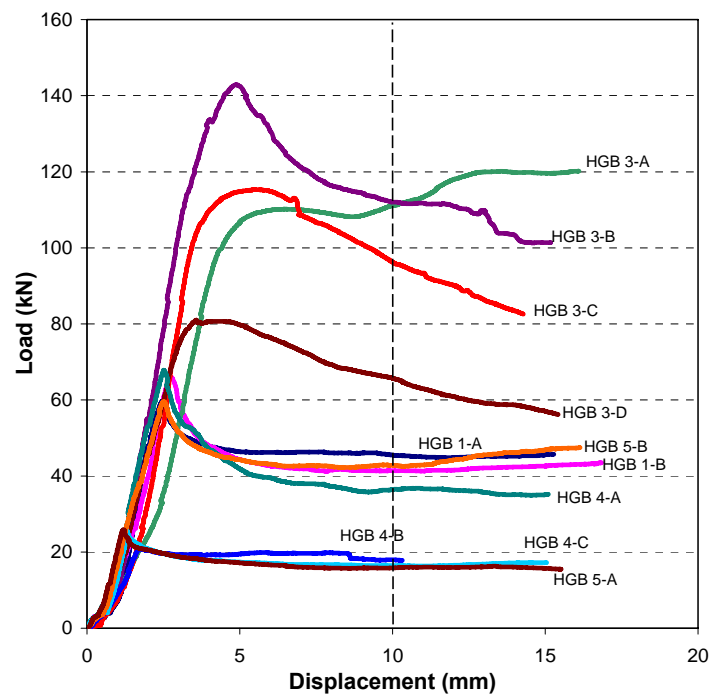
Figure 5.37 Combination of relative push test capacities for all HGB tests (embedment length 300 mm).

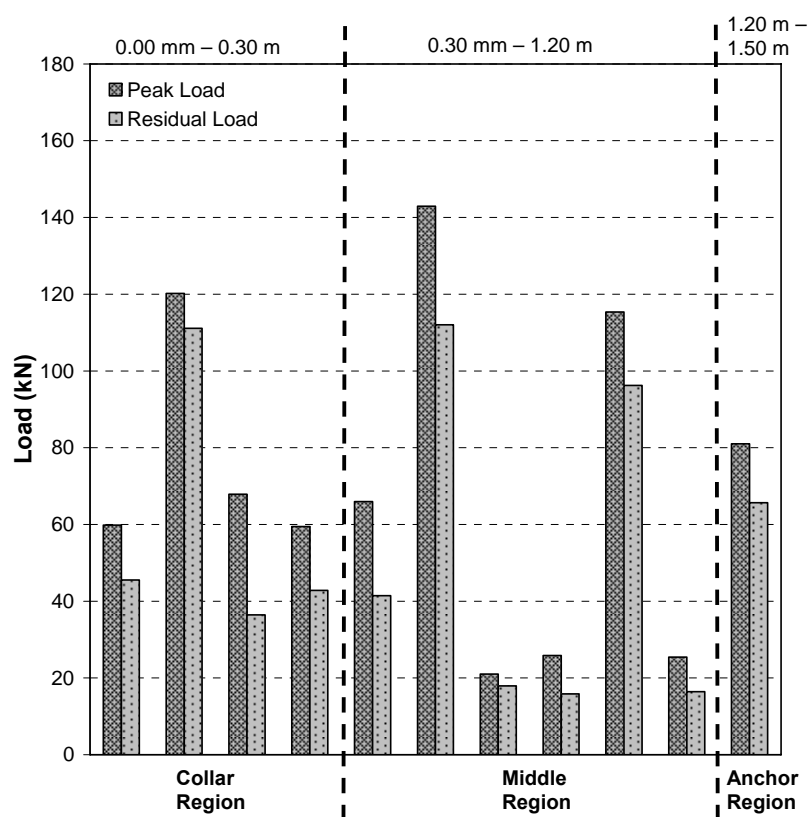
Figure 5.38 Peak and residual load for relative push test of HGB along bolt axis.

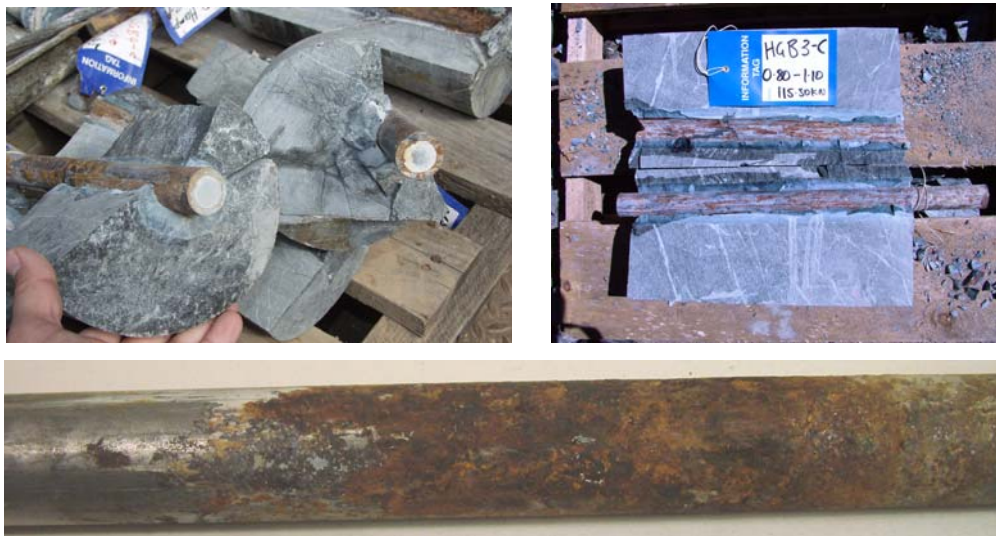
Figure 5.39 Light surface corrosion in fully grouted areas (top) with isolated areas of stronger surface corrosion where grout encapsulation was not as good (bottom).

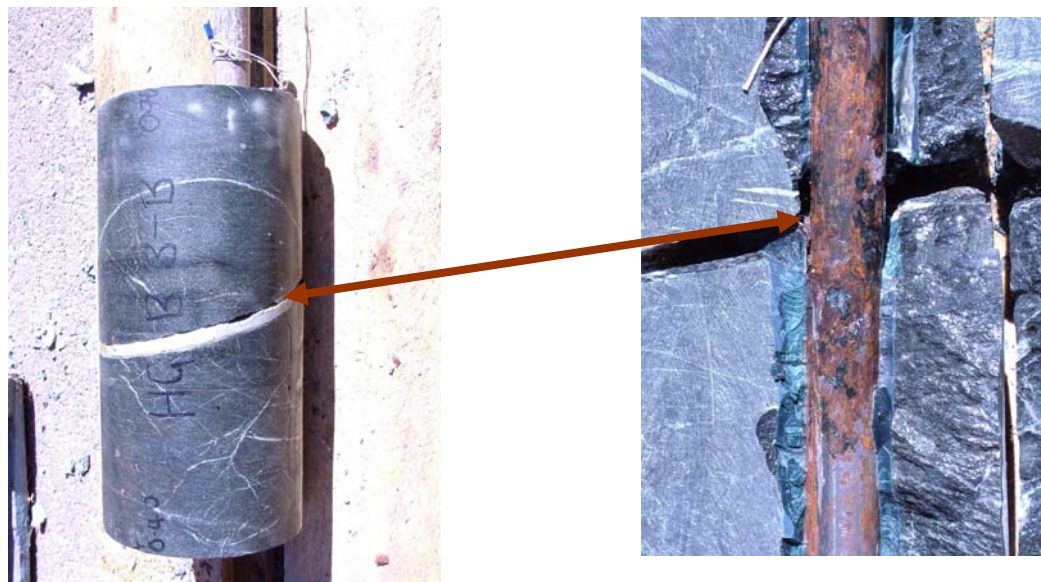
Figure 5.41 Corrosion protection due to migration of grout preventing groundwater interaction with bolt.

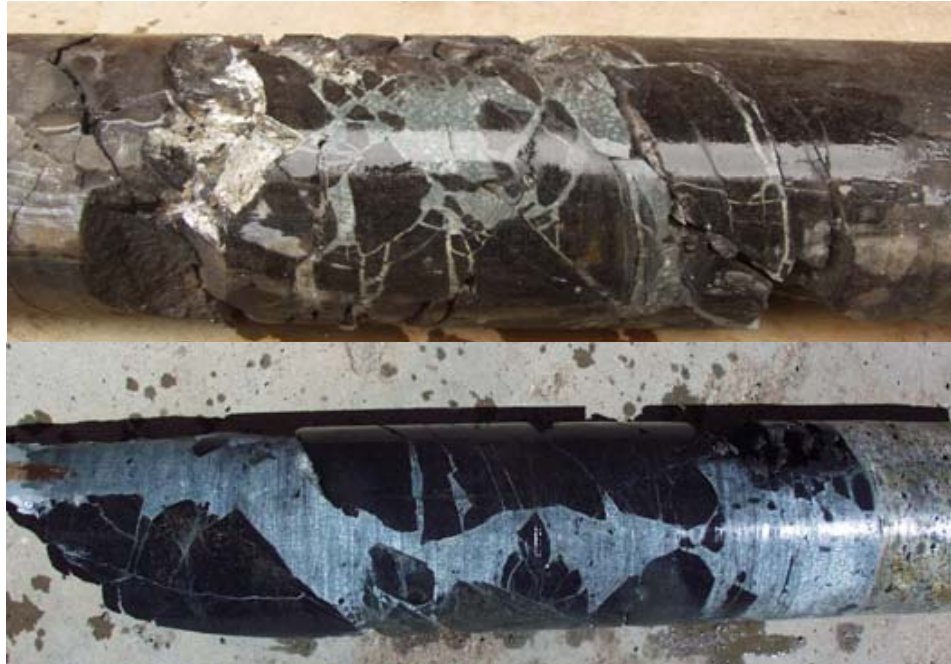
Figure 5.45 Cement grout migration interlocking a broken rock mass.

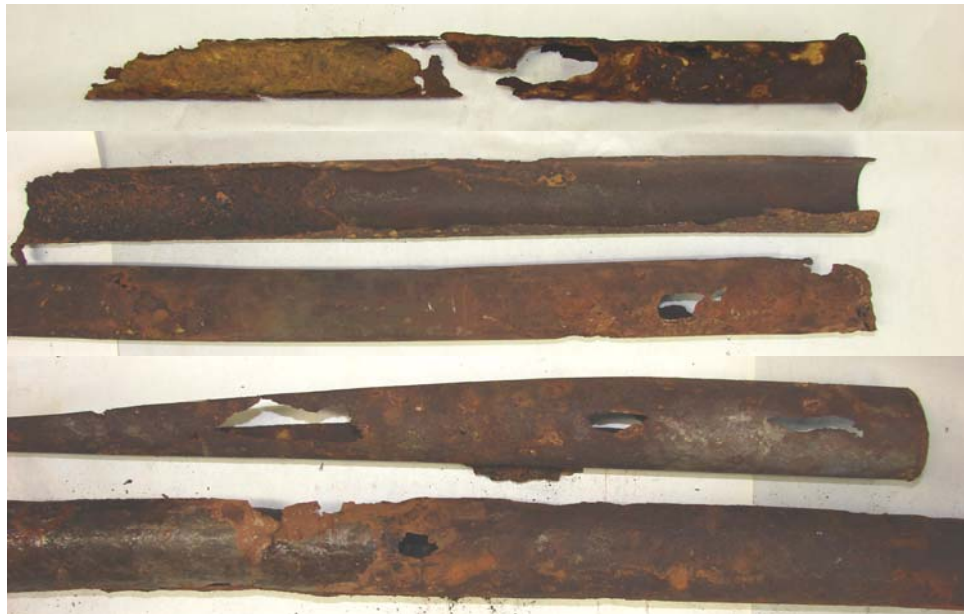
Figure 5.46 Extremely corroded friction rock stabilisers recovered from Olympic Dam Mine.

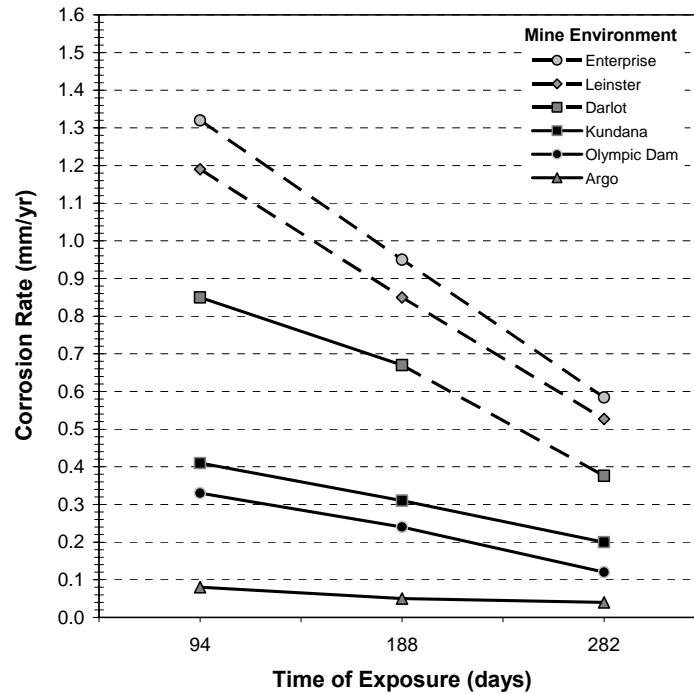
Figure 6.4 Corrosion rates for each WASM chamber over time.

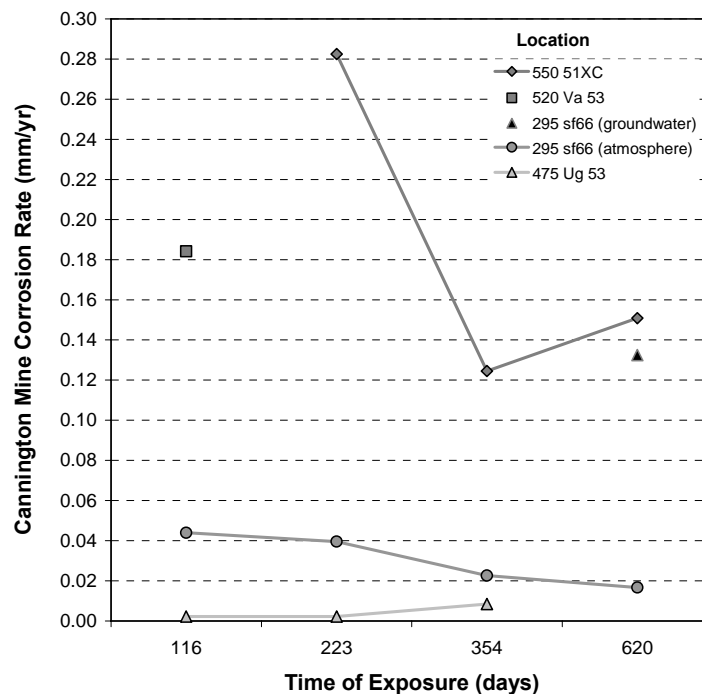
Figure 6.6 Corrosion rates from coupons at each location at Cannington Mine.

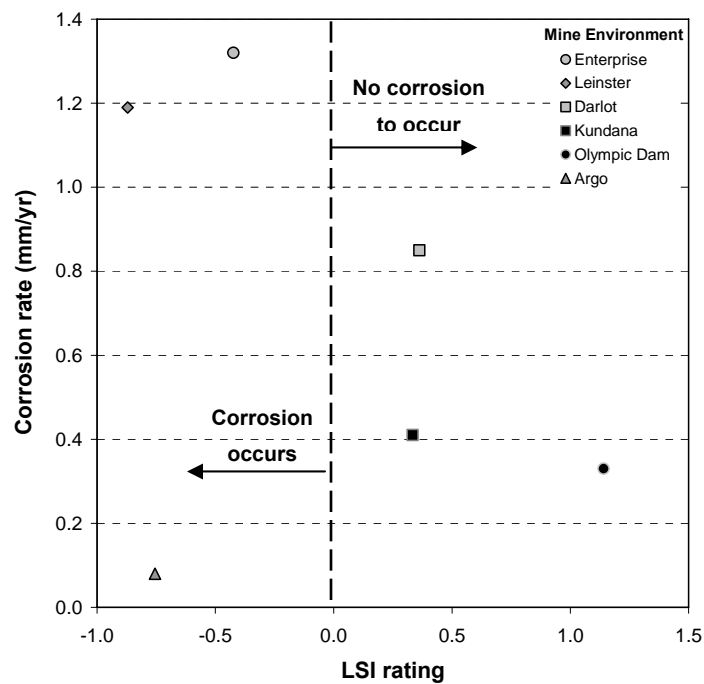
Figure 7.1 Comparison between the calculated LSI rating and the corrosion chamber corrosion rates.

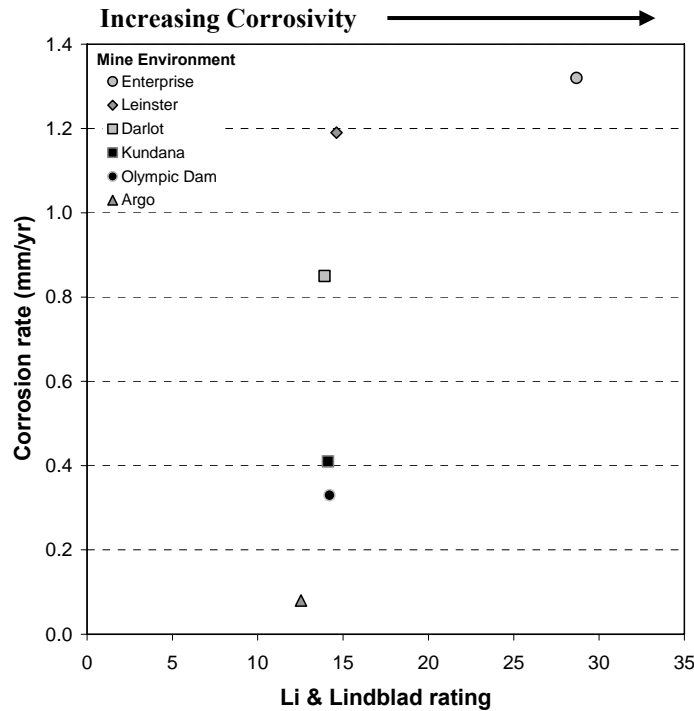
Figure 7.3 Comparison between the calculated Li & Lindblad (1999) rating and the corrosion chamber corrosion rates.

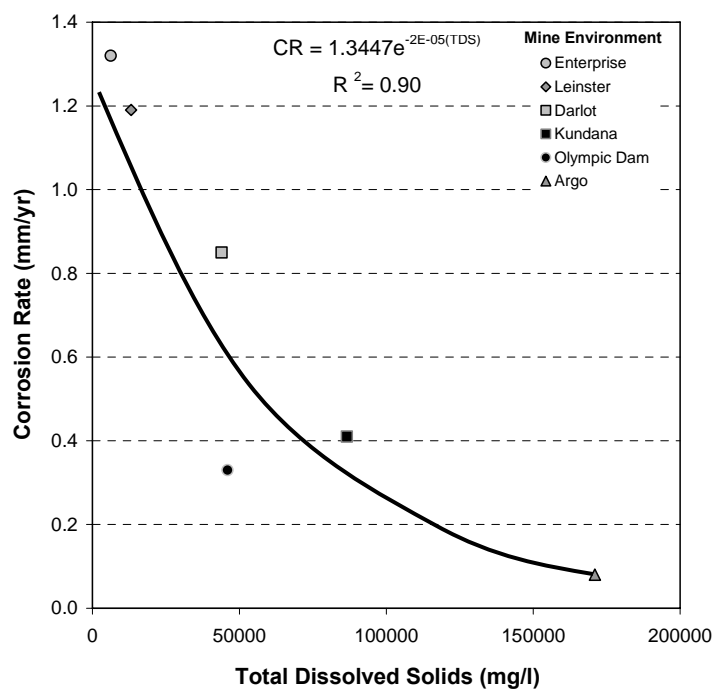
Figure 7.5 Relationship between the corrosion chamber corrosion rates and the TDS of the groundwater.

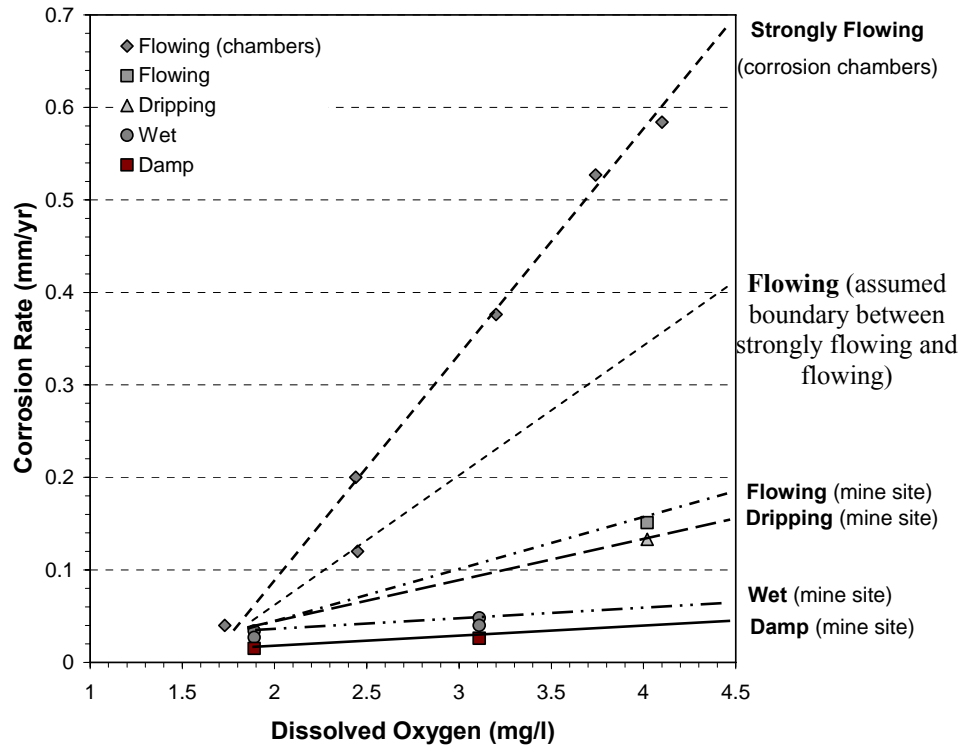
Figure 7.8 Corrosion coupon test data from the field and chambers grouped by water velocity.

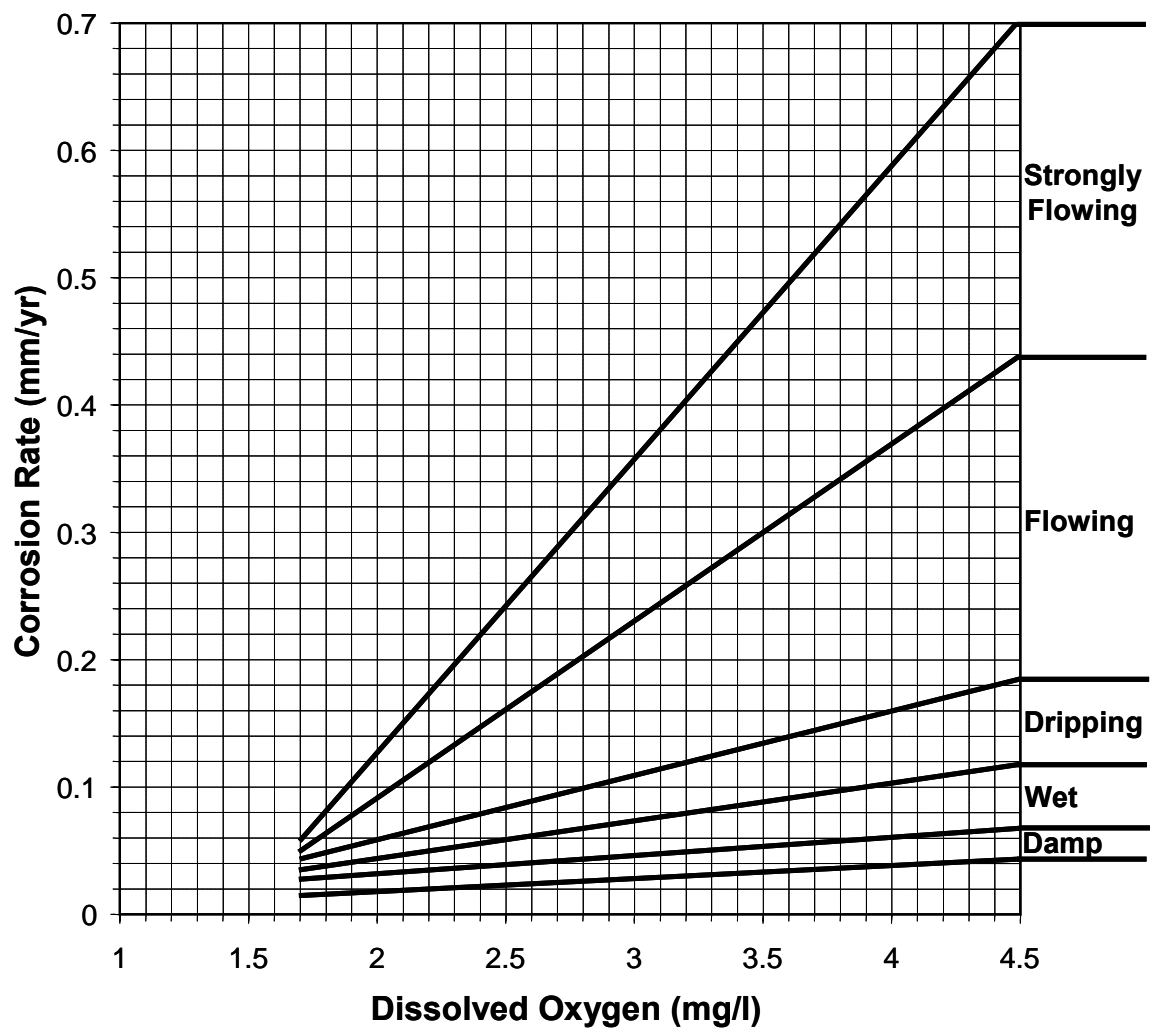
Figure 7.9 Corrosivity classification for groundwater affected, Australian hard rock environments.

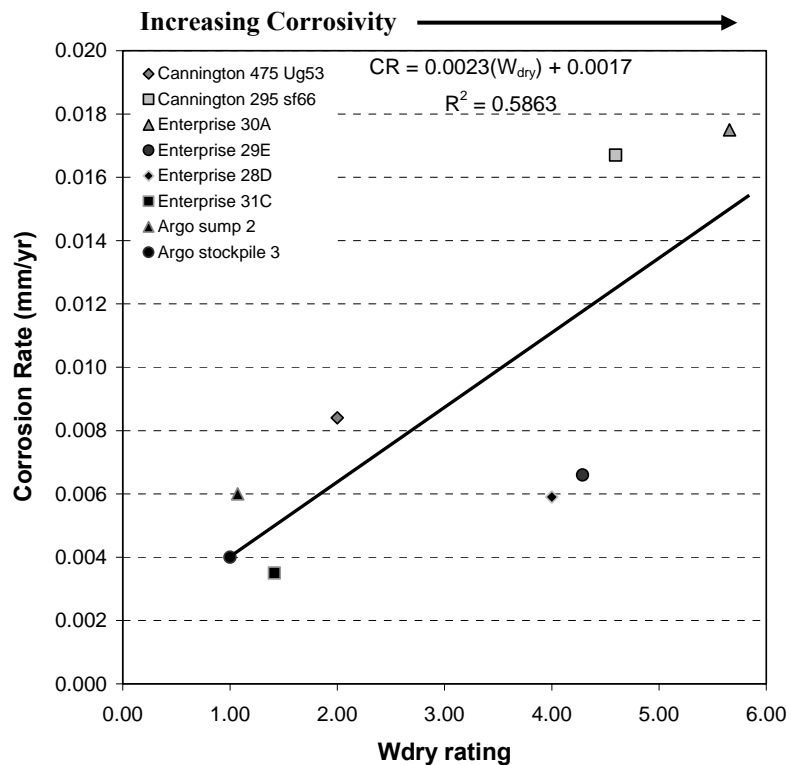
Figure 7.10 Relationship between corrosion rates and W_{dry} rating.

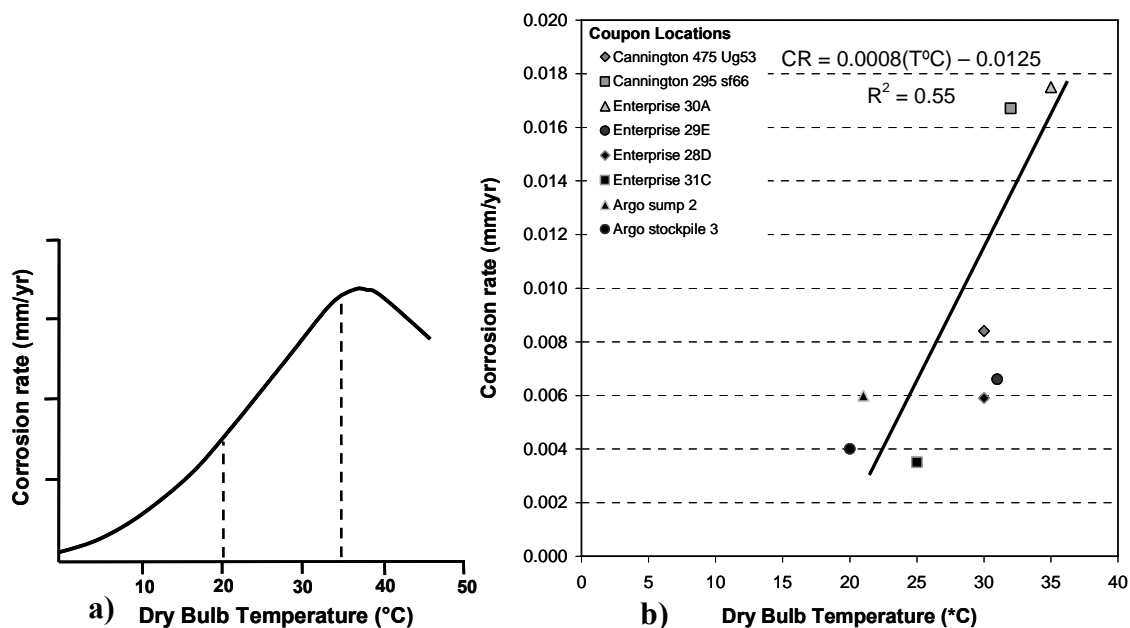
Figure 7.11 Relationship between the corrosion rate and temperature from a) Roberge (2000) and b) from the site coupon rates and measured temperature.

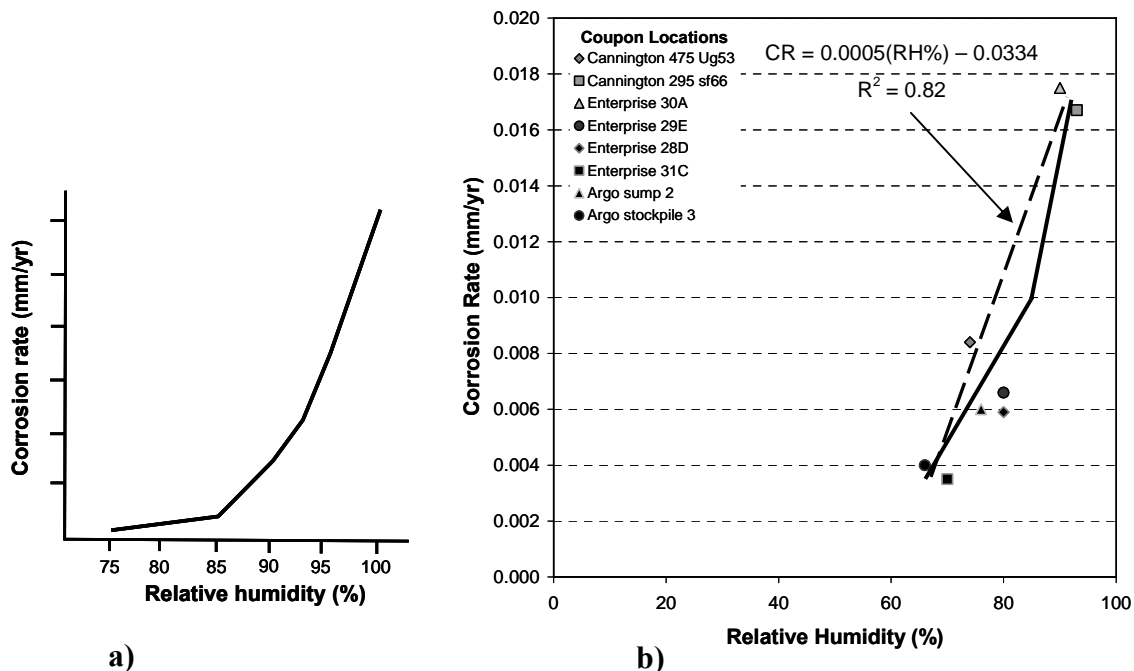
Figure 7.12 Relationship between coupon corrosion rates and relative humidity from a) Roberge (2000) and b) from the site coupon rates and measured humidity.

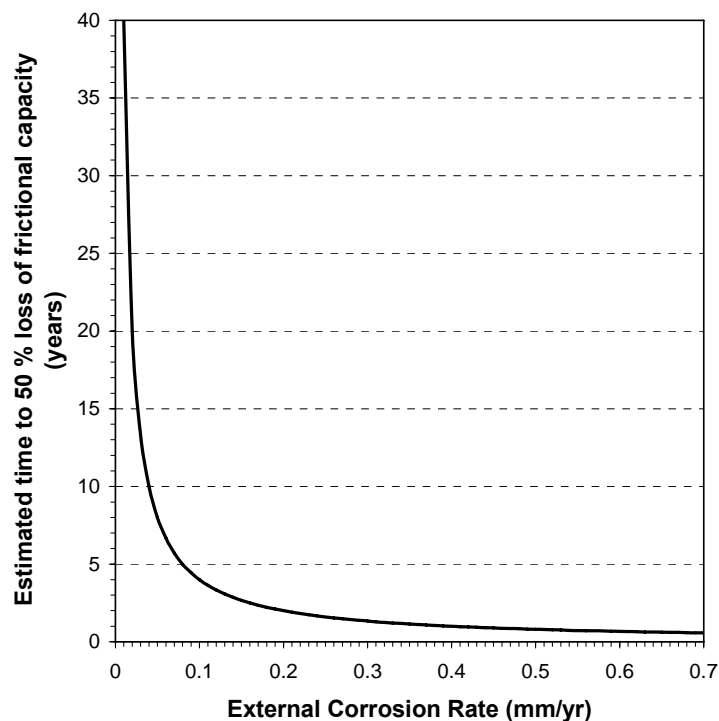
Figure 8.1 The estimated time taken for a 20% reduction in steel thickness of a 47 mm diameter, nominal 3 mm thickness FRS corresponding to a 50% decrease in pull out strength.

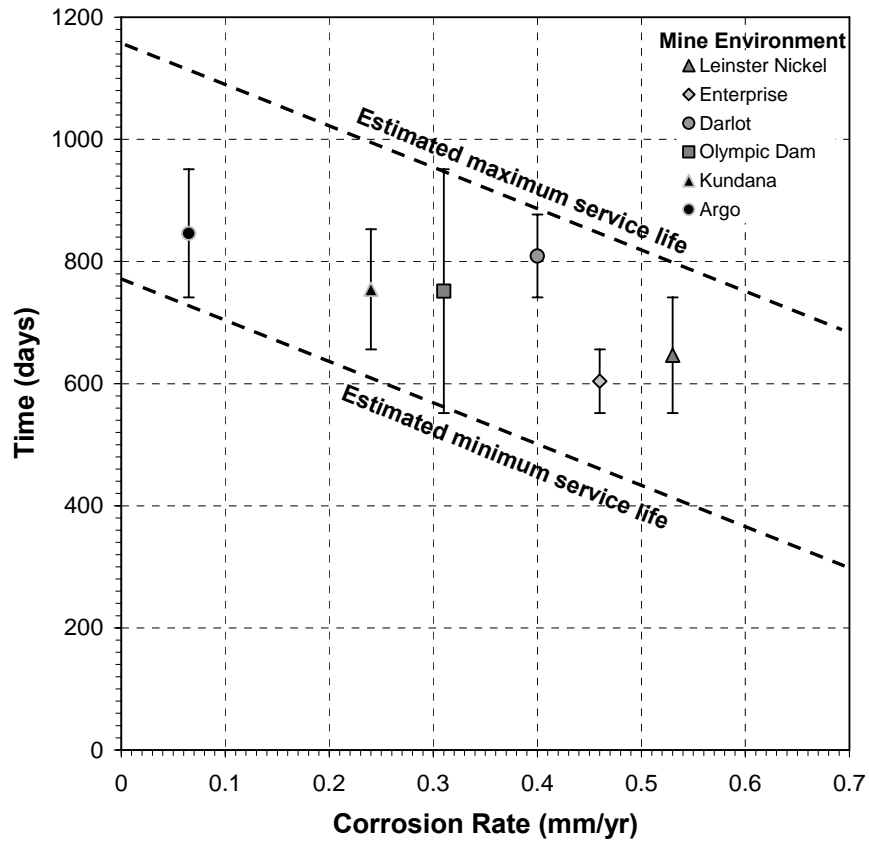
Figure 8.2 Service life estimates for cable strand in strong groundwater flow environments.

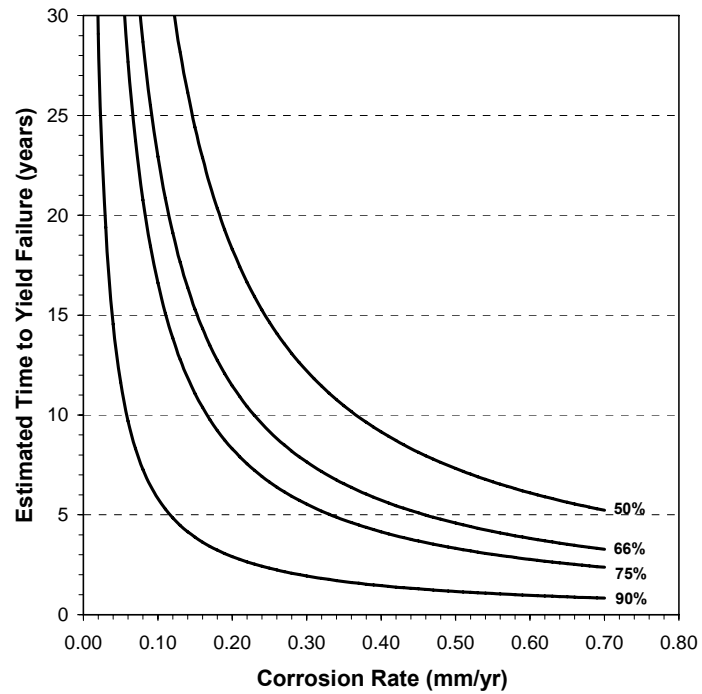
Figure 8.5 Estimated service life to yield failure for 25 mm thread bar due to corrosion at various working stresses (percentage of yield strength).

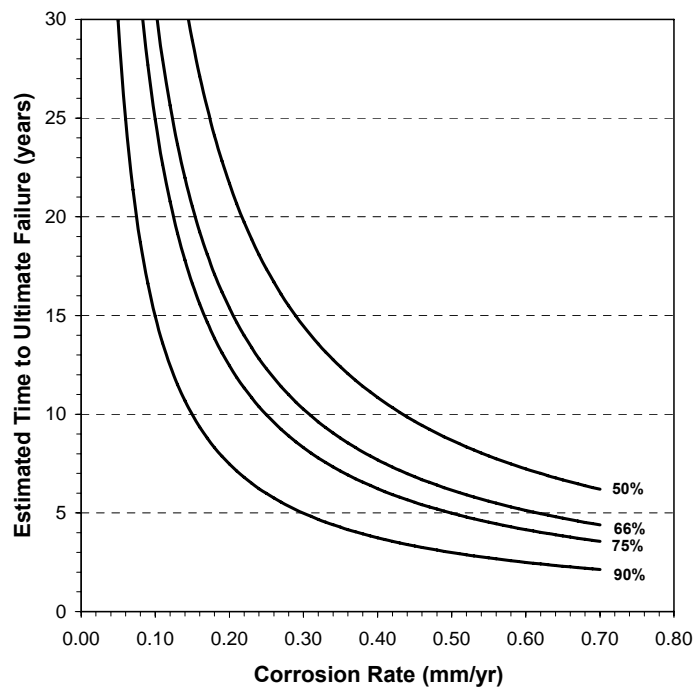
Figure 8.6 Estimated service life to ultimate failure for 25 mm thread bar due to corrosion at various working stresses (percentage of yield strength).

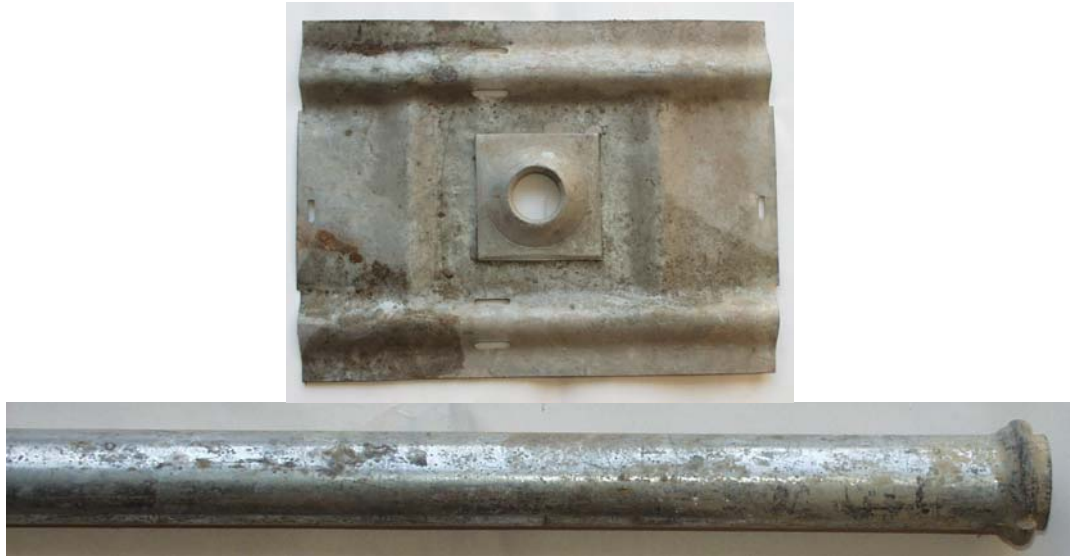
Light Corrosion (LC)

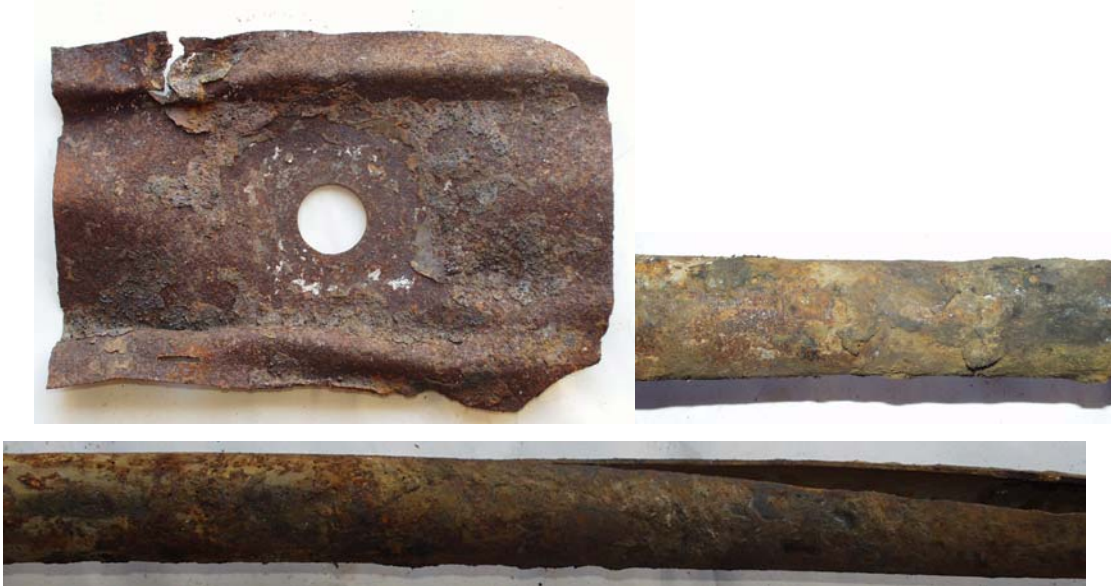
Extreme Corrosion (EC)
