**Investigation of Performance of Carbon and Glass Fibre
Strengthened Concrete Beams with Different End Anchorages**

**This thesis is presented for the Degree of
Master of Philosophy (Civil Engineering)**

Curtin University

March 2012

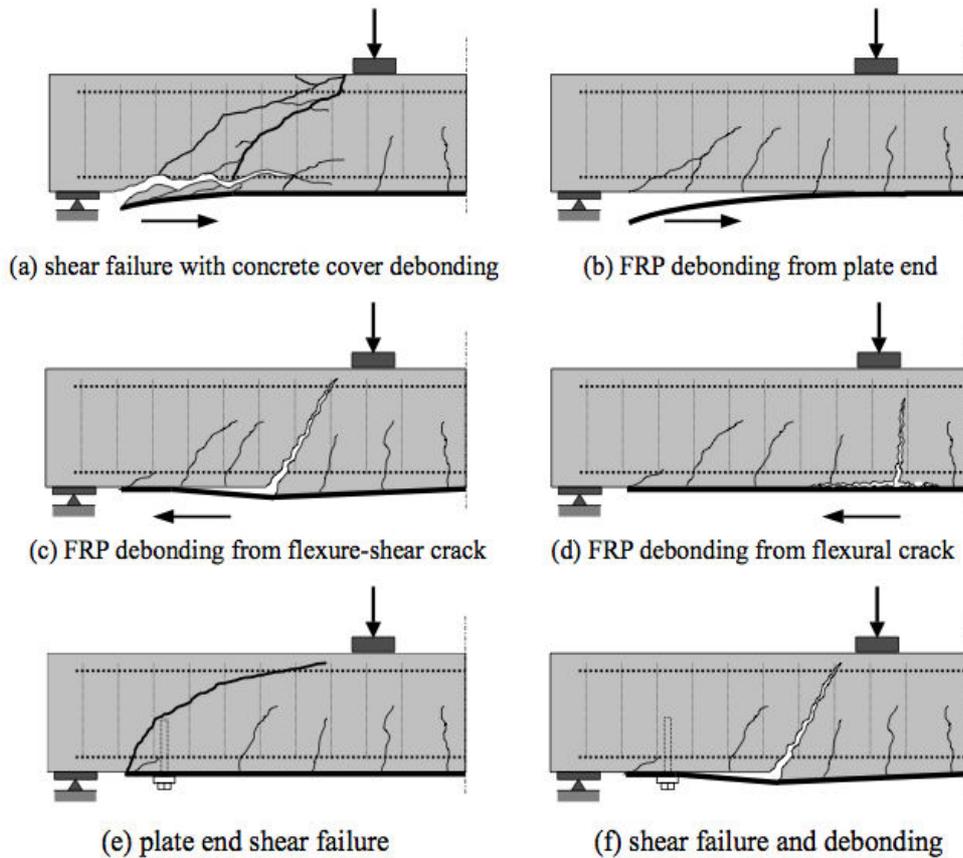
Figure 2.1: Debonding Mechanisms of FRP (taken from Gunes 2004)

Fundamental debonding mechanisms that may result in premature failure of FRP-strengthened beams with and without plate-end anchorages are shown in Figure 2.1 (Gunes 2004). They are (a) shear failure with concrete cover debonding, (b) FRP debonding from plate end, (c) FRP debonding from flexure-shear crack, (d) FRP debonding from flexural crack, (e) plate-end shear failure and (f) shear failure and debonding.

The mechanism of shear failure with the debonding of the concrete cover, as shown in Figure 2.1(a) is usually associated with high interfacial stresses, low concrete strength and/or extensive shear cracking. If the concrete strength and the shear capacity of the beam are sufficiently high, potential debonding failure is most likely to take place through FRP debonding, as shown in Figure 2.1(b), which initiates at the plate ends and propagates towards the centre of the beam. Depending on the material properties, FRP debonding may occur within the FRP plate, at the concrete–FRP interface or a few millimetres within the concrete. If the shear span of the strengthened beam is sufficiently long enough to enable proper bond development, or

the plate ends are anchored against shear failure and debonding, as shown in Figure 2.1(f), debonding may initiate at flexure-shear cracks and propagate towards the ends of the beam as in Figure 2.1(c). If the shear capacity of the beam is sufficiently high, debonding may also initiate from the flexural cracks as shown in Figure 2.1(d). However, this failure mechanism is very rare, especially in four-point bending tests (Büyüköztürk, Gunes and Karaca 2002). Propagation of debonding within the constant moment region does not change the stress distribution within the strengthened system. Thus, a conceptual interpretation suggests that debonding within the constant moment region is unlikely to happen. It is possible that high stress concentrations around flexural cracks promote debonding (Leung 2001). However, such stress concentrations diminish rapidly with propagation of debonding, resulting in a limited debonded area.

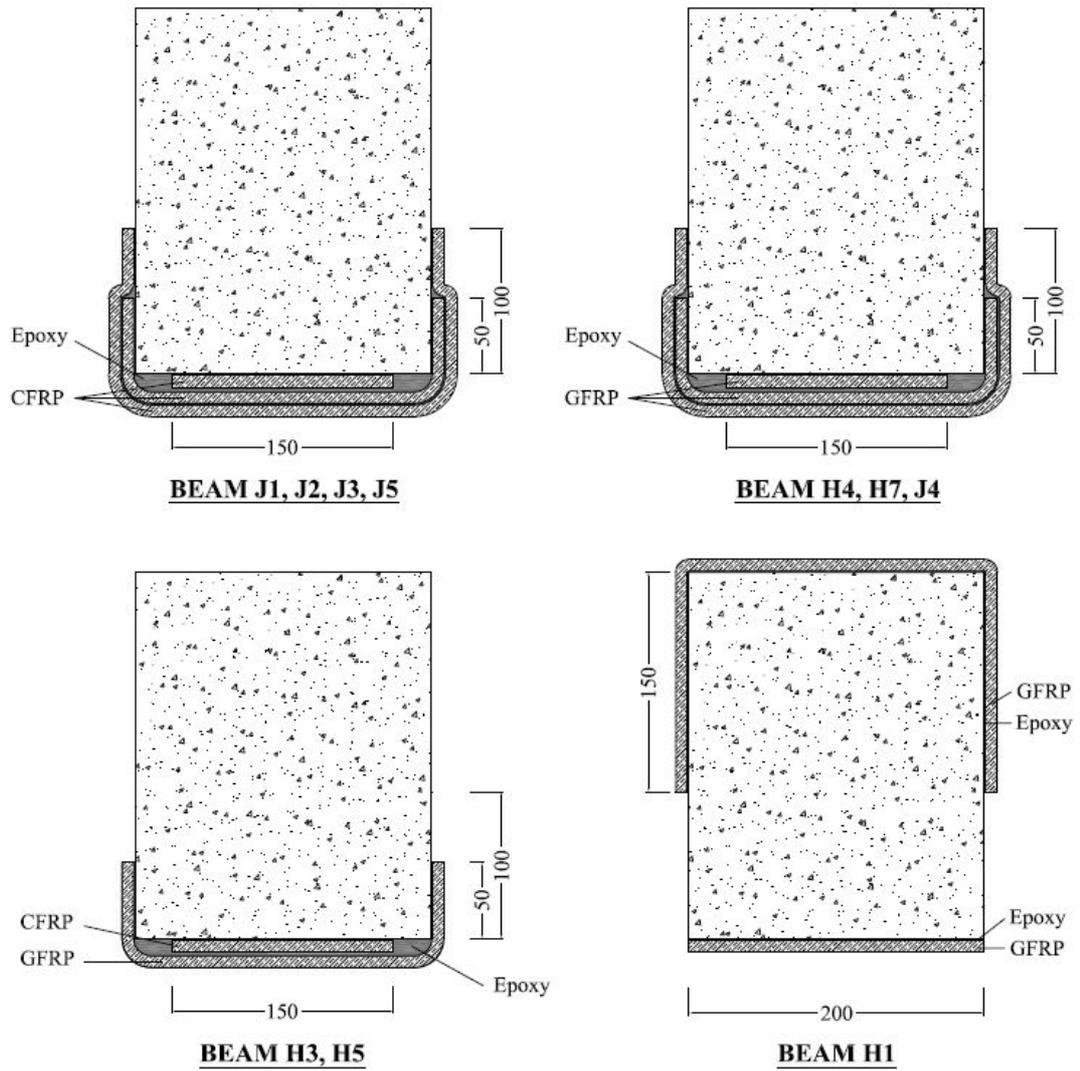
Figure 3.2: Cross-sections of FRP-strengthened specimens

In this research, both CFRP and GFRP fabrics were used to strengthen the RC beams. Specimens J1, J2, J3 and J5 were strengthened with three layers of CFRP, while specimens H4, H7 and J4 were strengthened with three layers of GFRP. Specimen H3 and H5 were strengthened with two layers of FRP, with the inner layer being CFRP and the outer layer being GFRP. Specimen H1 was strengthened with a layer of GFRP on the tension face and another layer of GFRP on the compression face. Figure 3.2 shows cross-sections of all FRP-strengthened specimens detailing the layers of FRP. Table 3.3 summarises the materials used in strengthening the RC beams.

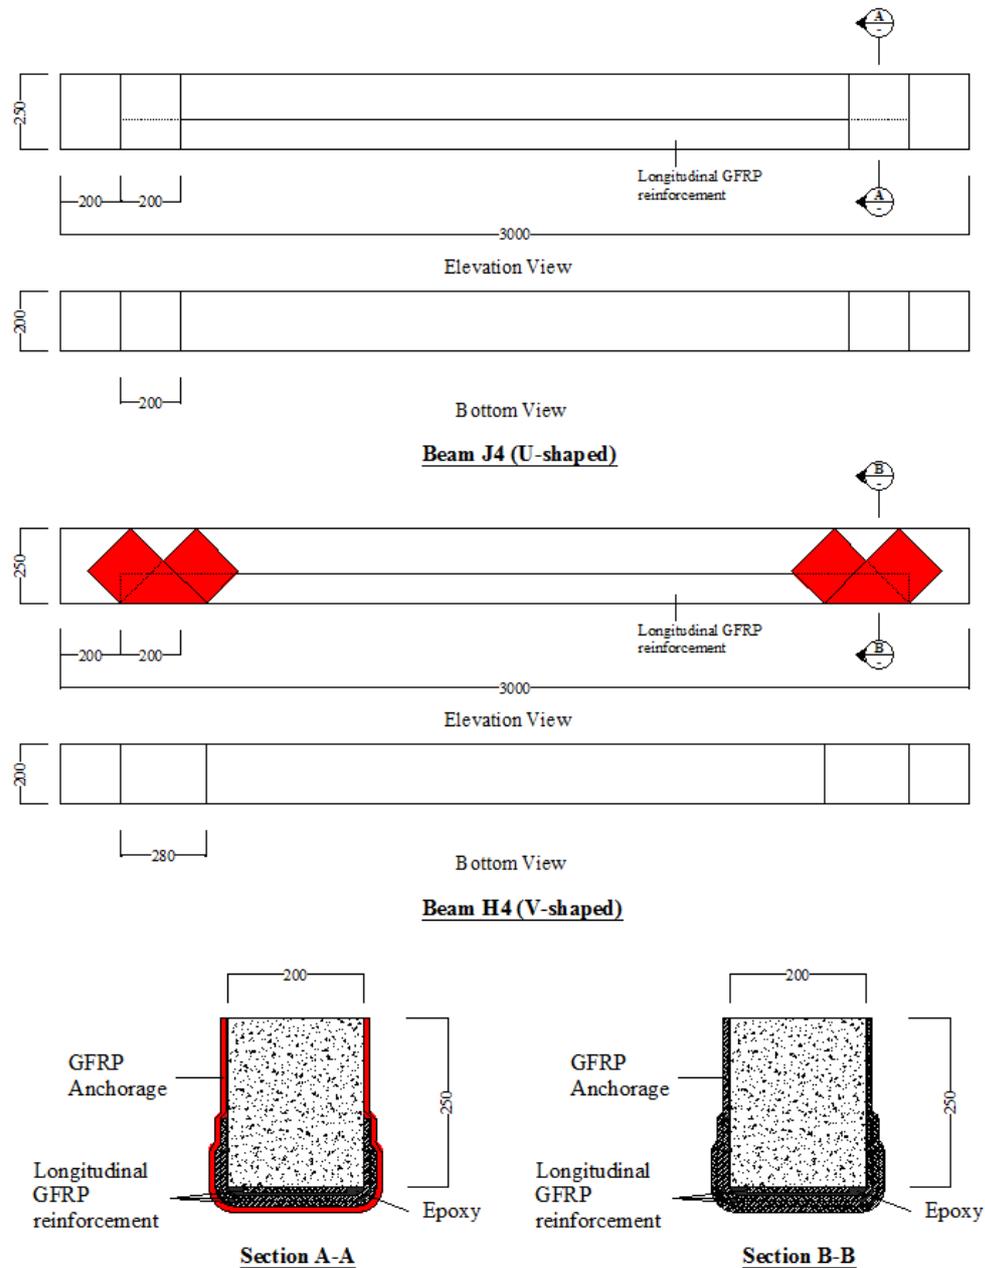
Figure 3.3: U-shaped and V-shaped anchorages

The major difference between these two anchorage designs is the direction of the strap. Since both the CFRP and GFRP used in this project were uni-directional fabrics (see technical data sheet, Appendix A), the fabric was concentrated in one direction only, which meant that the fabric performed well in resisting the tension force in the longitudinal direction, and less well in the transverse direction. Hence, if any internal tension occurred in the longitudinal direction, the U-shaped anchorage would not be able to provide much resistance, as there was no horizontal component

to the design. Therefore, failure occurring in this area would simply tear off the vertical strap. However, with the V-shaped anchorage, the inclined strap provided both horizontal and vertical components which were able to resist any internal action coming from either direction. Figure 3.4 illustrates the internal action of the beam and the FRP behaviour during loading.

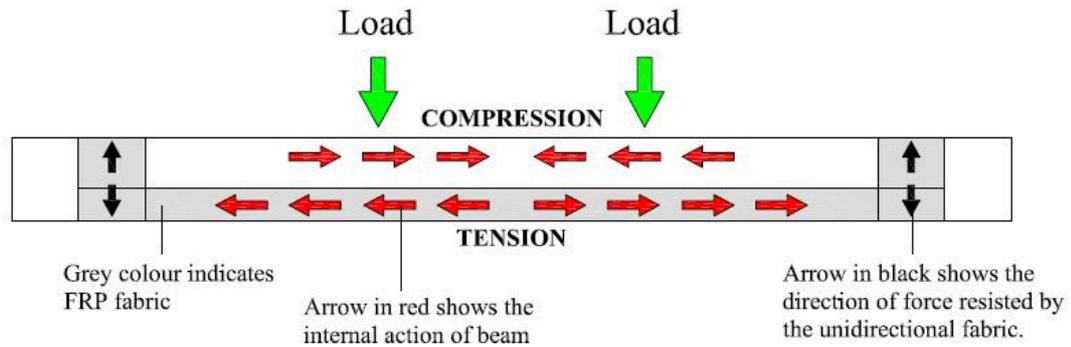
FRP Strengthened Beam with U-shaped anchorage

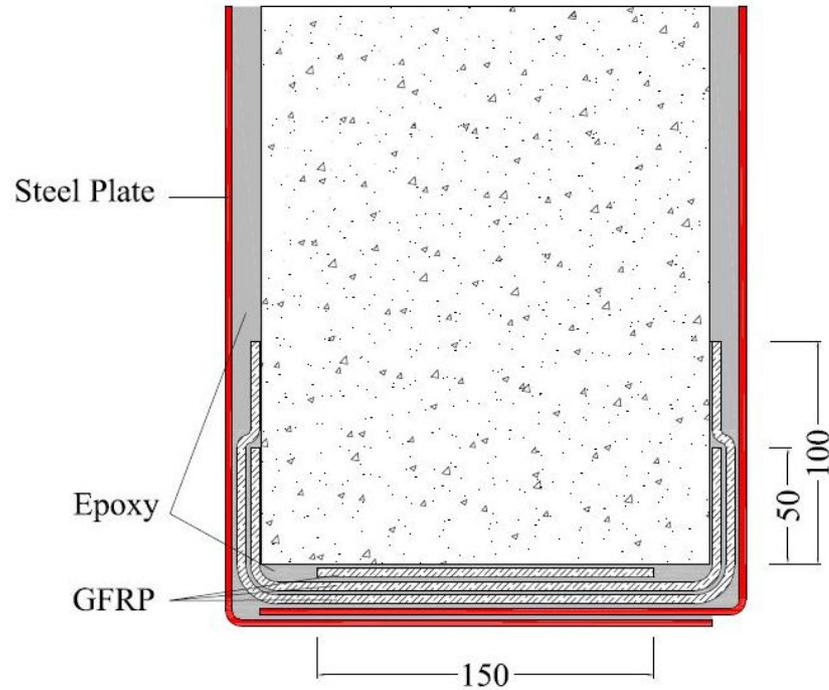
SECTION OF BEAM H7

For illustration purpose only. Actual specimen varies

plates placed in any direction perform well at resisting both tension and compression. Figure 3.5 shows the design of steel-plate anchorages used for this research. It should be noted that Figure 3.5 is a not-to-scale illustration (the contact between the beam surface and the steel plate was thinner than indicated; GFRP thickness was 0.4 mm).

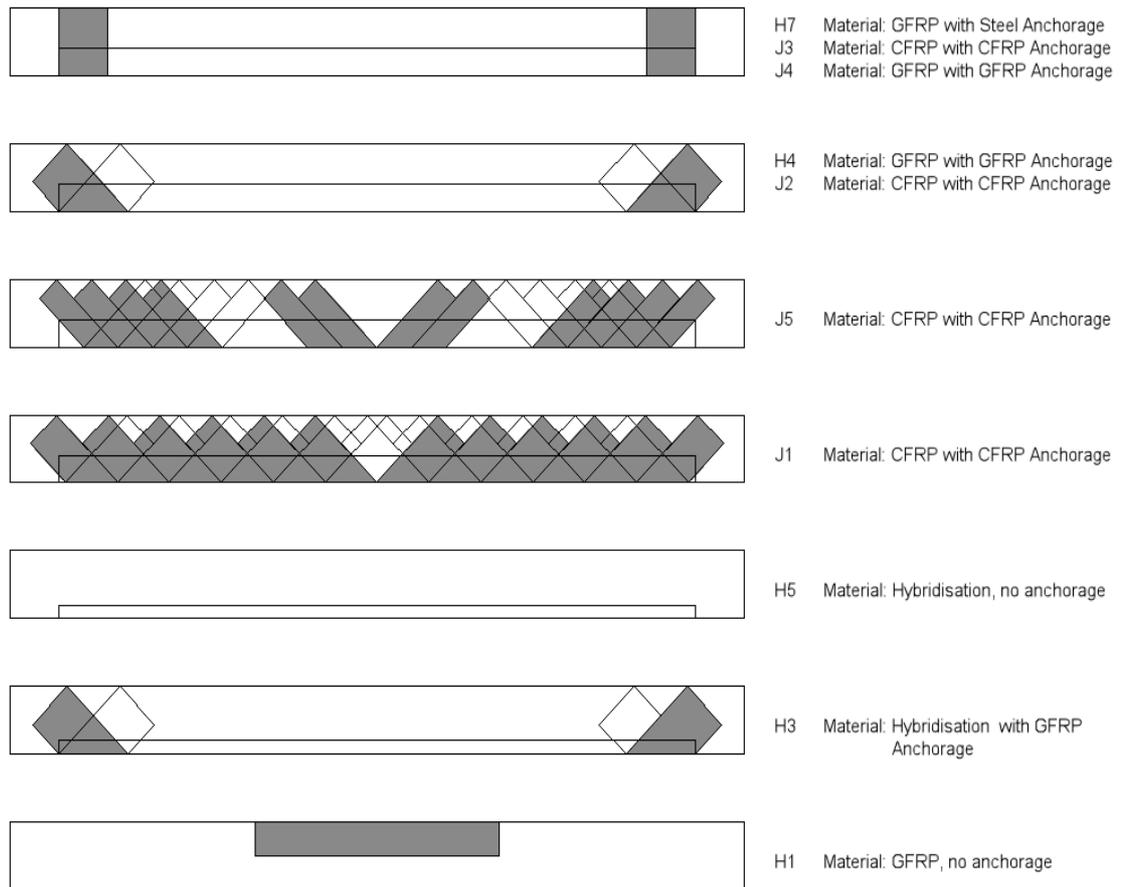
Figure 3.6: Anchorage arrangements of FRP-strengthened specimens

Specimen	Anchorage	Anchorage material	Description
H1	Nil	Nil	No anchorage wrapping at either end of the longitudinal GFRP layer
H2	Nil	Nil	Upper control beam
H3	V-shaped	GFRP	V-shaped GFRP anchorage wrapping at both ends of the longitudinal hybrid FRP layer
H4	V-shaped	GFRP	V-shaped GFRP anchorage wrapping at both ends of the longitudinal GFRP layer
H5	Nil	Nil	No anchorage wrapping at either end of the longitudinal hybrid FRP layer
H6	Nil	Nil	Lower control beam
H7	U-shaped	Steel plate	U-shaped steel-plate anchorage wrapping at both ends of the longitudinal GFRP layer
J1	V-shaped	CFRP	V-shaped CFRP anchorage wrapping the entire length of the longitudinal CFRP layer
J2	V-shaped	CFRP	V-shaped CFRP anchorage wrapping at both ends of the longitudinal CFRP layer
J3	U-shaped	CFRP	U-shaped CFRP anchorage wrapping at both ends of the longitudinal CFRP layer
J4	U-shaped	GFRP	U-shaped GFRP anchorage wrapping at both ends of the longitudinal GFRP layer

J5	V-shaped	CFRP	V-shaped CFRP anchorage wrapping the entire length of the longitudinal CFRP layer

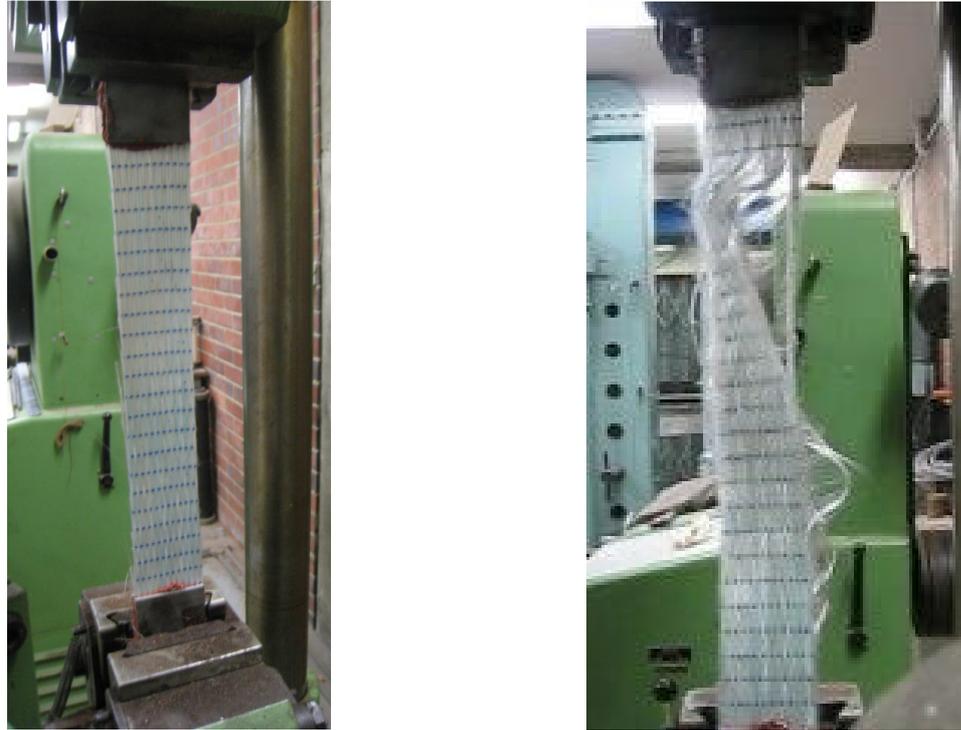
Figure 4.2: Setup of GFRP tensile test and failure of GFRP

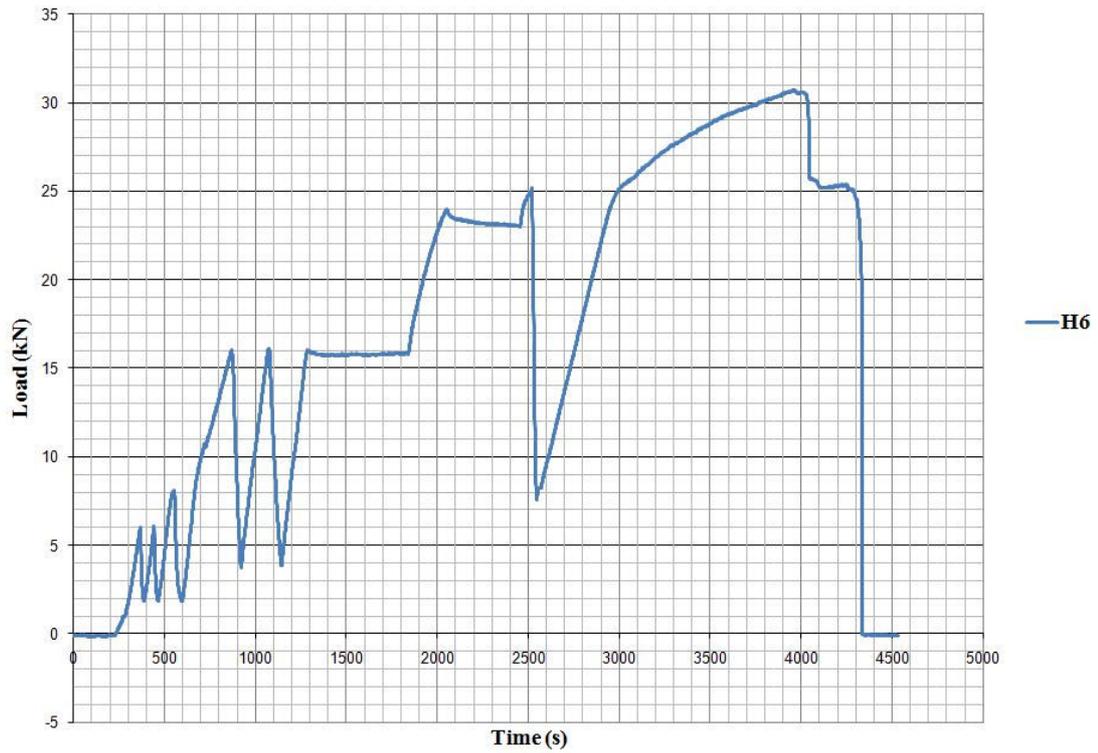
Figure 5.1: Loading cycles for Specimen H6

Specimen H6 was tested as a lower control beam. As H6 was a typical RC beam, the expected failure mode for Specimen H6 was the yielding of tensile steel followed by the failing of the beam in a ductile manner. Specimen H6 was initially loaded to 6 kN for two cycles and then loaded up to 8 kN. It was then loaded up to 16 kN for three cycles and then eventually up to yielding load, which was 25 kN. The loading jack was then released back to 8 kN for another cycle to check whether yielding load has achieved, and it was then reloaded until failure. All loading cycles for Specimen H6 are illustrated in Figure 5.1.

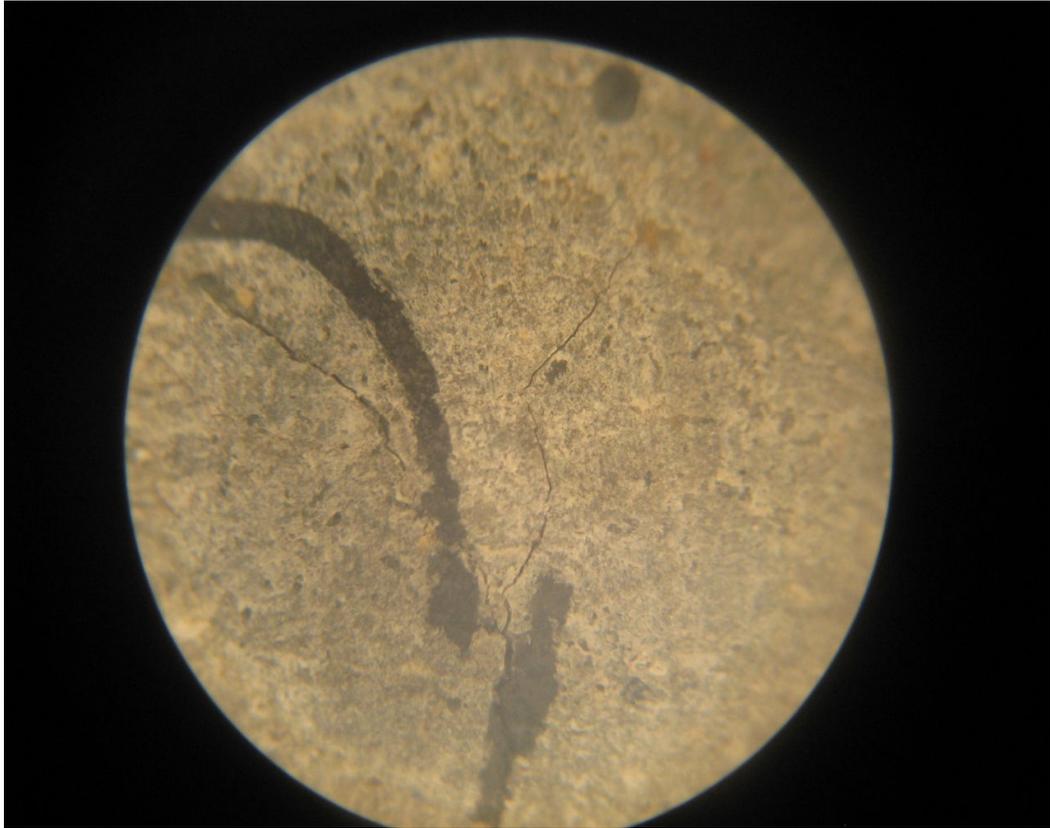
Figure 5.3: Cracks in Specimen H6 sighted using crack-detection microscope

The first sign of cracking appeared at a load magnitude of 6 kN near the mid-span of the beam. As mentioned in Chapter 2 (Section 2.2), these cracks, known as flexural cracks, emanated upwards. The hairline cracks at this stage were so fine that a crack-detection microscope was needed to measure the crack width (see Figure 5.3). The crack width at that time was about 0.5 mm. With progressive loading, the cracks grew wider to measure about 1.0 to 2.0 mm. After reaching the yielding load of 25 kN, the internal tensile rebar started to exhibit plastic deformation. This is shown in the load-deflection graph in Figure 5.2 where the gradient of slope after 25 kN is less steep than the gradient at earlier loadings. Subsequently, the beam began to exhibit concrete compression failure at the mid-span of the compression zone (Figure 5.4). Further loading caused the tensile reinforcement to fracture and eventually fail. This is shown in Figures 5.5 and 5.6.

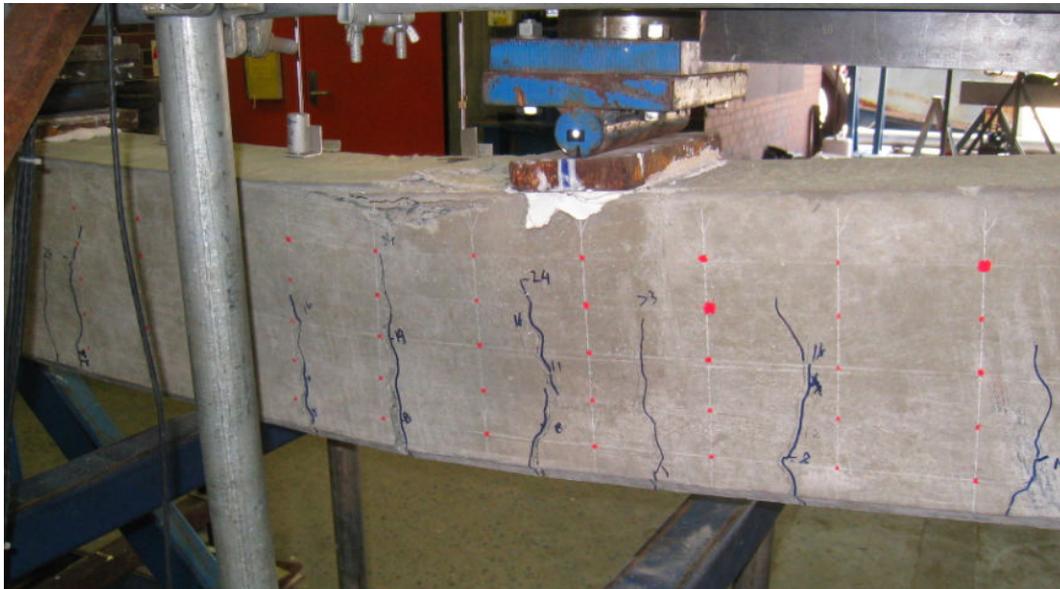
Figure 5.4: Concrete compression, Specimen H6

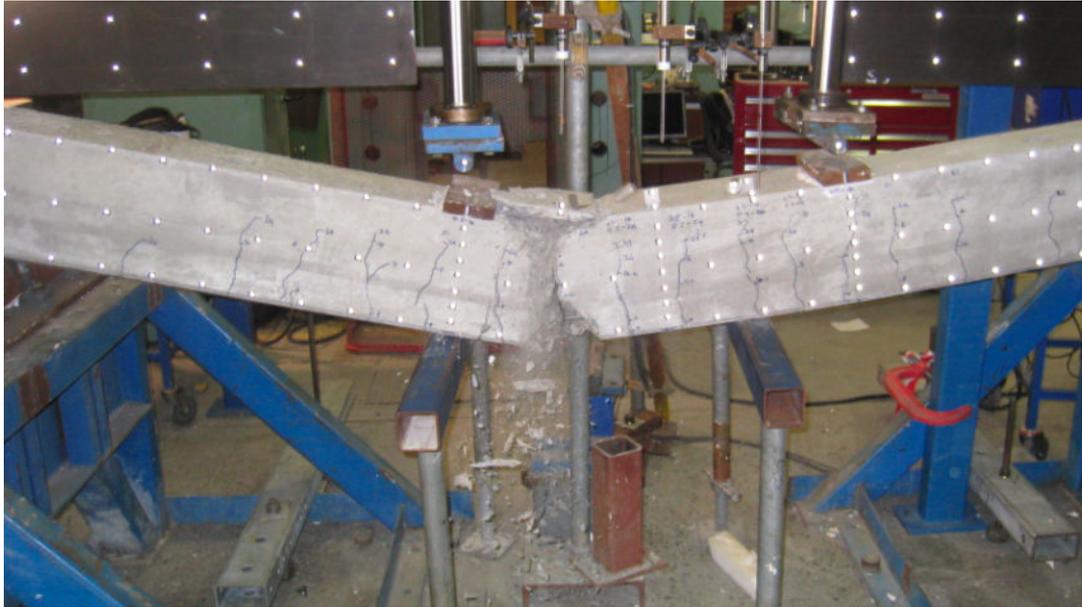
Figure 5.5: Total failure of Specimen H6

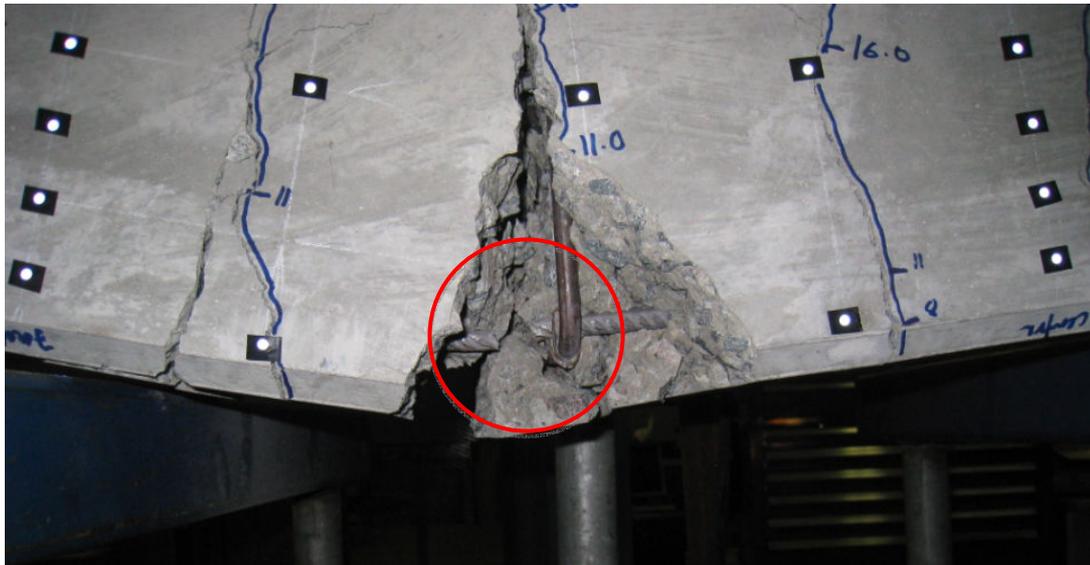
Figure 5.6: Tensile reinforcement fracture, Specimen H6

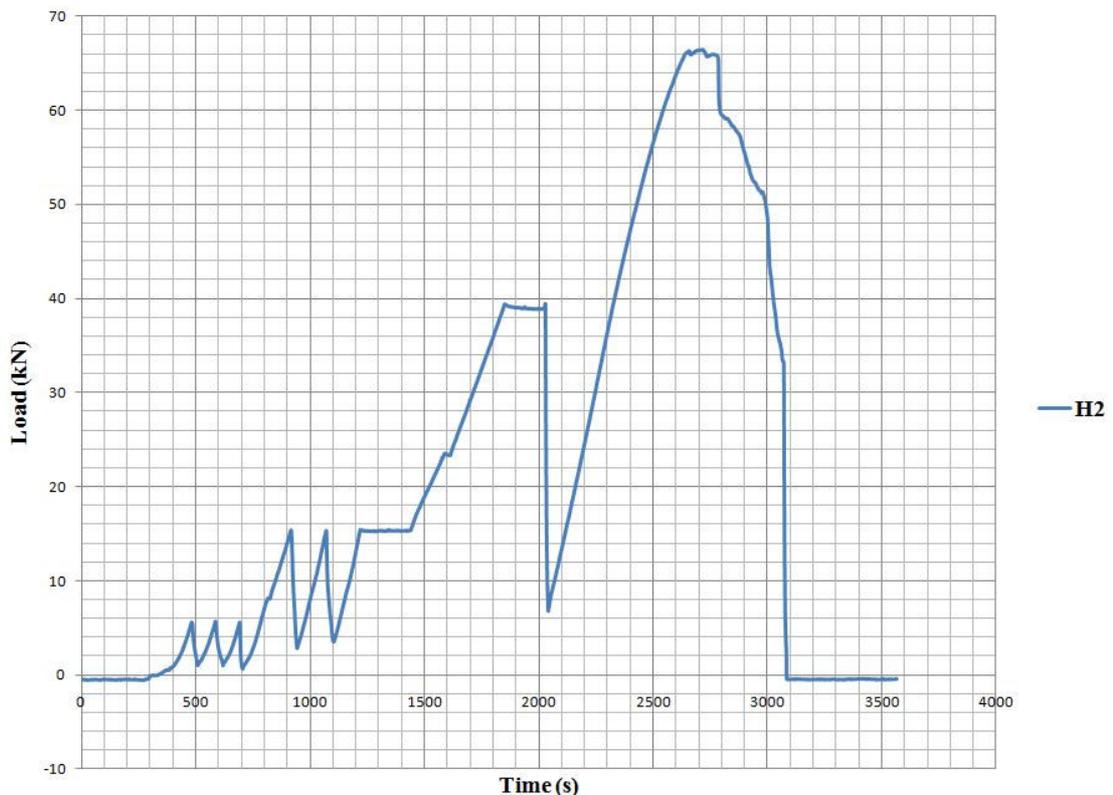
Figure 5.7: Loading cycles for Specimen H2

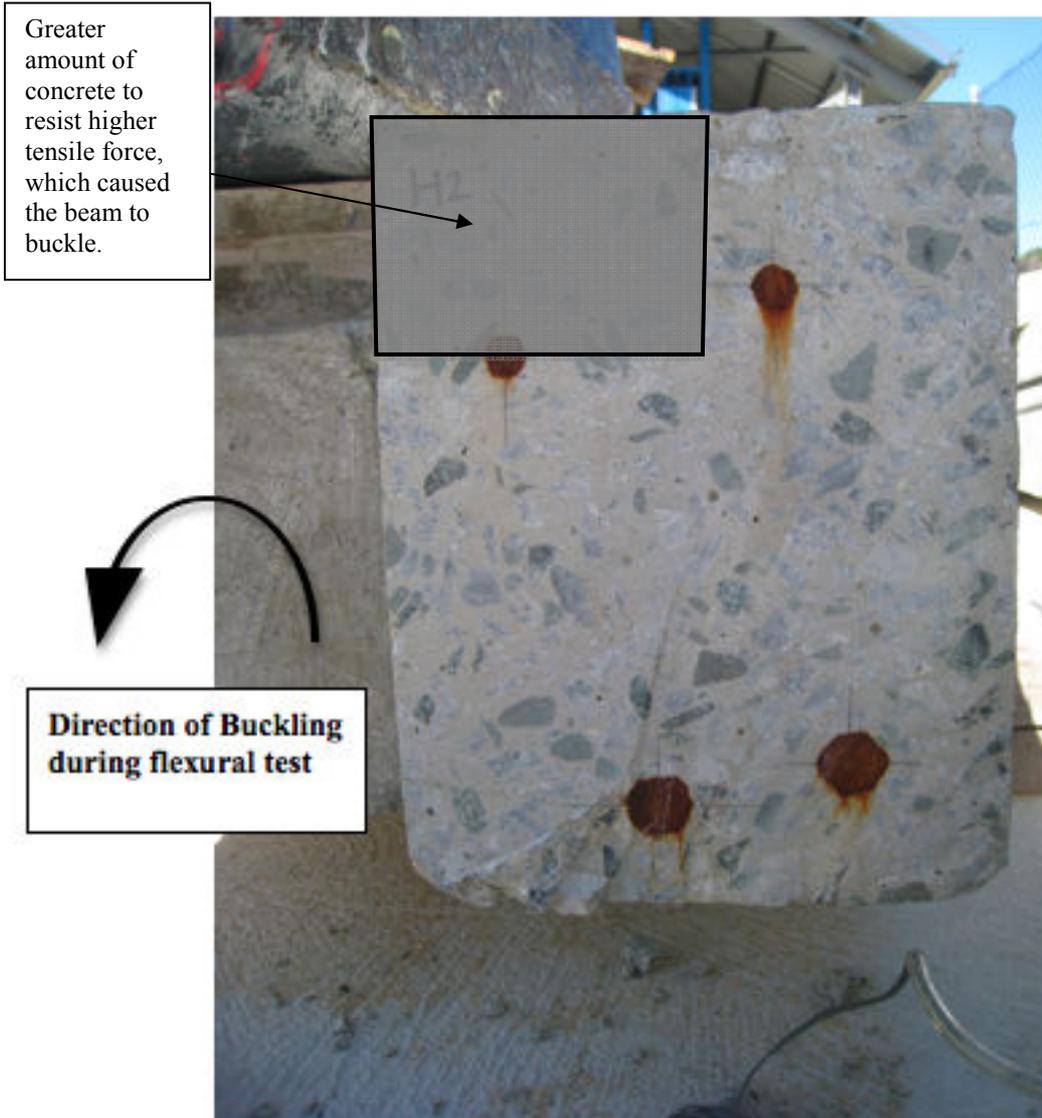
Figure 5.9: Uneven steel positioning in Specimen H2

unexpected. For this reason, after the completion of the flexural, test the beam was sawn in half to check the steel bar location. As shown in Figure 5.9, the two N20 tensile reinforcements and the two N10 compressive reinforcements were located at different depths, causing the beam to produce an unequal neutral axis. This is shown by the shaded area in Figure 5.9. The shaded area contained more concrete and therefore a greater compressive force with which to resist greater tensile force. This caused the load magnitude to be distributed towards the shaded area, which caused the entire beam to buckle laterally during the flexural test. Figure 5.10 shows only one buckled compressive reinforcement bar visible, as the other compressive reinforcement is further down. Figure 5.8 shows the load versus deflection graph for Specimen H2 during the flexural bending test. The beam deflected up to 22 mm upon reaching the peak load. The beam then continued to sustain the load while deflecting up to 30 mm. Meanwhile, concrete crushing and buckling of the compressive reinforcement bar occurred. With the further vertical displacement that came from the loading jacks, the beam continued to deflect and eventually failed.

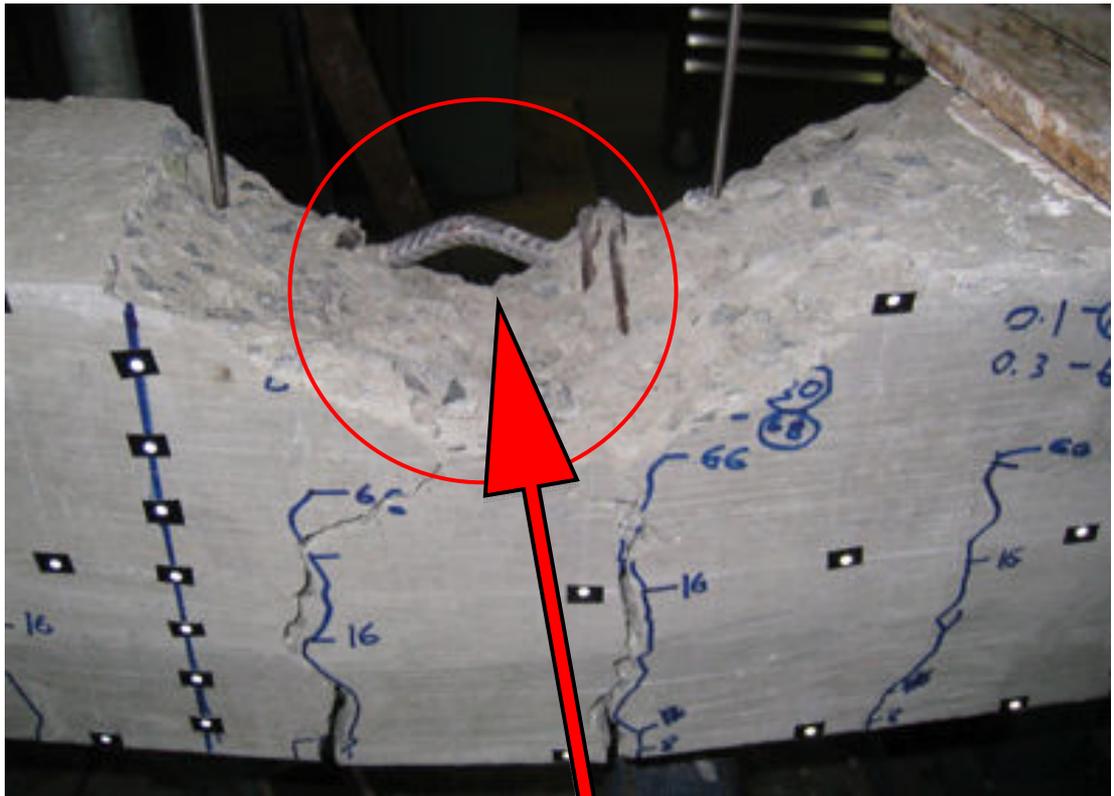
Figure 5.10: Buckling of compressive reinforcement, Specimen H2

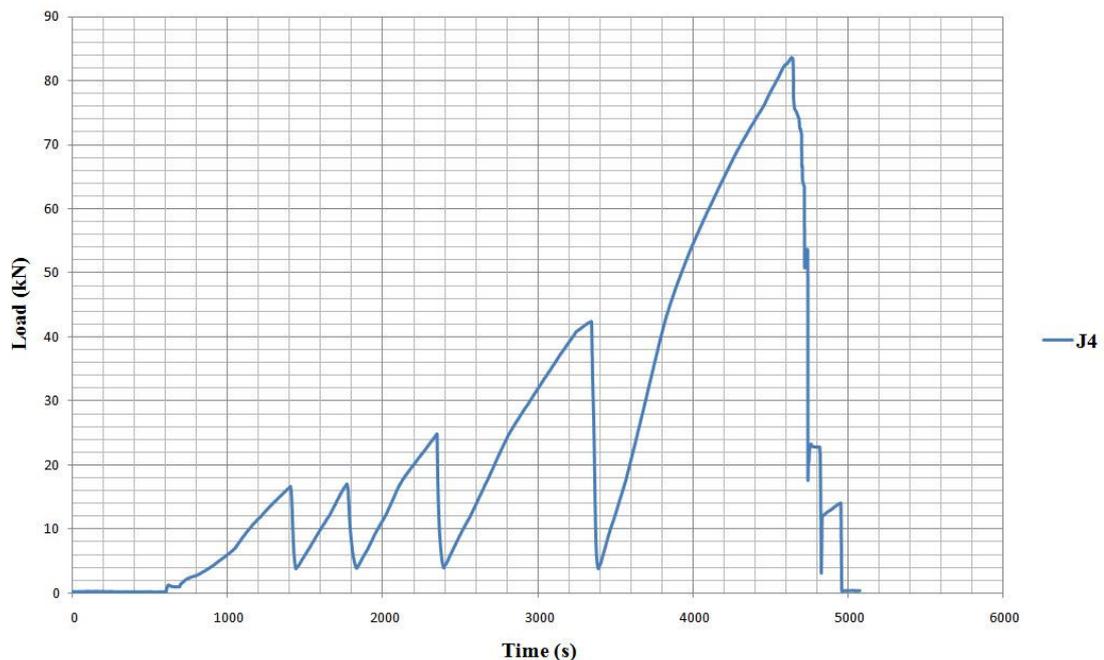
Figure 5.11: Loading cycles for Specimen J4

Specimen J4 was strengthened with three layers of GFRP with a typical U-shaped anchorage at each end (the end anchorages). As usual, the beam was loaded for several cycles at the initial testing stage. The first sign of cracks occurred at the 33 kN load, with more cracks showing at 40 kN and above. Shear cracks also appeared near the end support of the beam at a load magnitude of 40 kN, as shown in Figure 5.13. Specimen J4 continued to sustain loading up to 82 kN, when the primary failure occurred in the compression zone of the beam at mid-span where the concrete appeared to undergo concrete crushing; this is shown in Figure 5.14. Meanwhile, no sign of tensile rupture or debonding of the GFRP was detected. With further vertical displacement from the loading jack, the tensile capacity of the GFRP was fully utilised. A ‘tickling’ sound was heard, and the GFRP at the tension face fractured due to tensile rupture. The end anchorage exhibited shear failure (Figure 5.15) and eventually debonded (Figure 5.16). Figure 5.12 shows the load-deflection graph for Specimen J4, demonstrating that the specimen had a brittle failure as the load decreased rapidly after the concrete-crushing failure. Figure 5.11 illustrates the loading cycles for Specimen J4.

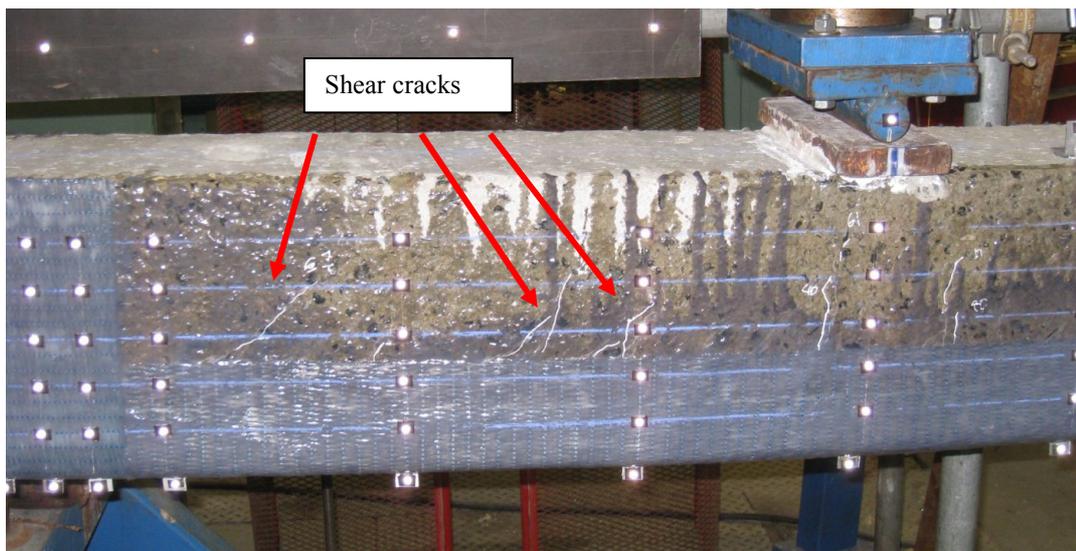
Figure 5.13: Shear cracks, Specimen J4

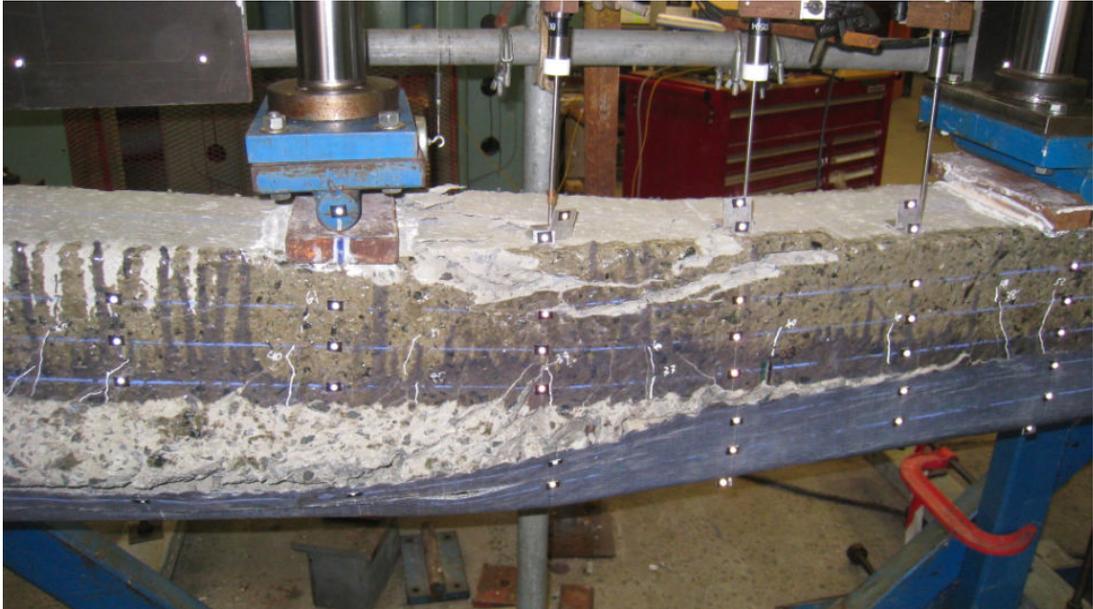
Figure 5.14: Concrete crushing at compression zone followed by debonding of GFRP, Specimen J4

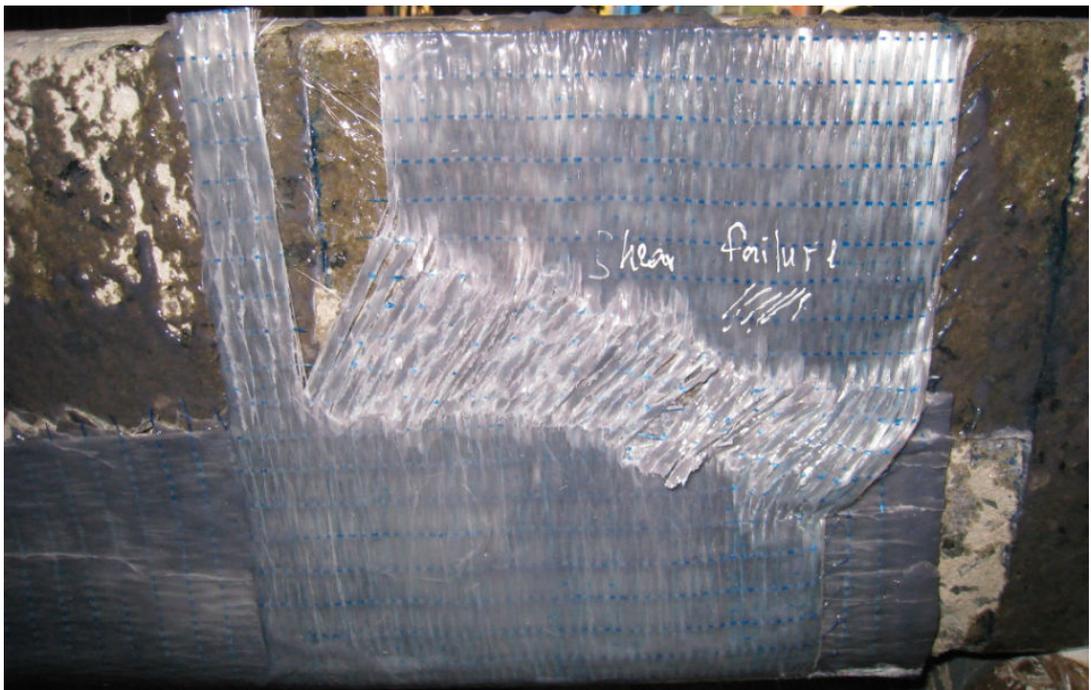
Figure 5.15: Shear failure at end anchorage, Specimen J4

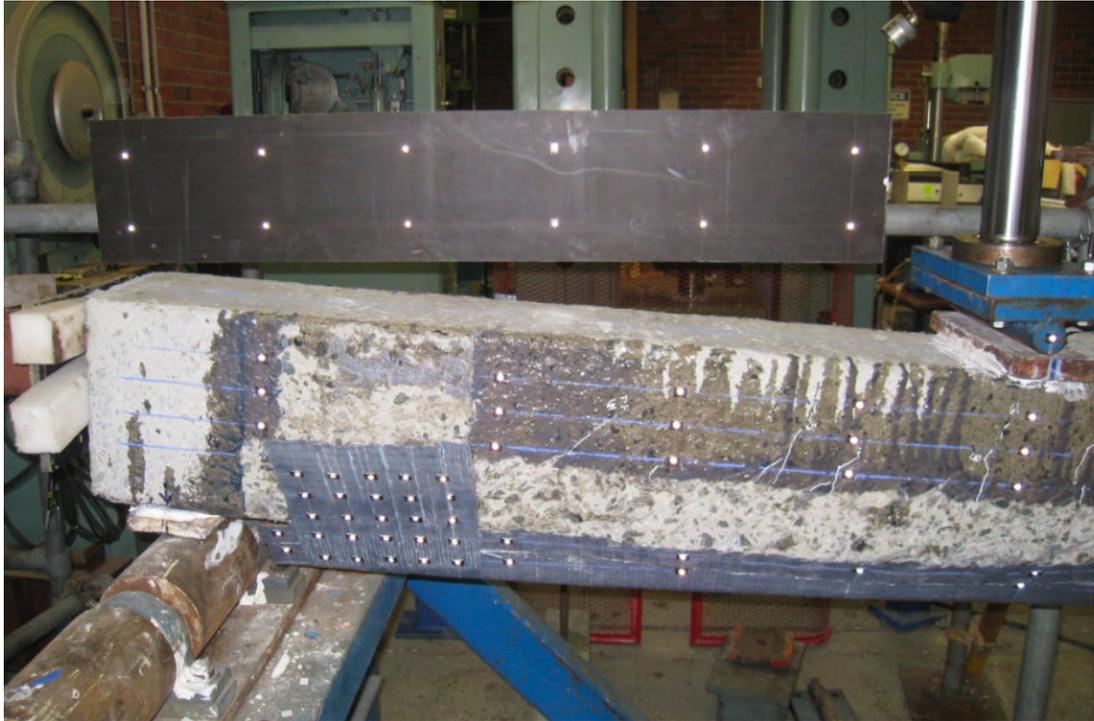
Figure 5.16: Debonding of end anchorage, Specimen J4

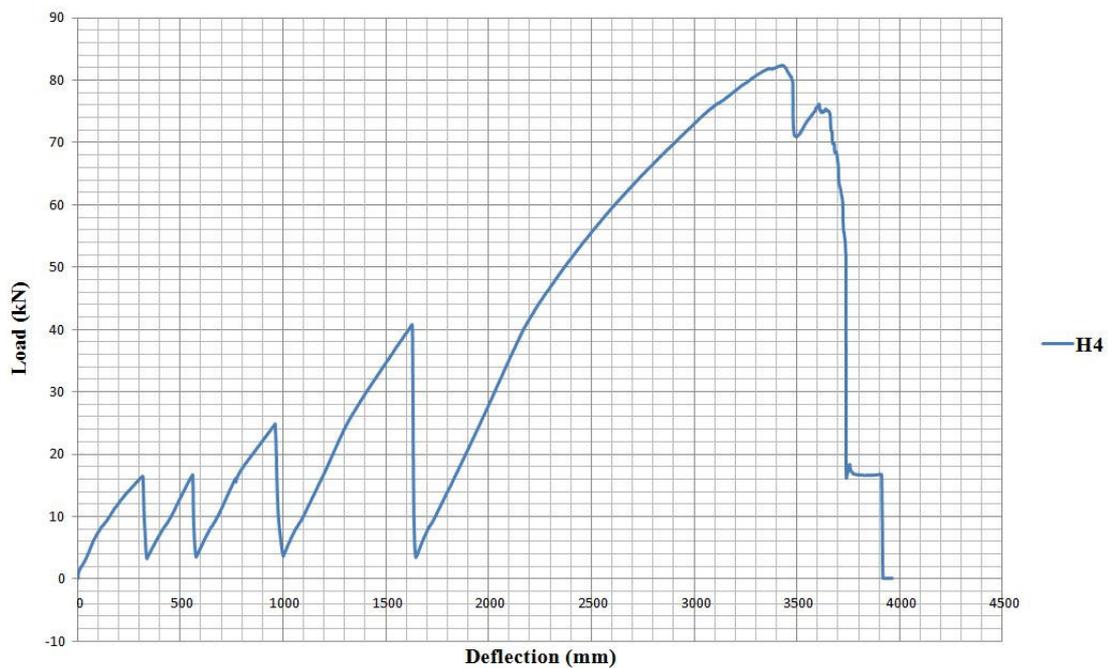
Figure 5.17: Loading cycles for Specimen H4

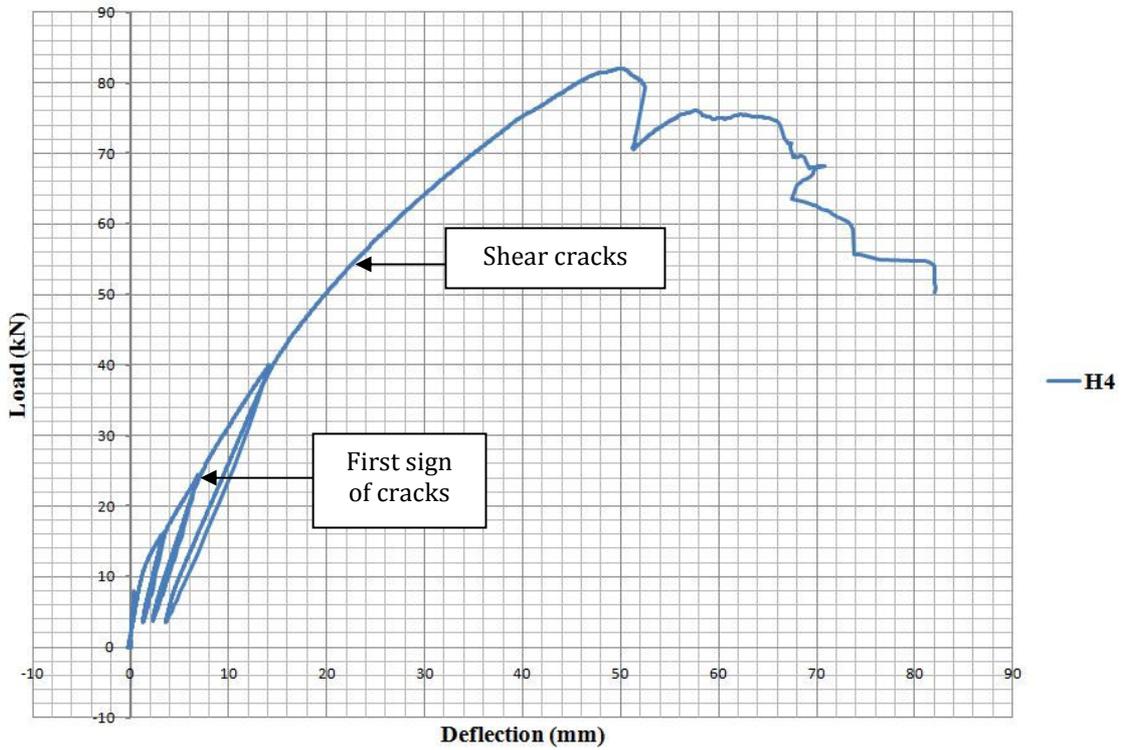
Figure 5.18: Load v. deflection graph for Specimen H4

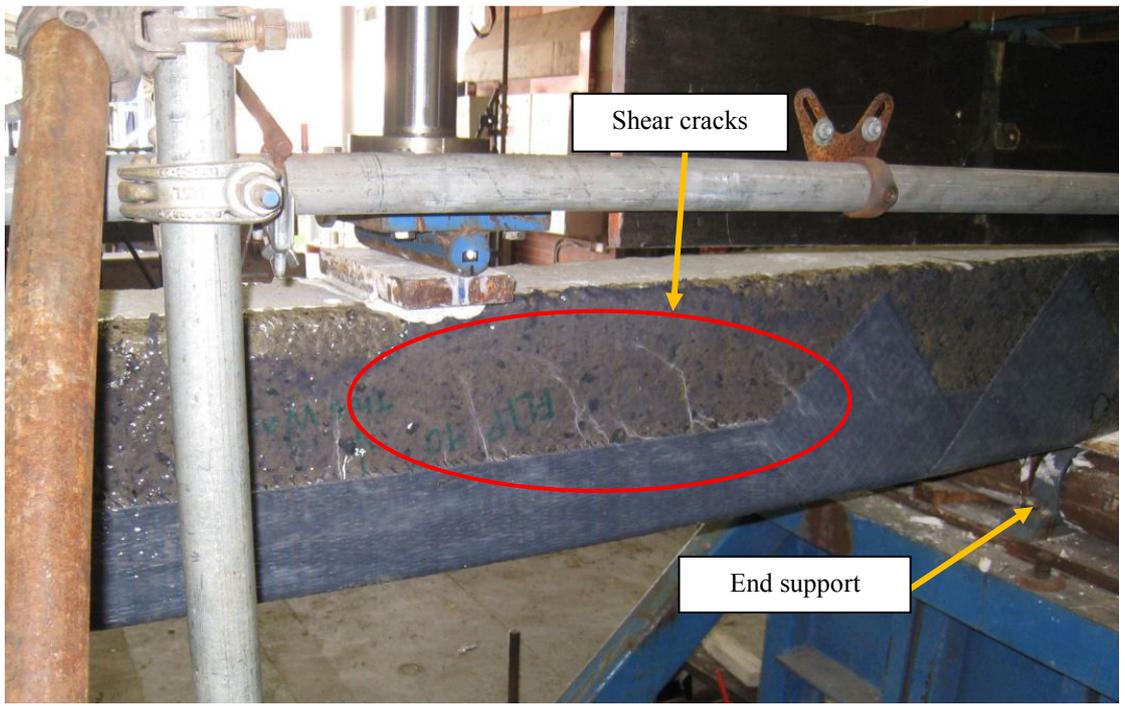
Figure 5.19: Shear cracks near the end support of Specimen H4

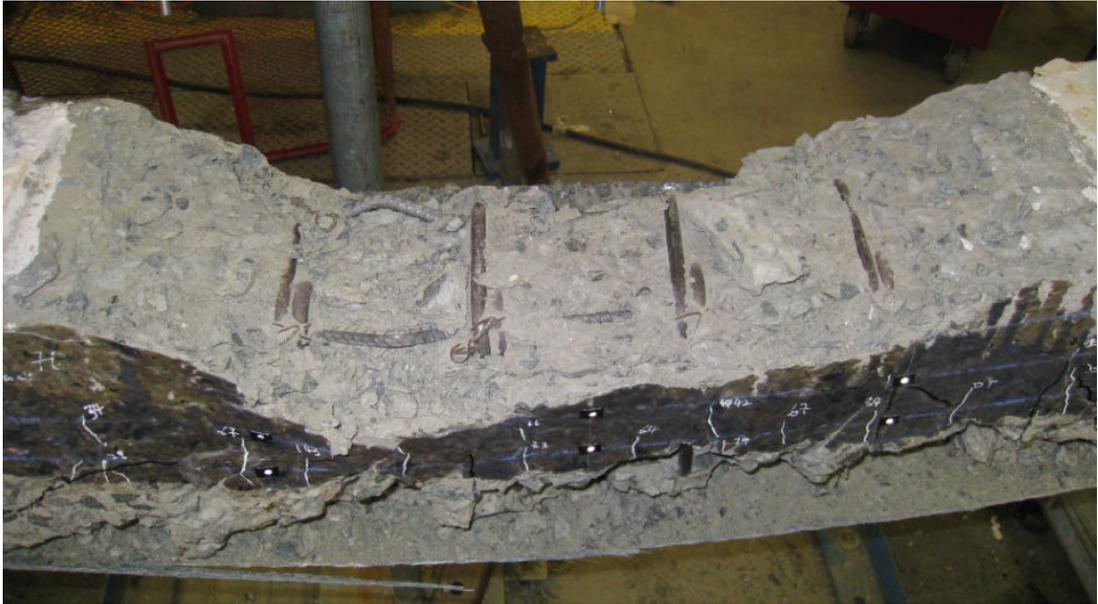
Figure 5.20: Compressive reinforcement exposed due to concrete crushing and spalling, Specimen H4

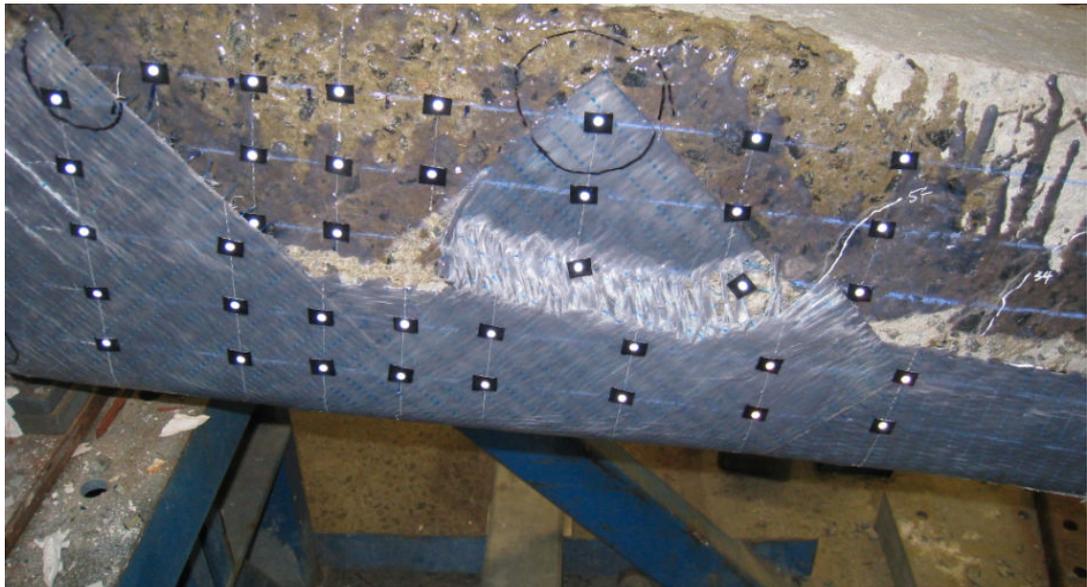
Figure 5.21: Shear failure of end anchorage, Specimen H4

to 71 kN at a deflection of 68 mm, both ends of the GFRP at the tension face started to debond. However, the end anchorages prevented this from happening. Figure 5.21 shows the shear failure of the end anchorage where it was being stretched by the GFRP at the tension face but the anchorage was still intact. Total failure happened at a load of 50 kN when the GFRP fractured at mid-span due to tensile rupturing with a sudden brittle failure. After the flexural test, the fabric was cut away using an angle grinder to inspect the interior damage to the beam. Figure 5.22 shows the interior damage to the beam after the test; nearly all of the concrete at the tension face was damaged. Figure 5.23 shows how well the epoxy bonded the GFRP to the concrete surface; some concrete can still be seen where it adhered to the surface of the GFRP.
