**Investigation of Performance of Carbon and Glass Fibre
Strengthened Concrete Beams with Different End Anchorages**

**This thesis is presented for the Degree of
Master of Philosophy (Civil Engineering)**

Curtin University

March 2012

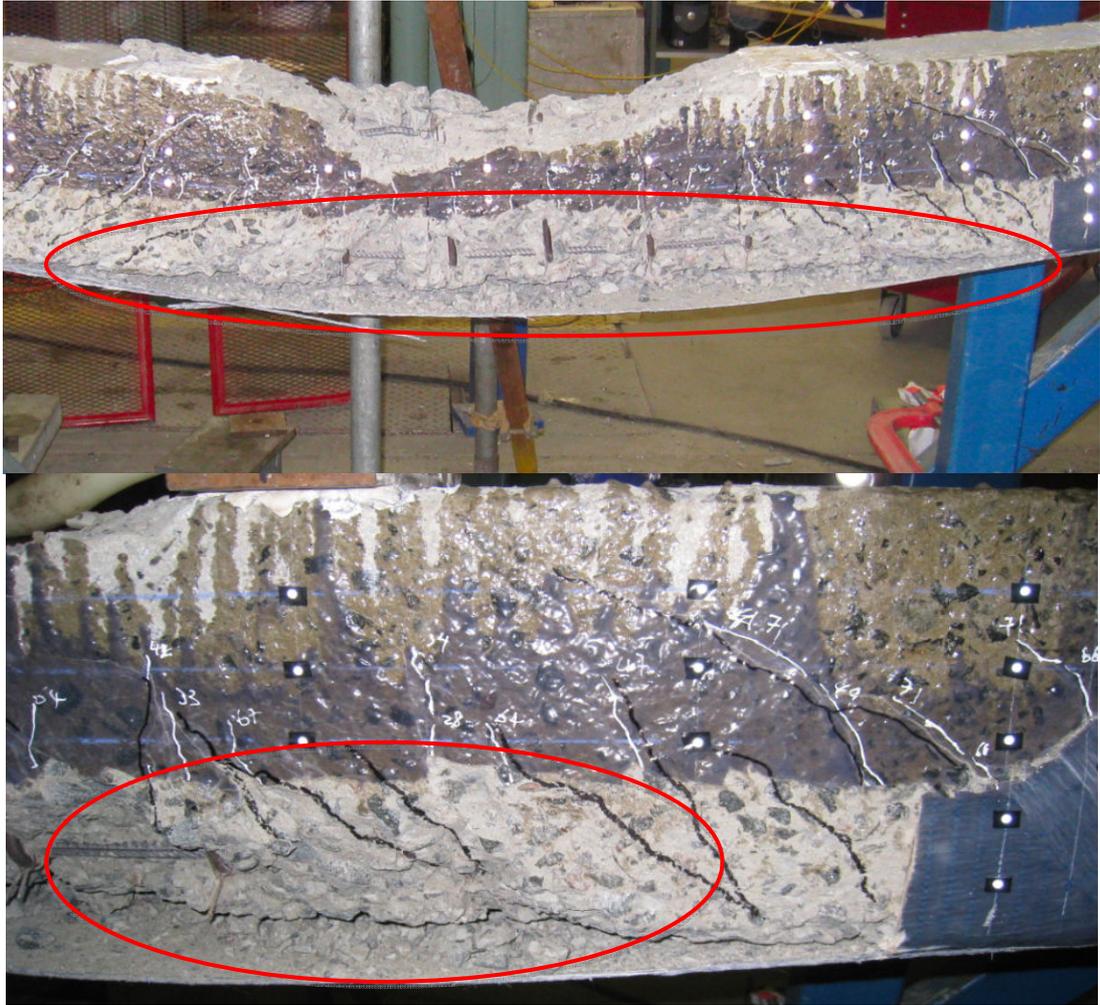
Figure 5.22: Interior damage to Specimen H4

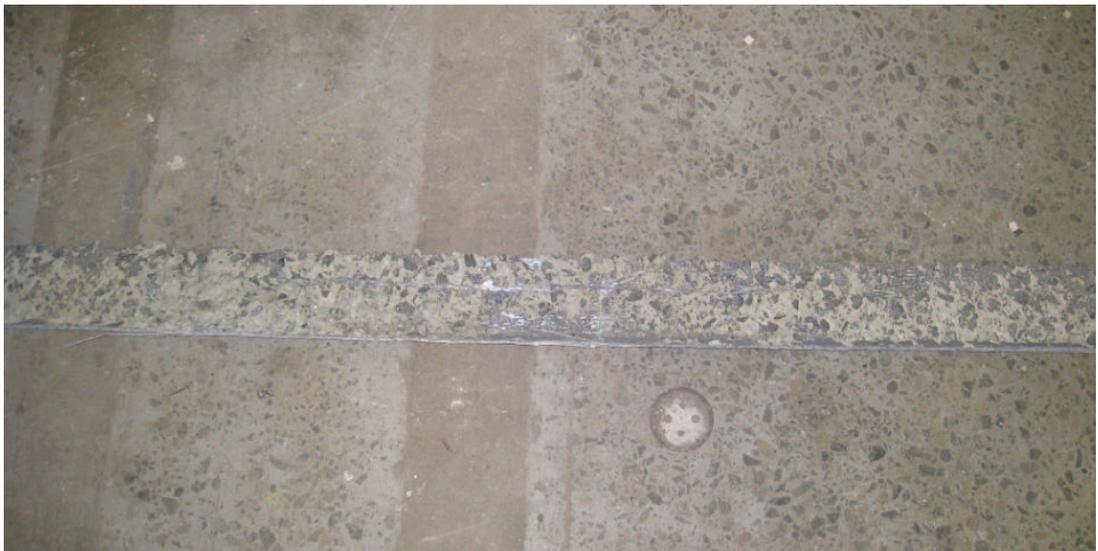
Figure 5.23: Concrete still adhered to the GFRP surface, Specimen H4

to 71 kN at a deflection of 68 mm, both ends of the GFRP at the tension face started to debond. However, the end anchorages prevented this from happening. Figure 5.21 shows the shear failure of the end anchorage where it was being stretched by the GFRP at the tension face but the anchorage was still intact. Total failure happened at a load of 50 kN when the GFRP fractured at mid-span due to tensile rupturing with a sudden brittle failure. After the flexural test, the fabric was cut away using an angle grinder to inspect the interior damage to the beam. Figure 5.22 shows the interior damage to the beam after the test; nearly all of the concrete at the tension face was damaged. Figure 5.23 shows how well the epoxy bonded the GFRP to the concrete surface; some concrete can still be seen where it adhered to the surface of the GFRP.

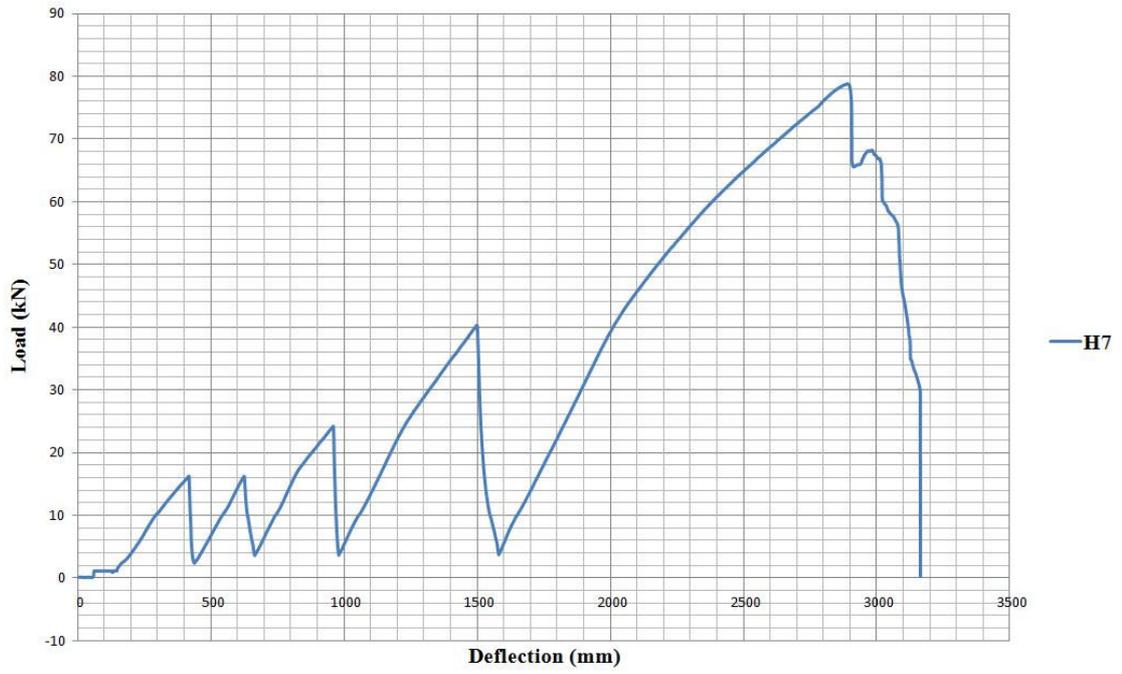
Figure 5.24: Loading cycles for Specimen H7

Specimen H7 was strengthened with GFRP and was the only specimen where a mechanical strengthening method was used to install the end anchorages onto the beam. Since the beam was wrapped with GFRP to a height of 100 mm from the soffit, cracks were not visible at low load magnitude. Cracks became visible at 24 kN as they propagated above the GFRP zone. Shear cracks started to appear at 34 kN. The crack pattern is shown in Figure 5.26 and Figure 5.27. The first sign of failure started with concrete compression at 78 kN, which was also the ultimate load. The load started to drop rapidly with major failure from the crushing of the concrete. Meanwhile, the GFRP held onto the beam with no signs of debonding. With further vertical displacement from the loading jack, the GFRP started to undergo ultimate tensile stress at 46 mm deflection. The first major failure of the GFRP was the tensile rupture of the GFRP from the side, as shown in Figure 5.28. With further displacement, the beam eventually failed with debonding of the steel plate anchorage (Figure 5.29). Inspection after the flexural test showed that the compressive reinforcement had buckled, as shown in Figure 5.30. In conclusion, the beam failed with concrete crushing failure followed by debonding of the GFRP. The load versus deflection graph for Specimen H7 is shown in Figure 5.25. Figure 5.24 shows the loading cycles for Specimen H7.

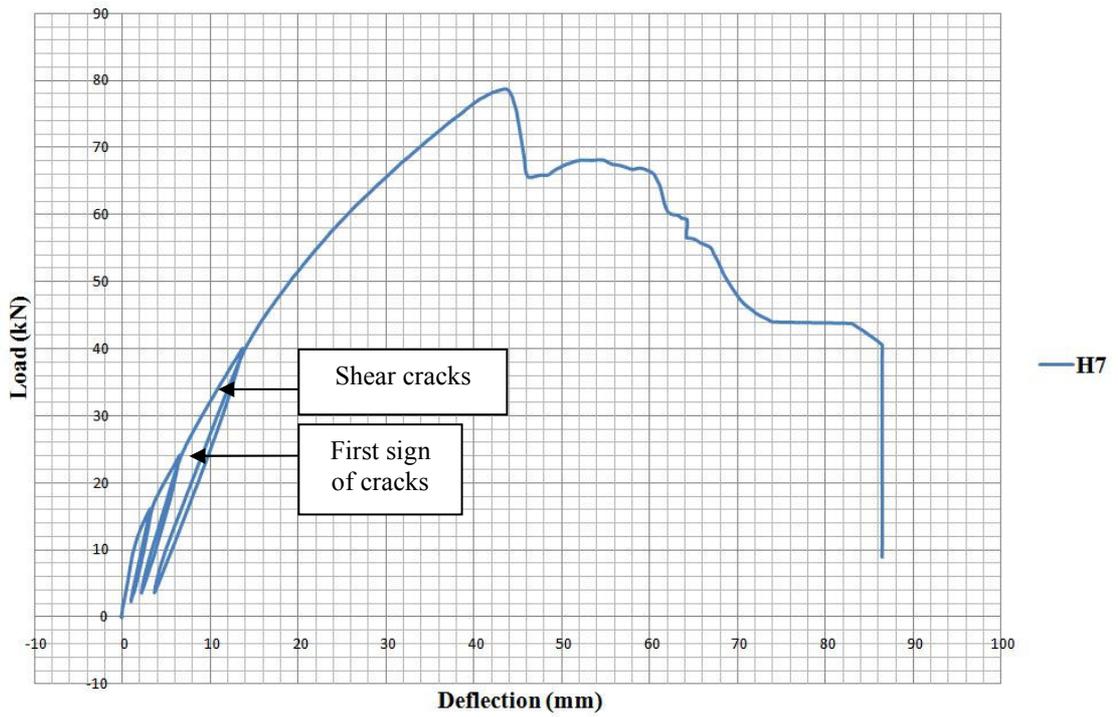
Figure 5.25: Load v. deflection graph for Specimen H7

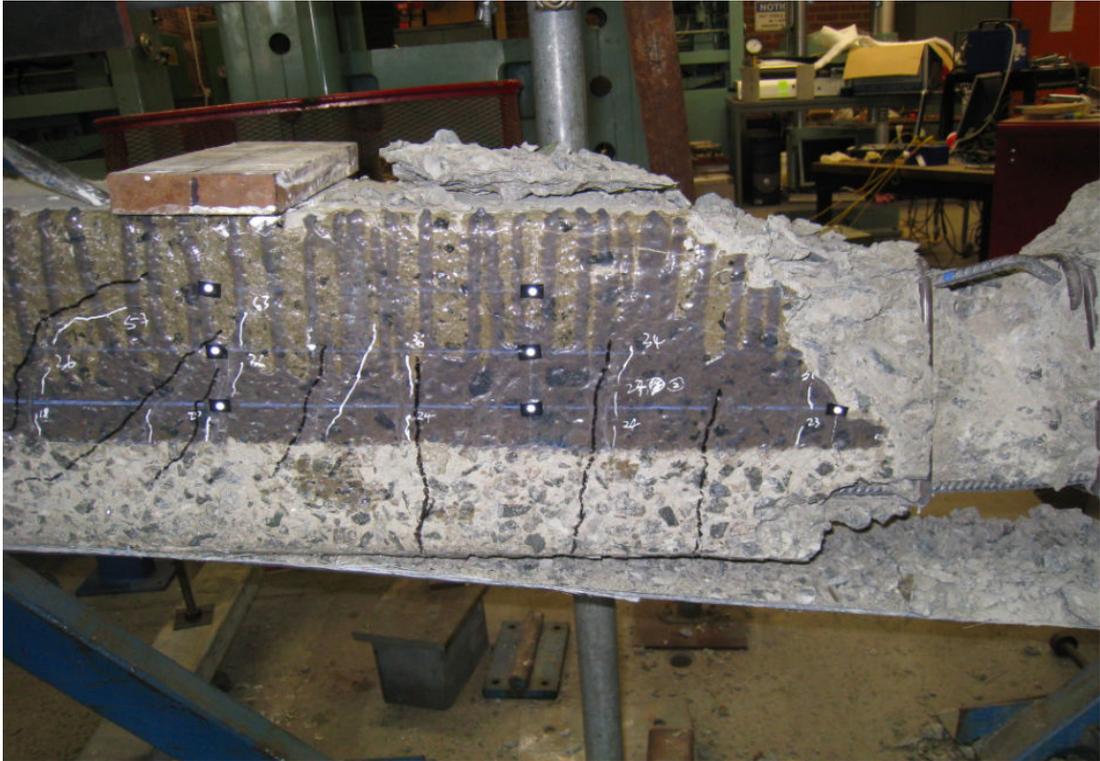
Figure 5.26: Flexure crack pattern of Specimen H7

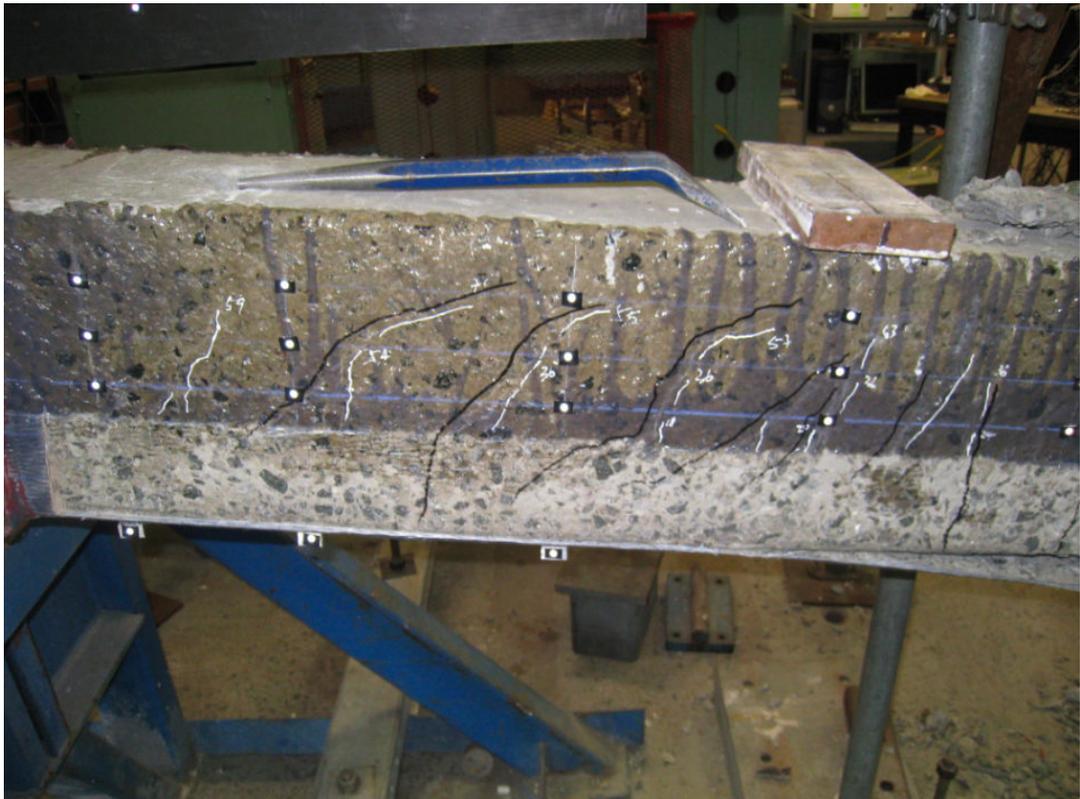
Figure 5.27: Shear crack pattern of Specimen H7

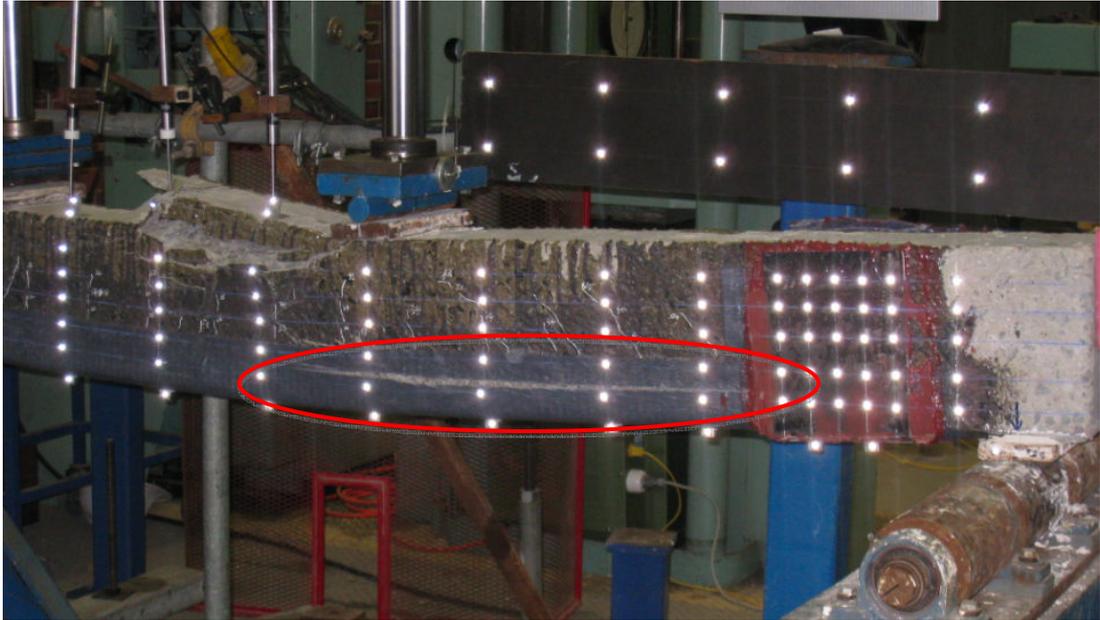
Figure 5.28: Debonding of side FRP, Specimen H7

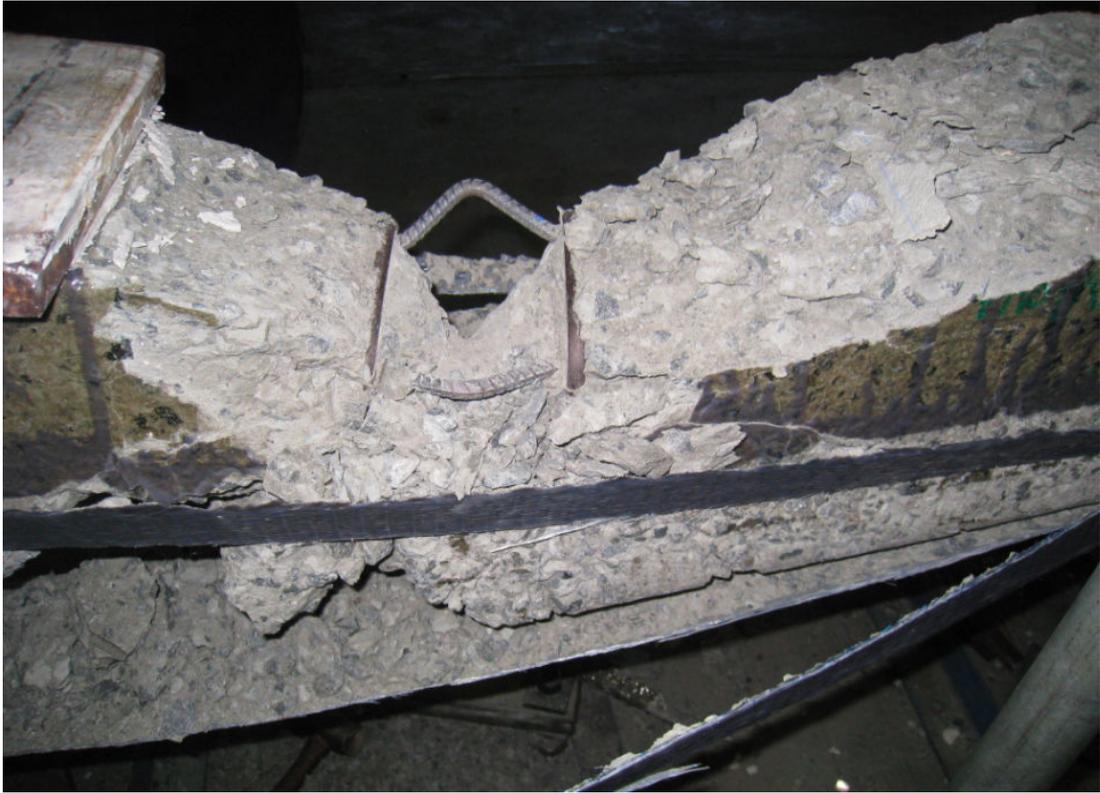
Figure 5.30: Total failure of compression zone and buckling of compressive reinforcement, Specimen H7

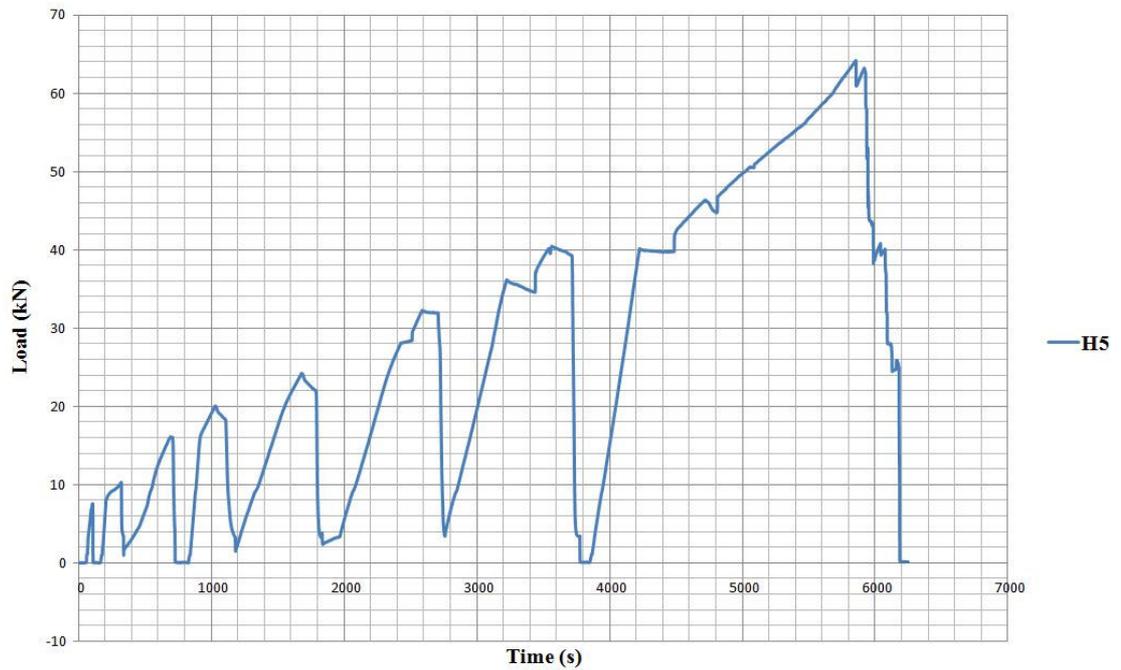
Figure 5.31: Loading cycles for Specimen H5

Figure 5.36. The final failure occurred when the side strap at one end of the beam completely debonded. This is shown in Figure 5.37. The loading cycles for Specimen H5 are shown in Figure 5.31.

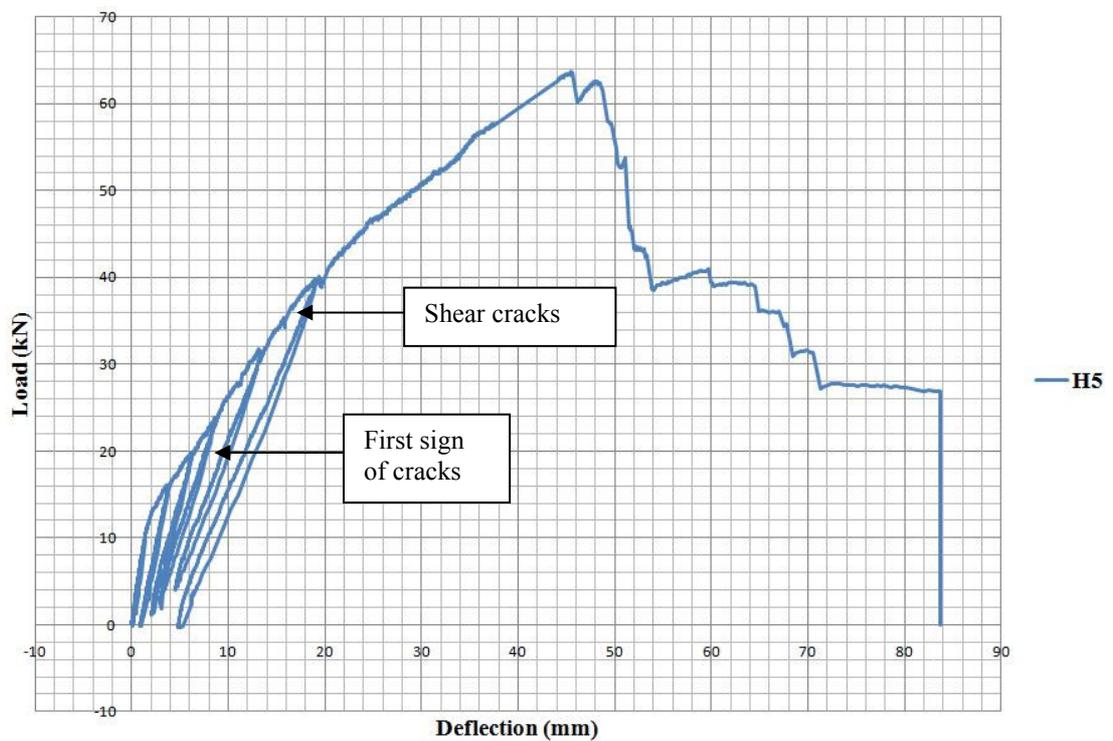
Figure 5.32: Load v. deflection graph for Specimen H5

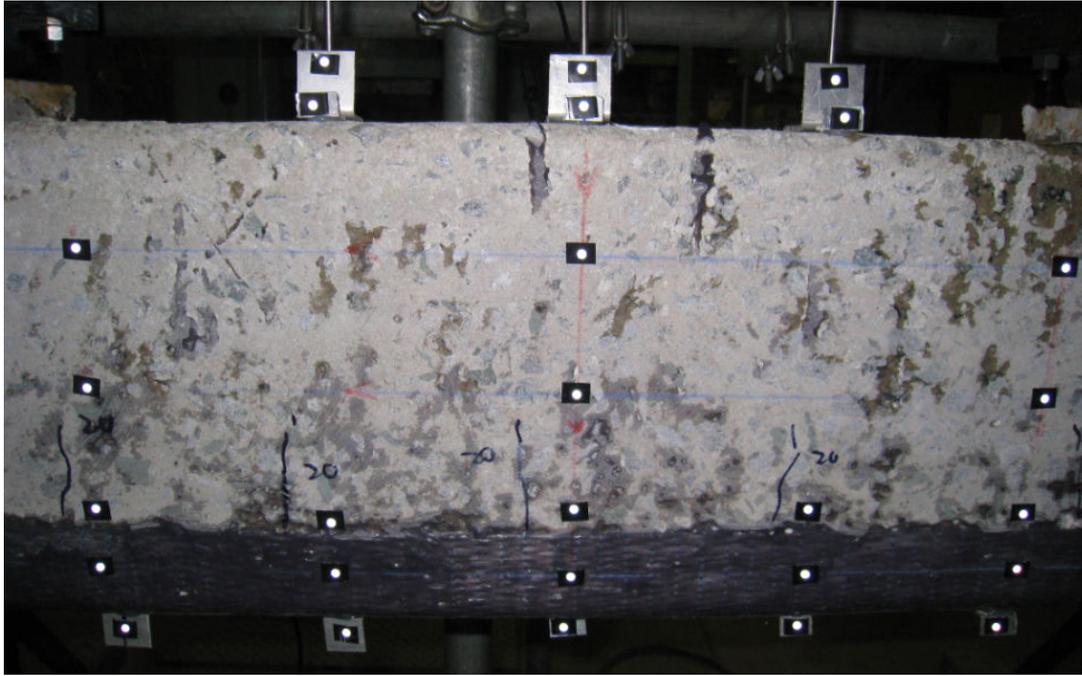
Figure 5.33: Cracks appeared at 20 kN, Specimen H5

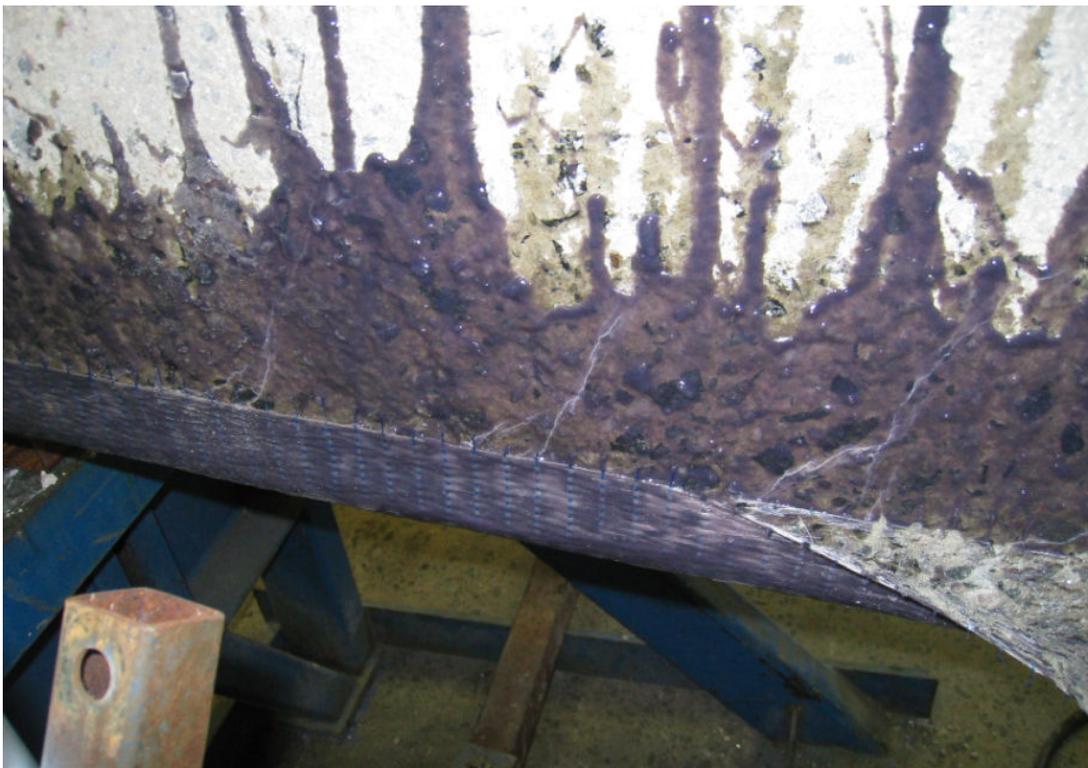
Figure 5.34: Shear cracks appeared at high load magnitude, Specimen H5

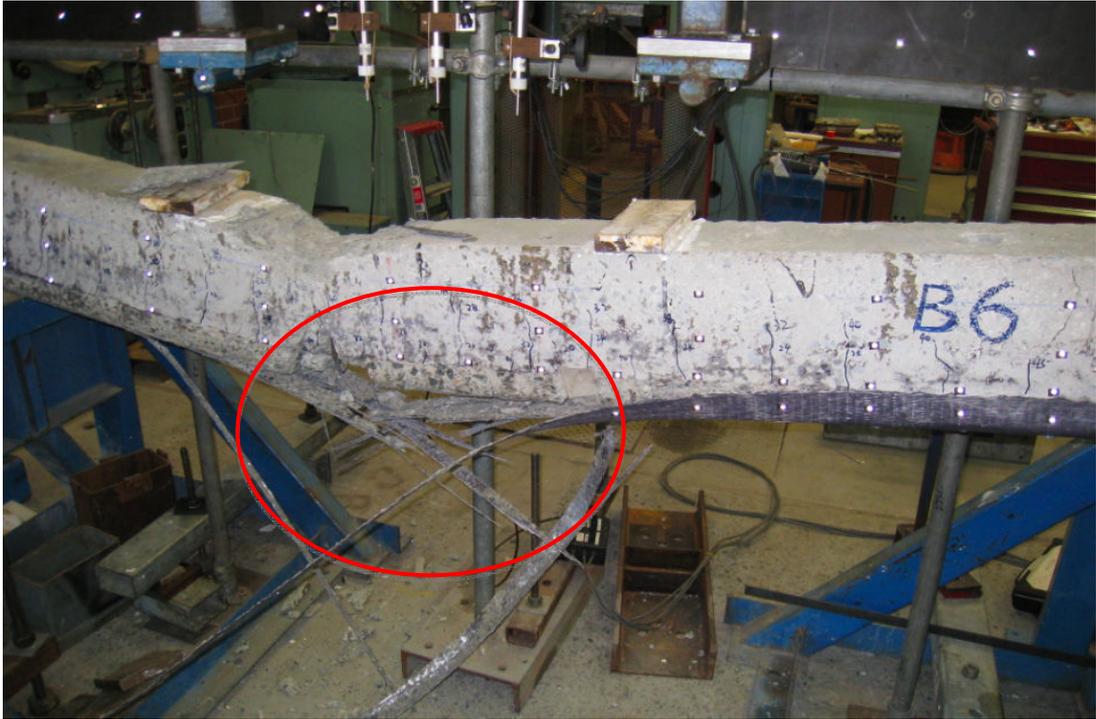
Figure 5.35: FRP fractured at mid-span, Specimen H5

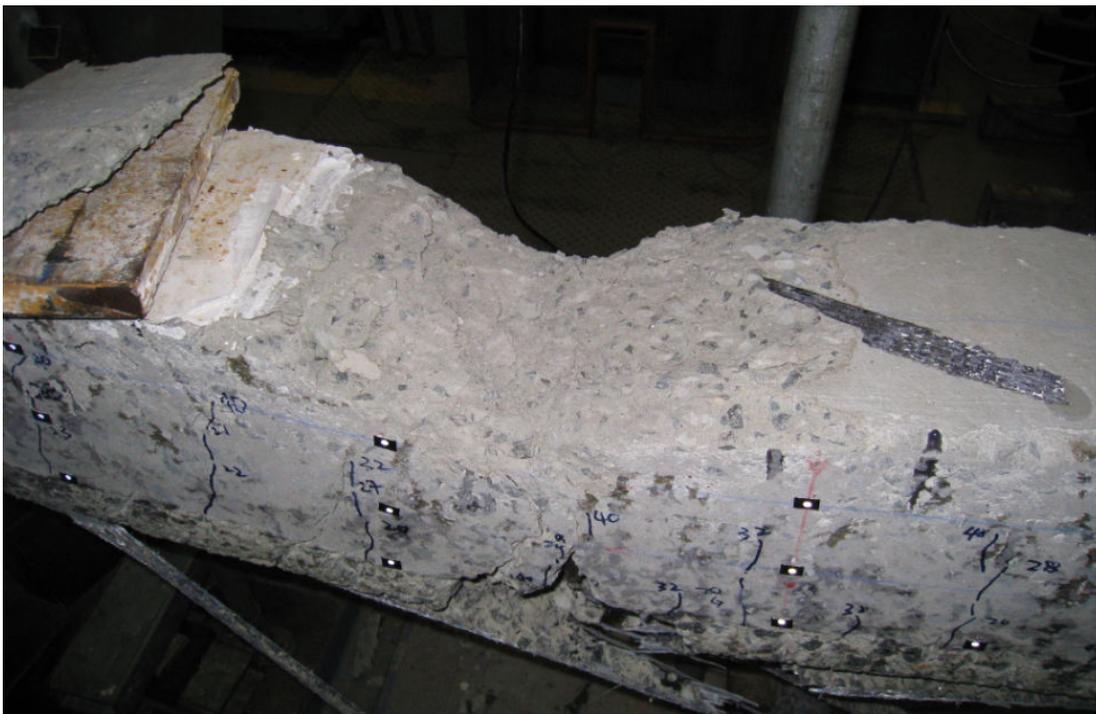
Figure 5.36: concrete crushed at compression zone, Specimen H5

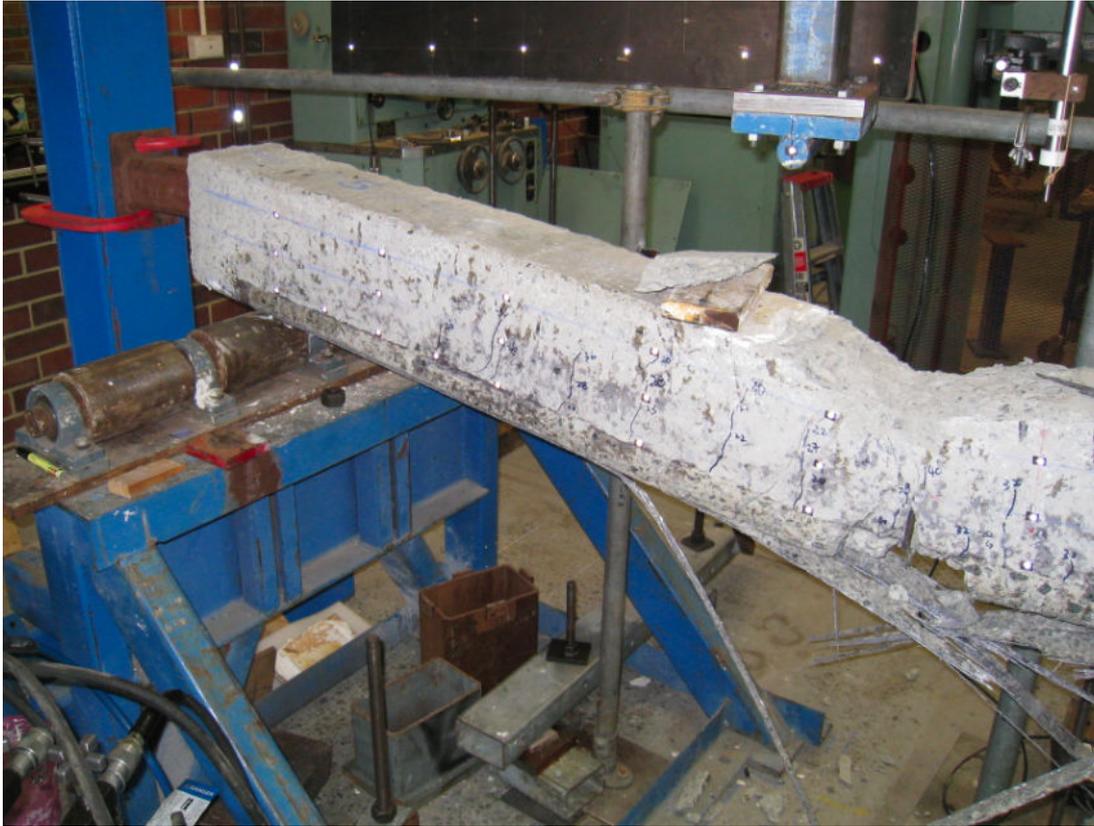
Figure 5.37: Side FRP completely debonded, Specimen H5

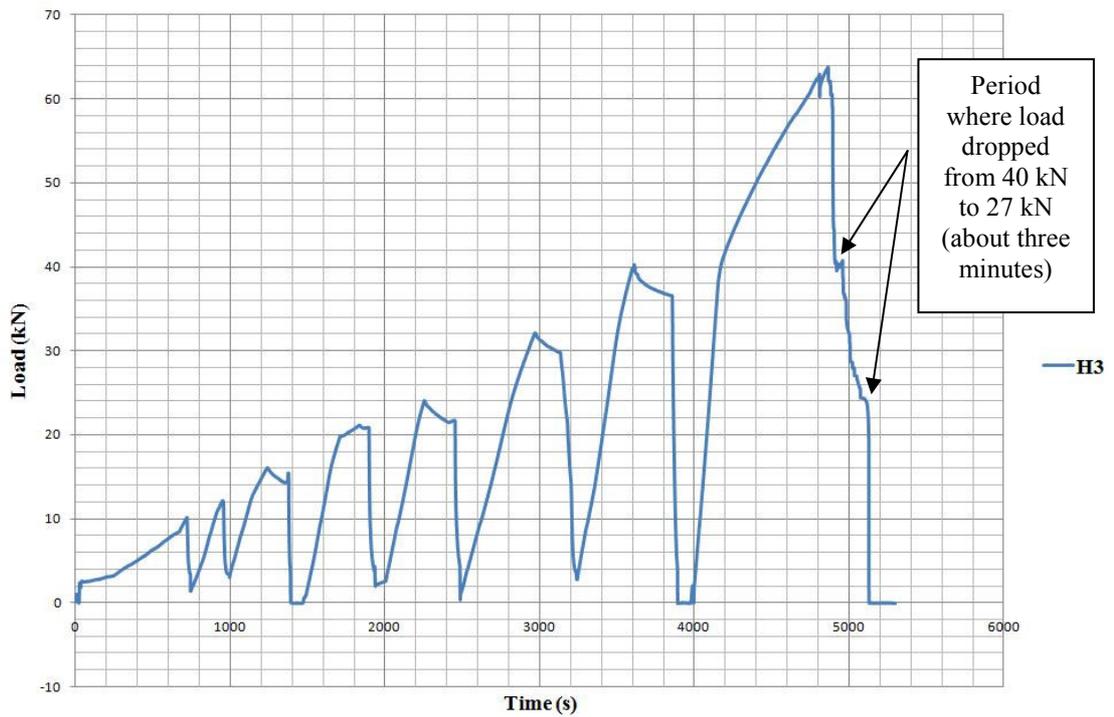
Figure 5.38: loading cycles for Specimen H3

where it remained for about three minutes before dropping to 27 kN at 100 mm deflection, as shown in Figure 5.38. This was where the beam became independent from the strength of the FRP. It continued to sustain a constant load with increased deflection. Final failure occurred at 130 mm deflection, at which point the beam fractured in half, as shown in Figure 5.43. After final failure, an inspection was made and, as shown in Figure 5.44, the end anchorages were still well bonded to the concrete surface of the beam. This shows the effectiveness of V-shaped anchorages. The load versus deflection graph for Specimen H3 is shown in Figure 5.39.

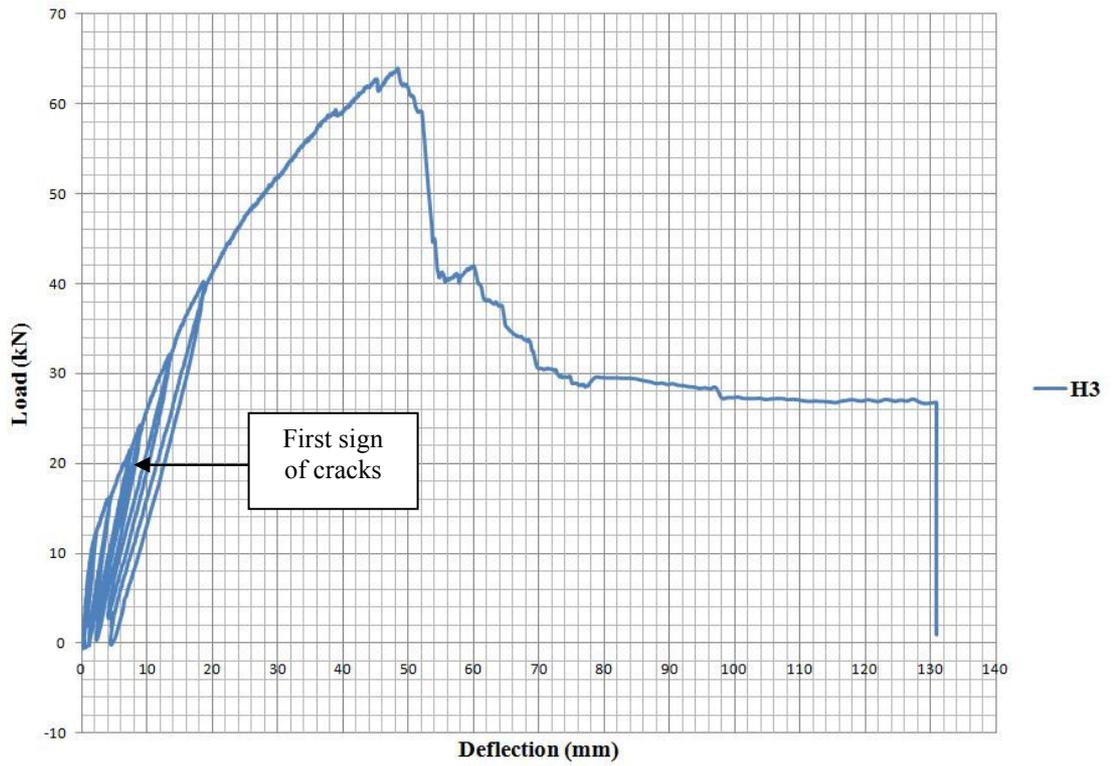
Figure 5.39: Load v. deflection graph for Specimen H3

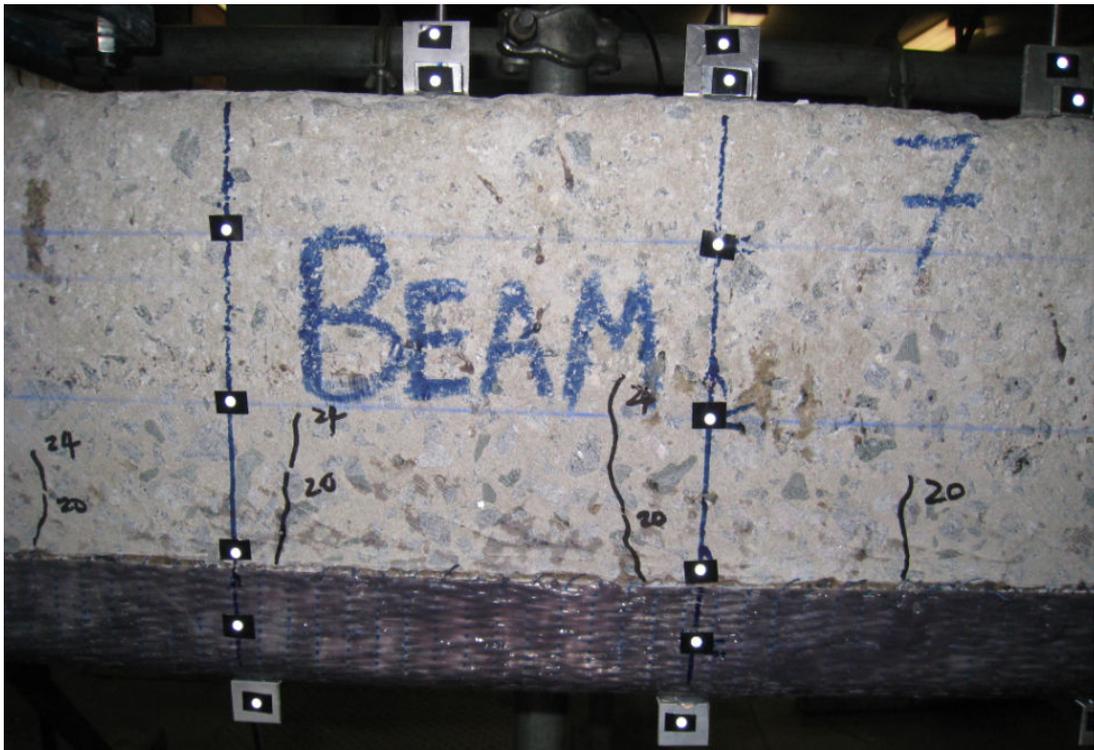
Figure 5.40: Observation of cracks at 20 kN, Specimen H3

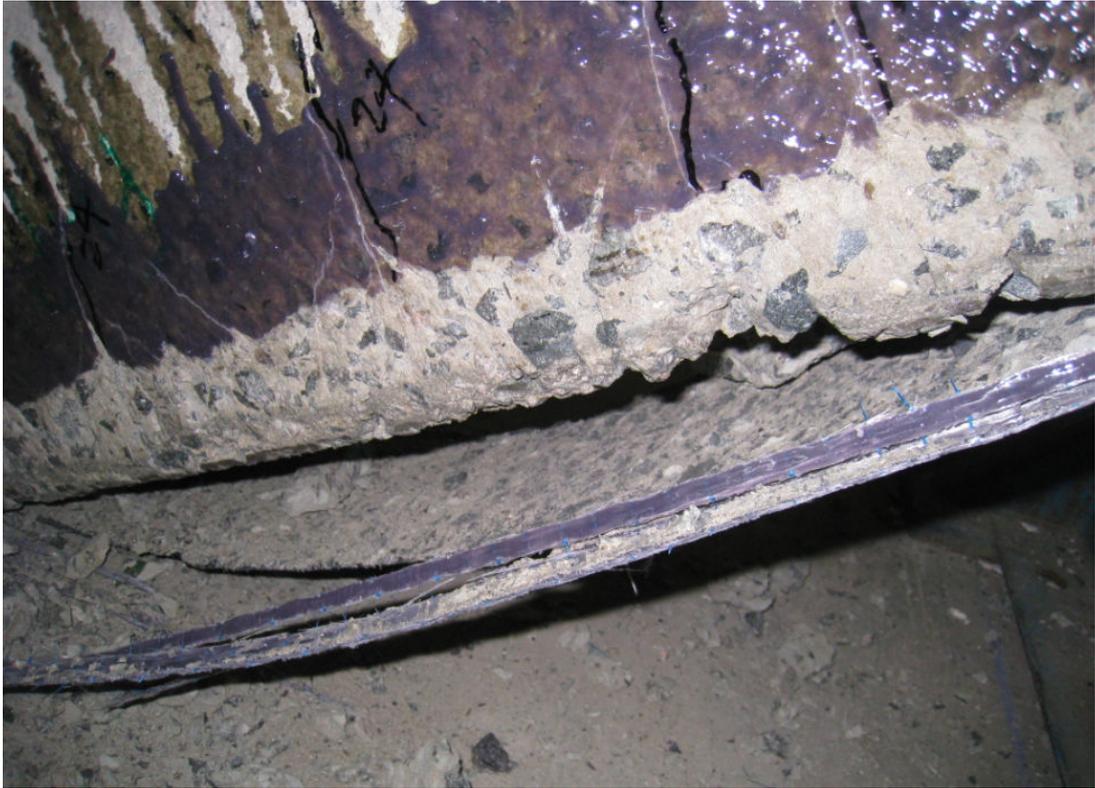
Figure 5.41: Debonding of FRP at side and tension face of Specimen H3

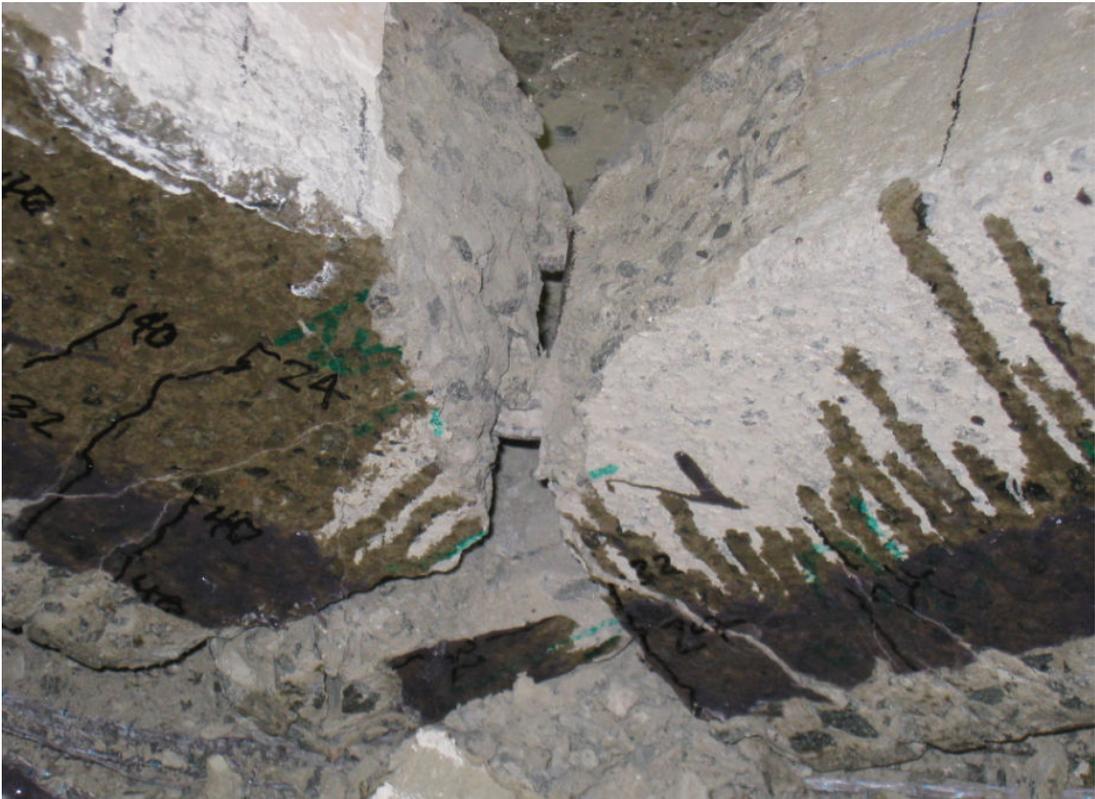
Figure 5.42: Concrete crushing at compression zone, Specimen H3

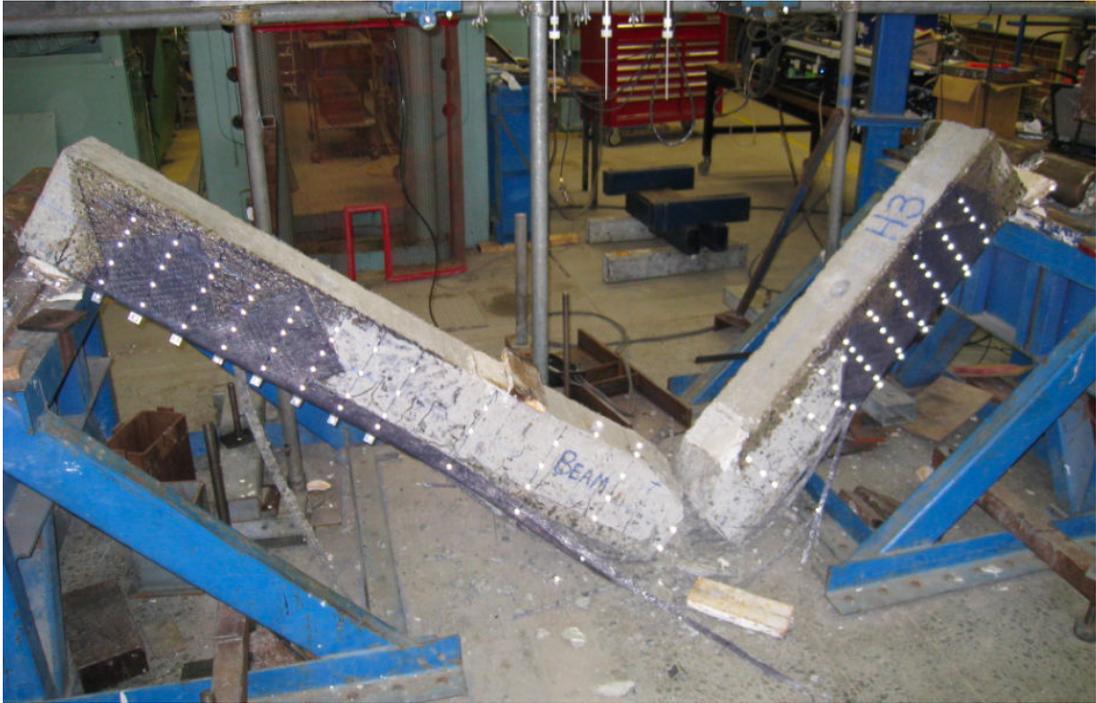
Figure 5.43: Specimen H3 fractured in half at final failure

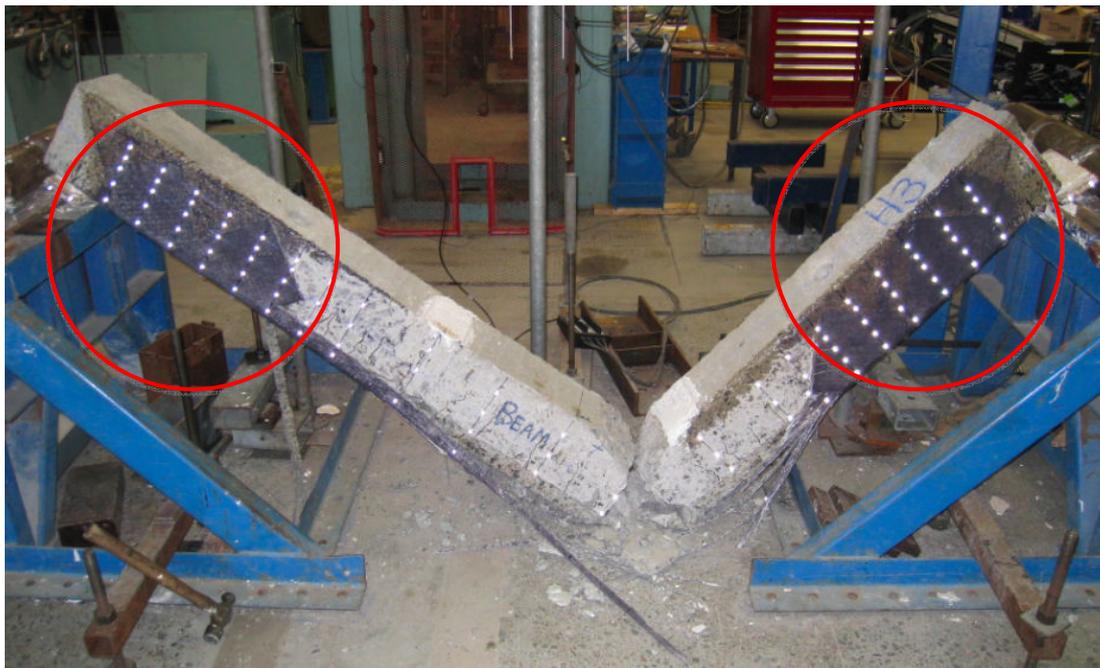
Figure 5.44: End anchorages remain well bonded with the concrete after failure, Specimen H3

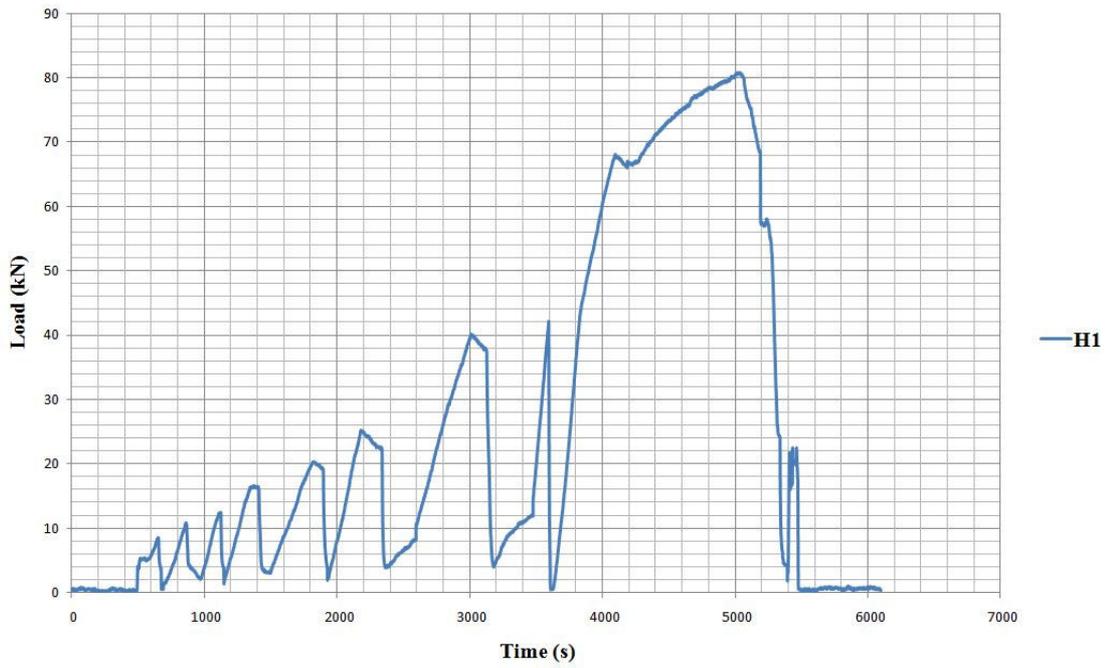
Figure 5.45: Loading cycles for Specimen H1

Specimen H1 had the same internal rebar configuration as the upper control beam, Specimen H2. However, Specimen H1 was strengthened with a layer of GFRP of 2600 mm in length at the tension face, and another layer of GFRP of 1000 mm in length at the compression face at mid-span. GFRP was used at the compression zone to prevent the crushing of the concrete. No end anchorages were applied to this specimen. Figure 5.47 shows the setup of Specimen H1. Initial cracks started to appear at magnitude 16 kN (Figure 5.48). The specimen started to exhibit a typical cracking pattern at the position of fitment. With the increase in load magnitude, cracks started to expand to a width of about 0.5 mm. Cracks then widened further with high load magnitudes of 40 kN and above; the zones between the initial cracks began to exhibit cracks, as shown in Figure 5.49. This phenomenon only occurred with FRP-strengthened specimens. ‘Tickling’ sounds occurred at 70 kN, which indicated that the fibre had started to rupture. The specimen continued to be loaded until a peak load of 80 kN was reached. During this period, the compression zone of the beam was experiencing compressive failure, which was the crushing of the concrete. The compressive failure was resisted temporarily because the compression zone had been strengthened with a layer of GFRP. However, with further vertical displacement from the loading jack, compression failure eventually occurred at a peak load of 80 kN when the compressive reinforcement bar buckled. These two occurrences are shown in Figures 5.50 and Figure 5.51 respectively. After the peak load of 80 kN, another failure occurred when the GFRP at the tension face gradually debonded due to the absence of end anchorages. Once the debonding had occurred, the load magnitude sustained by the beam began to decrease until it dropped to 68 kN. A brittle failure then occurred when the GFRP on the tension side completely debonded, as shown in Figure 5.52. Figure 5.46 shows the load versus deflection graph for Specimen H1 during the flexural bending test. Figure 5.45 shows the full loading process with loading cycles for Specimen H1.

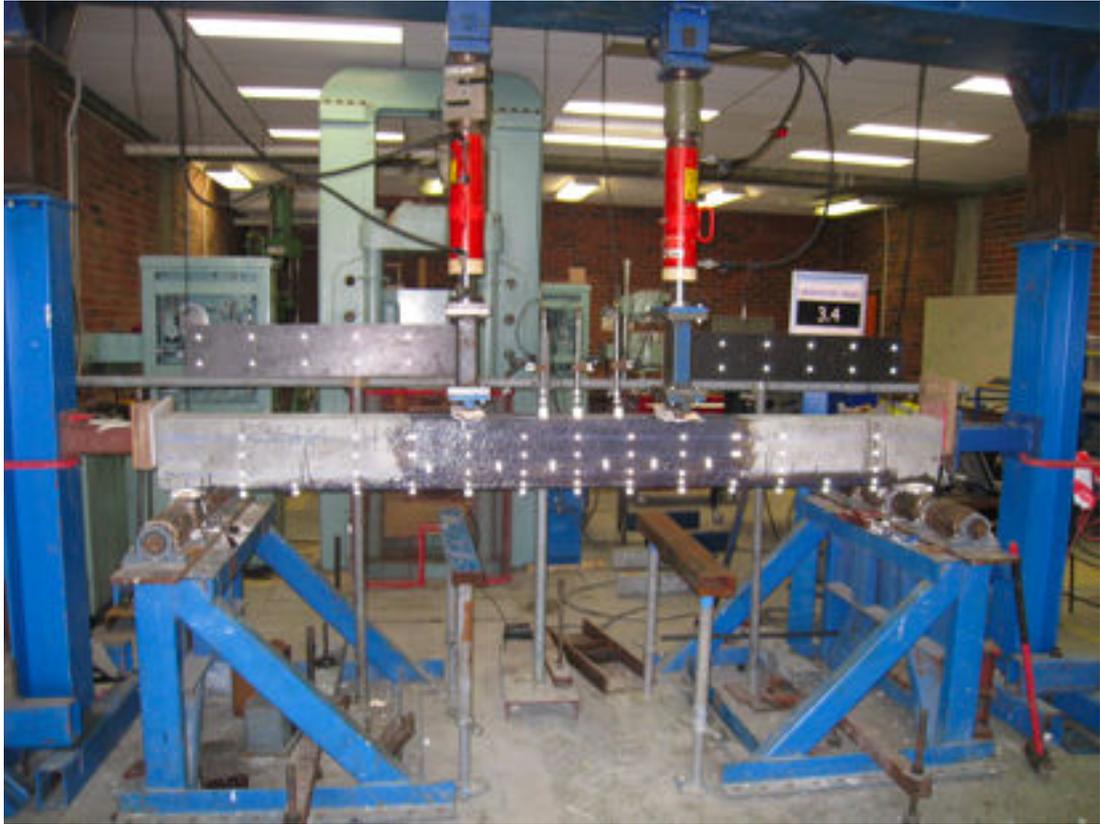
Figure 5.47: Set-up of Specimen H1

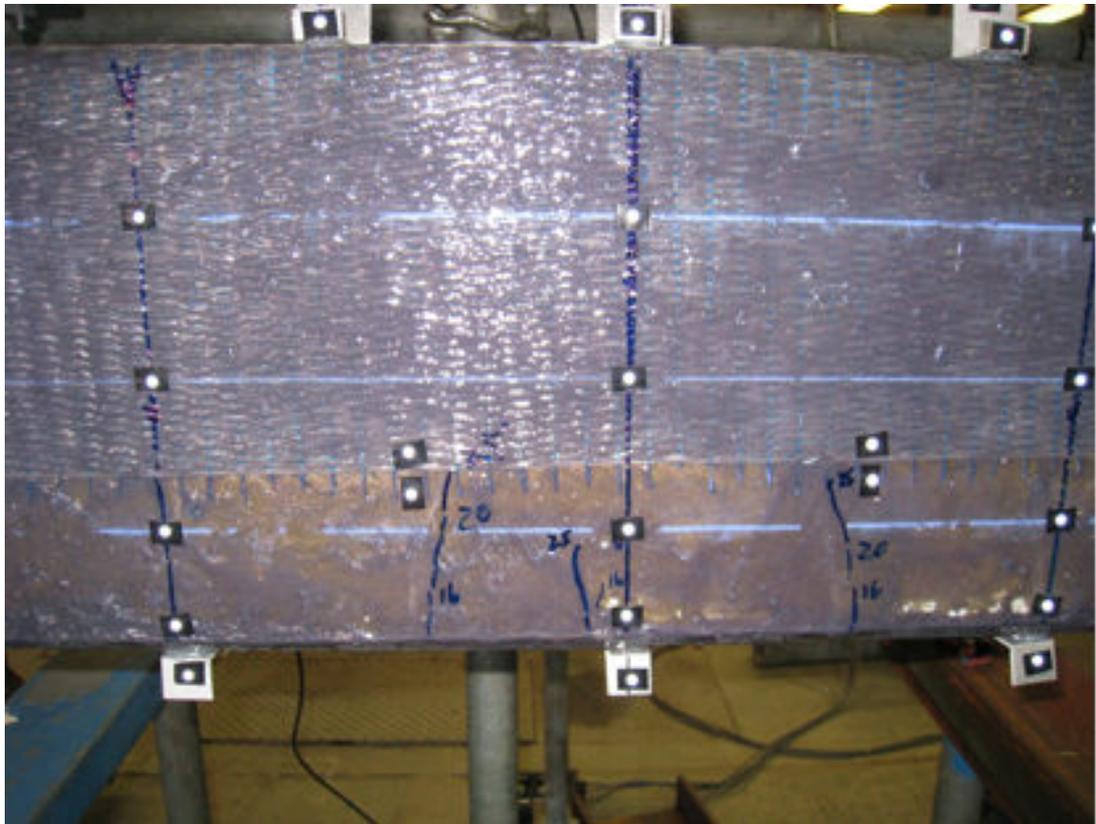
Figure 5.48: Cracks start to show at 16 kN, Specimen H1

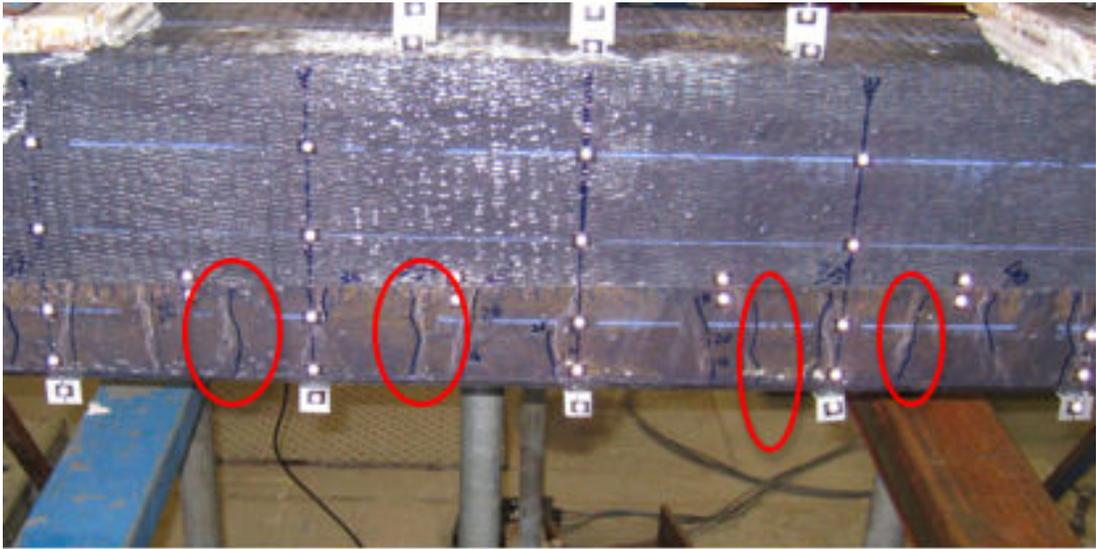
Figure 5.49: More cracks shown between the positions of fitment at 40 kN and above, Specimen H1
