**Investigation of Performance of Carbon and Glass Fibre
Strengthened Concrete Beams with Different End Anchorages**

**This thesis is presented for the Degree of
Master of Philosophy (Civil Engineering)**

Curtin University

March 2012

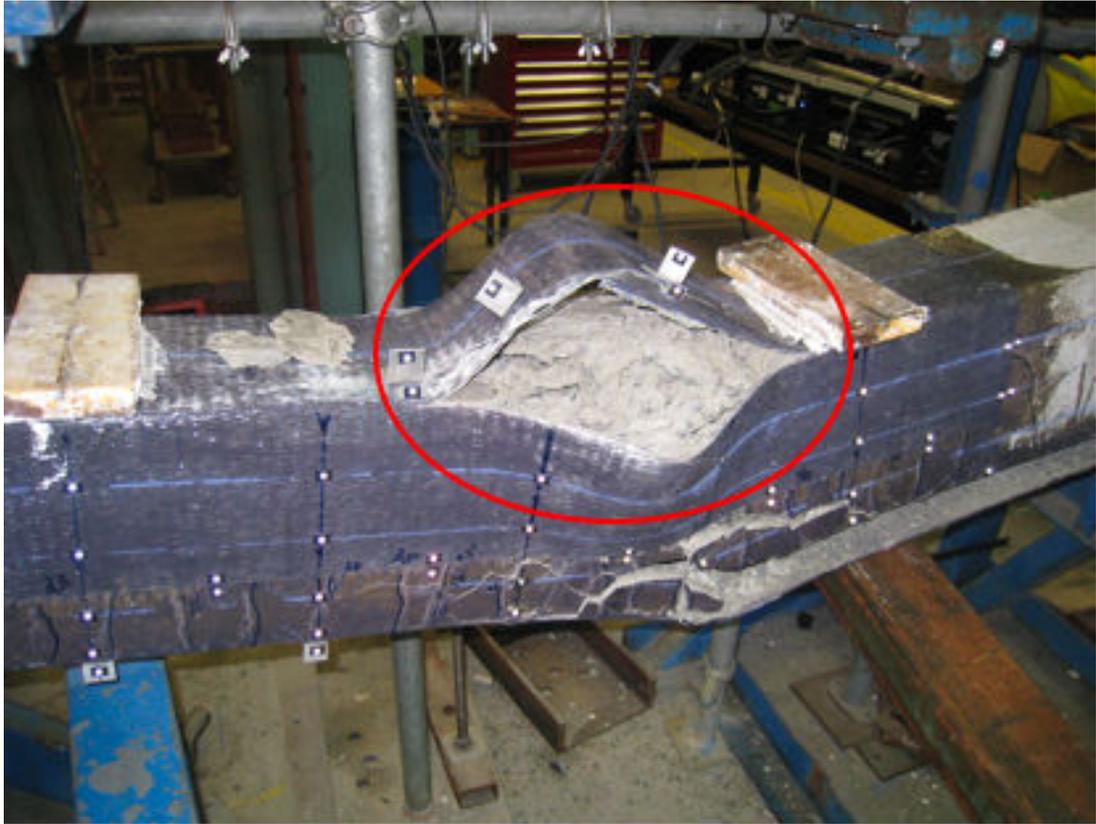
Figure 5.50: Crushing of the concrete at the compression zone, Specimen H1

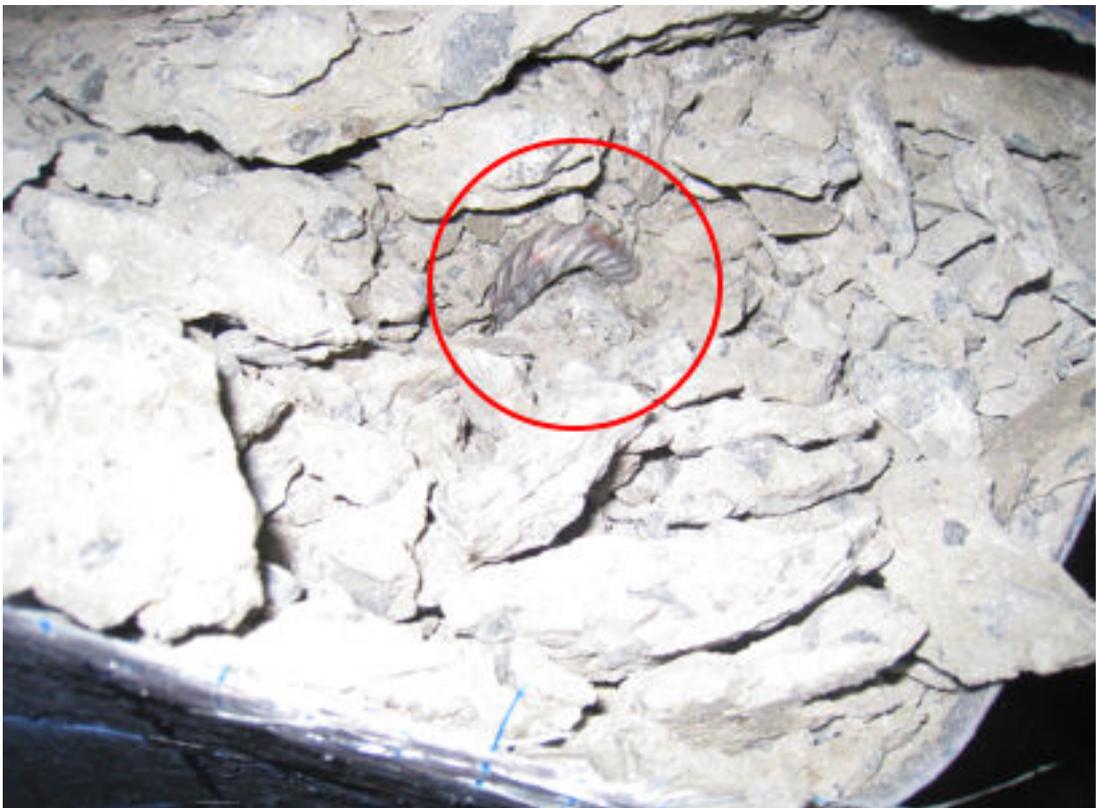
Figure 5.51: Compressive reinforcement bar buckled, Specimen H1

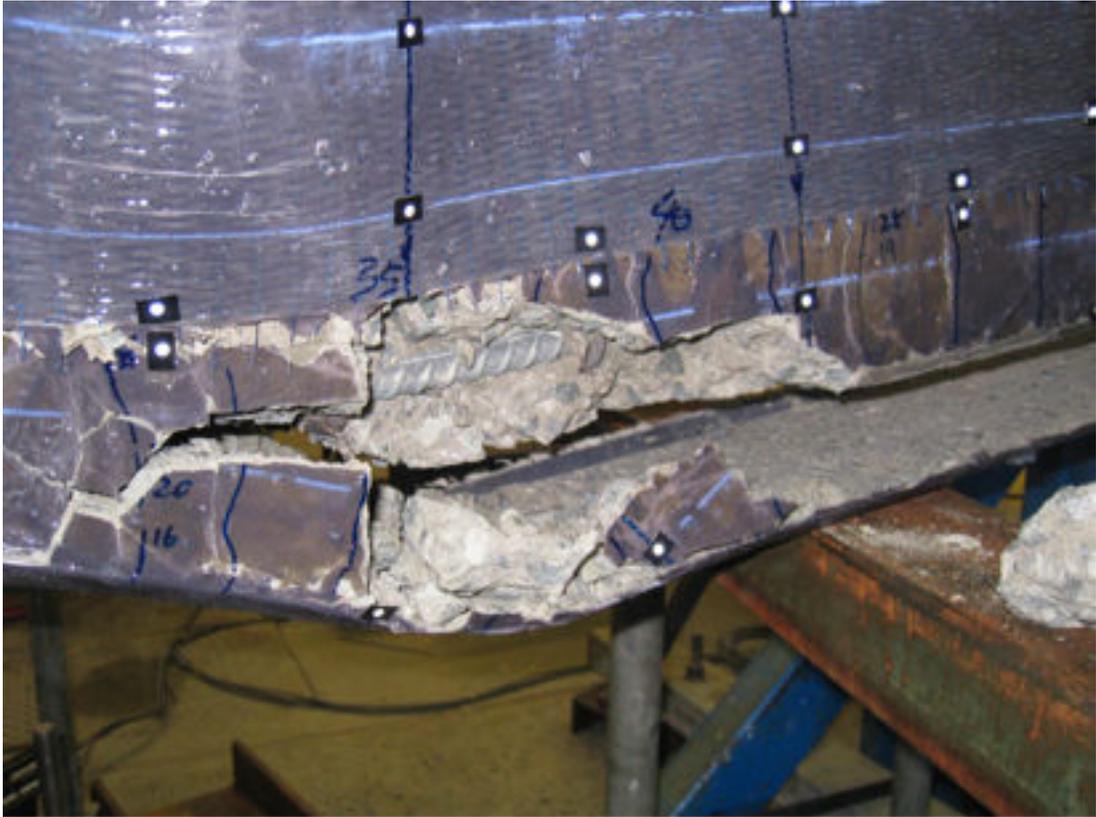
Figure 5.52: Debonding of the GFRP, Specimen H1

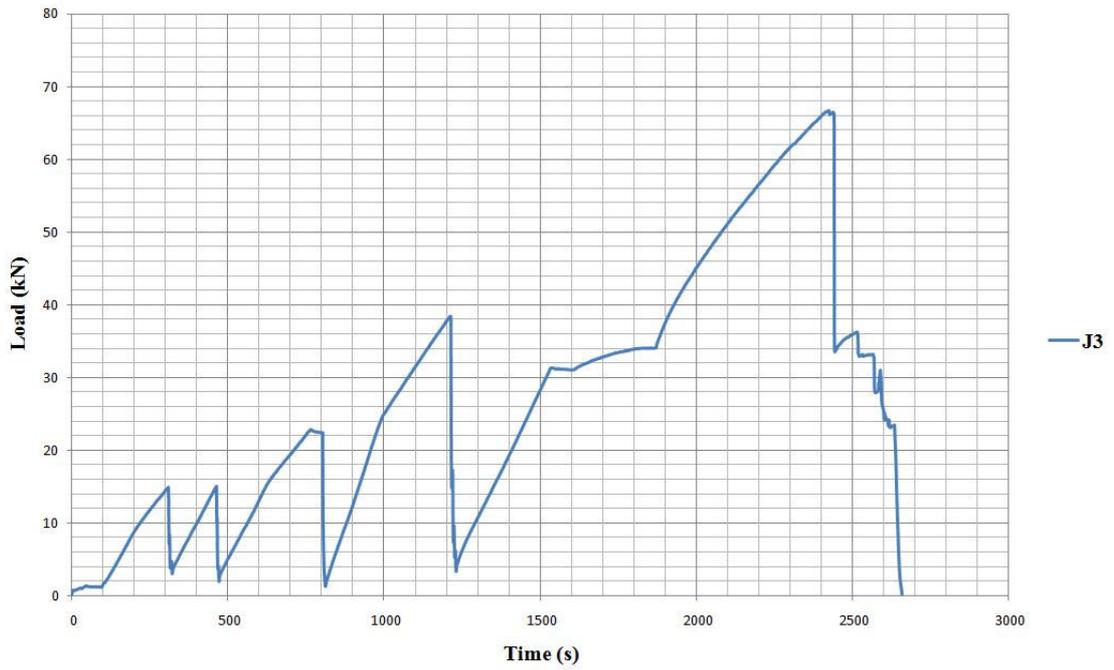
Figure 5.53: Loading cycles for Specimen J3

full loading process illustrating the loading cycles for Specimen J3 is shown in Figure 5.53.

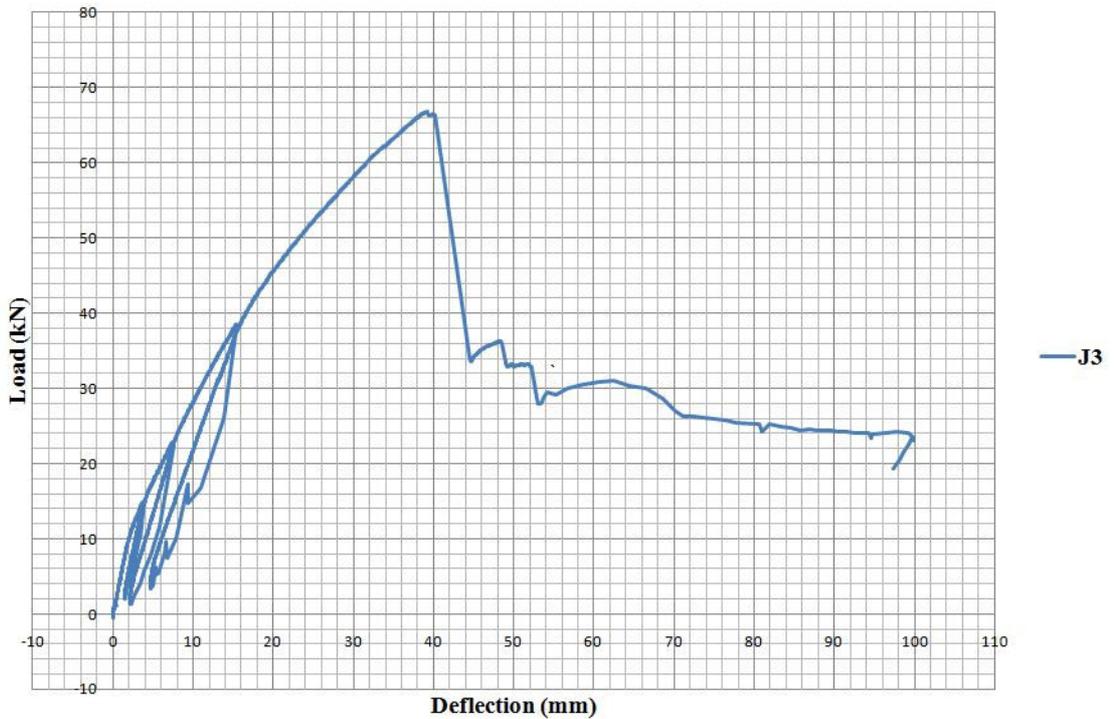
Figure 5.54: Load v. deflection graph for Specimen J3

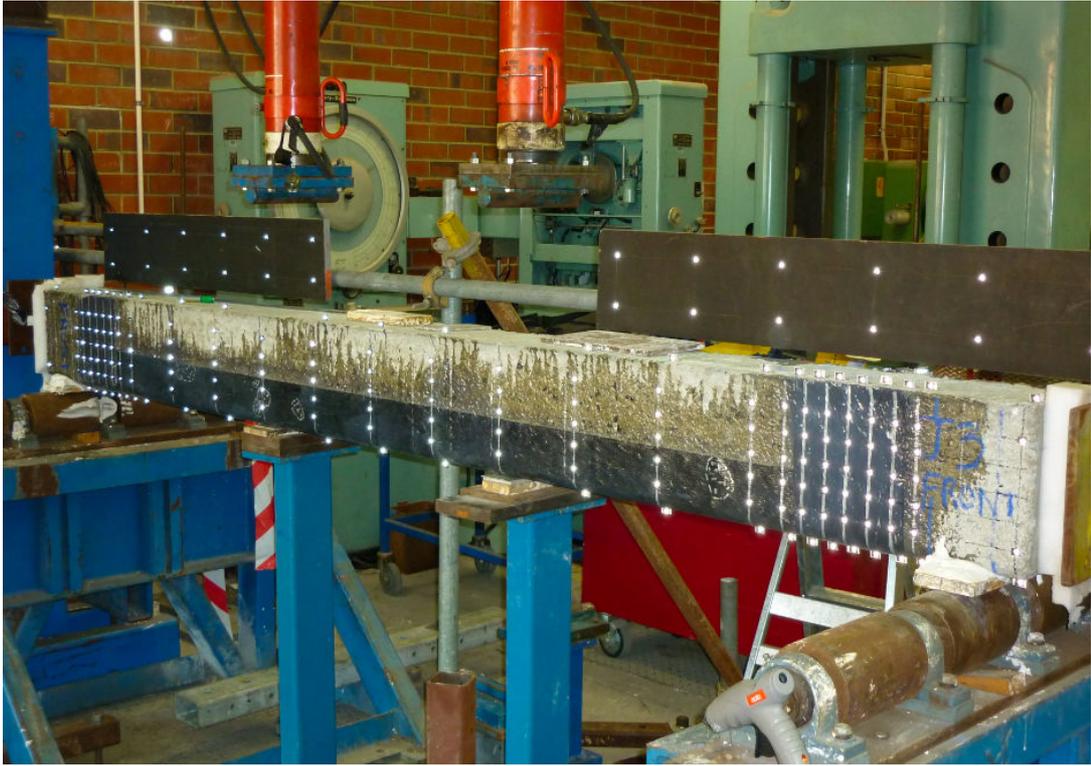
Figure 5.55: Typical Setup for Specimen J3

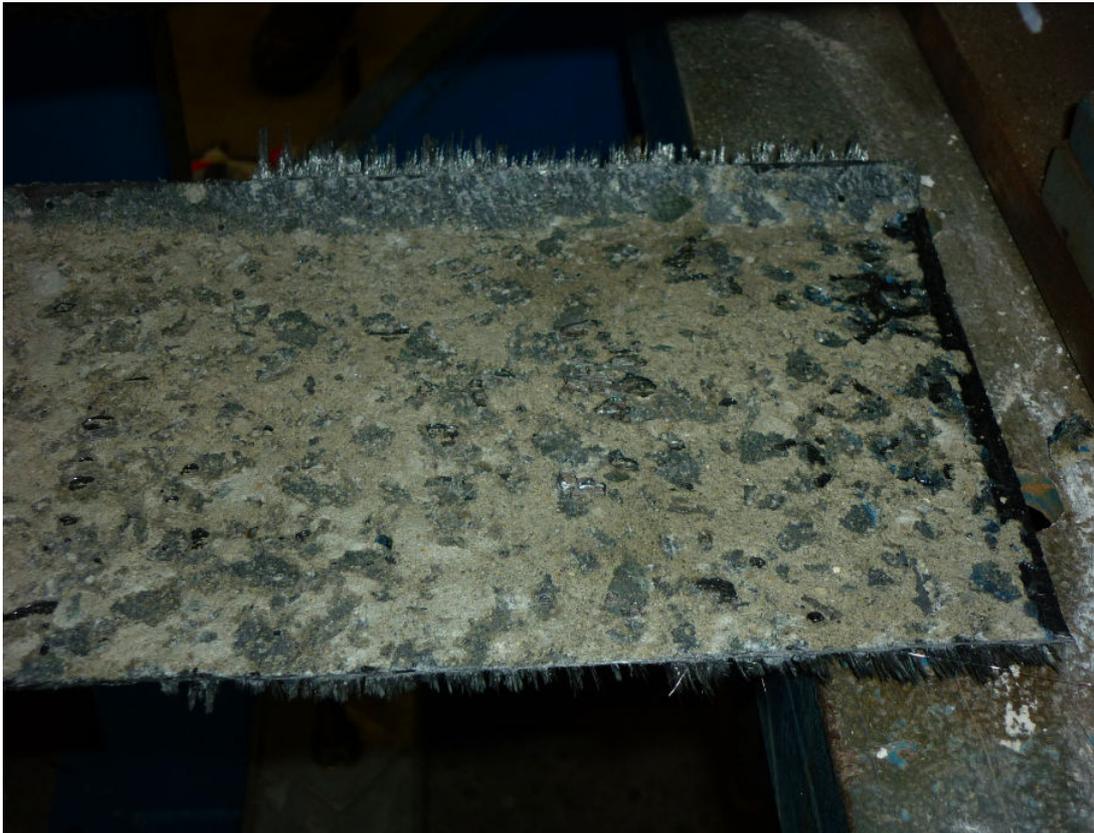
Figure 5.56: Debonding of longitudinal CFRP tore apart the end anchorage, Specimen J3

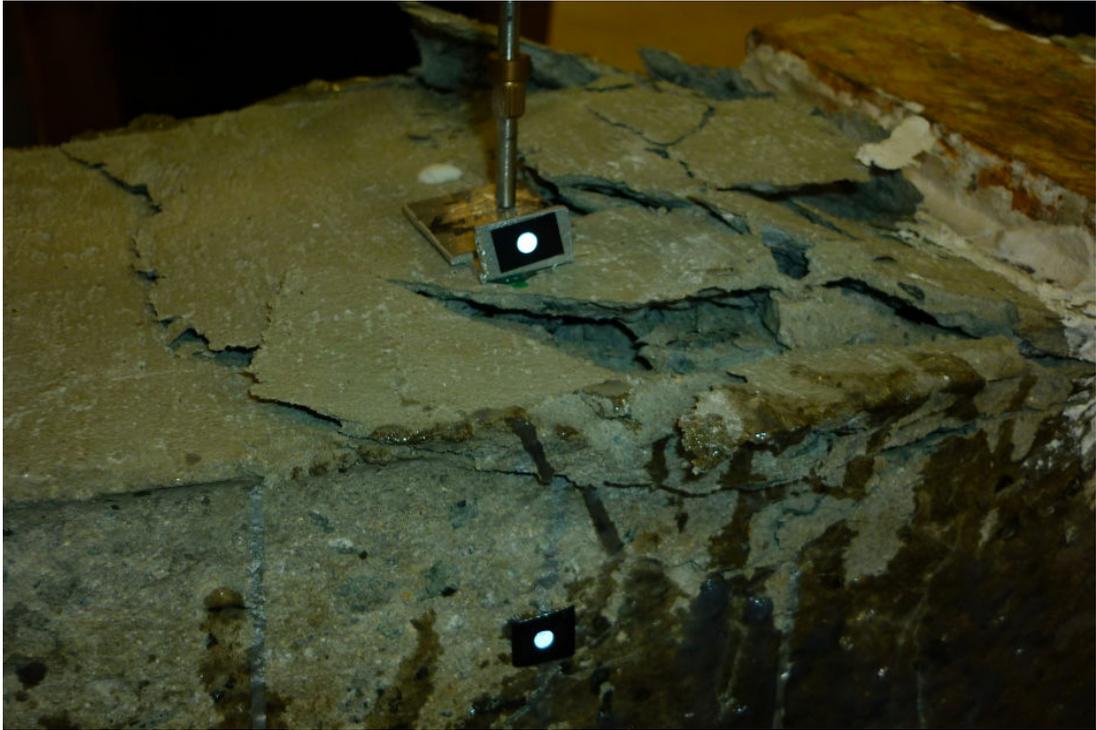
Figure 5.57: Concrete compression of Specimen J3

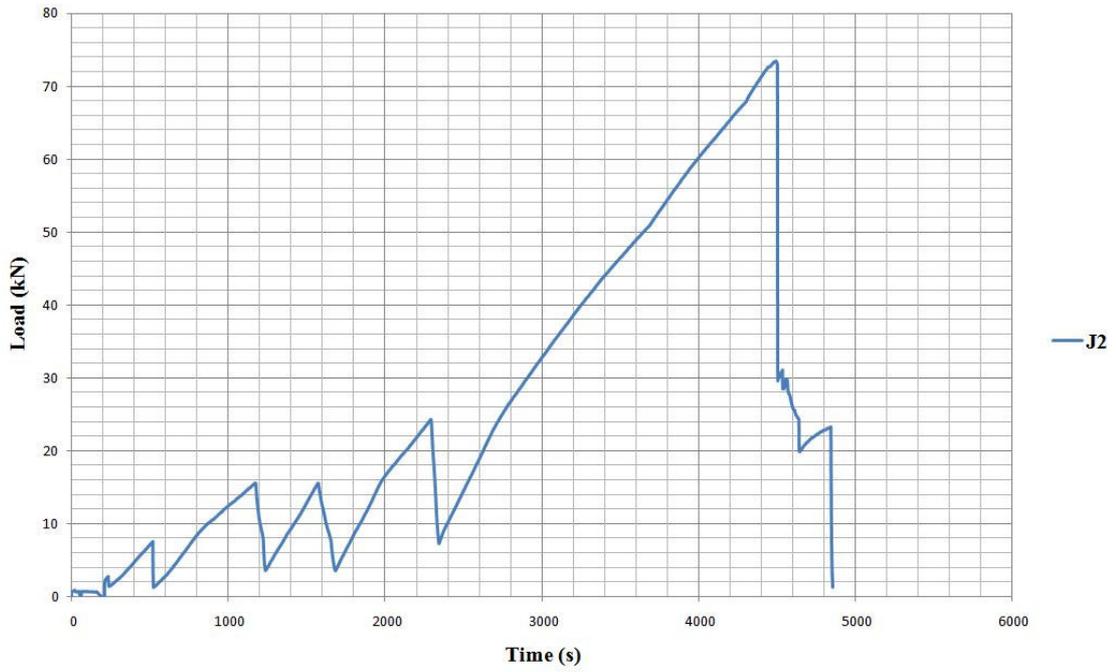
Figure 5.58: Loading cycles for Specimen J2

Specimen J2 was strengthened with three layers of longitudinal CFRP as well as V-shaped end anchorages on both ends of the beam. The major failure of Specimen J2, which happened at a load magnitude of 74 kN, was the tensile rupture of the CFRP at the longitudinal face, which indicates that the tensile capacity of the CFRP layers was fully utilised. The CFRP layer at the tension face underwent tensile rupture, as did the CFRP at the side face of the beam (see Figure 5.60), followed by the crushing of the concrete at the compression zone at mid-span (see Figure 5.61). Neither side of the end anchorages exhibited tensile rupture or debonding throughout the entire testing stage. However, Specimen J2 had an extremely brittle failure, as shown in the load versus deflection graph in Figure 5.59, with the load magnitude decreasing rapidly from 72 kN to 30kN due to the tensile rupture of the CFRP. The beam continued to sustain vertical displacement from 50 mm to 100 mm, experiencing concrete crushing at this stage. A full loading process illustrating the loading cycles for Specimen J2 is shown in Figure 5.58.

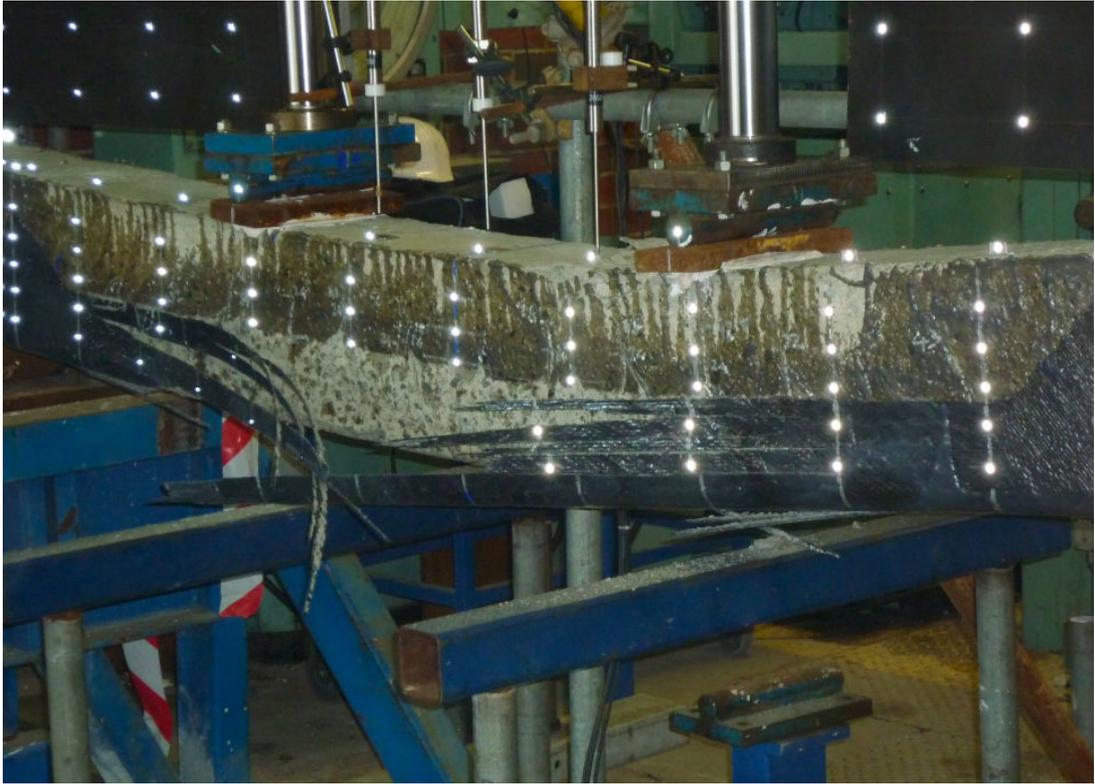
Figure 5.60: Tensile rupture of longitudinal CFRP, Specimen J2

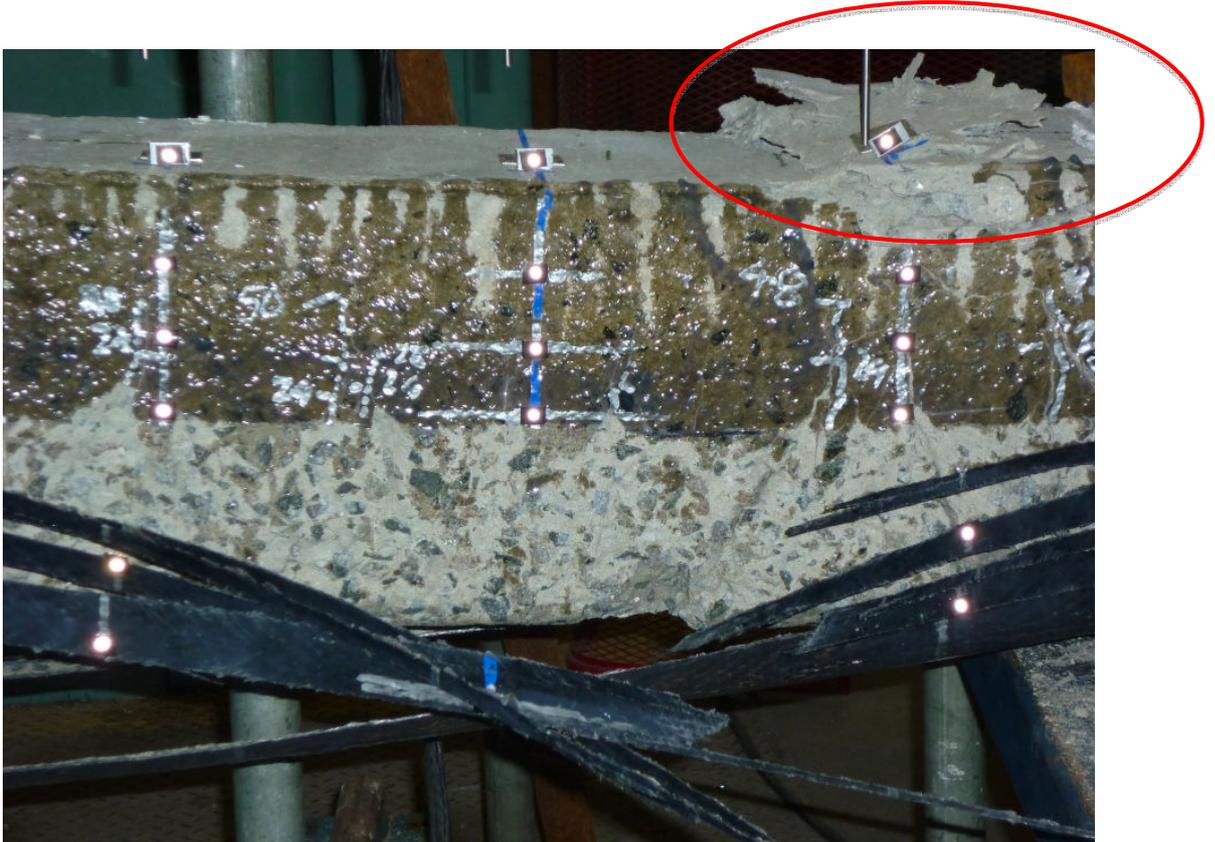
Figure 5.61: Crushing of concrete at compression zone, Specimen J2

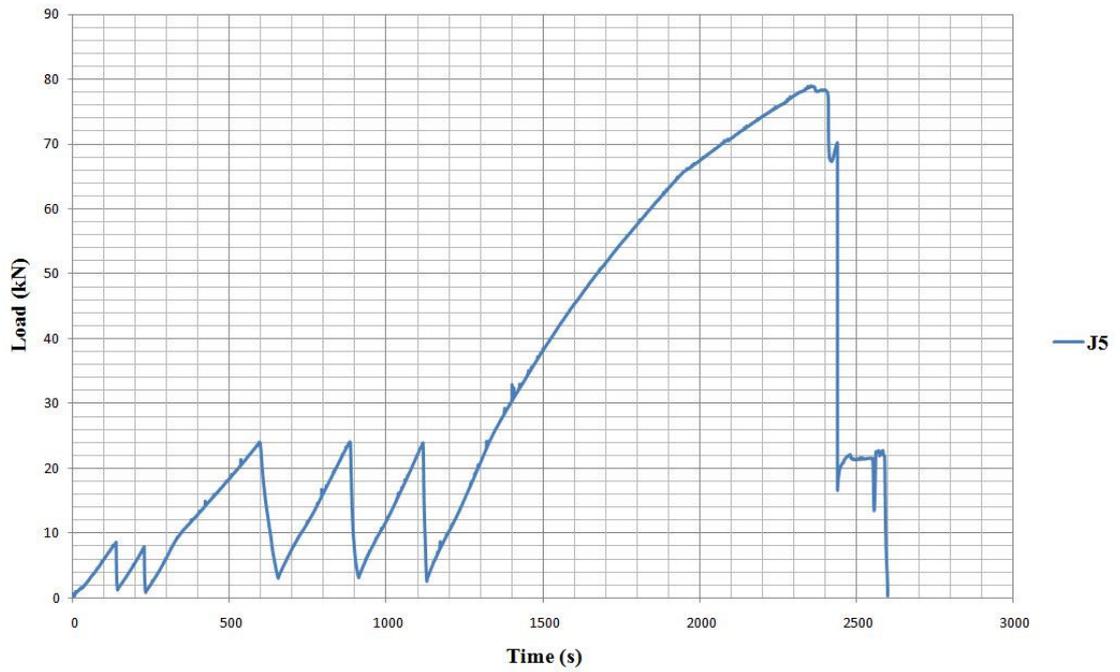
Figure 5.62: Loading cycles for Specimen J5

Specimen J5 was a CFRP-strengthened concrete beam with a similar configuration to Specimen J1. It was strengthened with V-shaped anchorages wrapped across the entire beam. Specimen J5 utilised 24 pieces of 810 mm by 100 mm CFRP sheet anchorages. According to Domazetoski, each end of the beam utilised eight CFRP sheet anchorages, which were double-wrapped. The middle section of the beam was also strengthened with eight double-wrapped CFRP sheet anchorages. With six times the anchorage of Specimen J2, Specimen J5 was significantly better anchored. Therefore, it was assumed that the failure mode of Specimen J5 would not be debonding of the CFRP. At the end of the flexural test, this assumption was proven correct, as the beam eventually failed due to the tensile rupture of the CFRP sheets at the tension face. Since the longitudinal CFRP arrangement of Specimen J5 was the same as that of Specimen J2, it was assumed that Specimen J5 could sustain at least the same flexural load as had Specimen J2. Eventually, Specimen J5 failed at a high load of 79 kN, which was 8 kN more than the load at which Specimen J2 failed. See Figure 5.63 for the load versus deflection graph for Specimen J5. The additional load came from the extra tensile force provided by the anchorage at the middle section of the beam. The first noticeable failure was concrete compression at the mid-span of the beam (see Figure 5.64). Shortly after the crushing of the concrete, the tensile capacity of the longitudinal CFRP was fully utilised when it exhibited tensile rupture (see Figure 5.65). The full loading cycles for Specimen J5 are shown in Figure 5.62.

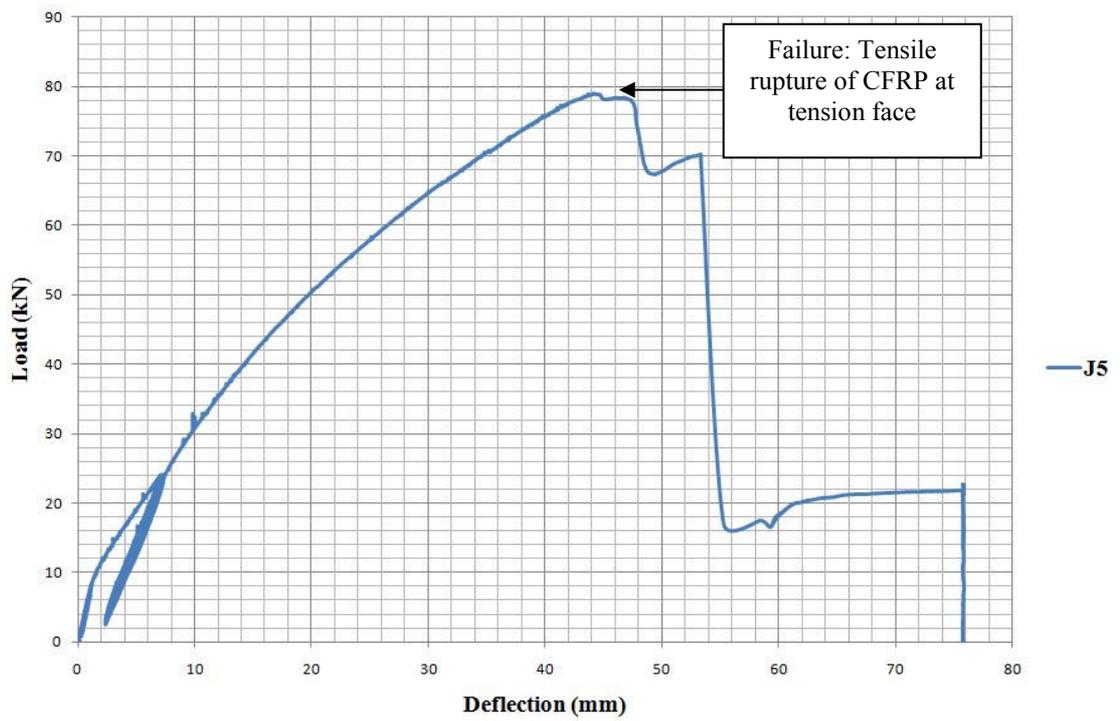
Figure 5.63: Load v. Deflection graph for Specimen J5

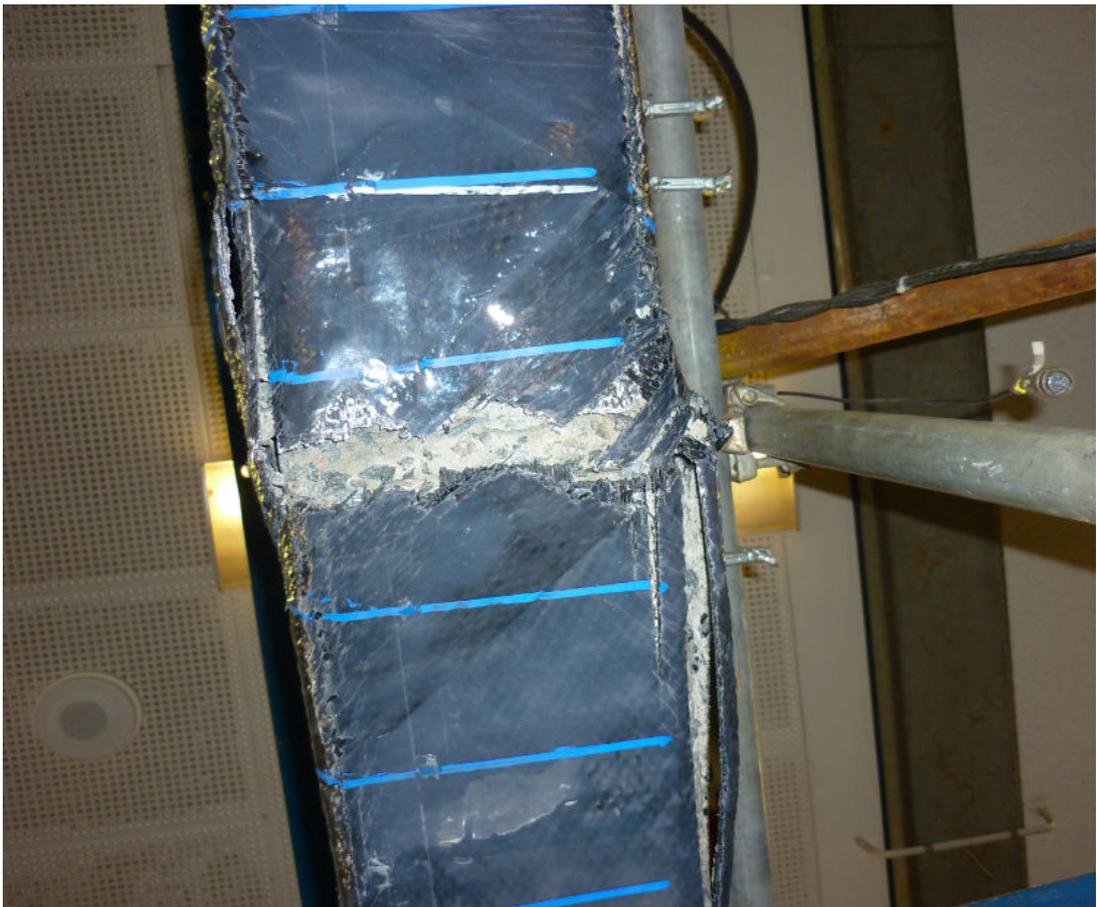
Figure 5.65: Tensile rupture on the tension face, Specimen J5

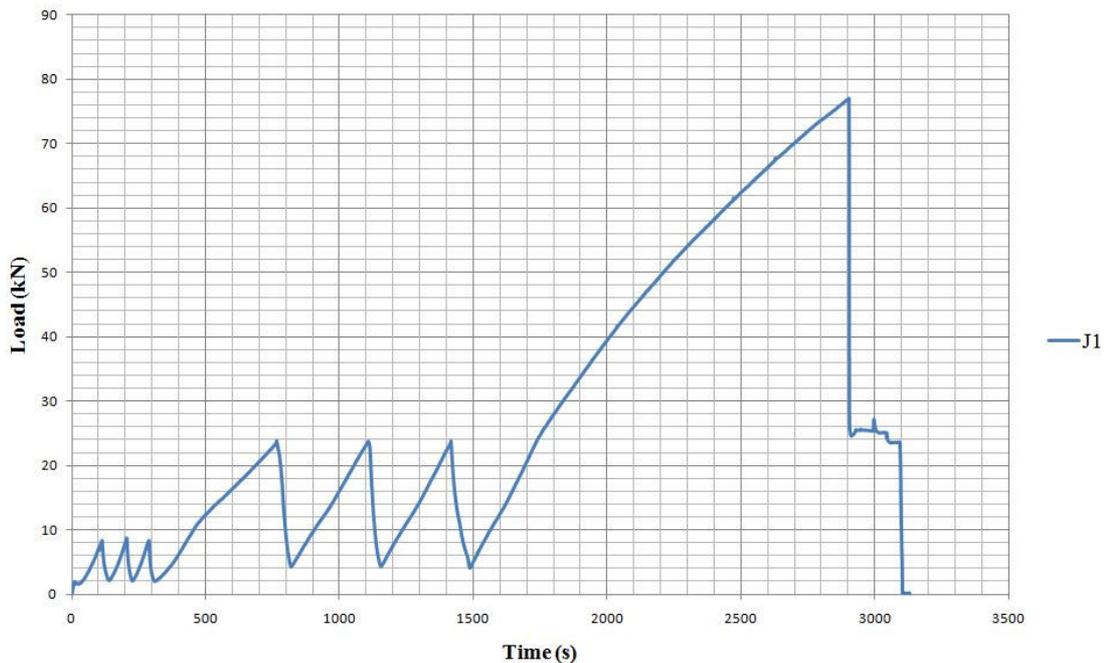
Figure 5.66 Loading cycles for Specimen J1

Specimen J1 was strengthened with three layers of CFRP on the tension face of the beam. The entire length of the specimen was strengthened with 20 sheets of 150 mm by 760 mm V-shaped anchorages. The V-shaped anchorages were wider than for Specimen J5. According to Domazetoski, it was initially planned that Specimen J1 would be strengthened with 26 sheets of CFRP anchorage. However, due to hardening of the epoxy during the installation of the CFRP fabric, the middle section of the beam was not covered with CFRP anchorage. It seems for this reason, Specimen J1 failed at a failure load of 77 kN. The first noticeable failure was the tensile rupture of CFRP at the tension face (see Figure 5.68), followed by the crushing of the concrete at the compression zone at mid-span. This is shown in Figure 5.69. Due to the lack of CFRP sheeting at the middle section of the beam, Specimen J1 had less significant tensile force in the middle section, causing the CFRP to have a tensile rupture and eventually fail. Figure 5.67 shows the load versus deflection graph for Specimen J1. It can be seen that after the specimen reached the peak load, the beam exhibited an extremely brittle failure as the load capacity dropped rapidly from 68 kN to 20 kN. This suggests the requirement for further investigation to improve the ductility of the beam. Figure 5.66 shows the loading cycles for J1.

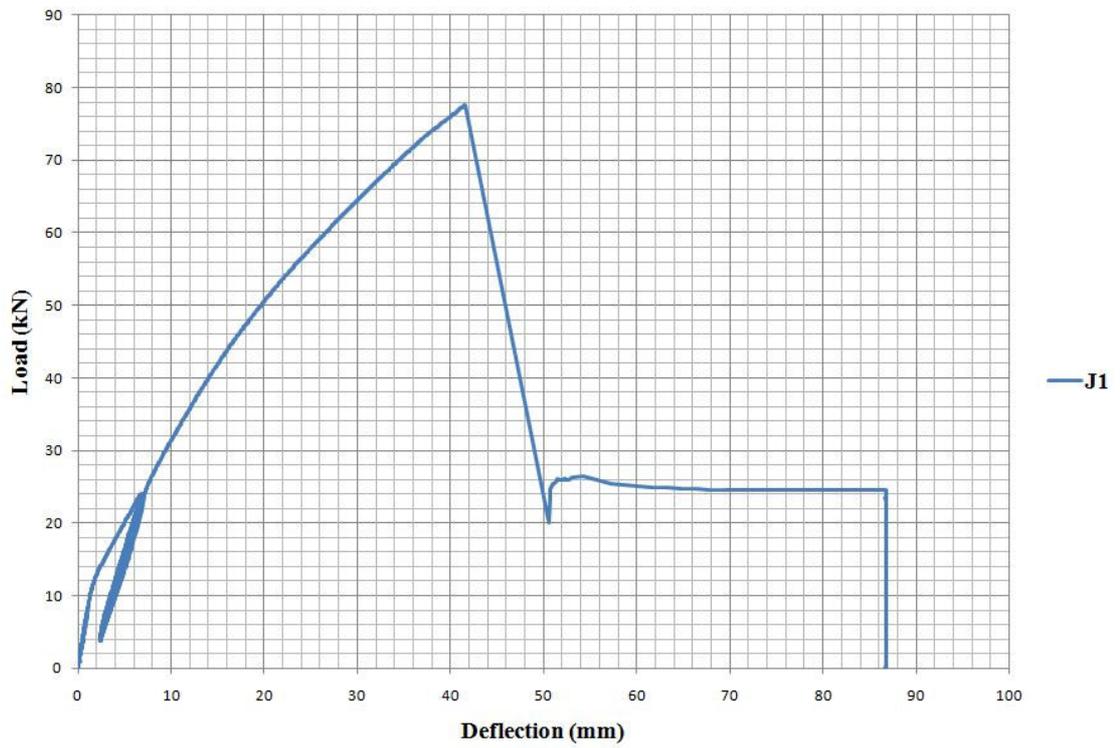
Figure 5.67: Load v. Deflection graph for Specimen J1

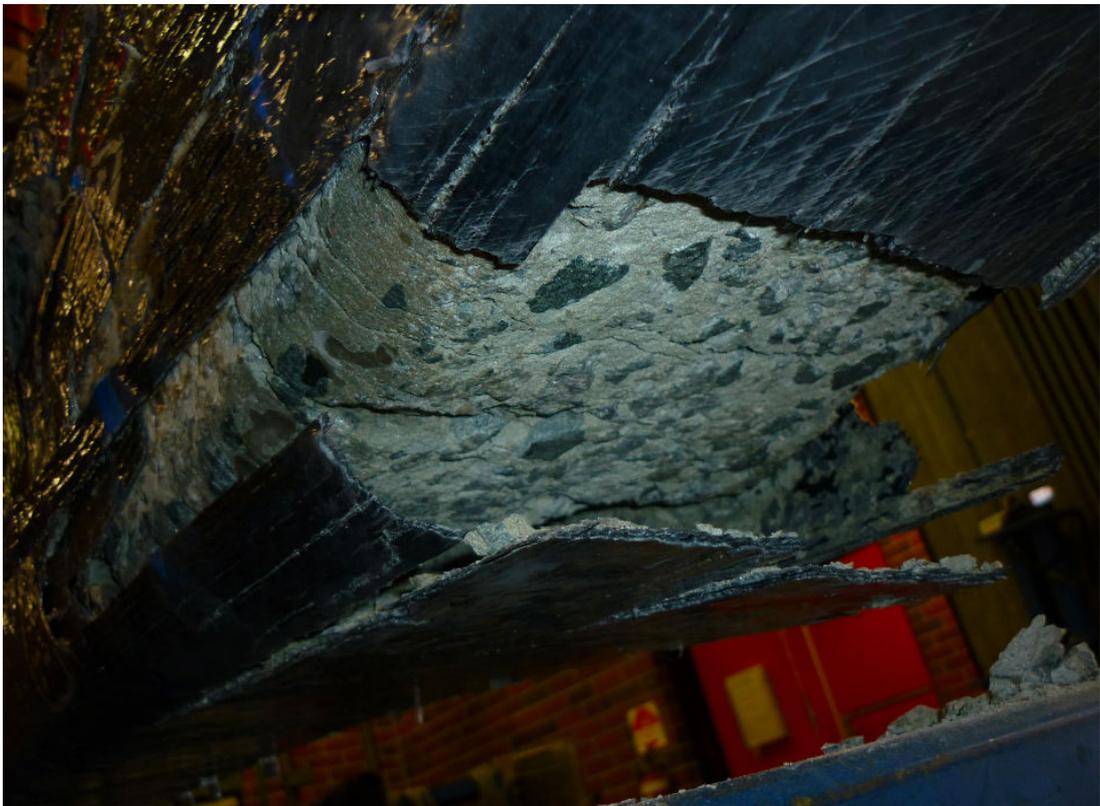
Figure 5.68: Tensile rupture at tension face, Specimen J1

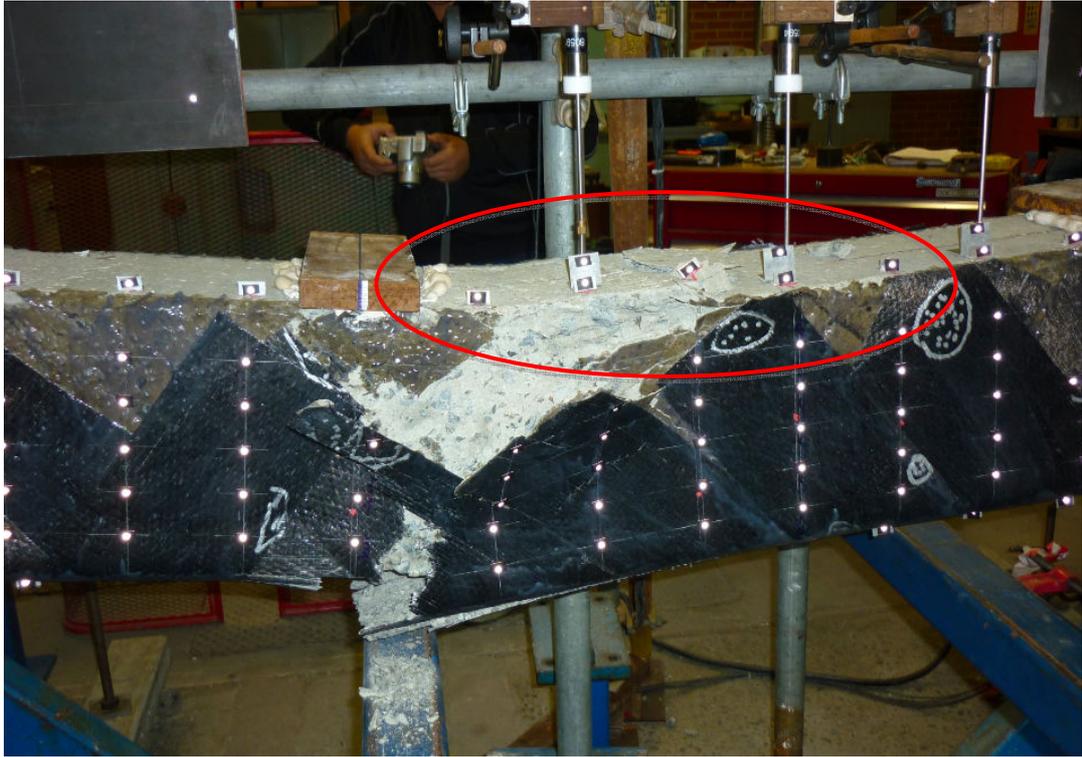
Figure 5.69: Compression failure of Specimen J1

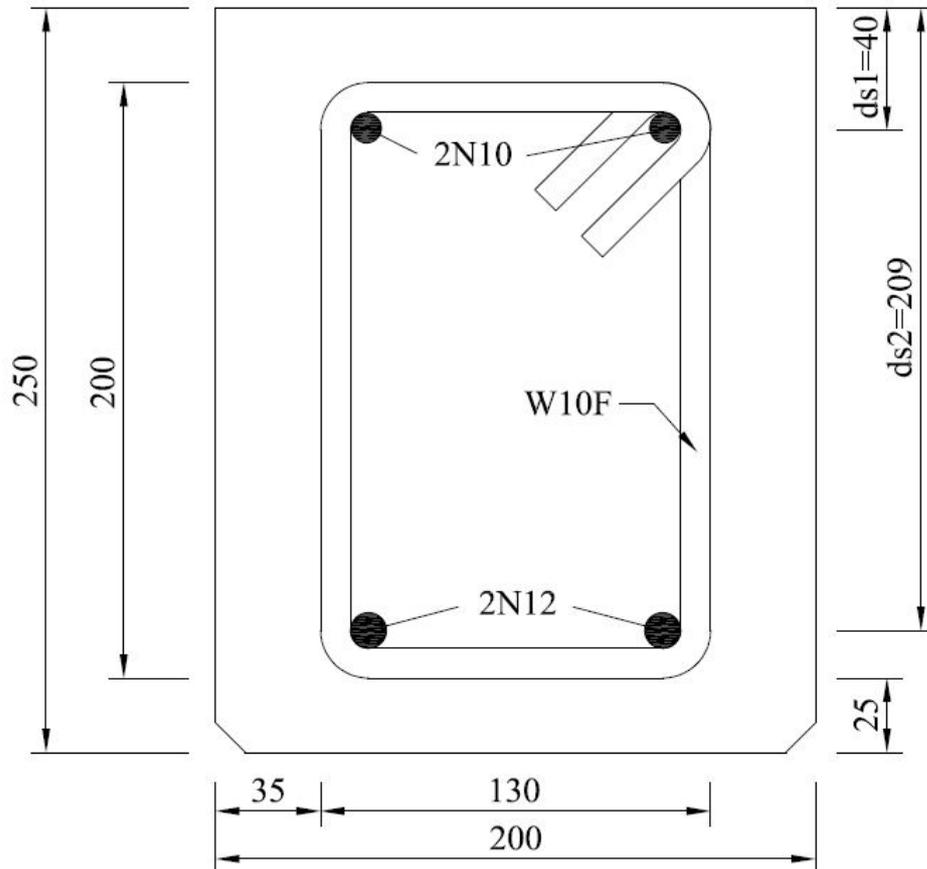
H6 (Lower Control Beam)

Steel

Area of steel, 2N10, $A_{s1} = 157 \text{ mm}^2$
