ENGINEERING CHARACTERISATION OF *IN SITU* FOAMED BITUMEN STABILISED PAVEMENTS

This report is the second of two papers that reviews the results of research undertaken into the stiffness and fatigue performance of *in situ* foamed bitumen stabilised pavement materials at various sites in the Cities of Canning and Gosnells in Western Australia. In the first paper “The development of a fatigue transfer function for *In situ* Foamed Bitumen Stabilised Pavements,” the authors reported a review of laboratory fatigue testing that was undertaken over a 13 year history.

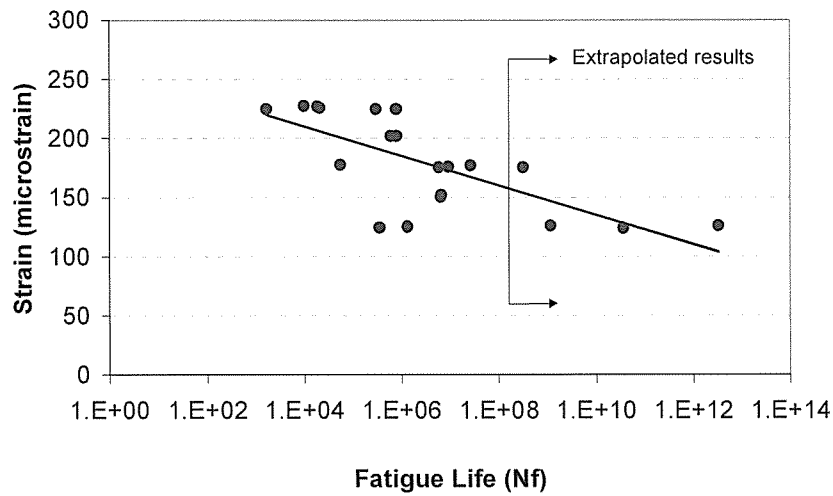
“The strain dependency for beams exhibiting Type 1 and Type 2 trends have been plotted for individual beams as shown in Figure 2.5 and Figure 2.6. A trendline has been included on each plot. The extrapolated points are for those beams where the test was terminated prior to the modulus reaching half of the initial value. Two extrapolated points were not included in the analysis for the trendline of the Type 1 data because they appeared to be outliers, but were included in the Type 2 trendline.”

Figure 2.6: Strain dependency for Type 2 data sets (Source: Alderson, 2001).

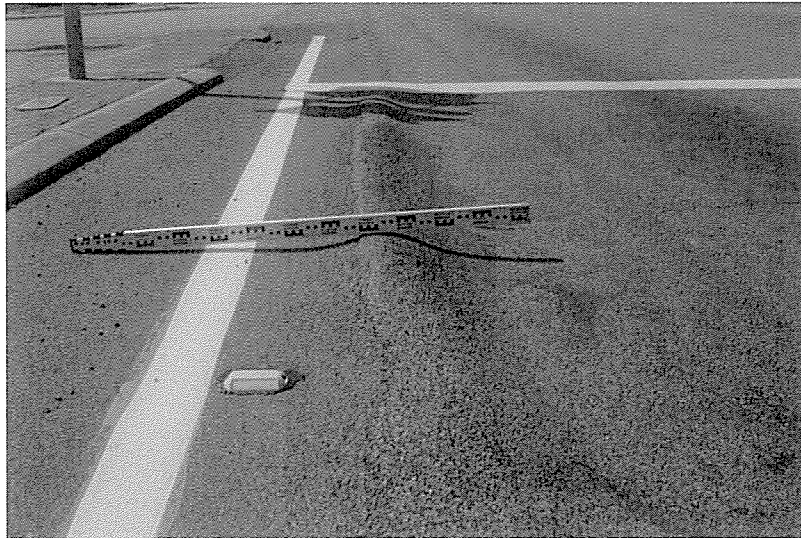
Other shear failures in pavements with heavy traffic and consisting of mixed crushed granular materials have previously been observed at intersections with slow moving traffic. These locations at the Bannister Road Forum Avenue intersection (Figure 2.9) and the Nicholson Road Spencer Road intersection Figure 2.10) exhibited shear failure relatively early in the life of the pavement.

Figure 2.9: Shear failure at Bannister - Forum intersection.

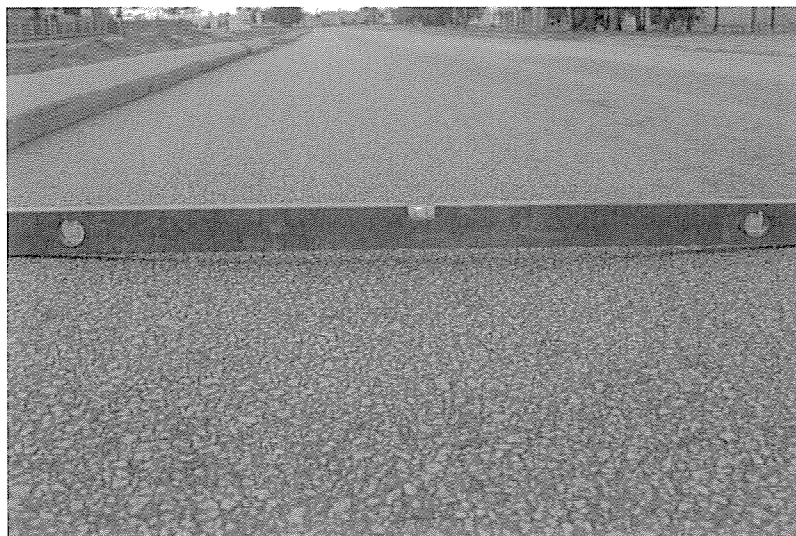
Figure 2.11: Shear failure Kewdale near Welshpool intersection 1999.

Other shear failures have occurred in materials containing laterite gravels, but only when subjected to very heavy traffic as evidenced by two examples from Kewdale Road as shown in Figure 2.11 and Figure 2.12. The rounded nature of the material in Kewdale Road (note only sections are natural gravel) is shown in Figure 2.13 compared to the more usual crushed materials found in Canning pavements as shown in Figure 2.14.

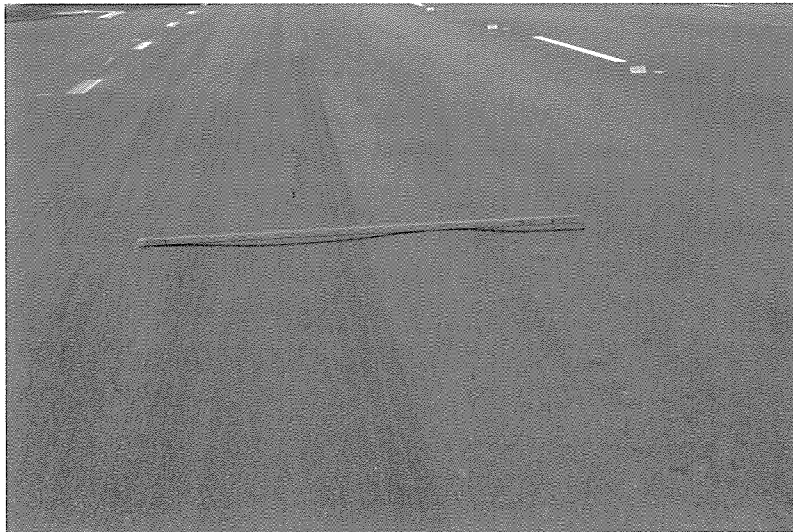
Figure 2.12: Shear failure Kewdale Dowd intersection 2012.
