# Deterioration Mechanisms in Dragline Wire Ropes

**Abstract.** Failures in hoist and drag ropes are studied and described based on site inspections on Marion and BE draglines. Causes of the failures are discussed. Some of the analyses of the wire rope failures centres on the wire rope accessories through which these ropes travel during machine operation. The influence of wire quality on wire rope life is also studied. Visual and metallographic examinations are both used in this study leading to a better understanding of deterioration mechanisms that lead to failure of hoist and drag ropes under service loading.

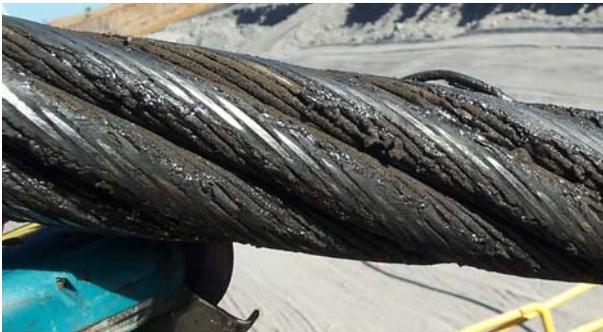
(a) Wear on One Side

Figure 1: Uniform Wear on a BE1370 Hoist Rope

It has been shown that BE1370 hoist rope life is much better than that for M8050 draglines (Dayawansa et al 2005). According to the information obtained by inspecting a large number of BE1370 hoist ropes, the main reason for this is the uniform wear on the perimeter of the hoist ropes. Therefore, during the later stages of life the wire breaks are more evenly distributed over the length and perimeter of the rope. A typical BE1370 hoist rope and its wear patterns are shown in Figure 1.

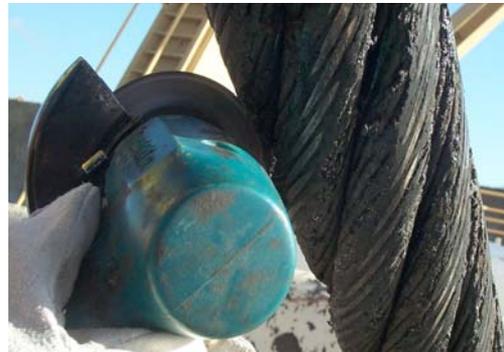
(b) Wear on the Other Side

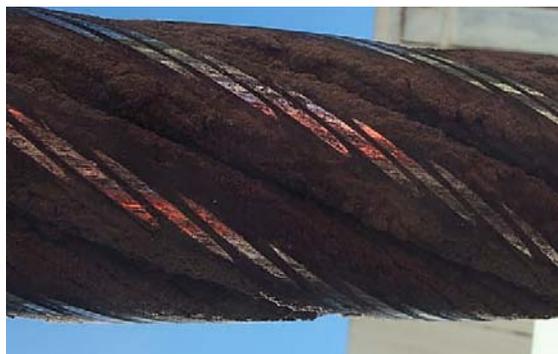
(a) Heavy Wear on One Side

Figure 2: Non-Uniform Wear on a M8050 Hoist Rope

On the other hand the wear in Marion hoist ropes is non-uniform, and the wear is most severe in the portion of the rope that passes over the gantry sheave. A typical M8050 hoist rope and its wear patterns are shown in Figure 2. The short span between the drum and the gantry sheave also contributes to this as the rope does not get sufficient room to twist under load.

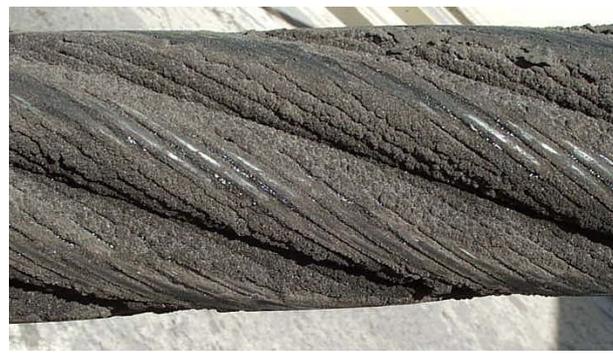
(b) Light or No Wear on the Other Side

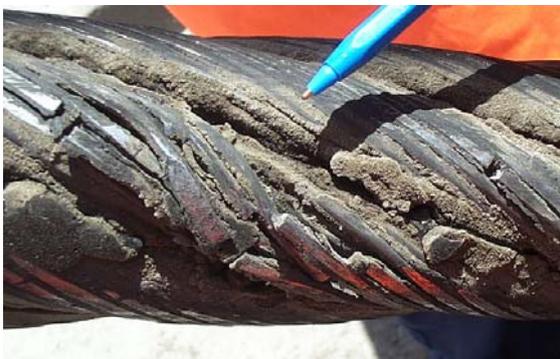
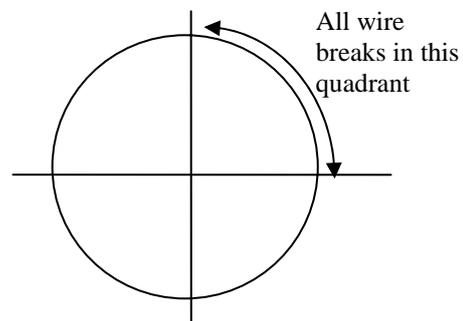
In one M8050 hoist rope, closer to the drum end, there was a length of ~10m where a unusually large number of wires had been broken on one side of the rope as shown in Figure 3. This damage was likely to be due to the abrasive wear on the gantry sheave.

At the gantry sheave the hoist rope bends in two directions. In most normal situations, if a rope direction is to be changed, a sheave is placed in the plane of bending of the rope. However, at the gantry sheave this is not the case. At the gantry sheave, whether the rope is in the plane of the sheave depends on the number of turns in the drum. The number of turns in a drum results in a given fleet angle. Therefore, when the fleet angle is high the rope rubs on the side of the sheave groove, resulting in uneven wear. Furthermore, the friction between the sheave and the rope prevents the rope rotation when the load is applied. Given this situation, the lubrication of the rope at the gantry sheave is extremely important.

Figure 3: A Large Number of Wire Breaks Concentrated on One sector of M8050 Hoist Rope

The non-uniform wear problem can be rectified by introducing an additional sheave in the second plane of bending.

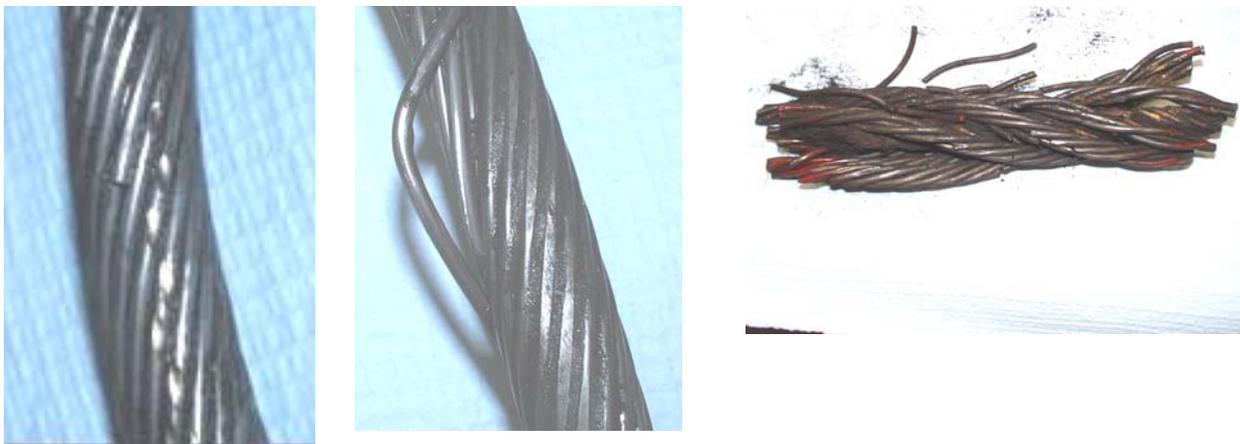
The rope showed typical non-uniform wear on the outer wires as pointed out previously. Figure 5 shows the state of the outer strands and the core of the rope after it was dismantled. The outer strands showed typical abrasive and plastic wear on the outer surface as shown in Figure 5(b), and indentations on the inner wires as seen from Figure 5(a). There were a large number of internal wire breaks on the outer strands as shown in Figure 5(a). Most interestingly, the core of the rope was literally broken into pieces as seen in Figure 5(c), making it a futile exercise to count the number of wire breaks. Based on the number of wires broken within one lay length this rope would have been well outside all known discard criteria, yet it continued to be in service.

(a) Indented Wires – Inside of Strand      (b) Worn out Wires – Outside of Strand      (c) Core – Wires Broken into Small Pieces

Figure 5: Discarded M8050 Hoist Rope

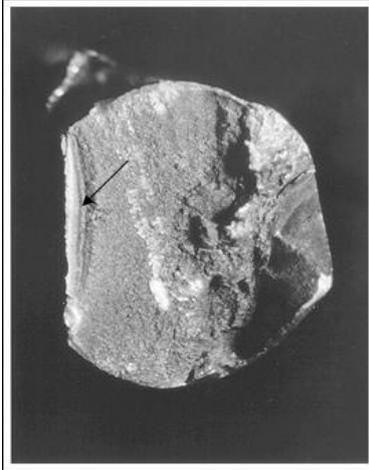
Optical examination of the outer strand wires revealed a failure mode common to all of them; namely fatigue fracture originating at a heavily deformed surface as typically shown in Figure 6.

The fatigue fracture indicated by the arrow in Figure 6 has initiated at a severely abraded and crushed surface. Metallographic examination of longitudinal sections taken along the defective wires revealed the presence of a brittle martensitic layer (arrowed) associated with the heavily abraded surface as shown in Figure 7. Below the martensite is the heavily drawn microstructure of the wire material. This brittle martensite phase can give rise to cracking, which can propagate transversely into the parent microstructure and eventually lead to failure.

Figure 6: Typical Wire Break in Outer Strand of Hoist Rope

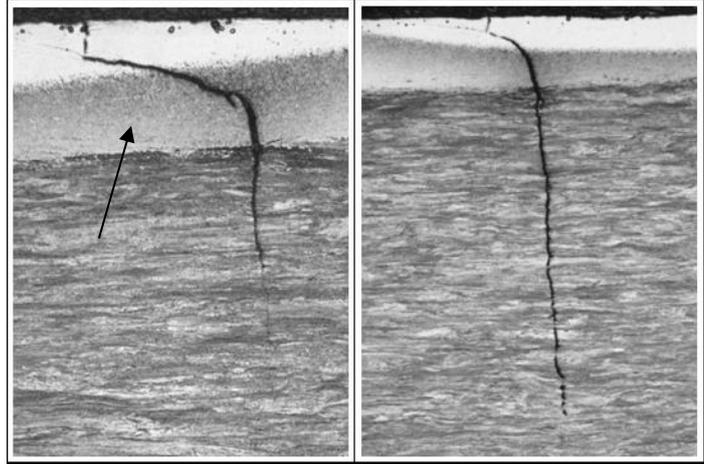
Figure 7: Martensite Layer and Heavily Drawn Microstructure

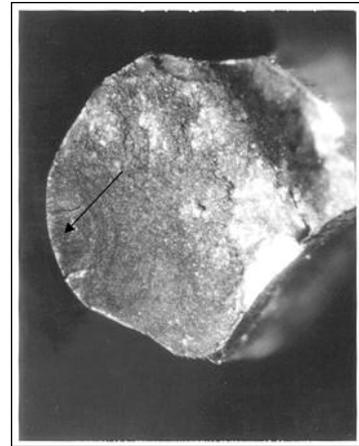
The core strand taken from a discarded Marion dragline hoist rope revealed its wires were severely crushed as shown in Figure 8(a). Closer examination of the wire failure surface revealed that the fracture was not associated with the deformed sharp regions as was the case in the outer strands. The initiation point of the fracture was in the relatively undeformed part of the wire as shown in Figure 8(b). It is not possible to conclude whether the fatigue crack initiated before the wire was crushed.

(b) Crack Location in a Wire

Figure 8: Wire Failures from a M8050 Hoist Rope Core

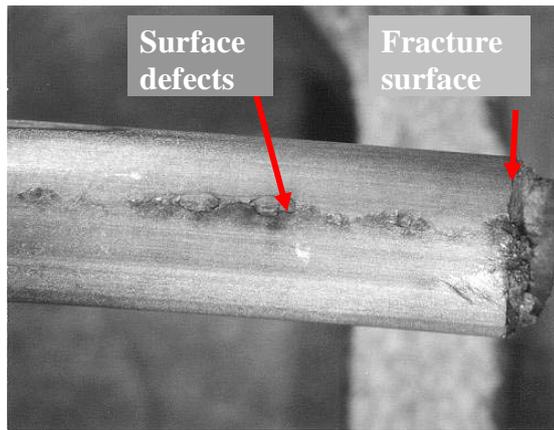
It is also very important to understand what the implications of wire quality is on fatigue life of the rope. An investigation on a failed suspension rope revealed that the surface irregularities of the wires contributed to the premature failure of the rope. The samples of the tested wires from this rope are shown in Figure 9. It is believed that the surface irregularities were generated at the stage of wire production. If routine wire tests are conducted as part of the quality checks the quality and reliability of the ropes can be improved.

(a) Surface Defects

Figure 9: Surface Defects on a Suspension Rope Wire and Subsequent Fatigue Failures

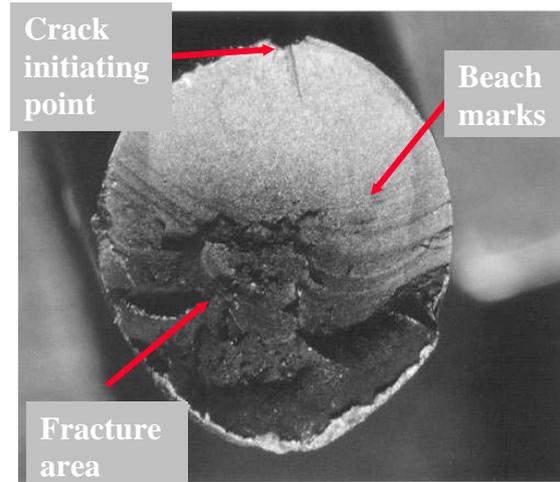
(b) Fatigue Failure due to Surface Defects
