# Domino-type progressive collapse analysis of a multi-span simply-supported bridge: a case study

Hongqi Viaduct, a multi-span simply-supported bridge in Zhuzhou city, Hunan Province, China, collapsed progressively during the mechanical demolishing of the bridge on May 17, 2009. Totally nine spans collapsed in the accident and it is a typical Domino-type progressive collapse. The accident resulted in the loss of 9 lives and 16 injuries. Investigations were conducted after the accident to determine the cause of the unexpected progressive collapse. This paper is aimed at presenting a summary of the bridge before and after the incident, the demolishing plans and field investigations after the accident. To better understand the cause and mechanism of the progressive collapse, a numerical simulation is carried out. A detail 3D finite element (FE) model is developed by using the explicit FE code LS-DYNA. The bridge components including the bridge slabs, wall-type piers, longitudinal and transverse reinforcement bars are included in the model. The non-linear material behaviour including the strain rate effects of the concrete and steel rebar are considered. The model is used to simulate

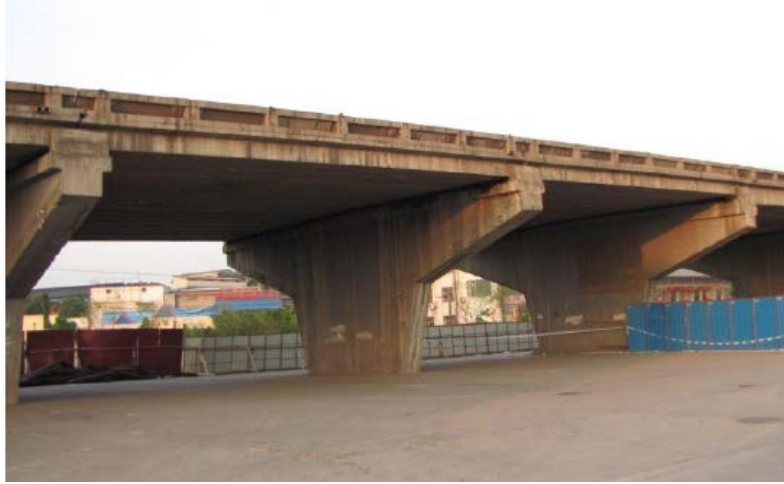
**Fig.1.** Typical view of Hongqi Viaduct (before collapse)

Hongqi Viaduct is a multi-span simply-supported bridge located in Zhuzhou city, Hunan Province, China. It includes 121 piers and 122 spans, with 15 spans of length 13 m, 3 spans of 18 m and 104 spans of 20 m. The total length of the bridge reaches 2329 m. Fig. 1 shows the bridge before collapse. Each span consists of 16 prestressed concrete hollow slabs. The height of each slab is 0.85 m and the width is 1 m. The total width of the superstructure is 16.5 m including 0.25 m overhang in the first and last hollow slab as shown in Fig. 2, with an equivalent density of  $2241 \text{ kg/m}^3$ . The height of the wall-type pier is 7.875 m from the pile cap and the thickness is 0.8 m. Fig. 2 shows the numbering of the slabs and the cross sections of the pier. The superstructures are simply-supported by 7808 laminated rubber bearings located on the top of the piers.

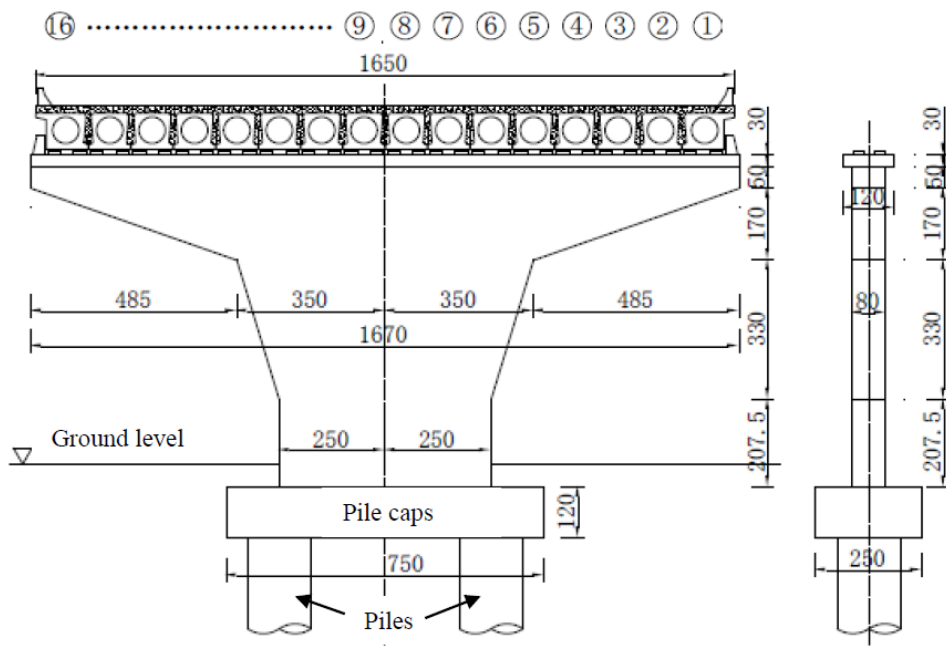
**Fig. 2.** Numbering of the slabs and cross sections of the pier (unit: cm)

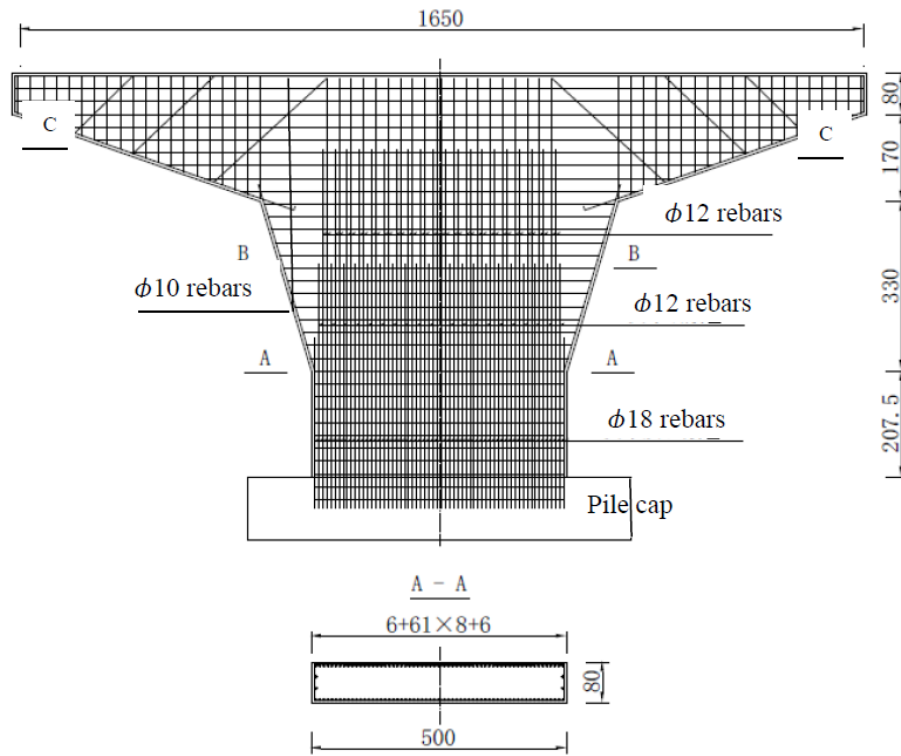
Fig. 3 illustrates the reinforcement bars in the piers. Deformed steel bars with diameter of 1.8 cm ( $\phi 18$ ) were pre-buried in the pile cap. The length of these pre-buried bars is 267.5 cm with 60 cm buried in the pile cap and the spacing is 8 cm. The size of the rest vertical bars is 1.2 cm ( $\phi 12$ ), and the spacing varies with the height of the pier, with 8 cm between sections A-A and B-B, 16 cm between sections B-B and C-C and 24 cm between section C-C and the top of the pier. The transverse stirrups are round steel bars. The diameter is 1.0 cm ( $\phi 10$ ), and the spacing between the transverse bars is 25 cm.

**Fig. 3.** Reinforcement bars in the pier (unit: cm)

With the parameters given in the previous sections, for section A-A shown in Fig. 3, it has  $V_c = 4407.9$  kN and  $V_s = 212.65$  kN and the nominal shear strength is 4620.55 kN. It should be noted that, the above results are obtained by considering half weight of the second span and neglecting that from the falling span in calculating the axial load. In fact, when the slabs of the first span drop from the pier, they generate a vertical impacting force on the pier initially, and followed by a vertical force through friction of the falling span with the pier. Neglecting this axial force leads to a slight underestimation of the actual nominal shear strength of the bridge pier. Moreover, Eqs. (8) and (9) are obtained based on the quasi-static analyses, the nominal shear strength of the pier can be slightly higher under dynamic impact loading. However, because of the poor understanding of the dynamic

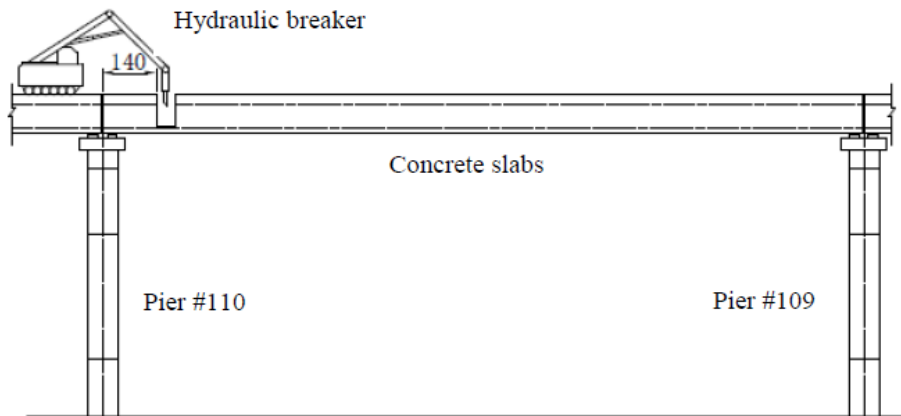
Two different methods were adopted to demolish Hongqi Viaduct, i.e. blasting demolishing method and mechanical demolishing method. The spans between piers #12 and #100 were demolished by using the blasting method and the rest spans were planned to be demolished by mechanical method. The original scheme of mechanical method was to remove the connections between any two hollow slabs first, and then a hydraulic breaker located on the adjacent span would be used to break the first hollow slab. The broken hollow slab would drop to the ground due to the gravity load. Then the hydraulic breaker would move to break the second slab. This process would be repeated until the total 16 slabs being demolished successively. The breaking location of the slab by the breaker is about 1.4 m to the left end of the slab. Fig. 4 shows the mechanical demolishing method.

**Fig. 4.** Mechanical demolishing method

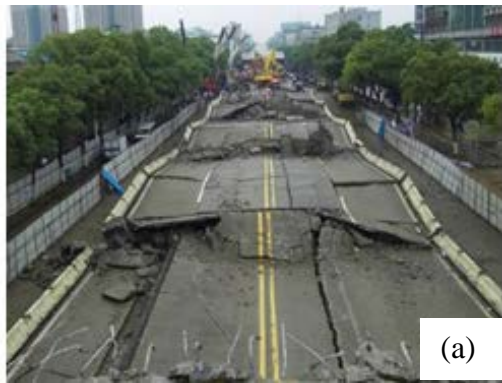
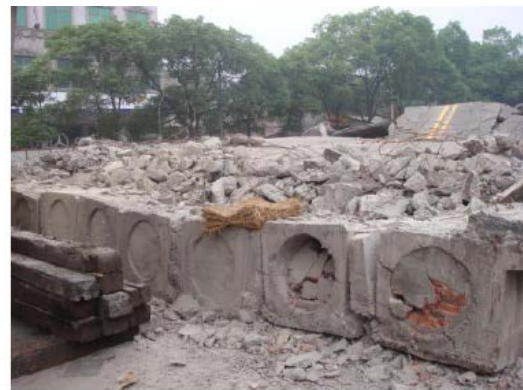
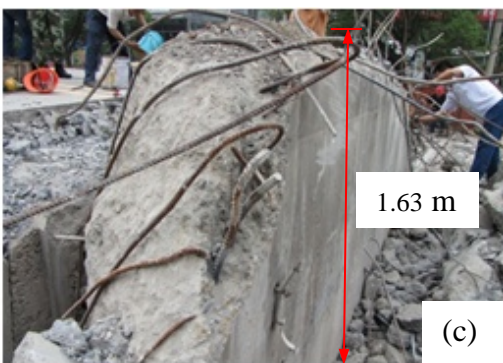
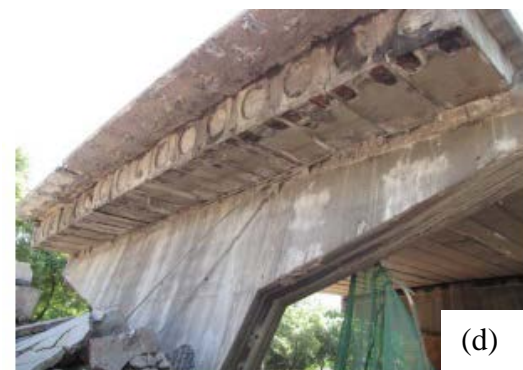
was not designed to resist such an impacting force, seriously damaged pier #109 and made it collapse toward pier #108. Consequently, the left ends of the slabs between piers #109 and #108 dropped to the ground due to the loss of support (pier #109), and the right ends collide with pier #108, which in turn resulted in the collapse of pier #108. The adjacent spans followed the same pattern and formed the domino-type progressive collapse as illustrated in Fig. 11. However, the collapse did not progress to the whole remaining bridge spans but stopped at pier #101, which deformed toward pier #100 with an angle of 30 degrees due to impact by the collapsed span but did not collapse as shown in Fig. 6(d). The collapsed spans and piers are designed and constructed the same. The reason why pier #101 did not completely collapse as piers #109 to #102 is not exactly known. Because the post incident investigation concentrated on the collapsed spans, no further information is available on pier #101. In this study, only the collapse mechanism is investigated. Totally 8 piers and 9 spans collapsed in the incident, and the collapsed length reached 180 m. Fig. 5 shows the plan view of the collapsed spans and Fig. 6 shows the bridge after collapse. 9 people died and 16 were injured in the incident.

**Fig. 6.** Hongqi Viaduct after collapse: (a) overview, (b) collapsed slabs, (c) remaining pier (#109) and (d) pier #101

The lower part of pier #109 below the shear failure section remains on the ground as shown in Fig. 12. The height of the remaining part is about 1.56 m in the numerical study, which is almost the same as that in Fig. 6(c), where the remaining part is about 1.63 m.

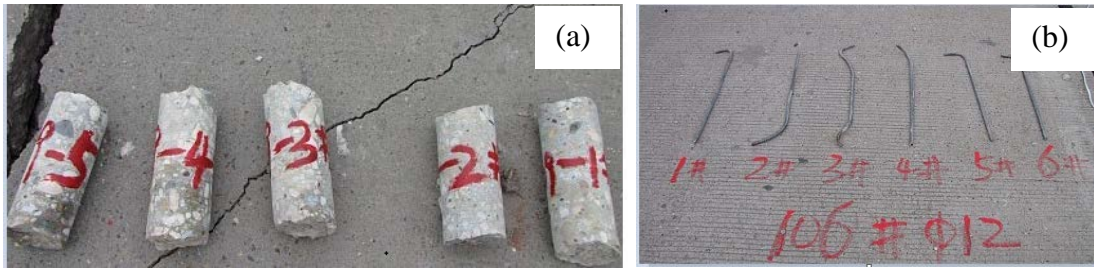
An investigation team was organized immediately after the incident. One important task of the team was to collect the concrete and reinforcement samples from the slabs and the piers. These samples were tested at the structural lab in Central South University in Changsha, China. For the slabs, 6 samples with diameter of 10 cm ( $\phi 100$ ) were drilled from the slabs between piers #110 and #109, and between piers #108 and #107. The pier samples were drilled from piers #106, #108 and #109, and 3  $\phi 100$  samples were drilled from each pier. 43  $\phi 12$  reinforcement samples, 9  $\phi 18$  samples and 12  $\phi 10$  samples were also collected from these piers. Fig. 7 shows part of the collected concrete and reinforcement samples. The test results found that the average compressive strengths of concrete of the slab and

**Fig. 7.** Samples: (a) concrete and (b) reinforcement ( $\phi 12$ )

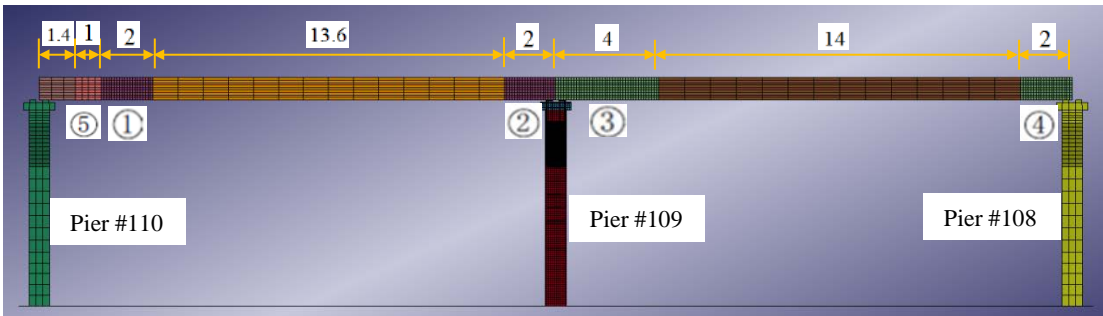
A detailed 3D finite element (FE) model of the bridge is developed in the software package ANSYS [22], and the analyses are carried out by using the explicit finite element code LS-DYNA [23]. Fig. 8 shows the elevation view of the FE model. To model the structural damage under impact loads and collapse, fine element mesh is needed, which usually results in huge FE models. To reduce the computational effort, without losing generality, only two spans and three piers (piers #110 to #108) are considered in the model. For the three piers, detailed modelling is only applied to pier #109, the pier that collapsed owing to the impact by the free falling span. In the detailed model the concrete and reinforcement bars are modelled separately, with constant stress solid elements for concrete and Belytschko beam elements for reinforcement bars. By conducting a numerical convergence test on various mesh sizes (0.16, 0.08 and 0.04 m), it was found that the 0.08 m mesh yields similar results with the smaller mesh but with much less computational time. A mesh size of 0.08 m is therefore used to model pier #109 for both solid concrete elements and beam elements for reinforcement bars.

property fully dependent on failure of concrete material. For piers #110 and #108, smeared model (i.e. reinforcement assumed to be uniformly distributed over concrete element) with element size of about 0.25 m is used to minimize the computational effort. Fine mesh is also applied to the span segments with possible contacts during impacts with ground and piers, (i.e., parts ①-④), e.g., part ① will contact with ground after the demolishing part ⑤ is removed and the falling span hits the ground; whereas part ② will impact pier #109. Relatively coarse meshes are applied to the other parts of the slabs. Smeared model is also adopted for the slabs. The length of each zone is shown in Fig. 8.

**Fig. 8.** Elevation view of the finite element model (unit: m)

⑤ shown in Figure 8. In this study, the hydraulic breaker is not modelled. The demolished part is simply removed from the model at 0.1 sec to induce the free fall of the remaining deck.

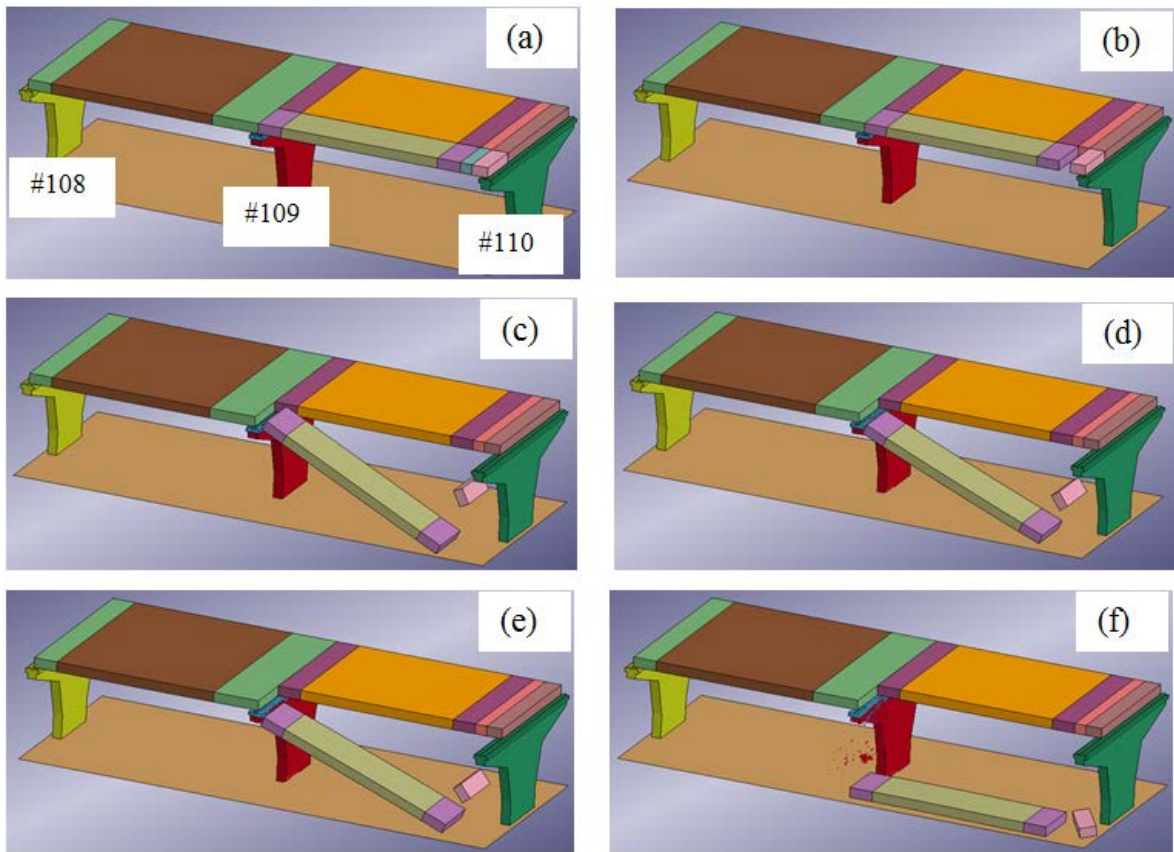
According to what had happened, demolishing of the last 4 slabs is simulated first. Fig. 9 shows the collapse process. Fig. 9(a) is the original model, part ⑤ of slabs 13-16 is removed at 0.1 sec as shown in Fig. 9(b). The broken slabs drop to the ground due to the gravity load and impact the ground at 1.33 s as shown in Fig. 9(c). The left ends of the falling slabs move off from the bearing supports and impact on pier #109 at 1.44 s (Fig. 9(d)), and then slide down along the surface of the pier (Fig. 9(e)) and finally hit the ground at 2.5 s (Fig. 9(f)). It is obvious that the simultaneous demolishing of the last 4 slabs does not cause the progressive collapse of the bridge. However, although the impacting force from the falling slabs does not knock off the pier, it causes local damages to pier #109. This simulation result agrees with the conditions observed during the real demolishing work. Fig. 10 shows the damage of pier #109 by impact of the falling slabs.

**Fig. 9.** Collapse process of simultaneously demolishing slabs 13-16: (a)  $t=0.0$  s, (b)  $t=0.1$  s, (c)  $t=1.33$  s, (d)  $t=1.44$  s, (e)  $t=1.50$  s and (f)  $t=2.5$  s

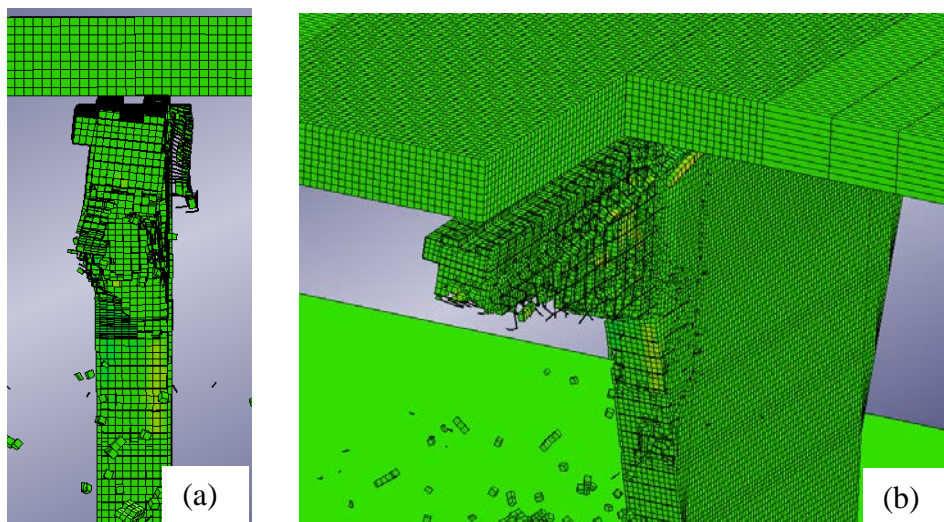
It can be observed that the impacting force results in concrete crushing damage near the impacting location, pushes pier #109 towards pier #108, and also results in slight torsional response of the pier. Large impacting force also damages some of the reinforcement bars. It should be noted that the slabs are modelled by elastic material and the damage of slabs is not considered in the study. In real case, some damage to the slabs is also expected. Damage of the slab material will absorb certain impact energy, which is neglected in the present study. Therefore, the simulation results obtained with the elastic slab assumption might slightly overestimate the pier damage.

**Fig. 10.** Detailed observation of damage on pier #109 due to demolishing slabs 13-16: (a) elevation view and (b) general view

slabs 13-16 as shown in Fig. 10 is not considered. This will lead to some underestimation of the pier damage. However, the primary purpose of this simulation is to demonstrate that impact from 12 falling slabs is enough to collapse the bridge pier owing to the large impacting force and the pier is not designed to resist such a lateral impact. The results will show that even if the pier has no any prior damage, it is not strong enough to resist the impact.

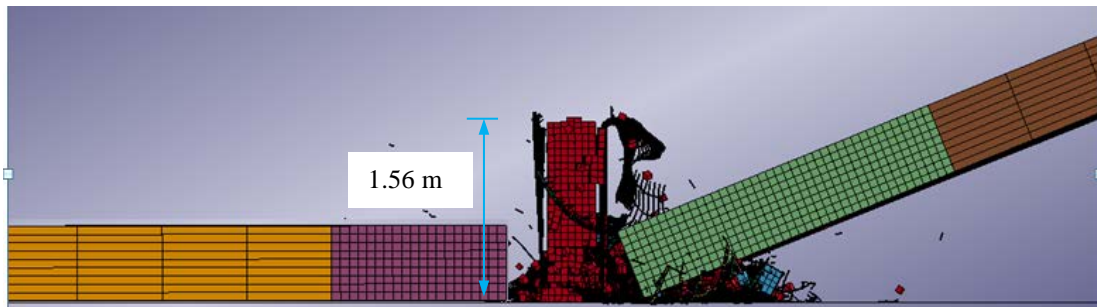
**Fig. 12.** The remaining part of pier #109

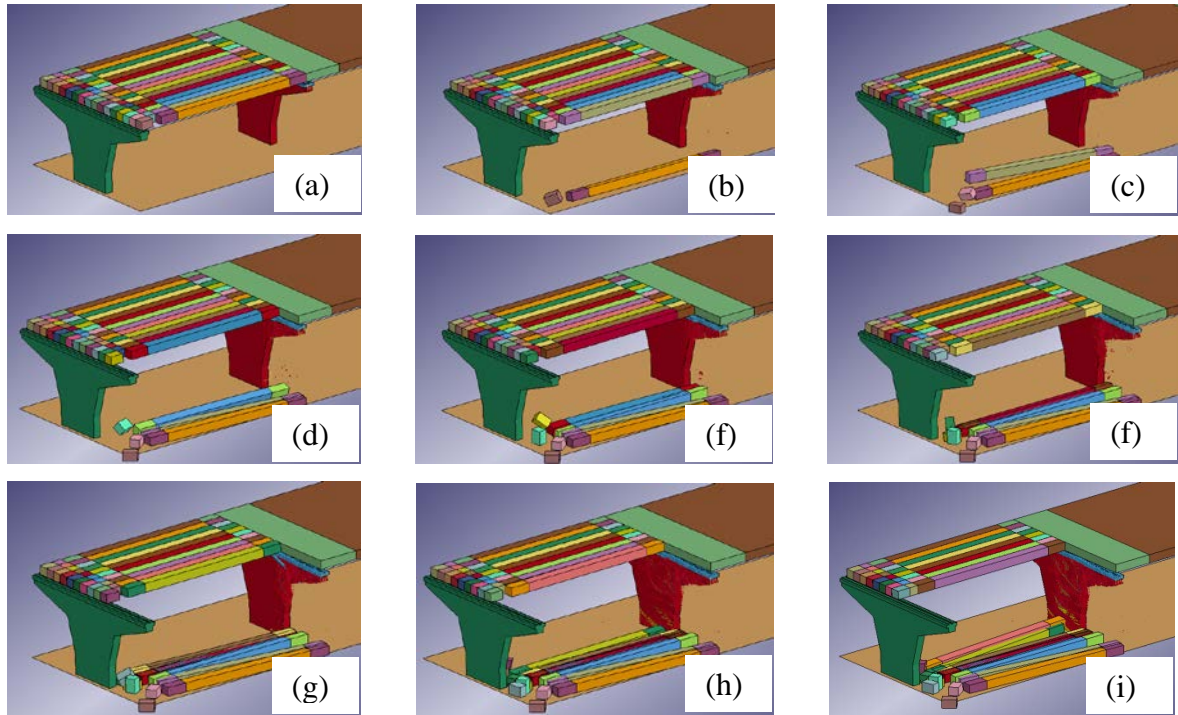
The original plan of the mechanical demolishing is that the slabs will be demolished one by one. The above simulations revealed that demolishing first 4 slabs simultaneously did not cause pier collapse owing to the relatively small impact force. However, these 4 slabs locate only at the edge of the pier. It will be interesting to know the situation of the bridge if the original demolishing plan, i.e., demolishing the slabs one by one, is followed. This section presents numerical simulations of the original demolishing process. To save computational effort, and also because the bridge is symmetrical along the axial direction, only demolishing half of the slabs, i.e., slabs 1-8, are simulated. Fig. 13 shows the collapse process. It can be found that the collapse of each slab generates local crushing damage to pier #109 at the surrounding area right underneath the collapsed slab. This indicates that the collapse of a particular slab only results in localized damage to the pier. Fig. 14 shows the damage on pier #109 after first 8 slabs dropping to the ground successively. It is obvious that pier collapse will not occur and hence progressive collapse will not be triggered. Relatively serious damage is generated when slab 5 is demolished. This is because the vertical reinforcements in the pier beneath slab 5 are sparse as shown in Figs. 2 and 3, which makes the base of the cantilever relatively easy to be damaged. This observation indicates that should the original demolishing plan have been followed, the tragic accident could have not occurred.

**Fig. 13.** Collapse process of demolishing slabs one by one: (a) demolishing slab 1 at  $t=0.1$  s, (b) demolishing slab 2 at  $t=2.6$  s, (c) demolishing slab 3 at  $t= 5.1$  s, (d) demolishing slab 4 at  $t=7.6$  s, (e) demolishing slab 5 at  $t=10.1$  s, (f) demolishing slab 6 at  $t=12.6$  s, (g) demolishing slab 7 at  $t=15.1$ s, (h) demolishing slab 8 at  $t=17.6$  s and (i) slab 8 dropped to the ground at  $t=20.1$  s

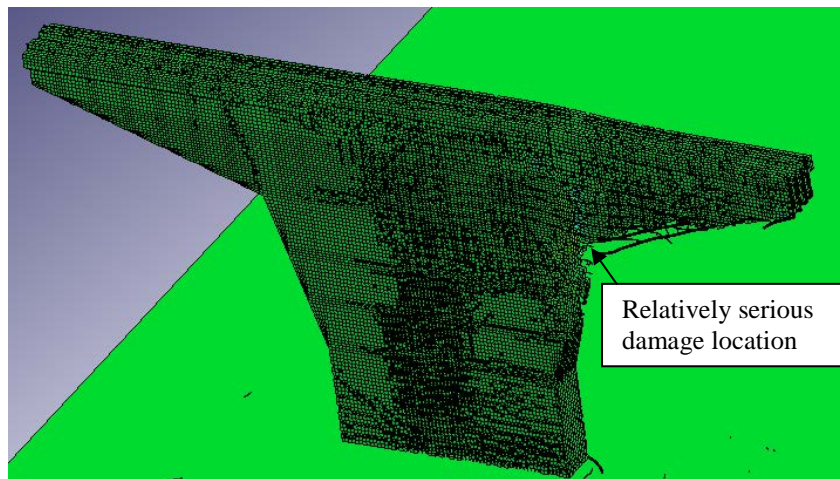
**Fig. 14.** Damage on Pier #109 after the first 8 slabs being demolished one by one

Similar damage is expected to adjacent bridge spans and piers, leading to progressive collapse of the bridge structure. It is interesting to note that the impacting force on pier #108 is smaller than that on pier #109 although the weight of the falling superstructure is larger (16 slabs fall in the second span) than that of the first span (only 12 slabs). This is because of the partial support provided by the damaged pier #109 as well as the relatively longer span length which results in a slightly smaller impact angle. When the slabs are demolished one by one, the resulted impact forces vary from 0.69 to 1.67 MN as shown in Fig. 17. The durations are between 0.03 and 0.06 s, resulting in the dynamic amplification factors vary from 0.54 to 1.07. The amplified impacting forces are smaller than the shear strength of pier #109. Therefore, if the demolishing work had followed the initial plan, the accident could have not happened and the falling slabs would only have caused some local damages on bridge piers as shown in Fig. 14.

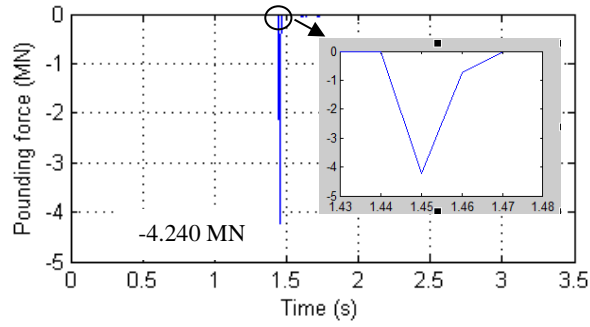
Figs. 15-17 show the numerically simulated horizontal impacting forces on the pier from different numbers of falling slabs. As shown in Figs. 15 and 16, the duration of the impacting force is quite short and it can be approximately regarded as a triangular pulse. It is well known that for a system subjected to a pulse force, the structural response can be amplified or de-amplified and the maximum response is related to the ratio of  $t_d/T_n$  [31], where  $t_d$  is the pulse duration and  $T_n$  is the natural vibration period of the system. For the pier shown in Fig. 2, it is found that the first natural vibration period is  $T_n = 0.176$  s based on an eigenvalue analysis.

It can be seen from Fig. 15 that the maximum pounding force due to demolishing slabs 13-16 is 4.24 MN, and the duration  $t_d$  is 0.03 s. For a triangular pulse, the dynamic de-amplification factor is about 0.54 when  $t_d/T_n = 0.03/0.176 = 0.17$  [31]. The de-amplified impacting force on pier #109 is thus  $4.24 \times 0.54 = 2.29$  MN, which is smaller than the shear strength of pier #109. Therefore, it generates crushing damages on concrete and damages some reinforcement bars, but the pier does not collapse as shown in Fig. 10. When the first 12 slabs are demolished simultaneously, the maximum impacting force on pier #109 reaches 15.70 MN and the duration is 0.05 s (Fig. 16(a)). The dynamic de-amplification factor is about 0.89 when  $t_d/T_n = 0.05/0.176 = 0.274$  and the de-amplified peak loading is 13.97 MN, which is substantially higher than the nominal shear strength of the pier. Therefore the pier collapses owing to insufficient shear strength to resist such a large impacting force. The horizontal impacting force on pier #108 from the impact of the falling span is 10.12 MN and the duration is also 0.05 s (Fig. 16(b)). The de-amplified impacting force is 9.00 MN, which is also larger than the shear strength of the pier. Therefore pier #108 also collapses owing to insufficient shear strength like pier #109.

**Fig. 15.** Horizontal impacting force on pier #109 due to demolishing slabs 13-16

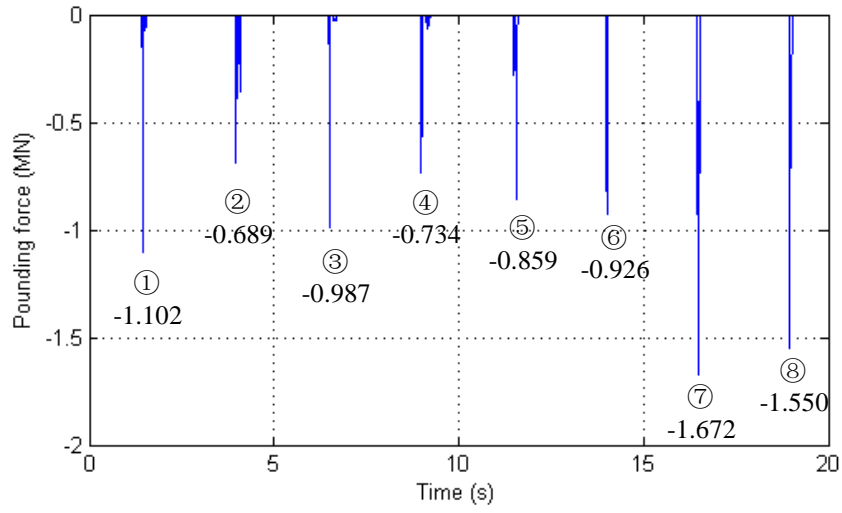
**Fig. 17.** Horizontal impacting forces on pier #109 when slabs are demolished one by one
