Title: Experimental and numerical study of composite lightweight structural insulated panel with Expanded Polystyrene core against windborne debris impacts

Experimental and Numerical Study of Composite Lightweight Structural Insulated Panel with Expanded Polystyrene Core against Windborne Debris Impacts

Wensu Chen^{*} and Hong Hao

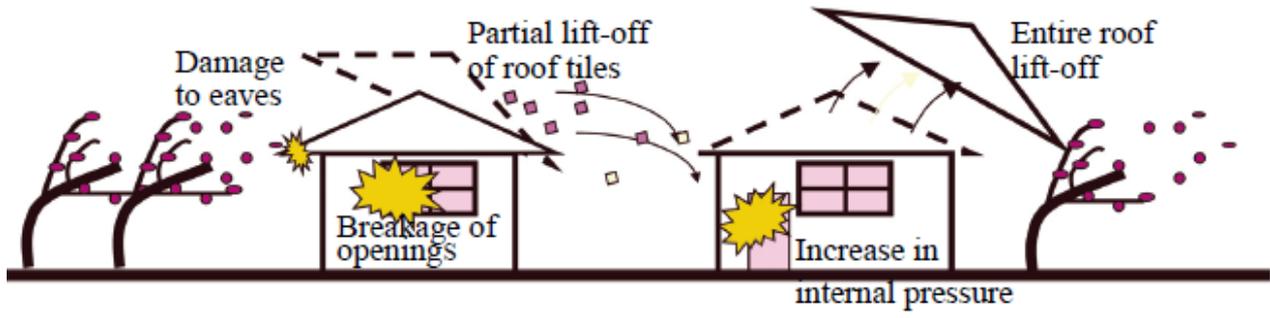
Figure 1 Illustration of possible windborne debris damage to building [7]

Hurricane Andrew in 1992 was recorded by that time as the most destructive and expensive natural disaster in US history, which caused \$25 billion damage and 65 deaths [2]. The post storm investigation found the hurricane created enormous amount of windborne debris and the windborne debris impact is highlighted as a major cause of damage to building envelope including wall, roof, door, windows shutters or screens etc.[3]. Windward wall is the most prone to debris impact among the building envelope. In a windstorm, unfixd objects or fixed objects such as roof tiles, roof gravel and rafter, etc which might turn loose under strong wind are the primary sources of potential windborne debris. The windborne debris can be classified into three types i.e. compact-like, rod-like and sheet-like [4]. Medium sized timber of 5.4~6.8kg, 100 mm×50 mm was found as the most representative of the windborne debris [5]. If wind speed is fast enough, the windborne debris might penetrate the building envelope, imposing threats to people inside the building. It also creates an opening. The opening in the envelope allows excessive amount of wind and rain to enter the building. Moreover, the opening might cause internal pressures increasing which results in more severe damage to the building such as collapse of the structural panel, entire roof lift-off, and total structure failure as

illustrated in Figure 1. Therefore, the windborne debris is a decisive factor to the performance of the building envelope and the building envelope is crucial to the performance of buildings in windstorms [3, 6].

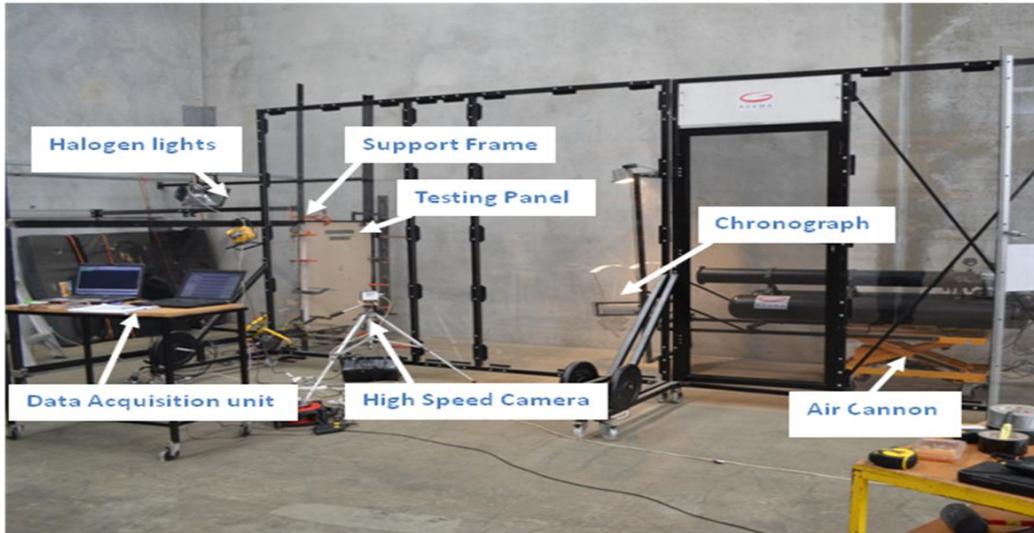
Figure 2 Experimental set-up of the overall test system

The experimental apparatus used in this study consists of a pneumatic cannon, a chronograph, a timber projectile, support frame, LVDTs, strain gauges, data acquisition system, grid chart, two high speed cameras, and halogen lights as shown in Figure 2. The specimens are located 3m in front of the pneumatic cannon. The specimens are mounted on the support frame by using G-Clamps on four edges, as shown in Figure 3 (L).

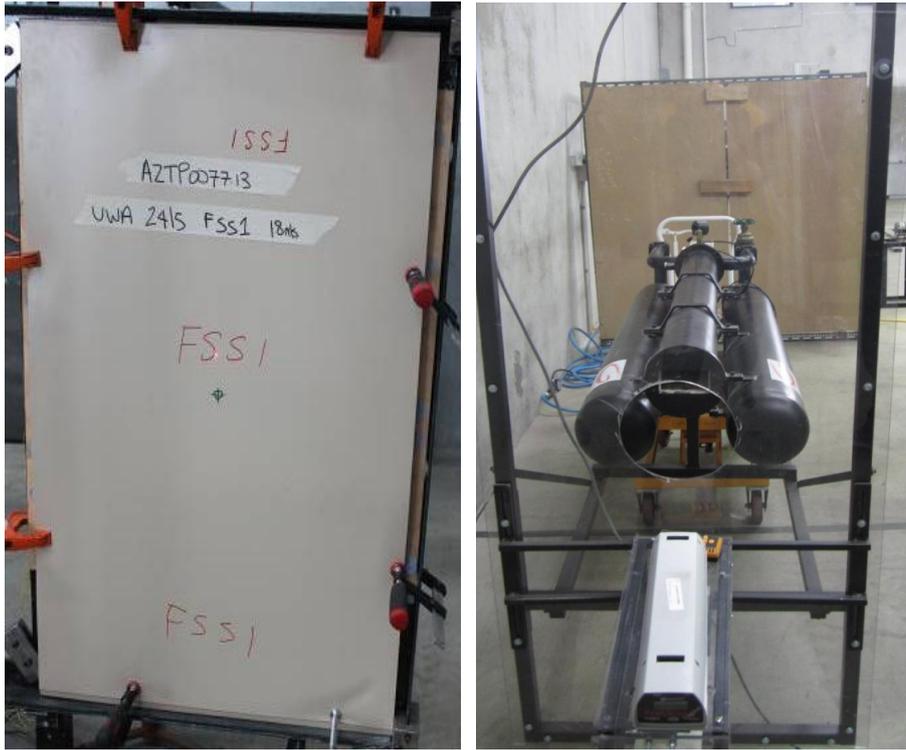
Figure 3 (L) Typical setup; (R) Pneumatic cannon

A pneumatically actuated cannon launch the projectile at a desired velocity, which is used to simulate the windborne debris driven by the wind. The pneumatic cannon can be adjusted to the specified impact location in lieu of its horizontal and vertical mobility as shown in Figure 3 (R). The projectile velocity varies by adjusting the air pressure inside the air chamber. The pressure-velocity relationship is obtained through large amounts of repeated testing for different types of projectiles. In this study, 4kg timber projectile with an impacting cross-section of dimension 100mm by 50mm was launched from the pneumatic cannon. The pressure-velocity relationship has the accuracy of $\pm 1\text{m/s}$ tolerance, which ensures launching the projectile at a desired velocity by pressuring the air pump. The projectile velocity of up to 44m/s can be achieved, which satisfies the testing requirement of Australian Wind Loading Code (AS/NZS 1170.2:2011) [1]. In the tests, a chronograph called Digital Chronograph Cei-3800 was installed at the exit of the barrel to record the actual projectile velocity. The actual impacting velocity can also be checked by high-speed camera images.

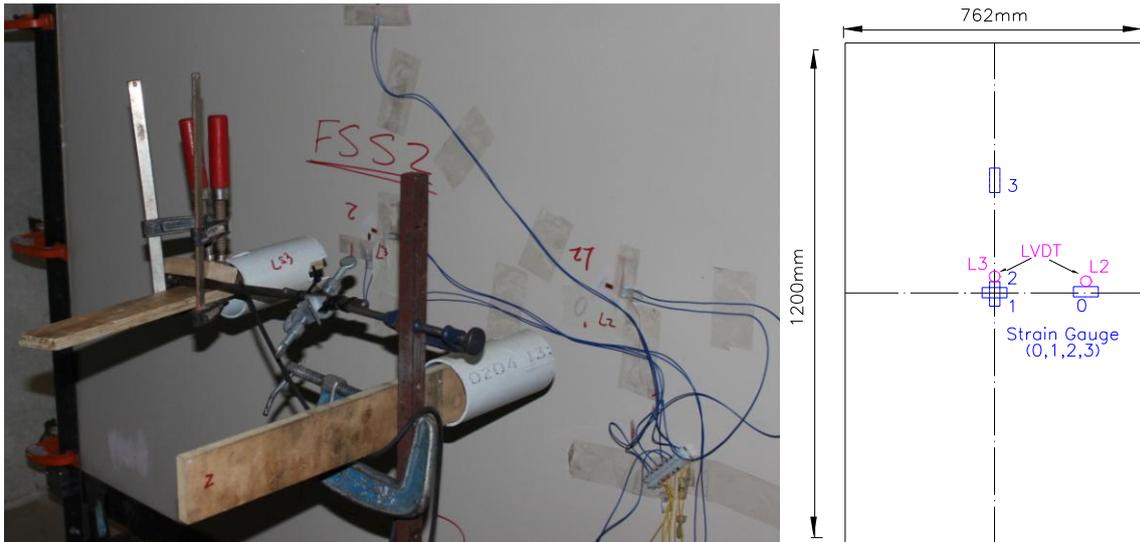
Figure 4 (L) Placement of four strain gauges and Laser LVDT on the back skin; (R) Schematic diagrams of strain gauges and LVDT placement

As shown in Figure 4 (L), two laser Linear Voltage Displacement Transducers (LVDT Keyence LB-70) were used to measure the displacement time history at the back skin (i.e. L2 and L3). To measure the residual velocity of the projectile after penetration or rebound, grid chart was used with the high speed camera. Four strain gauges (S0-S3) with gauge resistance of $119.8\pm 0.2\Omega$ and gauge factor of $2.1\pm 1.0\%$ were also adhered to the back skin of specimen to measure the strain history, as shown in Figure 4 (R). Strain gauges S1 and S2 were used to measure strains in two directions at the centre of the back skin. Strain gauges S0 and S3 were used to measure strains at the locations a quarter of panel length away from the edge.

Four response quantities were measured during the tests. They are opening size, residual velocity of projectile, two displacement time histories and four strain time histories on the back skin shown in Figure 4.

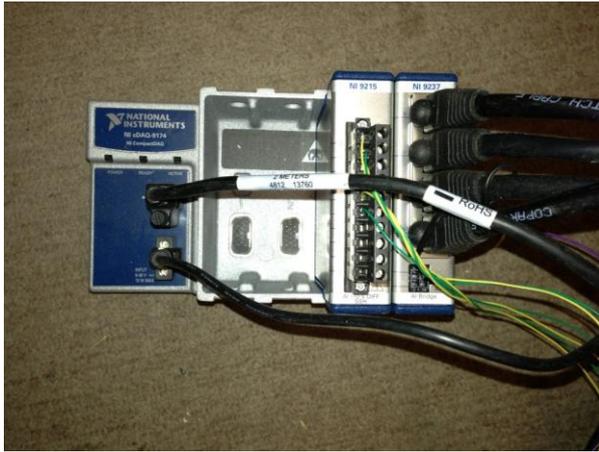
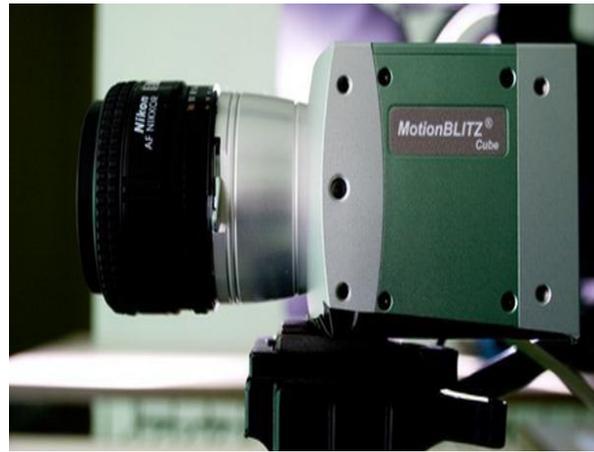
Figure 5 (L) Data Acquisition Unit by National Instruments®; (R) High-speed camera

High frequency data acquisition unit consists of DAQ9174 (4 slots), NI-9237 (for strain gauge) and NI-9215 (for LVDT recording displacement) made by National Instruments [35], which is shown in Figure 5 (L). The sampling rate of 25kHz has been used in this study. The data-logging software NI LabVIEW SignalExpress was used to record data from the data acquisition unit. Two high speed

cameras of up to 40,000 fps (frames per second) shown in Figure 5 (R) are used to record the damage process of the specimens from the front and back views. Both cameras were set as 1000 fps at its resolution of 640x512 pixels. Four halogen lights of 1500w were placed to provide intensive light to meet the requirement for capturing high speed images. The high speed camera was connected to a laptop on which commercial software MotionblitzCube was installed for managing the recording process.

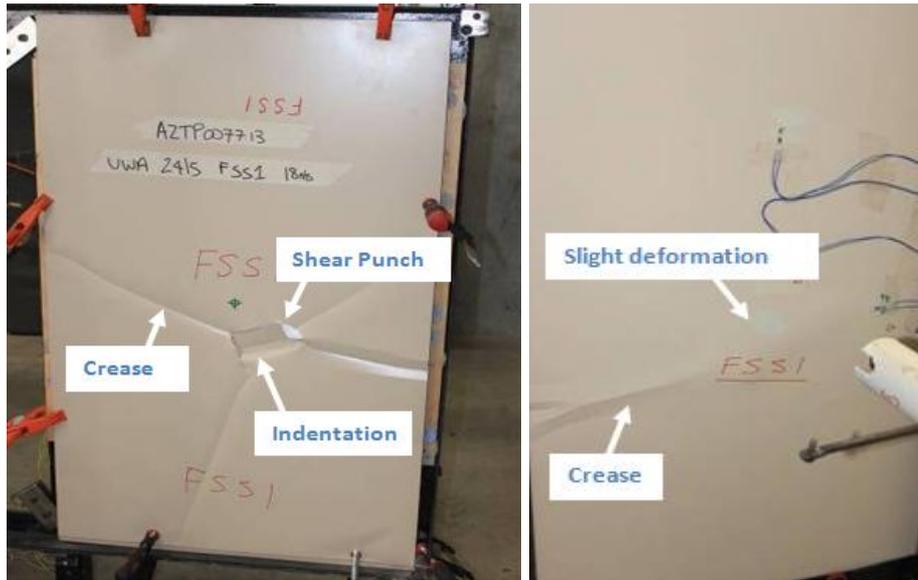
Figure 6 Photographs of specimen FSS1 (L) front view; (R) back view

Four specimens FSS1, FSS3, FSS7 and FSS8 rejected the projectile at the back skin with no complete perforation and opening. The rebound residual velocities of FSS1, FSS3 and FSS8 obtained from the high speed camera clips are -4.5m/s, -3.8m/s, -4.0m/s, respectively. The specimens FSS1, FSS3 and FSS8 experienced different levels but similar deformation and damage profiles as shown in Figure 6~Figure 9. The projectile impact resulted in indentation and shear punching on the front skin and deformation on the back skin. Creased lines (i.e. wrinkle) extending from the impact location to the G-clamps on edges were also observed on the both skins due to the intensive stretching. The major deformation on the back skin occurred around the impact location.

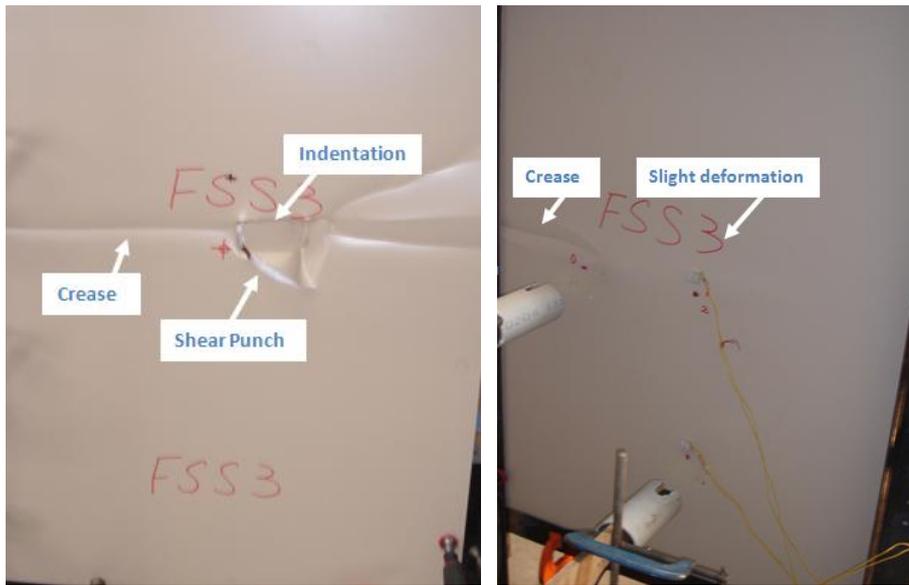
Figure 7 Photographs of specimen FSS3 (L) front view; (R) back view

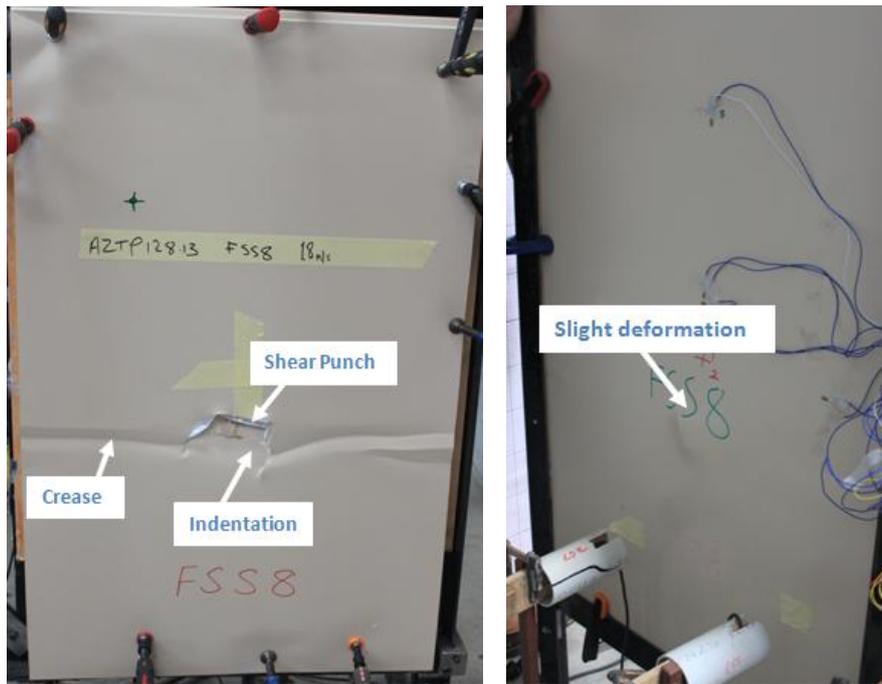
Figure 8 Photographs of specimen FSS8 (L) front view; (R) back view

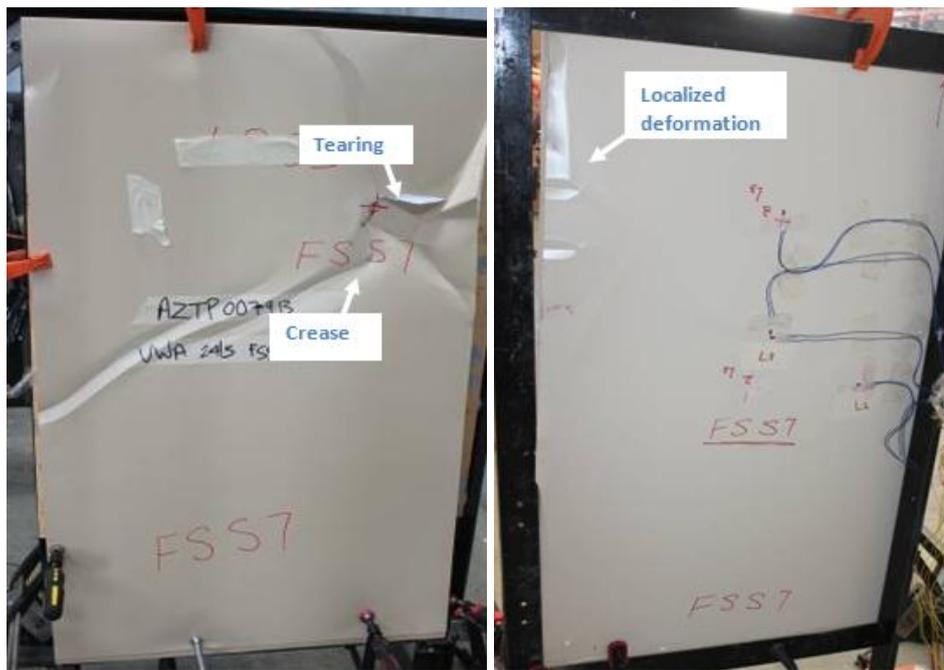
Figure 9 Photographs of specimen FSS7 (L) front view; (R) back view

To examine the effect of various impact locations on the panel's performance, the specimen FSS7 was impacted by the projectile at the quarter location while an identical panel FSS6 was impacted at the centre location by the projectile with the same impact velocity of 24 m/s. Specimen FSS7 rejected the projectile while FSS6 was perforated by the projectile. This is probably because the boundary of FSS7 was pulled out from the anchor by the impact force as shown in Figure 9. Damage of the panel boundary dissipated large amounts of impact energy, therefore alleviated impact energy to

penetrate into the panel. This observation indicates the significant effect of boundary conditions on the panel responses. However, it should be noted that damage of the boundary may also create an opening that makes the panel fail to meet the design requirement.

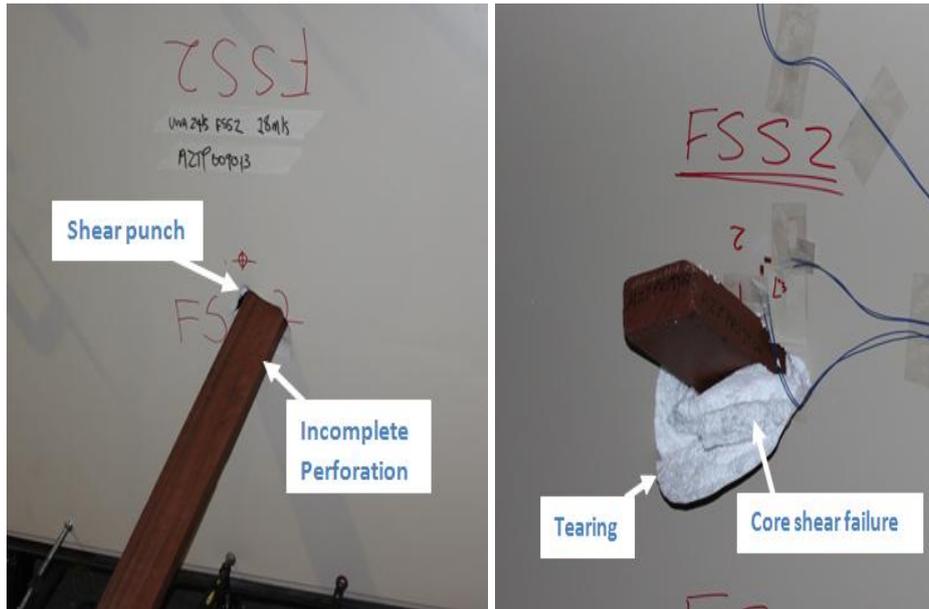
Figure 10 Photographs of specimen FSS2 (L) front view; (R) back view

As shown in Figure 10, the projectile pierced through but stayed in the specimen FSS2, which is the largest panel among all the tested panels. An initial rupture occurred at the impact area followed by tearing of the back skin. The tearing occurred when the shear strength of metal skin was exceeded. The projectile's kinetic energy was mainly absorbed by the deformation, tearing of the skins and core shear failure. As given in Table 2, the impact velocity is 18 m/s, which can be approximately considered as the velocity that just caused perforation of the panel since the projectile stayed in the panel. It is the velocity that separates the specimen FSS2 from "pass" to "fail" when it is impacted with a 4kg timber projectile.

To investigate the specimen size on the panel's performance, two specimens FSS1 and FSS2 with different sizes were tested. It can be found that specimen FSS2 with a doubled dimension than specimen FSS1 was perforated by the timber projectile while the specimen FSS1 survived the impact without perforation under a slightly smaller projectile impact velocity. This observation indicates that, as discussed above, penetration is a localized damage caused by brittle punching shear failure by projectile. When the projectile impact velocity is large enough to cause penetration, it absorbs significant amount of impact energy and the overall dynamic response of the panel is relative small. For the smaller panel FSS1, since the impact velocity is not big enough to cause perforation, the impact energy is therefore transferred to panel dynamic response. As a result the dynamic response of the panel (peak displacement and residual displacement, etc) is larger than that of panel FSS2 although it is stiffer than FSS2. By comparison with the damage modes of the two panels shown in Figure 6 and Figure 10, FSS1 developed obvious creased lines on both skins owing to large dynamic response which dissipated part of input energy, while no creased line was observed on panel FSS2 because penetration absorbed significant amount of impact energy.

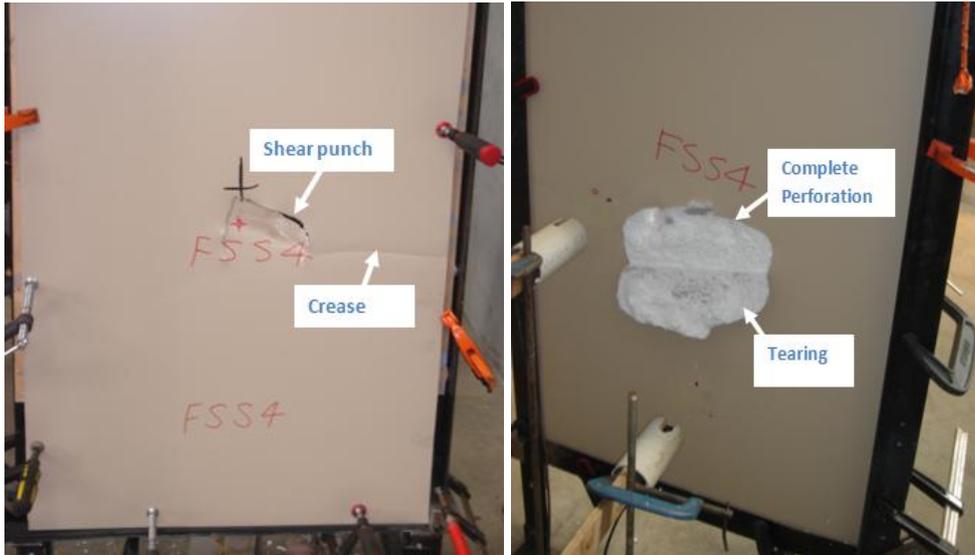
Figure 11 Photographs of specimen FSS4 (L) front view; (R) back view

Full length of projectile completely passed through three specimens FSS4, FSS5 and FSS6. As shown in Figure 11~Figure 13, the three specimens have similar damage and failure modes. The torn area of the front skin of the specimens FSS4 and FSS5 rebounds promptly after perforation. The specimen FSS4 with the total thickness of 50mm subjected to 26m/s projectile impact has a smaller opening size than the identical specimen FSS5 but larger projectile residual velocity when the impact velocity is 23 m/s, indicating more direct punching shear damage of the panel when impact velocity is higher. The specimen FSS6 with a thicker total thickness of 75mm has a smaller residual velocity but larger opening size and more severe damage than the specimen FSS5, which means more kinetic energy has been absorbed by the dynamic response of specimen FSS6.

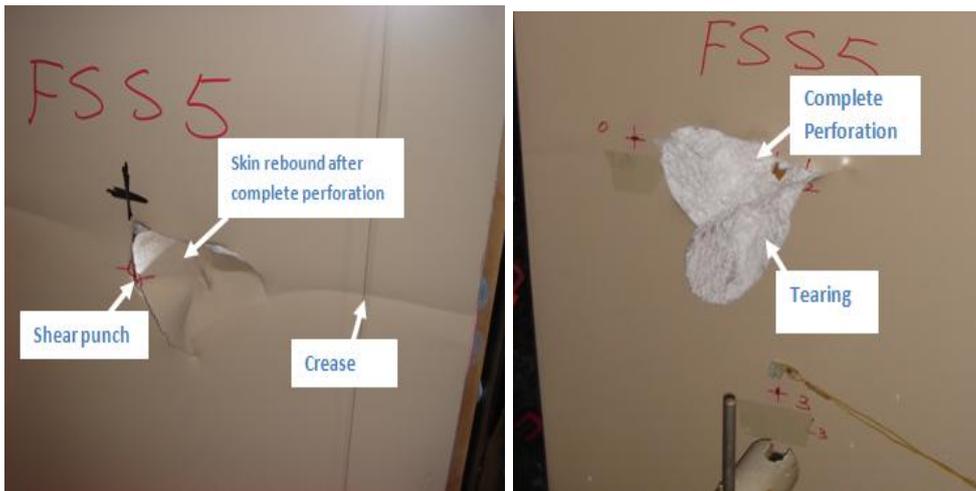
Figure 12 Photographs of specimen FSS5 (L) front view; (R) back view

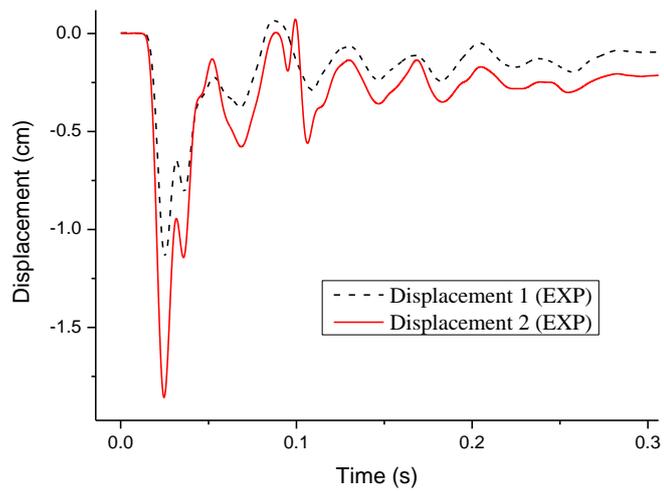
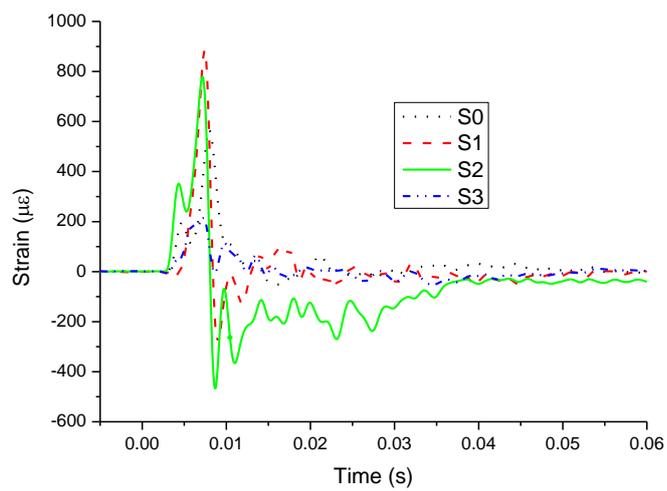
Figure 14 Specimen FSS6 (L) Displacement-time histories; (R) Strain-time histories

The specimen FSS6 experienced 1.8cm peak displacement and 0.35cm residual displacement at the center point on the back skin, as shown in Figure 14 (L). It is found that there is oscillation of the support frame during impact. Unfortunately, no LVDT sensor was placed to measure the vibration time history of the frame. To correct the measured displacement response of the panel, the high-speed camera images were analyzed. It was found that the peak frame displacement was about 0.3 cm. Therefore, the peak displacements are deducted by the oscillation of the support frame, which is around 0.3cm. The corrected results are summarized in Table 2. It should be noted that this correction is only approximate because the frame and panel responses are not necessarily exactly in phase. It is also observed that the specimens FSS1/FSS3/FSS7/FSS8 without perforation have larger residual deformation than others that the projectile penetrated through the panel. This is because larger portion of kinetic energy from the impact was taken by the skins' deformation of specimen if perforation did not occur. Figure 14 (R) shows the strain time histories of specimen FSS6 after projectile impact. It can be seen that there are almost no residual strain in the four strain gauges, indicating elastic deformation in the back face metal skin. Higher peak strains around $900 \mu\epsilon$ and $800 \mu\epsilon$ were measured by strain gauges S1 and S2 at the centre close to the impact location. Peak strains of $570 \mu\epsilon$ and $200 \mu\epsilon$ were captured by strain gauge S0 and S3. It should be noted that the strain gauges did not always give good measurements in the tests because some strain gauges were disconnected from the specimen due to the intensive impact load. It should also be noted that all the measured strains are relatively small, indicating small deformation at the back skin even perforation occurs. This is because perforation is a local failure of the panel owing primarily to punching shear damage. This also explains why the residual displacement of the panel is larger if the projectile did not penetrate through the panel

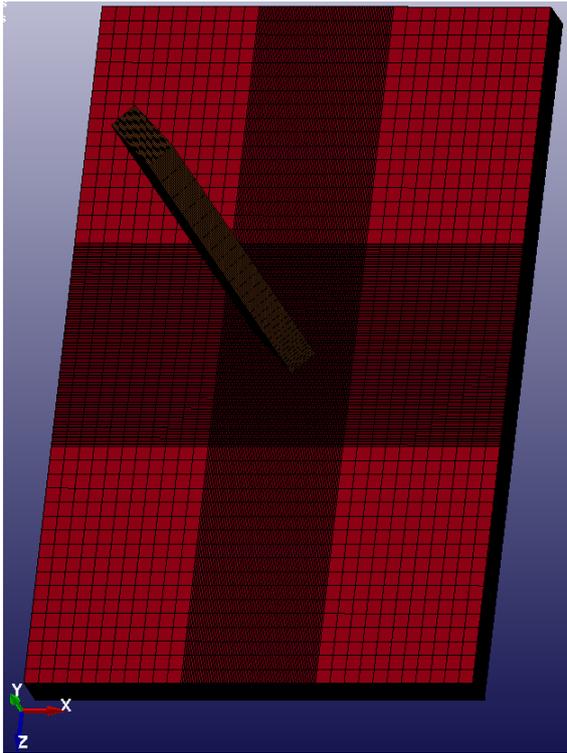
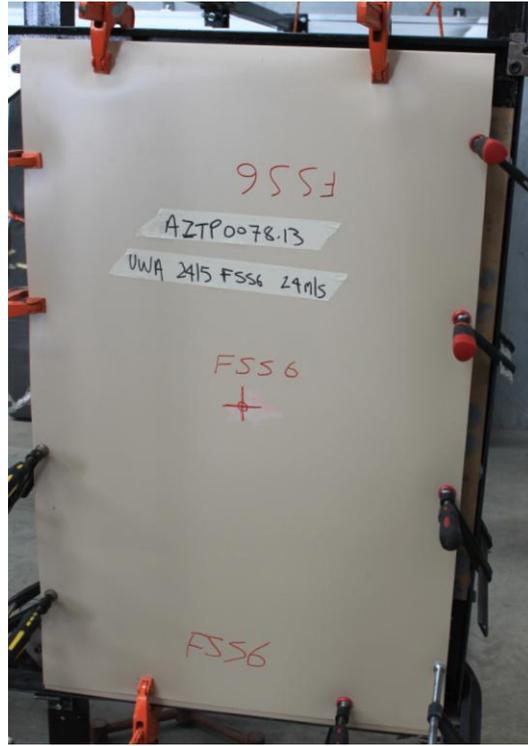
Figure 15 (L) Numerical model; (R) Experimental setup

The numerical models are created by using commercial software ANSYS and LS-PREPOST. The finite element model of the specimen is depicted in Figure 15 (L). The Belytschko-Tsay shell element [36] is used to model the both skins. The shell element with 5 integration points overcomes the lack of elements through the thickness direction. EPS core is meshed by using eight node solid element with single integration points (i.e. ELFORM=1, constant stress solid elements) to overcome the negative volume, which is prone to happen in full integration elements. To avoid the negative volume, hourglass control with assumed strain co-rotational stiffness form (i.e. IHQ=6) is used. The

Properly modeling the boundary condition is critical to achieve the reasonable numerical result. In this study, the specimen was clamped on the support frame by using G-clamps along four sides. In the numerical model, to reduce the modeling effort the specimen is assumed constrained on the three DOFs of UX, UY and UZ at the four edges by using *BOUNDARY SPC SET, closely approximating the boundary conditions in the test.

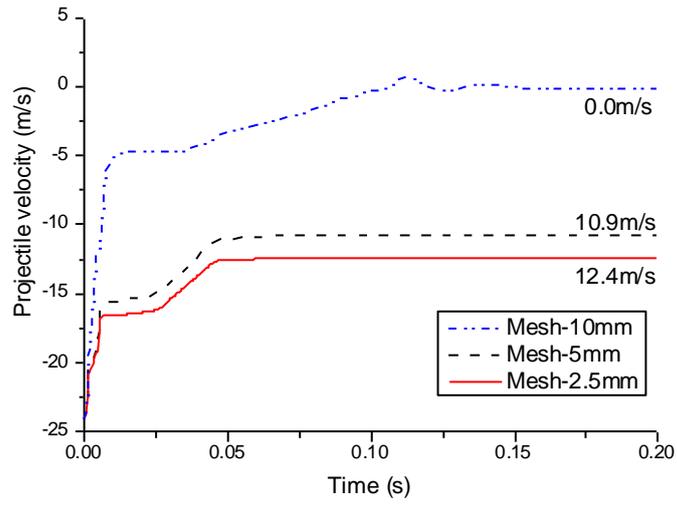
Figure 16 Residual projectile velocity time histories obtained with different mesh sizes

The simulation result is sensitive to mesh size. In general, finer mesh size yield more accurate results but increases the simulation time. Convergence study is carried out by halving the mesh size. Three element sizes of 10mm, 5mm and 2.5mm are used in the region of impact where dense elements are applied as shown in Figure 15. Other region uses 10mm mesh size. As shown in Table 3 and Figure 16, numerical results show the predicted residual projectile velocity by using 10mm mesh size is underestimated while both 5mm and 2.5mm yield close results to the actual projectile residual velocity of 10m/s recorded in the test. Further reduce mesh size only has insignificant influence on numerical results but leads to a substantial increase in computational time. To save calculation time, 5mm mesh size is utilized in the dense area in the subsequent simulations.

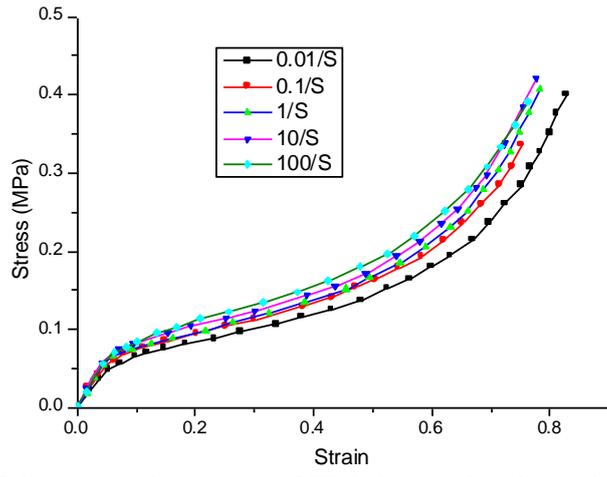
Figure 17 Stress-strain curves of EPS foam (density 16kg/m^3) [40]

EPS is a material with complex behaviors under stress. The compressive stress-strain curve of EPS can be divided into three zones, i.e. elastic region, plateau compaction region and densification region. It has been found that density affects the mechanical properties of EPS. With the increase of density, compressive elastic modulus and yield strength increase. Therefore, the material constitutive models should be selected appropriately. In LS-DYNA[39], there are some material models available

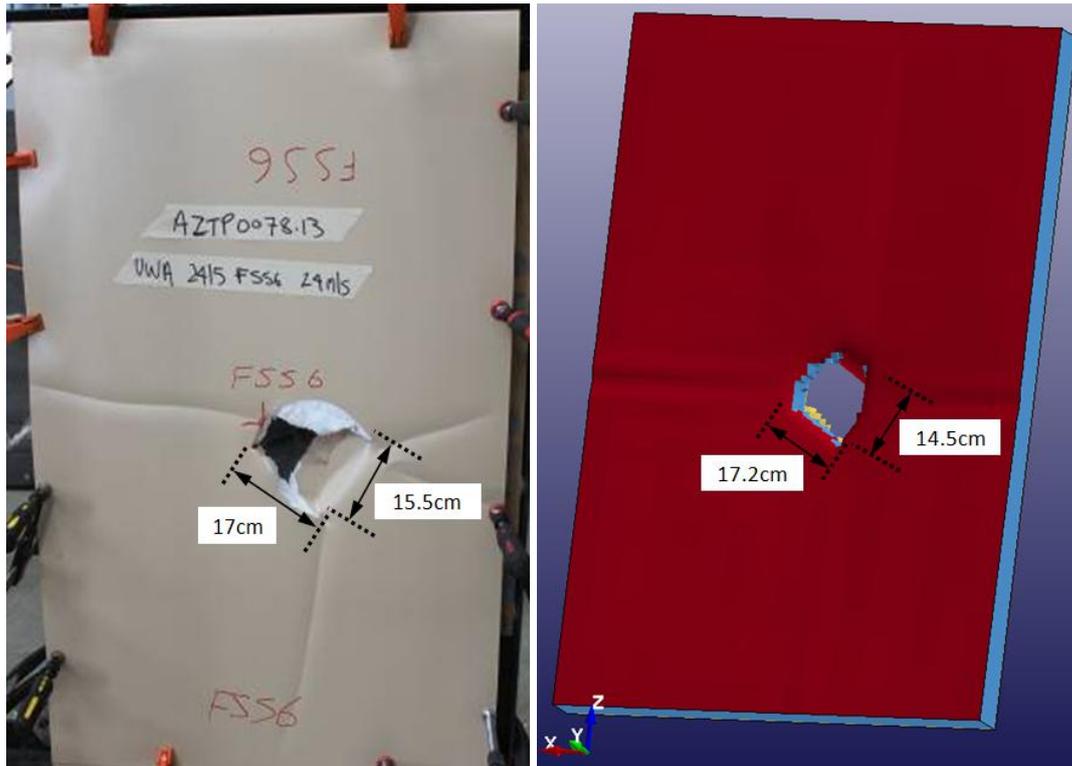
Figure 18 Opening size after testing (front view)

Figure 18 shows the numerical prediction of damage mode of specimen FSS6 after the projectile

impact. The opening size obtained in the numerical analysis is 17.2×14.5 mm, comparable to 17.0×15.5 cm obtained in the experimental test. The LVDT measures time histories of two locations. The residual velocity retrieved from the numerical results is 10.9 m/s which is closed to 10.0 m/s measured in the test.

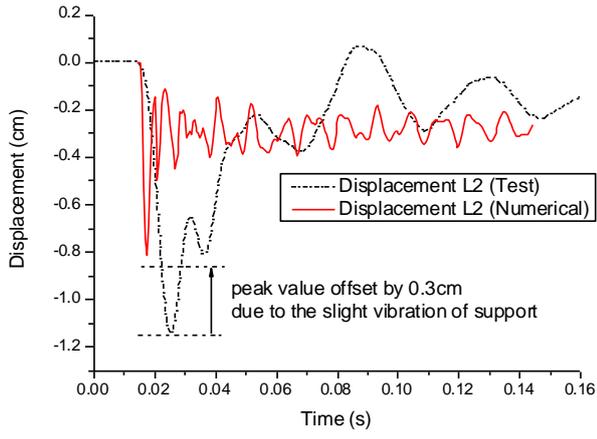
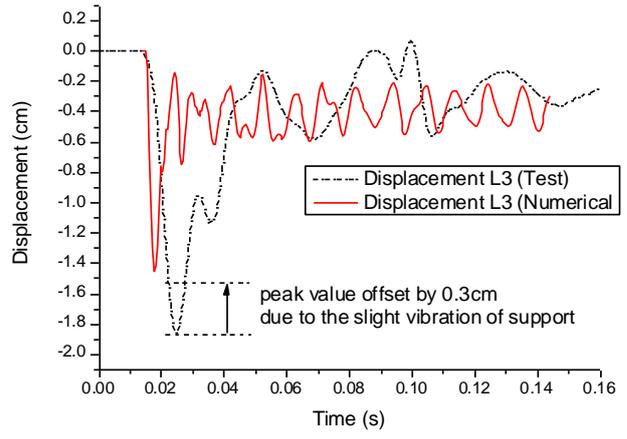
(a) (b)
Figure 19 Comparison of displacement-time histories from numerical simulation and experimental test of specimen FSS6 (a) Location L2; (b) Location L3

Figure 19 shows the comparison of the experimental and numerical displacement time histories at two locations for specimen FSS6. It should be noted that, as discussed above, during the test, small vibration of the supporting frame was observed. The LVDT measured peak panel displacements were thereby deducted by 0.3 cm of the support frame displacement. It should be noted that this correction is only approximate since the frame vibration was not necessarily in-phase with the panel vibration. Unfortunately the frame vibration was not measured in the test. Table 5 compares the predicted and the measured maximum displacements. The errors at the two measurement locations are about 5.9% and 6.5%, respectively. Numerical simulation also gives good predictions of strain time histories at the four locations as shown in Figure 20. As given in Table 6, the differences of the peak strains of the four strain gauges are around 11.7%, 9.6%, 10.8% and 0.9%, respectively. These errors are considered small and acceptable because of the unavoidable numerical errors. Through comparison of numerical results and testing results, it can be concluded that the numerical model gives reasonably accurate predictions of the panel responses to the projectile impact. The calibrated numerical model will be used to calculate the penetration resistant capacity of the panel subjected to windborne debris impact.

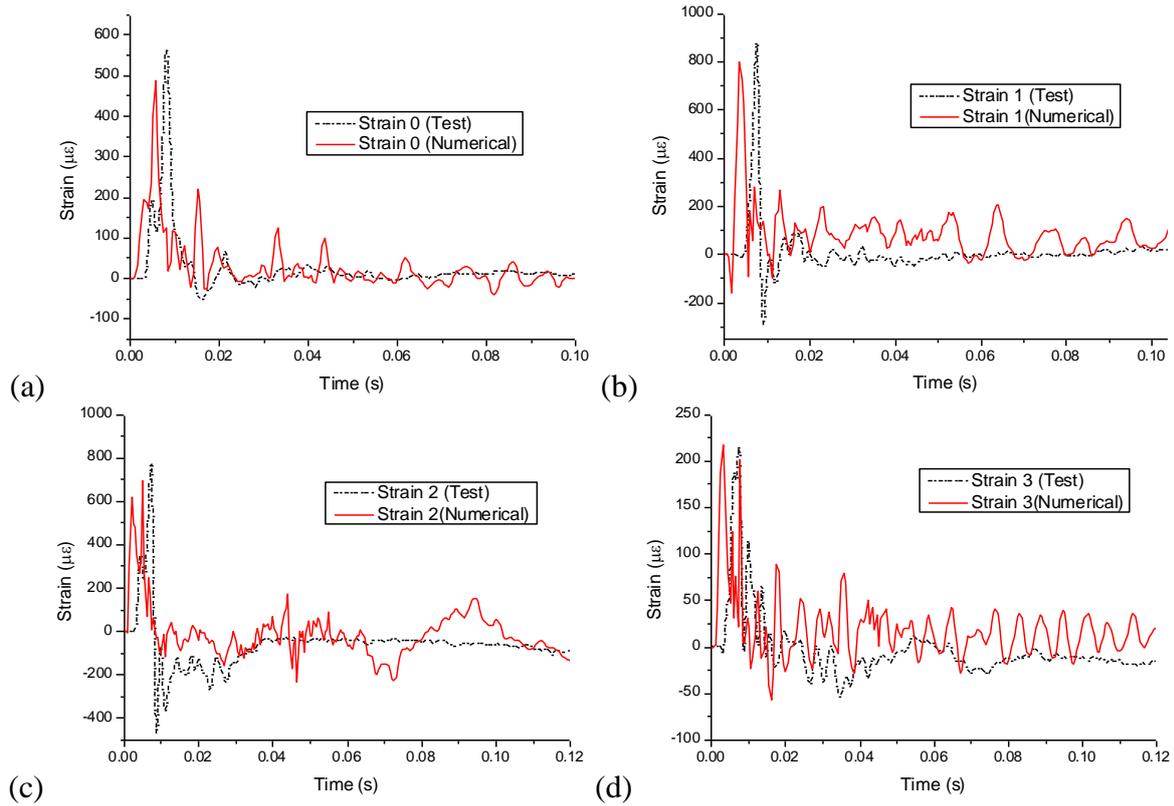
Figure 20 Comparison of strain-time histories from numerical simulation and experimental test of specimen FSS6 (a) Strain 0; (b) Strain 2; (c) Strain 3; (d) Strain 4

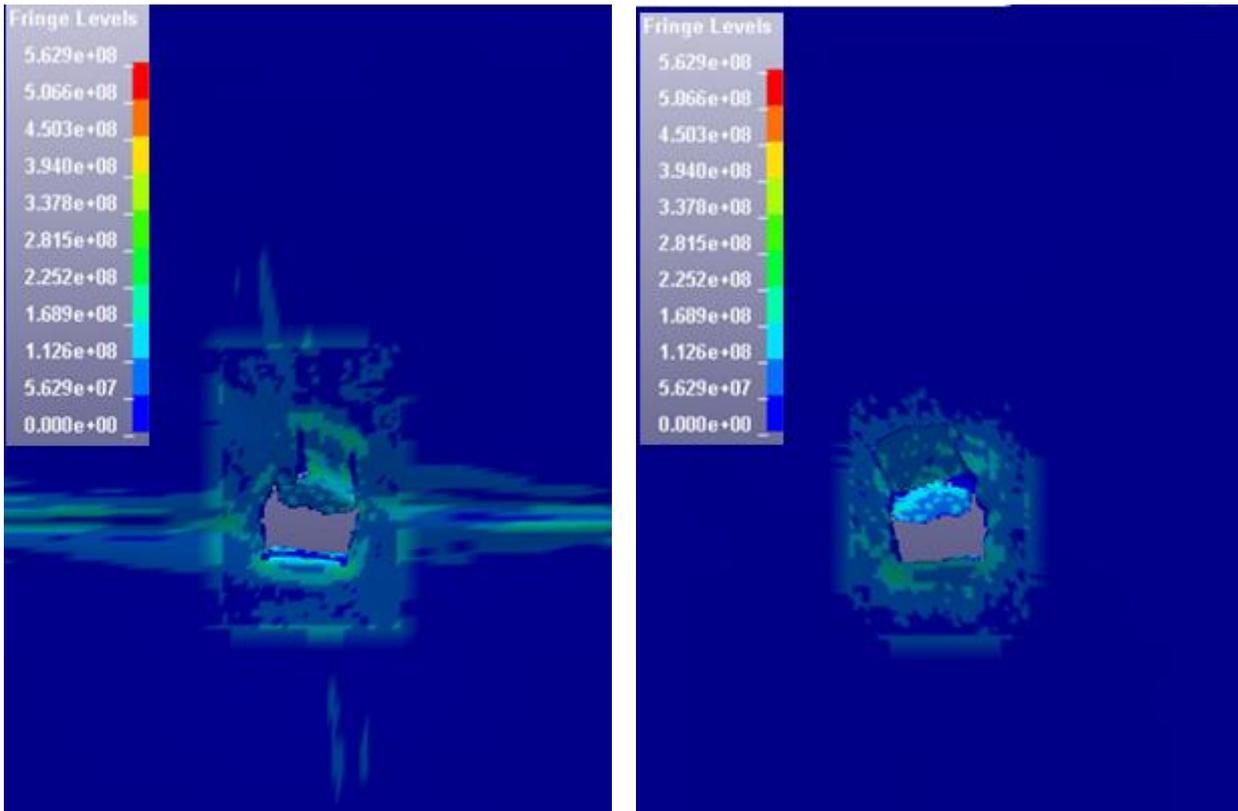
Figure 21 Von mises stress (L) Front view; (R) Back view

Figure 21 shows the Von mises stress distributions in the both skins. It can be seen that high stress occurs around the perforated hole on both skins. High stress also appears along the latitude line of the front skin due to the intensive stretching. As shown in Figure 22, the kinetic energy of 1152 J from the projectile was reduced to 276 J after penetration. The input energy from the projectile is absorbed in the forms of the penetration and deformation of the core and the two skins, as well as the vibration of the panel and the support frame. Table 7 shows the partitions of energy absorption by the skins and EPS. The two skins and the EPS core respectively absorb 19.9% and 32.6% of the total

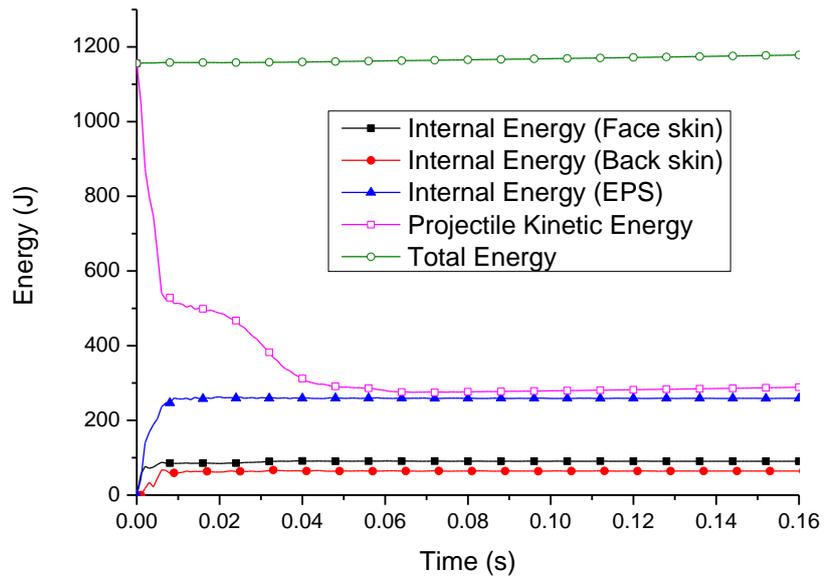
Figure 22 Time history of energy absorption

energy in the forms of deformation, rupture and shear damage. The sliding energy dissipated by the friction action also accounts for 22.2% of the total absorbed energy. The numerical simulated impact force time history by the projectile is shown in Figure 23. The projectile impacting the front skin results in a peak force around 15kN. The second peak of 11.9KN occurs when the projectile hits the back skin.

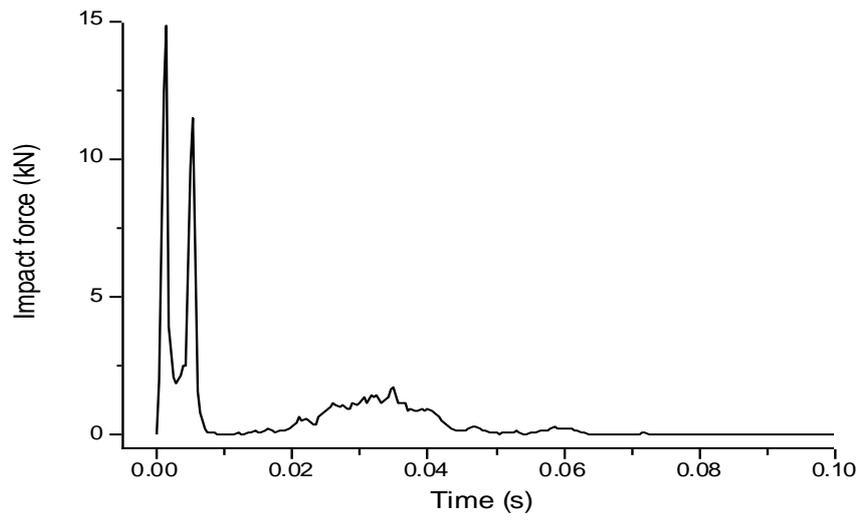
Figure 23 Impact force time-histories

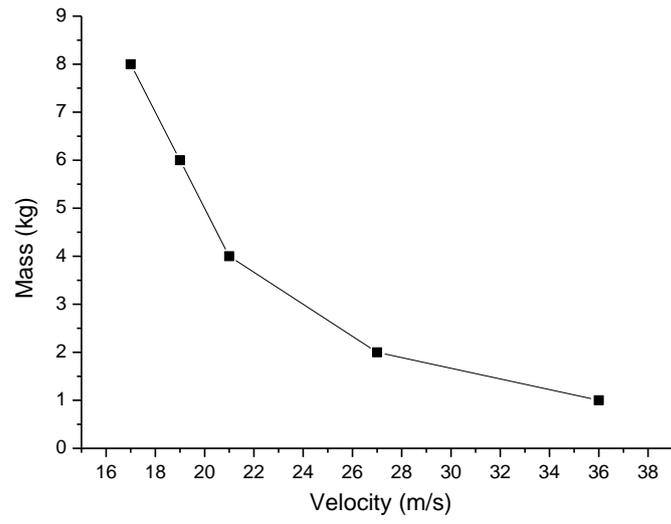
Figure 24 Panel penetration vulnerability curve

As shown in Figure 24, a perforation vulnerability curve is created with respect to projectile mass and impact velocity. The occurrence of perforation of the panel is divided by the curve. No perforation occurs when the combination of velocity and mass is on the left and below the curve while perforation occurs when it is on the right and above the curve. With higher velocity and larger mass,

the debris is more likely to penetrate the panel as expected. This vulnerability curve might be useful for the assessment and design of the composite SIP against the windborne debris impact.
