ESTIMATION OF DYNAMIC LOAD DEMAND ON A GROUND SUPPORT SCHEME DUE TO A LARGE STRUCTURALLY CONTROLLED VIOLENT FAILURE – A CASE STUDY

Christopher Drover, Ernesto Villaescusa

Western Australian School of Mines, CRC Mining, Curtin University

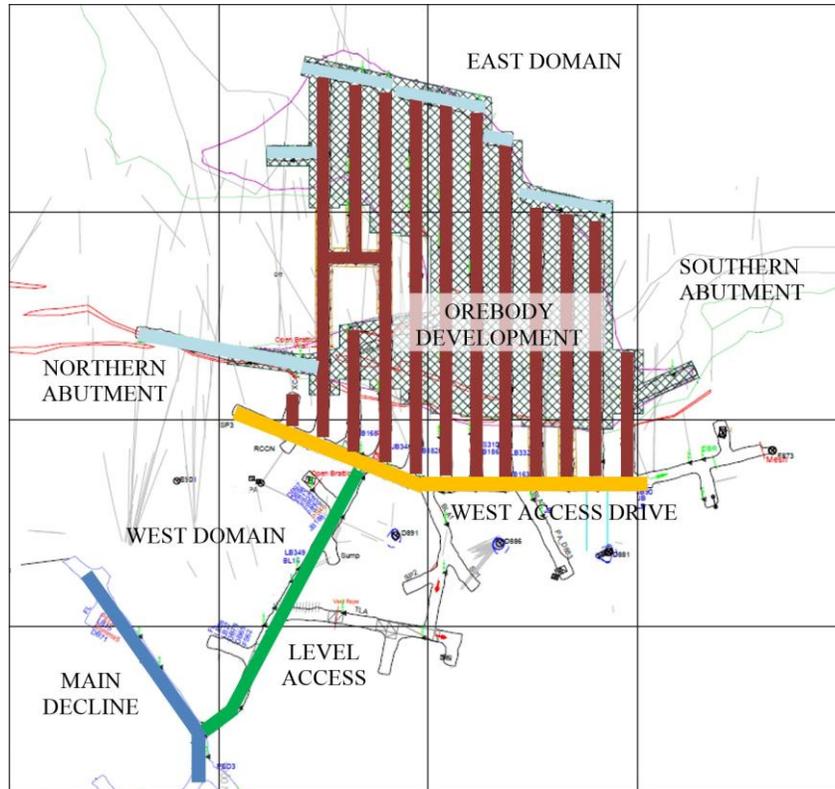
At this operation the permanent infrastructure such as material haulage drives, shaft and main decline are all located in the west domain of the orebody within a high strength rock mass (Figure 1). Production level access development is also located in the west domain. The orebody is extracted via transverse caving and is approximately 150 metres wide along strike and 200 metres wide across strike. A narrow mineralised limb extends some 90 metres north of the primary cave zone and this is also caved (Figure 1). The full width of the cave zone is therefore approximately 240 metres parallel to strike. This dimension is sub-perpendicular to the orientation of the pre-mining major principal stress and therefore the process of caving the orebody induces considerable alteration of the stress field.

Figure 1 - Plan view of mining infrastructure (grid 100m).

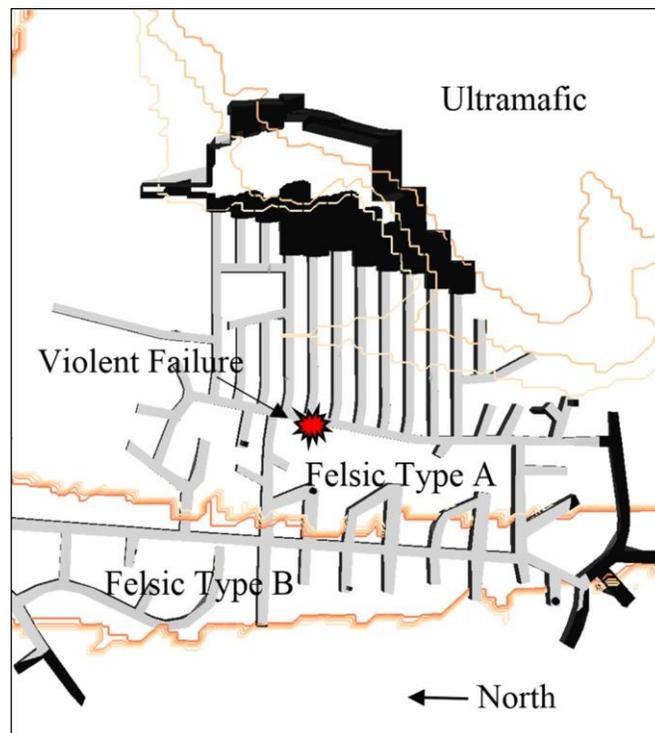
The mine may be broadly subdivided into east and west geological domains. The east domain consists of a mineralised ultramafic sequence where the dominant rock mass failure behaviour is a non-violent, time dependent convergence. The waste rock of the west domain is a felsic type prone to sudden violent failure due to its inherent material properties of strength and stiffness. This rock type was host to a severe case of excavation damage caused by a violent rock mass failure and so forms the focus of this discussion. West domain felsic rock types include metabasalts, metasedimentary schists, metavolcaniclastic schists and plagioclase-quartz porphyries. Although these rock types fall under the felsic categorisation, the material properties of the types are sufficiently diverse to cause varying mechanical reactions between the units. The boundaries of rock types relevant to the mining level where violent failure occurred are shown in Figure 2.

Figure 2 - Rock type boundaries where failure occurred.

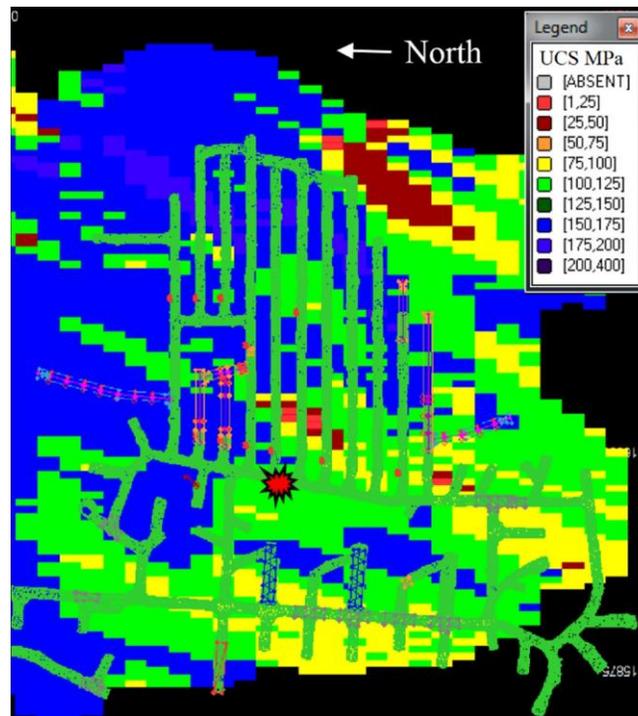
This failure case study occurred in the central west domain of the orebody in the west access drive. The variability in rock strength surrounding the failure location is shown in Figure 3. The failure was located in a felsic rock mass with a UCS ranging from 100-125MPa. Figure 4 presents typical diamond drill core of felsic material. Note the contrast between intact core samples and a discrete fracture zone at 59.2m representing a local geological structure. Such structures are common sources of seismic activity in the west domain of the mine. Material properties of the felsic rock types have been compiled via laboratory strength testing of core samples. A summary of rock properties relevant to the failure site are presented in Table 1.

Figure 3 - UCS (MPa) block model for the mining level where violent failure occurred.

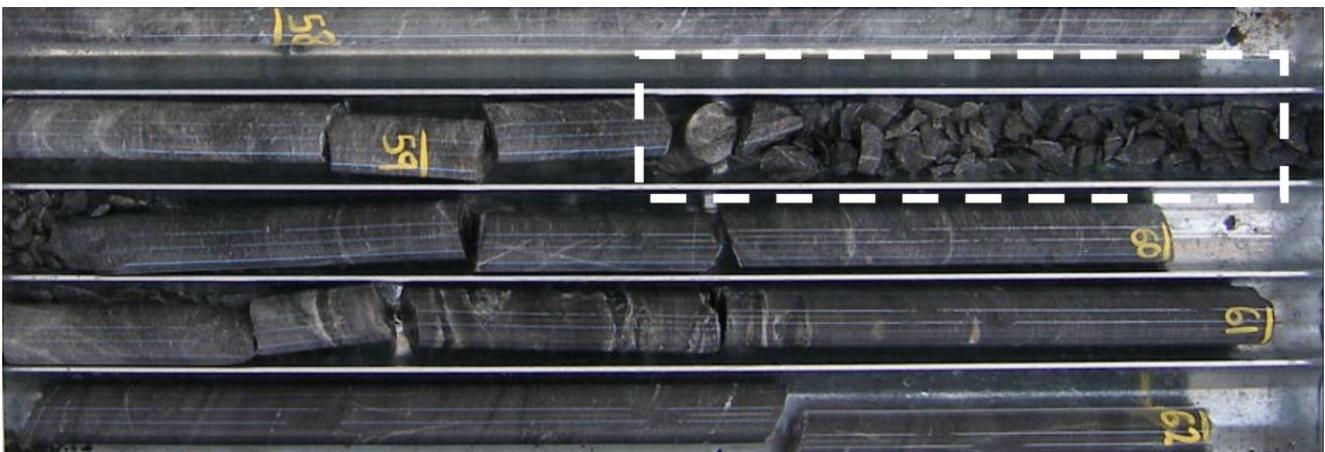
Figure 4 - Felsic drill core from the west domain showing intact rock and the effect of local geological structure.

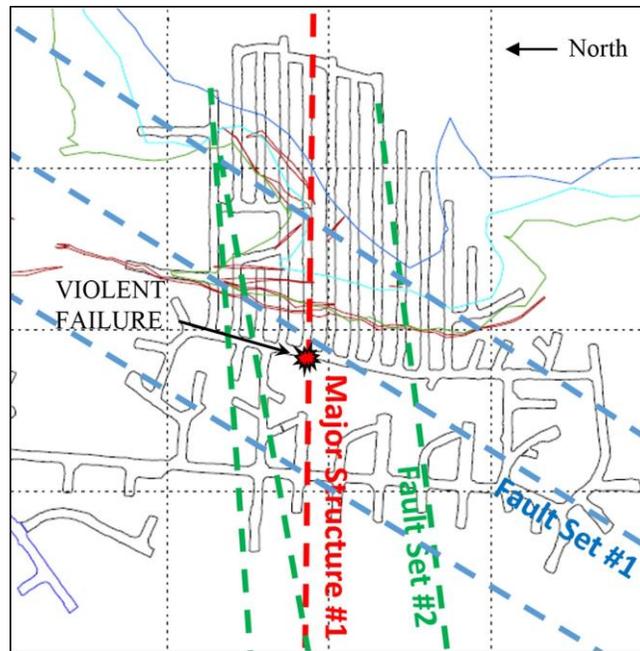
Over the course of several years a number of significant geological structures have been identified within the mining precinct as having an increased potential to generate sudden violent events. This conclusion is drawn on the basis of recorded fault-slip seismic activity coincident with these structures and associated ground support damage where these structures intersect excavations. A map of these structures is shown below in Figure 5.

Figure 5 - Plan view sketch of mine development, basic geology and significant seismically active structures with respect to the location of violent failure.

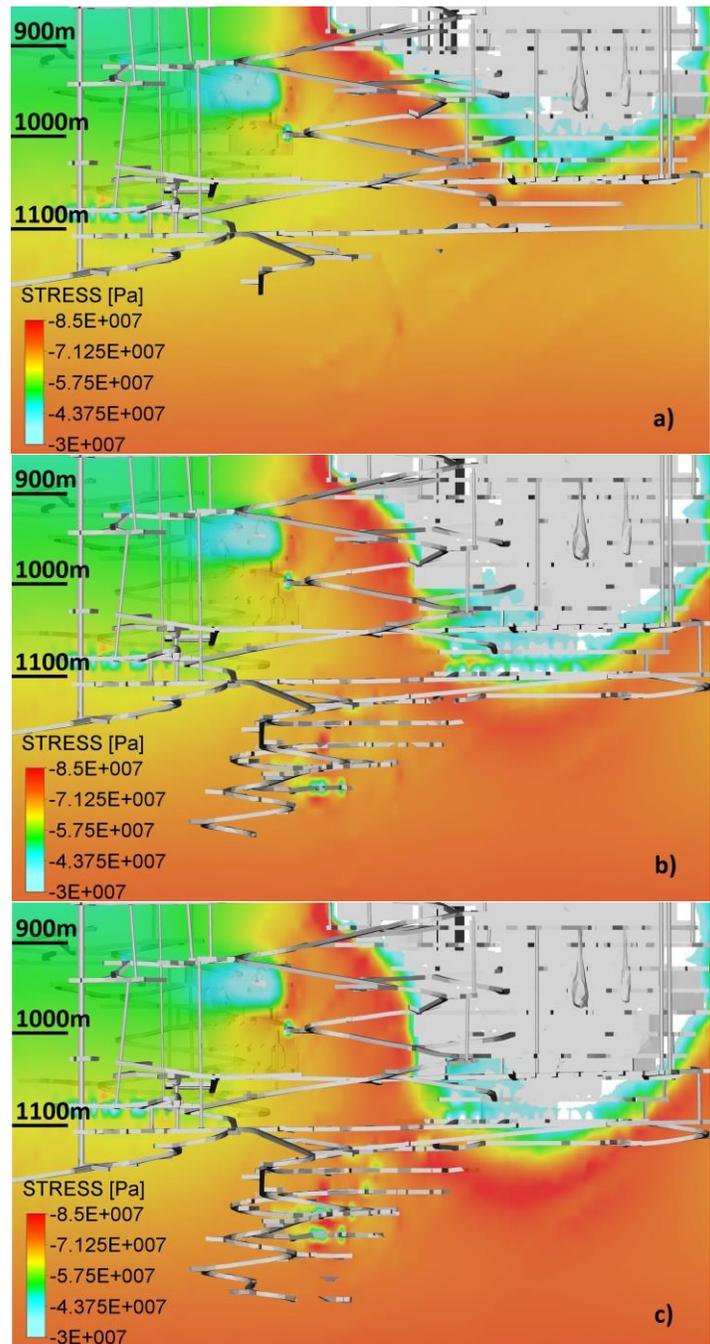
This process is illustrated by non-linear finite element modelling shown in Figure 6 as a series of long section views of the lower mine workings. These figures demonstrate how the process of stress redistribution around the cave controls the loading conditions to which development excavations are subjected. These zones of high rock mass loading generate seismicity and may be offset by several tens of metres from the cave due to stress shadowing effects and local zones of yielded ground around the perimeter of the cave.

Figure 6 - Long sections of modelled major principal stress showing increasing stress concentrations in the cave abutments for three cave extraction steps.

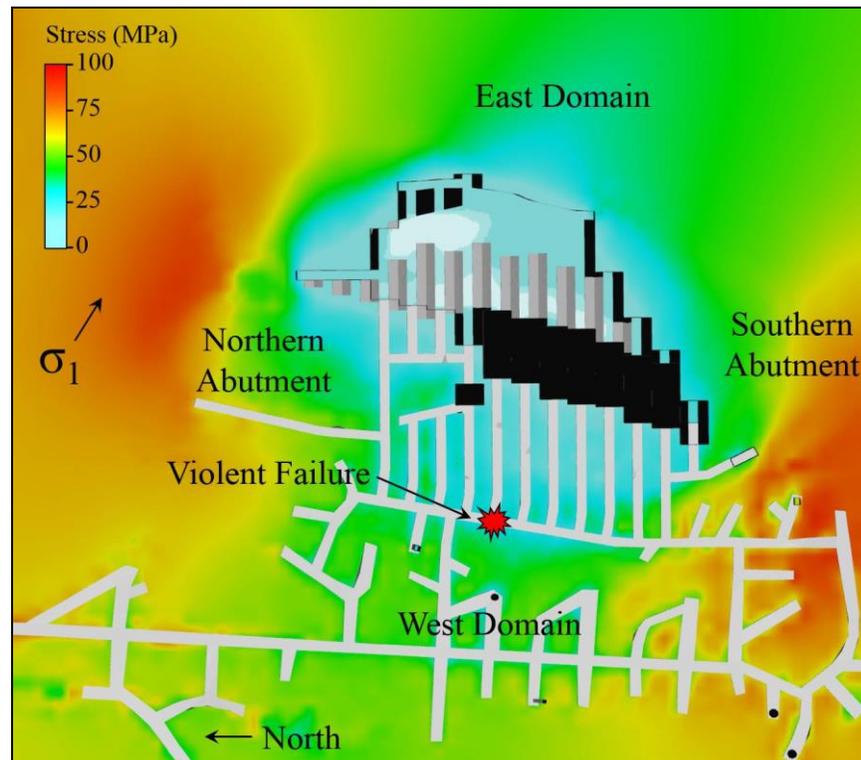
Further detail on the stress concentration around the cave is shown below in Figure 7. This figure is a horizontal section view of stress modelling results taken at a depth of 1055 metres below surface and coincides with the geometry of the cave at the time of violent failure. These results illustrate how the strike width of the cave has a significant influence on the location and magnitude of the concentrated stresses. Note that this figure illustrates an established production level approximately 45 metres above the orebody inflection and therefore does not show the lower abutment stress conditions. The location of the most severe excavation damage was in an area predicted to be subject to relatively low mining induced stress of 40MPa. This may be explained as a structurally controlled mechanism of failure, rather than a stress driven mechanism, as explained later.

Figure 7 – Plan view of modelled mining induced stress around the cave at the time of violent failure, taken at a depth of 1055m.

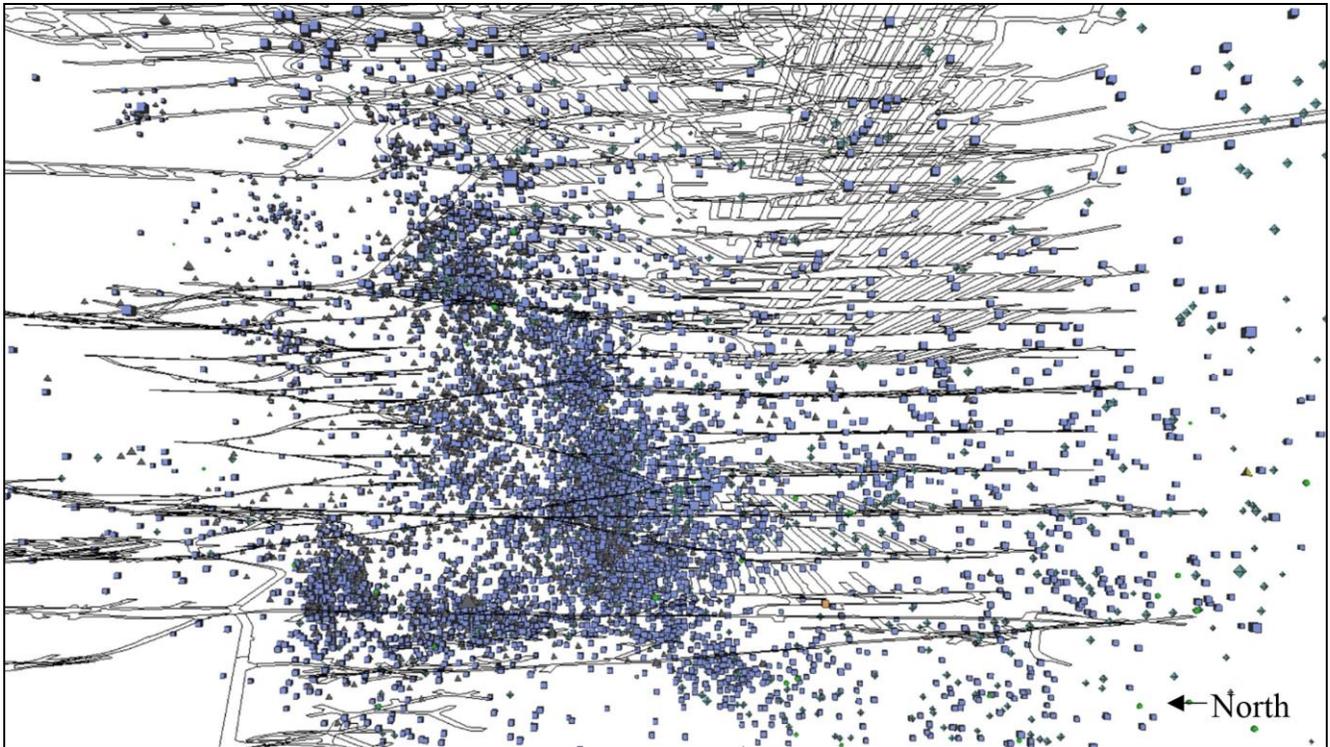
The consequence of these heavily concentrated stress conditions is elevated seismic activity. Seismicity in the northern abutment of the cave over a period of 48 hours following a mine scale instability event is illustrated in Figure 8. The shape and position of the seismogenic zone caused by this failure coincides with areas of very high stress concentrations predicted by the non-linear numerical modelling. As the cave approached the structural inflection of the orebody, 1100 metres below surface, the stresses beneath the cave began concentrating above the critical threshold of rock strength capable of sustaining these loads without large scale failure. This led to an increase in the frequency and magnitude of large events as the cave was extracted deeper towards the inflection.

Figure 8 - Seismogenic zone in the northern cave abutment following a large dynamic failure.

For the purpose of the failure source analysis the point dataset of seismic parameters from the population of events shown in Figure 8 have been interpreted using 3D data visualisation software. Zones of inferred rock mass damage shown in Figure 12 are contoured and coloured according to the radiated seismic energy, as per the inset scale. Areas enclosed by higher contours indicate the zones where the rock is considered likely to have yielded and shed load bearing capacity. It is necessary to note that this analysis considers point data of recorded seismicity. As the seismic sources are volumes, the representation of the volume distribution of rock mass damage may be underestimated by this method.

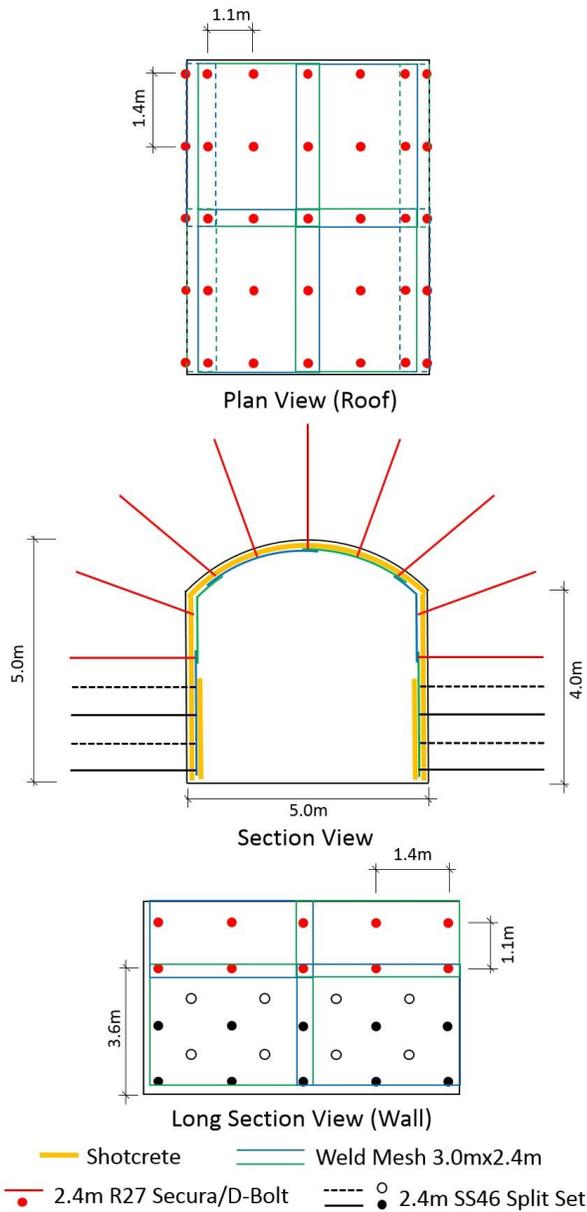
The excavation shape and installed ground support schemes relevant to this case study are shown in Figure 9 and Figure 11. These figures illustrate a section view of the entire ground support scheme, the plan view of reinforcement and mesh surface support installed in the roof of the excavation and a long section view of the wall reinforcement and mesh arrangement up to the shoulder height. The scheme depicted in Figure 9 is used in west domain development where medium energy demands (Villaescusa, et al., 2014) of 5-15kJ/m² are expected, such as level accesses, materials handling drifts and the main decline. The scheme consists of the following components, as illustrated:

Figure 9 - Excavation shape and ground support scheme for conditions of medium energy demand.

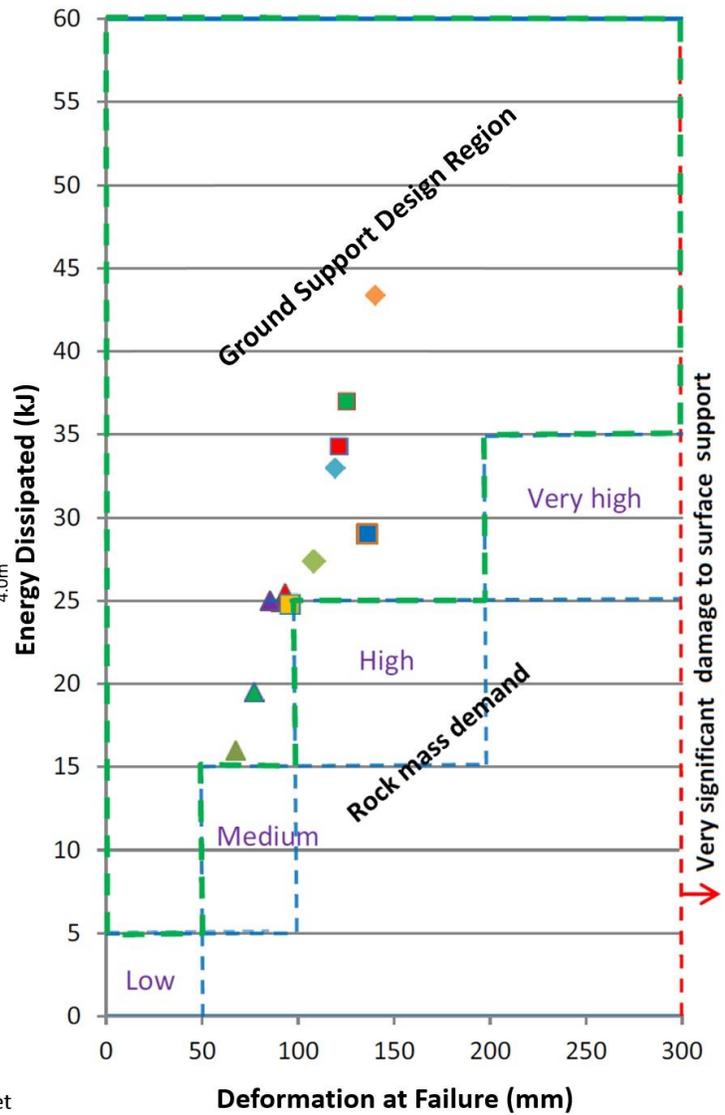
Figure 10 - Energy dissipated versus deformation at failure for combined schemes of rock bolts and mesh tested at WASM.

The energy dissipation capacity of the ground support scheme installed in this failure case study can be estimated by comparing the design with the results of combined bolt and mesh schemes tested at the WA School of Mines (Figure 10). The test schemes consisting of 20mm diameter, cement grouted, continuously mechanically coupled threaded bar and 5.6mm gauge weld mesh have been referenced as the most relevant for energy dissipation comparison. This is considered to be a conservative comparison due to the higher expected dynamic capacity of the 27mm diameter Secura bar, which was installed at the failure site. An adjustment of +2kJ/m² is made to the test results in order to account for the additional capacity provided by fibre-reinforced shotcrete, which was not included in these combined test schemes.

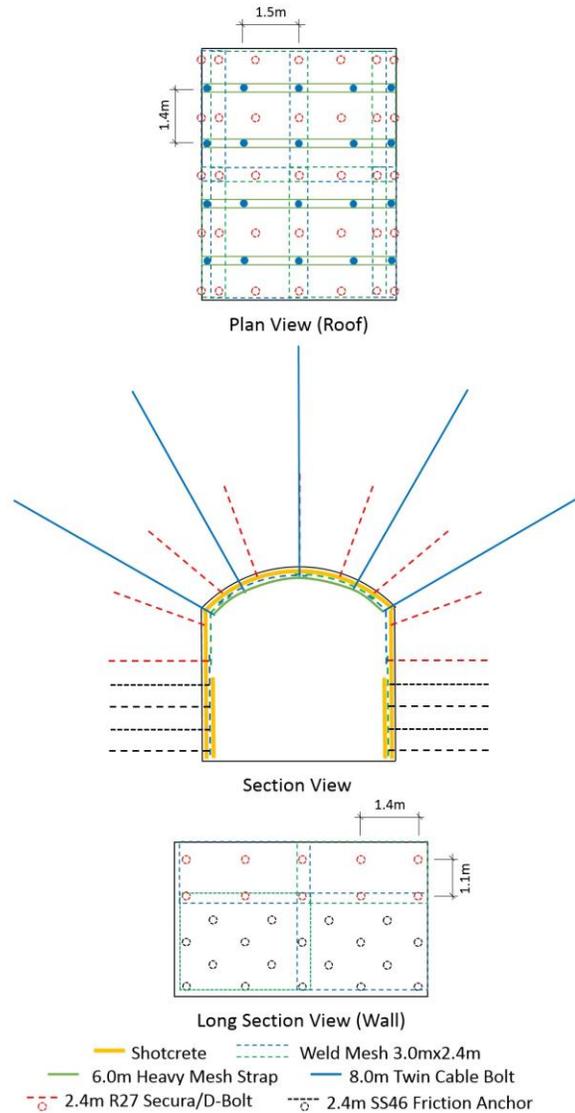
In addition to the standard scheme, an upgraded roof support scheme was installed due to high to very high rock mass demand expectations of 15-35kJ/m². This upgraded scheme is generally installed within the zone of high stress concentration in the west domain and wherever development is known to intersect any major geological structure which exhibits potential to generate dynamic loading demands within the aforementioned demand range. The scheme is illustrated in Figure 11 and consists of a 6.0m long by 0.3m wide heavy gauge mild steel mesh strap installed in a transverse orientation across the roof of the excavation. These straps were secured at 1.5 metre intervals using 8 metre long, twin plain strand cable bolts. Spacing between straps is 1.4 metres.

Figure 11 - Second pass upgrade ground support scheme for deep development with 15-35kJ/m² demand. First pass ground support scheme is represented by dashed lines.

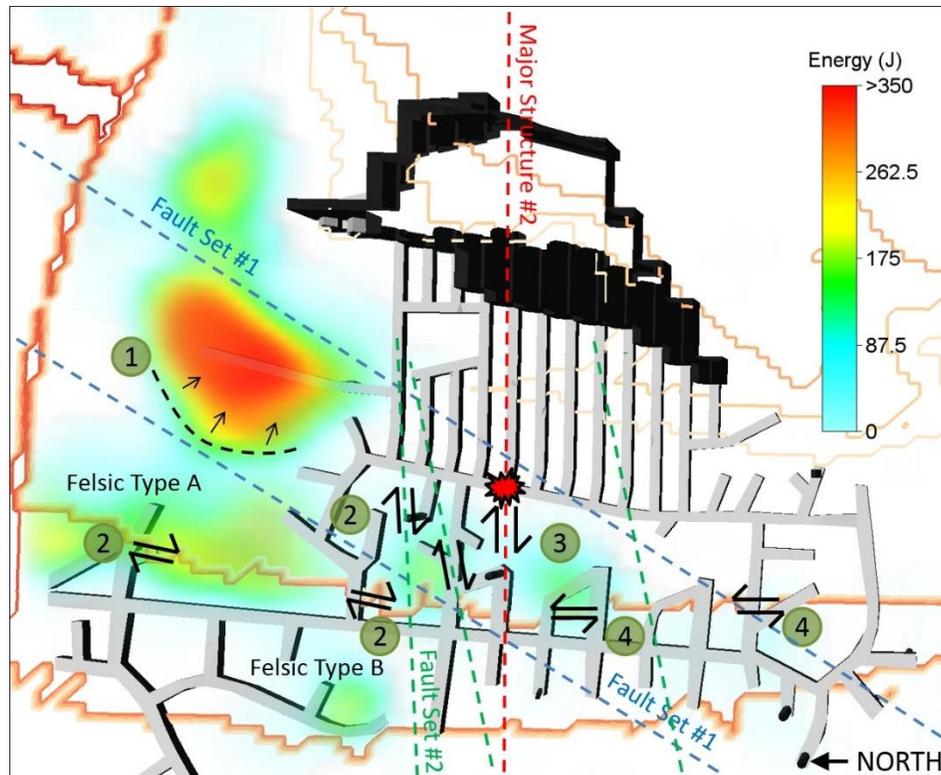
A sketch of the interpreted global mechanism of failure is shown below in Figure 12. The sketch is centred on the mining level where this case study of violent failure occurred, as shown in previous figures of rock structure and stress. The interpreted sequence of rock mass reactions during the failure are discussed as follows and numbered chronologically in Figure 12.

- 1) The northern abutment fails under compression due to concentrated stress and low confinement to the southeast due to the cave. A dislocation surface likely opened along a member of Fault Set #1, with the rock mass precinct east of this structure being displaced to the southeast. No excavation damage can be directly attributed to this process, despite workings coincident with the source of seismicity.

- 2) Load is transferred from the failing northern abutment to adjacent areas. Felsic boundaries and Fault Set #2 structures in the west domain are heavily loaded as a result, causing local sites of energy release on these features. Ground support damage occurs where features intersect mine excavations.

- 3) Major Structure #1 is heavily loaded due to the reactions of adjacent felsic rock types and structures in the west domain. Rapid accumulation of shear strain energy occurs on this structure as a result, causing highly localised ruptures where intersecting mine excavations.

- 4) Further loading reactions occur along the felsic boundary to the south of Major Structure #1, but only minor damage was observed.

Figure 12 - Failure mechanism sketch showing radiated seismic energy (inferred rock mass damage) and interpreted structural reactions.

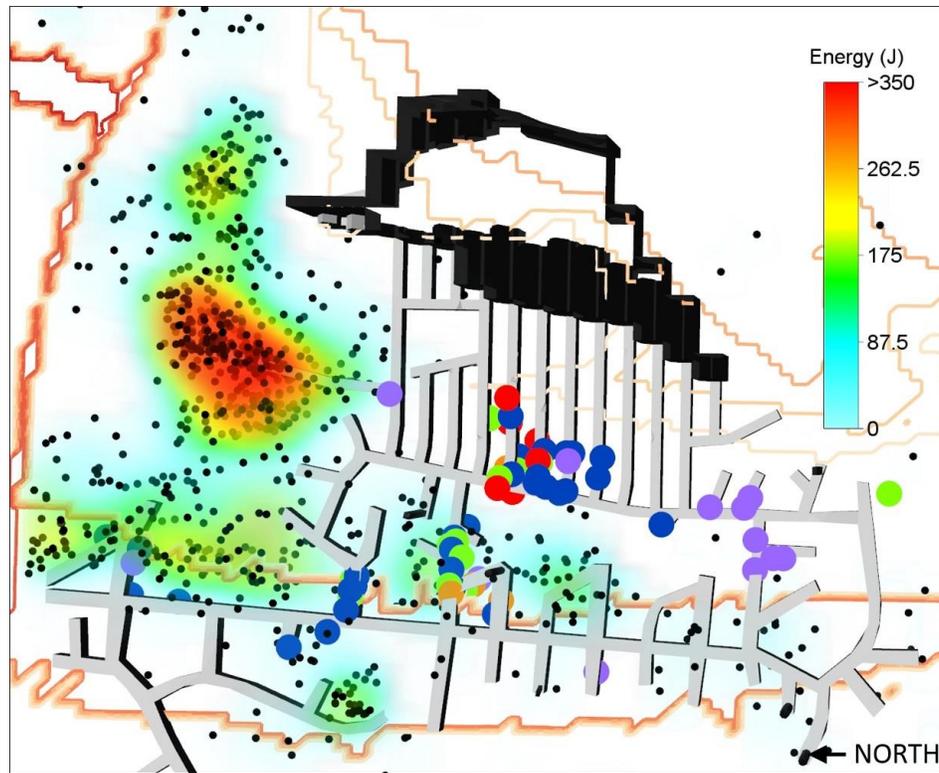
The damage to ground support on this level is illustrated in Figure 13 which presents the failure source analysis results and point dataset of seismic events for direct comparison to this damage. Damage severity is represented graphically according to the scale described below in Table 2.

This analysis indicates that severe ground support damage did not coincide with the most energetic seismic activity. In fact, damage was most intense throughout the central region of the west domain where major structural features were present and the mining induced stress conditions prior to failure were predicted to be relatively low in the order of 40MPa. On the basis of these observations, it is interpreted that excavation damage was the result of broad scale, structurally controlled mechanisms of load transfer. Variable dynamic loads were generated throughout the mine as a result of these discrete structural reactions. Stress-driven strain bursting may have played a role in some of the less severe damage locations. Due to the absence of any excavation damage at the hypocentre of most intense seismic activity, dynamic stress waves are not believed to be significant factors influencing the occurrence of damage. The absence of any damage in this area suggests that medium energy dissipation capacity ground support schemes have a high tolerance to loading by dynamic stress waves.

Figure 13 - Overlay of contours of radiated seismic energy, recorded seismic events and ground support damage locations.

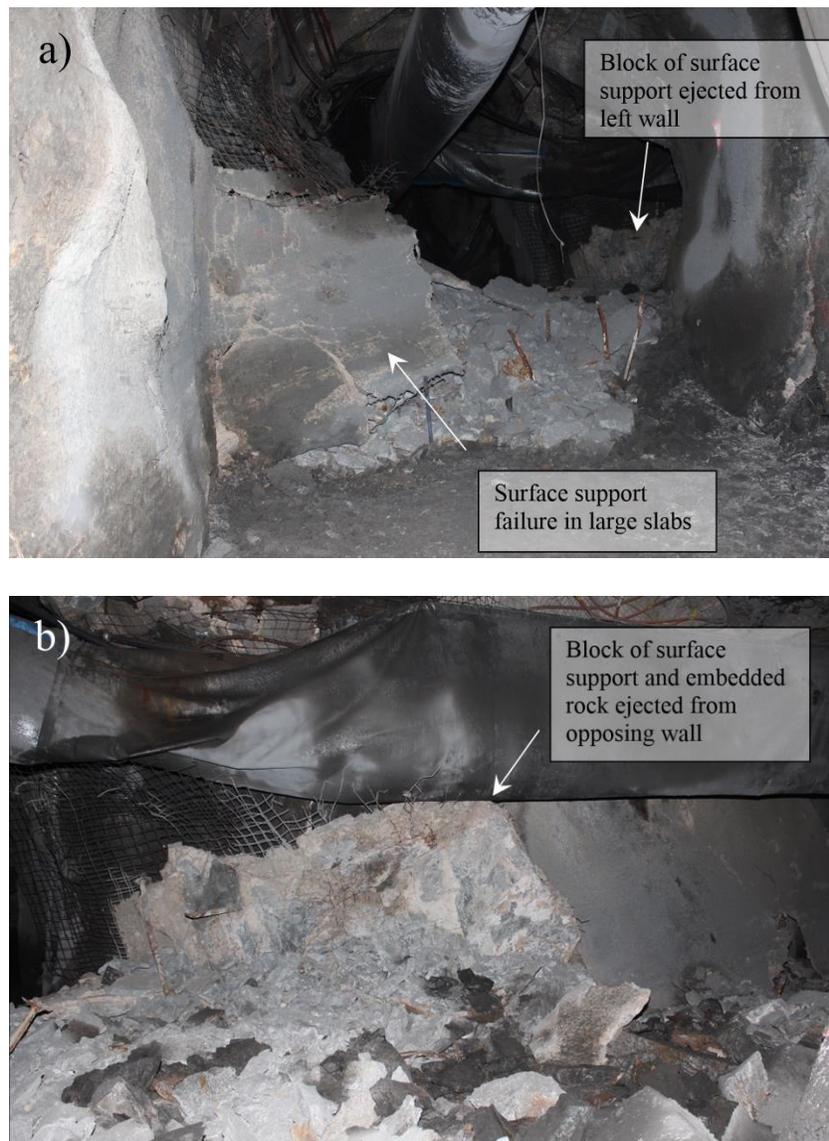
The focus of this case study is a particularly violent failure in the west access drive of a production level located at a depth of 1055 metres below surface. In this case the failure resulted in ejection of one of the walls of the excavation. The energy was such that the surface support system was ejected, coming to rest partially intact and upright against the opposite wall. A mass of rock estimated at 140 tonnes was also displaced. Figure 14 depicts two views of the failure: a) from the south looking north and b) a close up of the ejected block of surface support and embedded rock against the opposite wall. This level of damage is indicative of an extremely high energy demand and ejection velocity. Figure 15a) provides a reverse angle view of the ejected surface support while 15b) shows a photograph of a nearby location subject to moderate loading demands. Figure 15b illustrates a similar but much lower energy mechanism of surface support loading between the spacing of the reinforcement elements.

Figure 14 - Failure of ground support scheme leading to violent, very high velocity ejection.

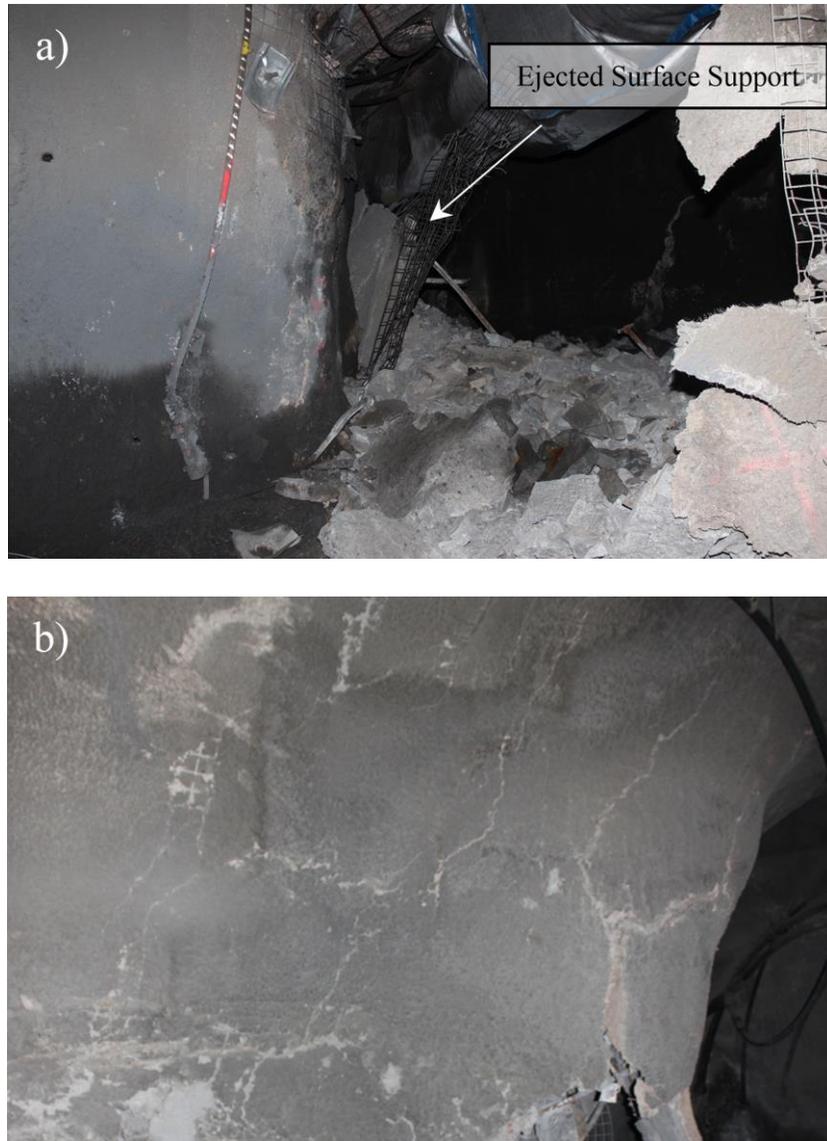
Figure 15 - a) Surface support damage after extremely high loading demand, b) surface support damage after low to moderate loading demand. Fracture pattern reflects reinforcement spacing with bolt locations where cracks intersect.

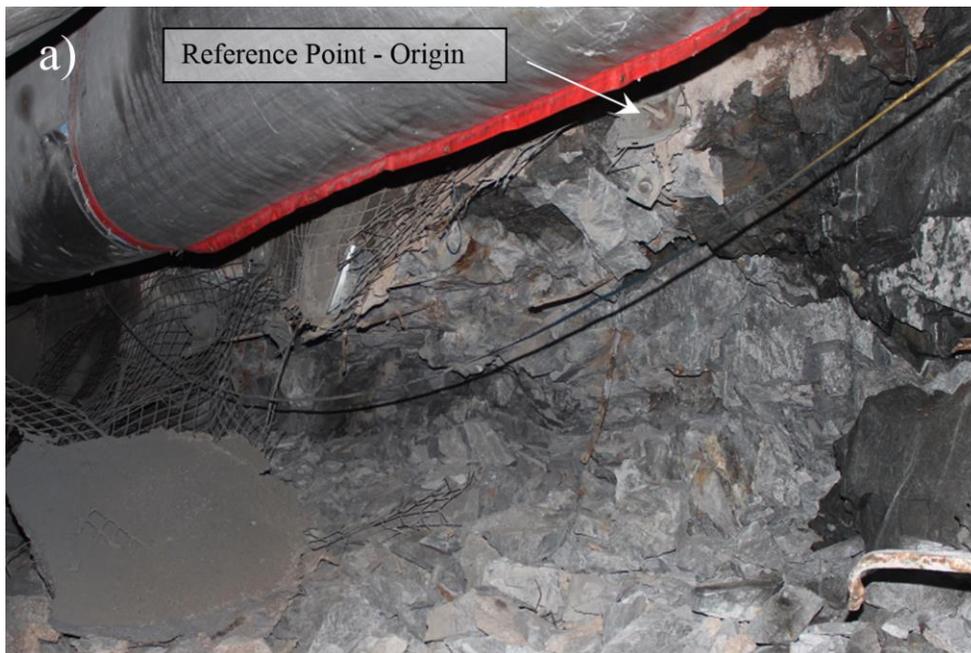
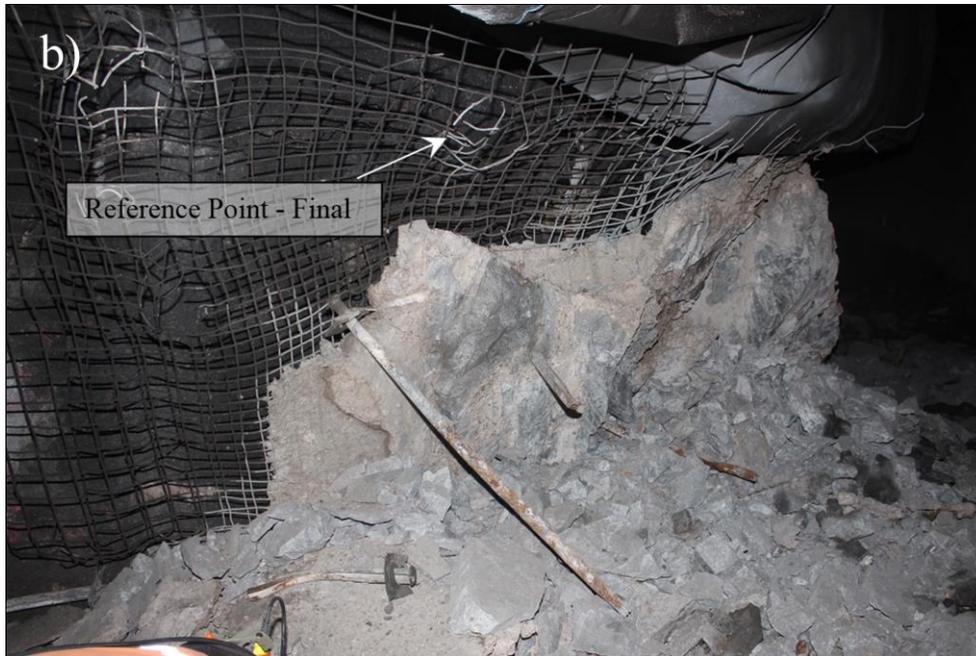
The final displacements in both the horizontal and vertical plane have been measured using high definition 3D survey data captured using a precision laser device. A reference origin and endpoint of ejection were established for this purpose by tracing visible damage in the ejected material back to the original excavation surface. Mesh failure at the face plate was traced back to a specific rock bolt location as shown in Figure 16. The measured displacements between these points were used as the equation inputs, as shown in Figure 17, which presents a view of the survey data looking north along the orientation of the excavation and perpendicular to the projectile path of the ejected surface support.

Figure 16 - a) Origin point of zero displacement and b) final reference point for projectile equations.

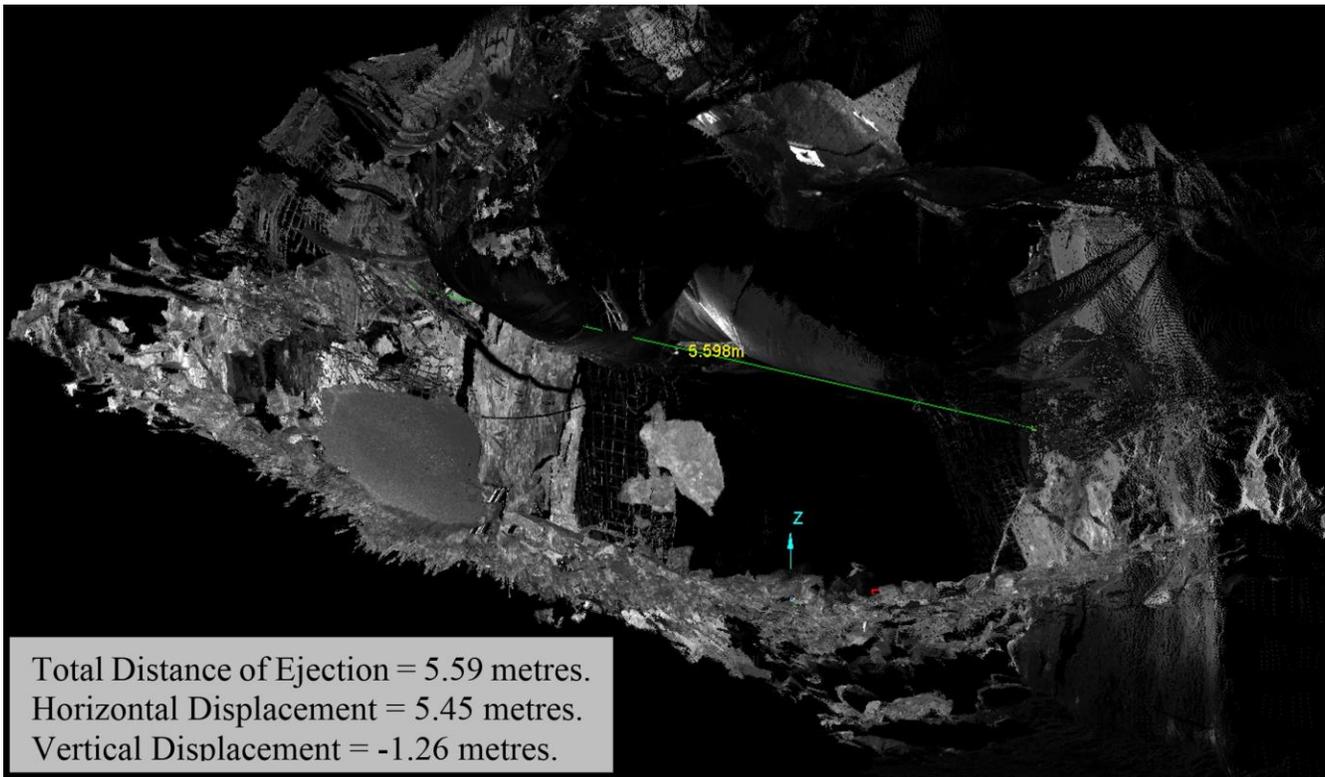
Figure 17 - Dimensions of the ejection path of the large block of support/rock, taken from HD survey scan data, view direction north, as in (Figure 14a).

Rearranging equation (3) and solving for the flight time of the ejected block and using $y = -1.264\text{m}$, $a_y = g = 9.81 \text{ m/s}^2$ and $V_{iy} = 0 \text{ m/s}$, the time, t , can be calculated as follows;

Now, rearranging Equation (2) to solve for the ejection velocity of failed surface support using $x = 5.453\text{m}$ and $a_x = 0 \text{ m/s}^2$, the ejection velocity, V_{ix} , can be calculated as follows;

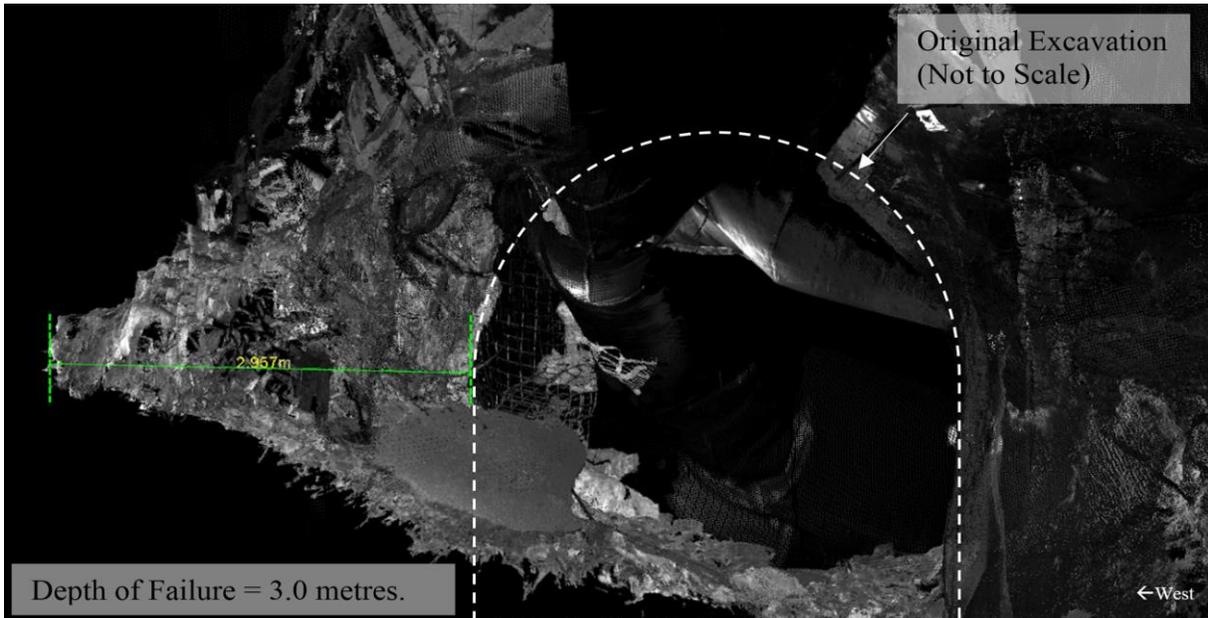
Figure 18 - Maximum depth of rock mass failure of 3.0m caused by sudden violent event.

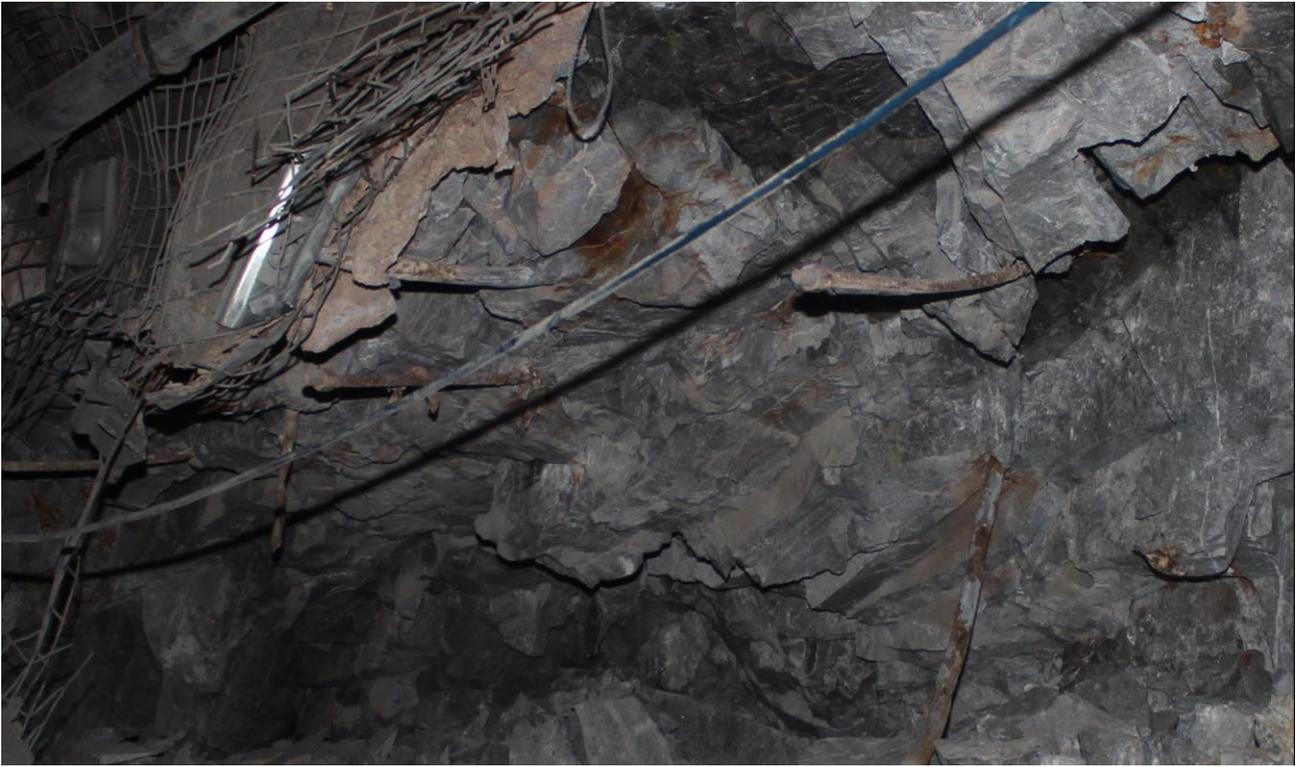
Taking into account the final depth of failure and observed retention deficiencies of the reinforcement elements due to poor resin encapsulation at the collar, as shown in Figure 19, it is considered reasonable and conservative to assume that only the first metre of ejected rock directly loaded the surface support. This assumes that the surface support failed and fragments were ejected in the instant that the rock mass failure propagated beyond one metre in depth. The loading mass per square metre would be a cubic metre of felsic rock with unit weight 2700kg/m^3 .

Figure 19 – Reinforcement retention inconsistency due to poor resin encapsulation at the collar likely caused the first metre of rock mass instability to preferentially load the surface support.
