**Capacity of OSB Skin Structural Insulated Panels with
Strengthening to Resist Windborne Debris Impact**

**This thesis is presented for the Degree of
Doctor of Philosophy
of
Curtin University**

April 2018

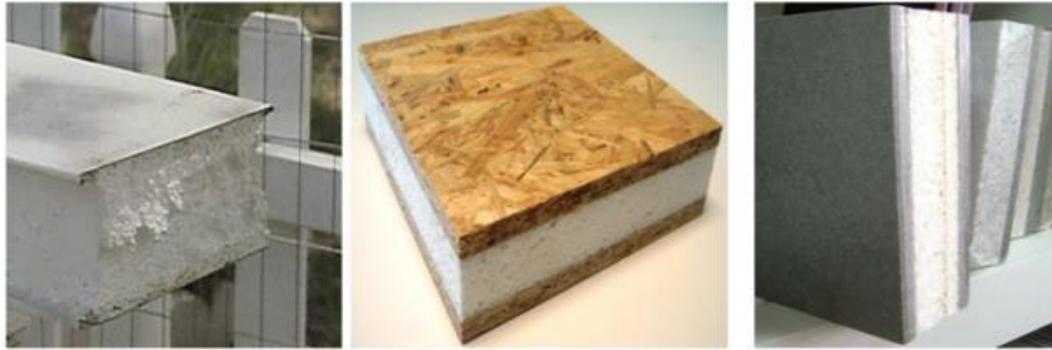
Figure 1.2 Steel skin SIP (L); Oriented Strand Board (OSB) skin SIP (M); Fibre cement skin SIP (R);

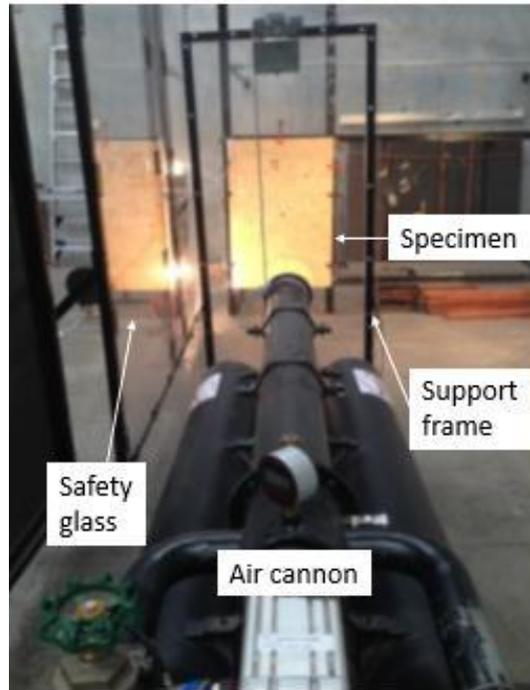
Figure 2.3 Typical pneumatic cannon impact test system (10, 11, 13-18)

propel a large missile to hit the test panels (49). Chen et al. (10-14) and Chen and Hao (15-18) used a pneumatic cannon system as shown in Figure 2.3 to generate windborne debris impact in Australia. The halogen lights were used to provide sufficient light for the high speed camera and the steel frame was used to provide a stable boundary for the SIP specimens subjected to the impact.

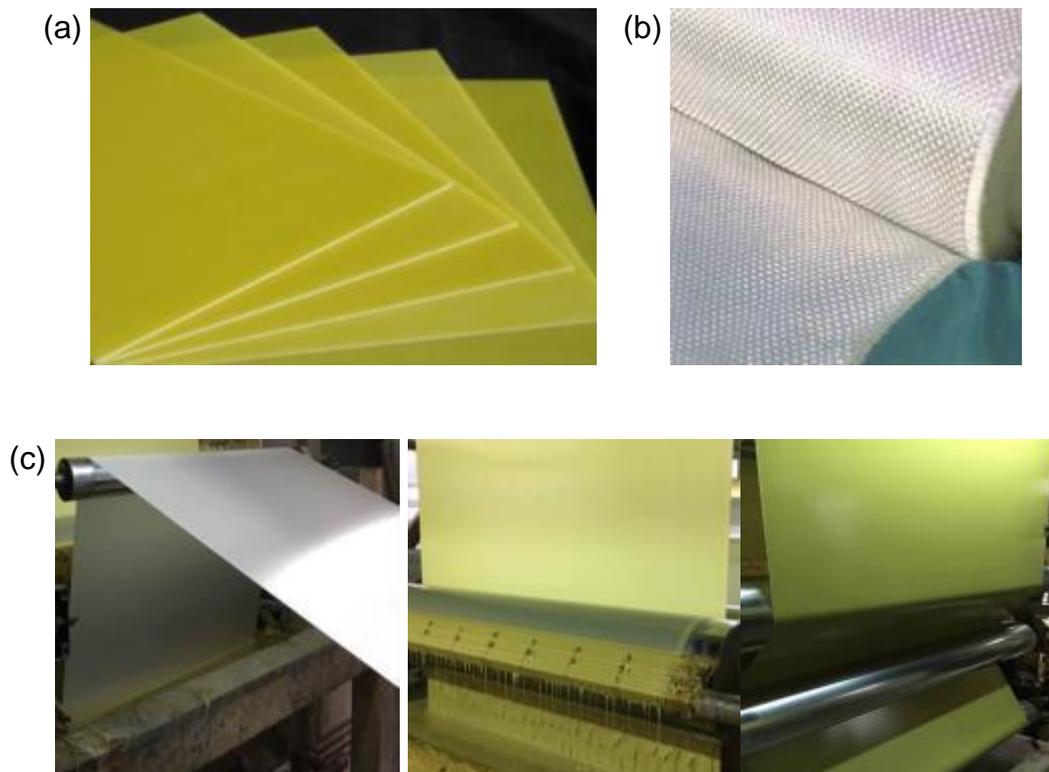
Figure 4.1 (a) Photograph of fiberglass/epoxy laminate sheet; (b) Fiberglass fabric layer; (c) Manufacturing process of fiberglass fabric layer impregnated with epoxy resin

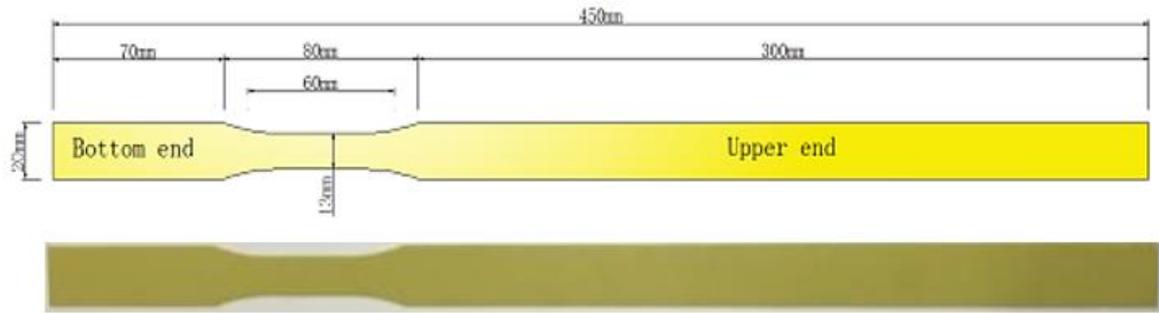
Figure 4.3 Schematic diagram of the dynamic tensile specimen (mm)

To meet with the specific requirements for using the INSTRON® VHS 160/100-20 system, the dimension of dumbbell-shaped specimens were adjusted as shown in Figure 4.3. The total length was changed to 450 mm and the two ends had different length. The upper end had a longer length of 300 mm, which ensured the upper jaw of the actuator to move and grip the specimen when the desired speed was obtained. The other end had a shorter length of 70 mm, which was fixed to the lower jaw. The width of ends and gauge section were kept as 20 mm and 13 mm, respectively. The gauge length was shortened to 60 mm, which reduced the time required for a stress wave to propagate through the gauge length to better achieve dynamic stress equilibrium. In addition, the shortened gauge could increase the testing range of strain rate. For each crosshead speed, at least three specimens were tested. A total of 34 specimens were prepared for the dynamic tensile tests.

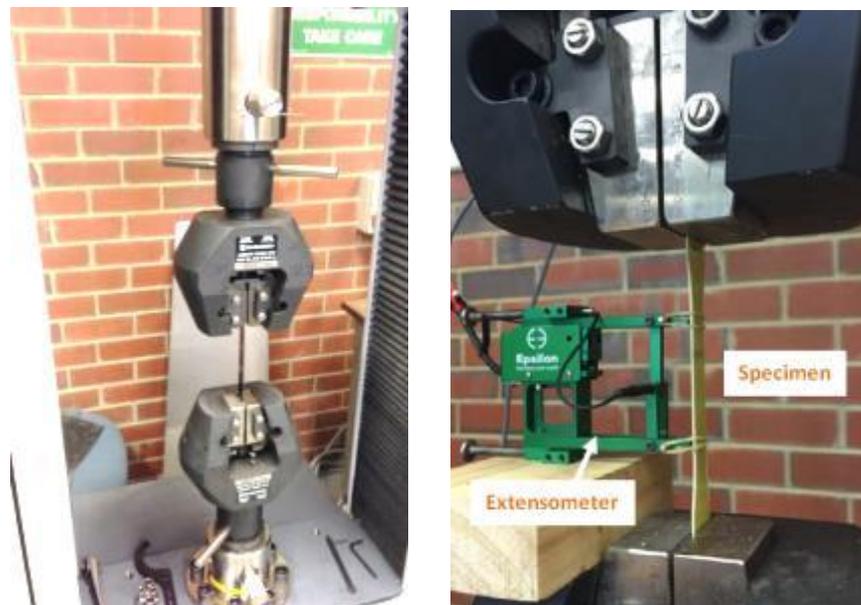
Figure 4.4 Quasi-static testing set-up (L) Shimadzu® AGS-300kNX; (R) Epsilon® Extensometer

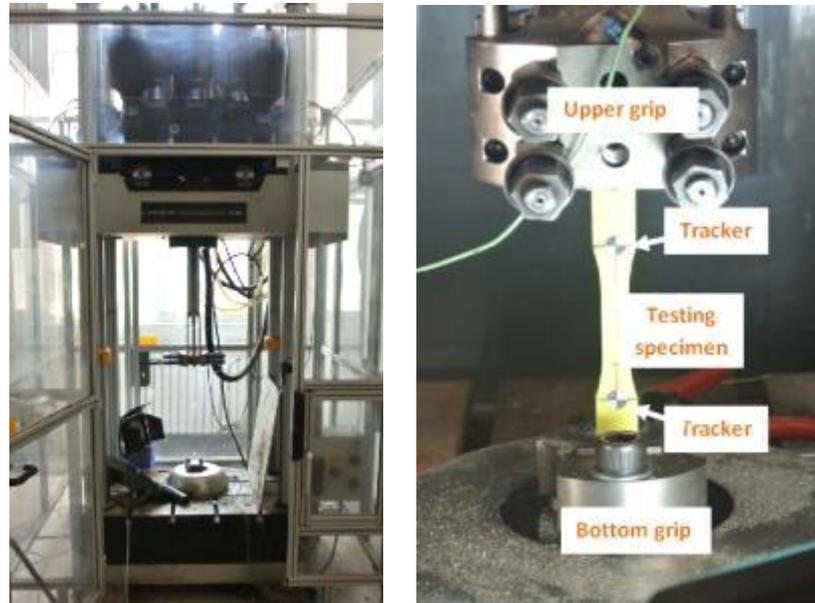
Figure 4.5 (L) Photograph of INSTRON® VHS 160/100-20; (R) Tensile testing setup

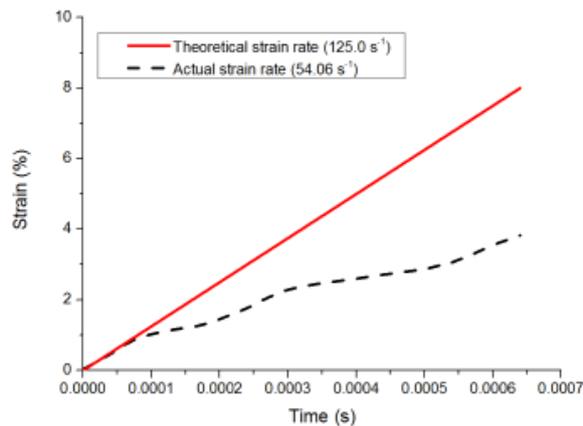
Figure 4.6 Strain time histories (theoretical strain rate vs. tracker measurement from high speed camera clip)

from 0.5 m/s to 20 m/s. The corresponding strain rate can be calculated based on the formula $\dot{\epsilon} = V/L$, where V is the constant velocity and L is the specimen gauge length. Six crosshead speeds (i.e. 0.5, 1, 5, 10, 15, 20 m/s) were applied for dynamic testing. The corresponding theoretical and actual strain rates were calculated as provided in Table 4.2. The theoretical strain rate was derived from the above relationship. It was found that the theoretical strain rates were higher than the actual strain rates, as shown in Figure 4.6. The actual strains were measured via tracing the trackers from the video clips captured by the high speed camera. The actual strain rate was calculated by linear fitting the slope of the strain time histories as shown in Figure 4.7. As shown in Figure 6 of a tested case the theoretical strain rate was around 125 s^{-1} , which was higher than the actual strain rate of 54.06 s^{-1} . The difference in strain rate obtained from the two approaches might be due to the slippage between the grip and the specimen. The deformation of the upper end and the bottom end of the specimen also contributed to the strain difference, which made the actual deformable length of the specimen longer than the gauge length. Therefore, the strain rate calculated by using the gauge length likely overestimates the true strain rate of the specimen.

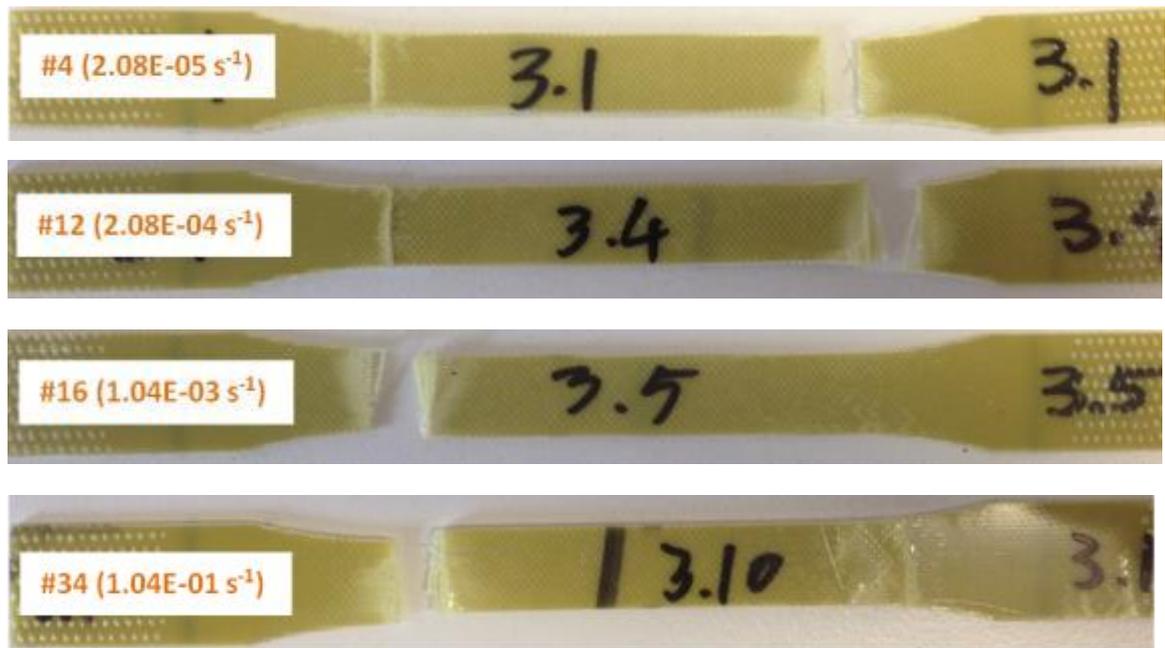
Figure 4.8 Failure patterns after quasi-static and low velocity tensile tests

A total of 34 specimens under nine extension rates were tested. Figure 4.8 shows the typical failure patterns of four specimens (i.e. #4, #12, #16 and #34) at quasi-static and low velocity tests. As observed, the specimens experienced the fracture failure occurred at either end or both ends of the gauge. Similar failure pattern was also observed in (140) in testing the fiberglass/epoxy reinforced thermoplastic material. The fractures occurred at gauge ends were due to stress concentration or unavoidable loading eccentricity effect.

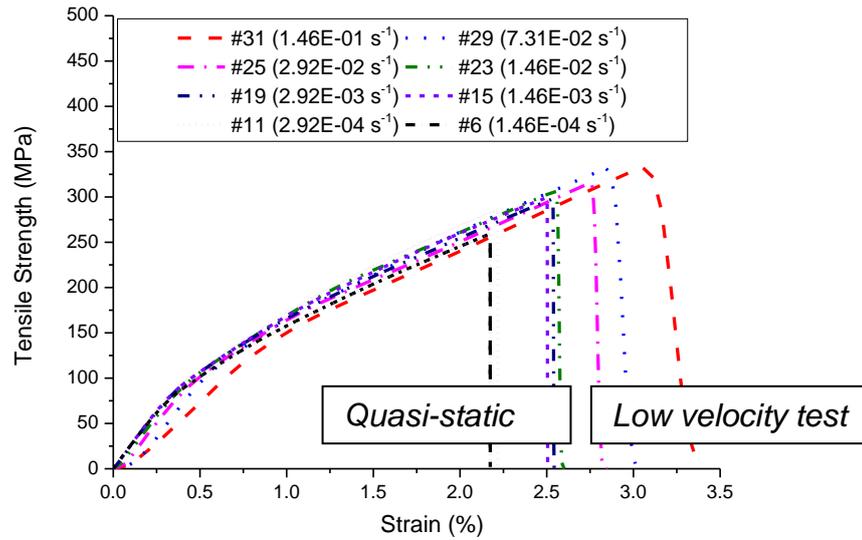
Figure 4.9 Stress-strain curves of quasi-static and low velocity testing

Figure 4.9 shows the stress-strain curves in the quasi-static and low velocity tests. The specimen showed approximately linear elastic behavior before the brittle failure. It was found that Young's Modulus of the specimen decreased slightly at each strain rate due to the initial damage and delamination of fiber and/or epoxy after loading. Based on the quasi-static and low velocity testing results, the tensile strength, failure strain and Young's Modulus at quasi-static (i.e. strain rate of $2.08E-05 \text{ s}^{-1}$) were calculated as 258.94 MPa, 2.24% and 11.60 GPa, respectively. When the strain rate reached $2.08E-02 \text{ s}^{-1}$ (#27), the tensile strength increased to 320.06 MPa and the corresponding failure strain increased to 2.96%. Figure 4.10 shows the mean tensile strength of the specimen under quasi-static and low velocity tests with standard deviation. It shows apparent dependence of tensile strength on the strain rate at low strain rate. The complete results in terms of failure strength, failure strain and Young's Modulus are given in Table 4.1.

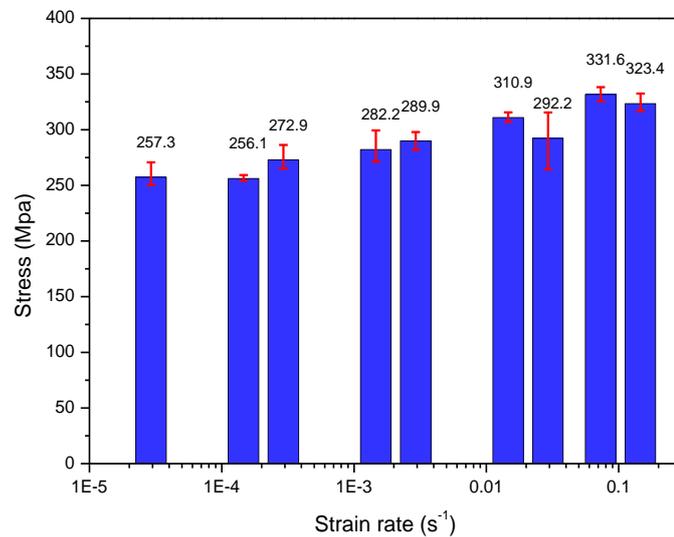
Figure 4.10 Testing summary of tensile strength in the quasi-static and low velocity tests
Table 4.1 Specimen configurations and results in the quasi-static and low velocity tests

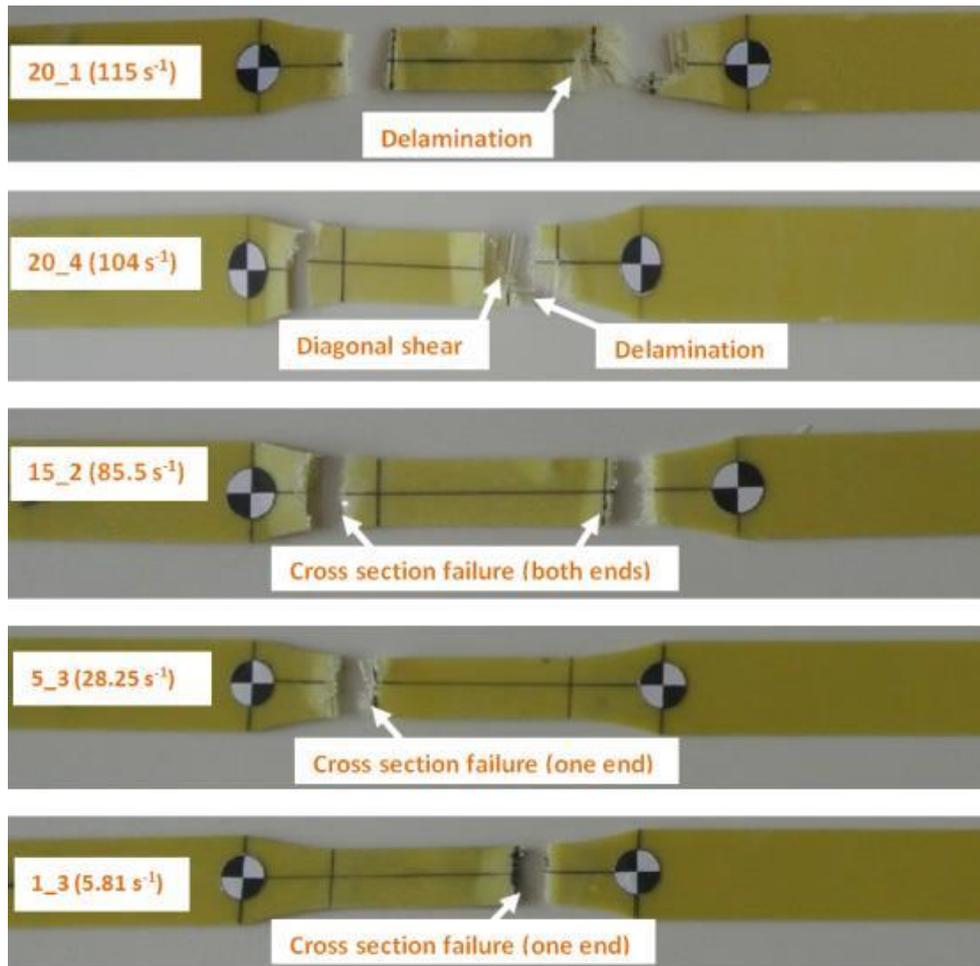
Figure 4.11 Failure patterns after dynamic tensile tests (at the strain rates of 5.81 s^{-1} , 28.25 s^{-1} , 85.2 s^{-1} , 104 s^{-1} , 115 s^{-1})

A total of 22 specimens under six crosshead speeds were tested. Figure 4.11 shows the failure patterns of the specimens at five strain rates of 5.81 s⁻¹, 28.25 s⁻¹, 85.2 s⁻¹, 104 s⁻¹, and 115 s⁻¹. The specimen failed at the adjacent region between testing gauge and the transition part. When the strain rate is less than 92 s⁻¹, most of the specimens experienced localized fracture occurred on either end of the gauge section. The delamination of the specimen was not observed. When the strain rate increased, most of the specimens experienced multiple breaks on both ends of the test gauge, which was also observed in (140). The specimen experienced fiber rupture along with some delamination. More damages such as delamination and diagonal cracks were extended to a larger area, which resulted in the increase of tensile strength of material. It can be concluded that the increase of tensile strength is heavily affected by the damage modes. In addition, at a high strain rate, the specimen had no time to initiate the failure at internal defects and weak points or stress concentrated areas. These multiple failures in the specimen require more energy to cause the damage, hence results in strength increment. By contrast, at a low strain rate the specimen had relatively longer time to develop the failure along the weaker section.

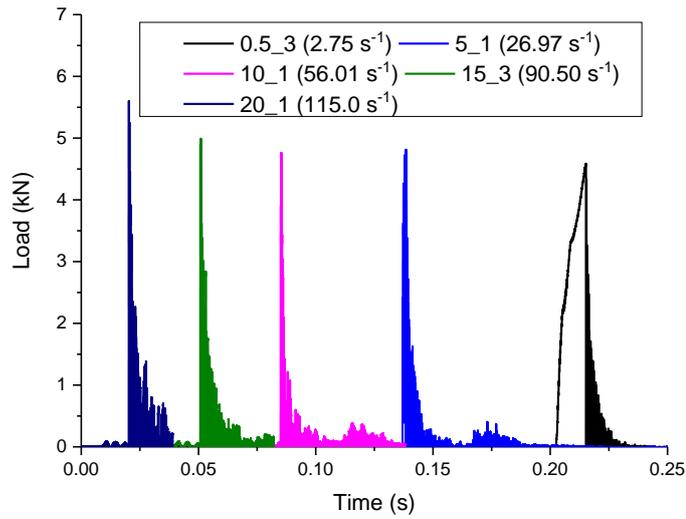
Figure 4.12 Load time histories at various strain rates

Figure 4.12 shows typical load time histories at various strain rates. The loads were measured by the inbuilt load cell. It is apparent that the tensile strength of the specimen is strain rate sensitive. The representative stress-strain curves of the specimen at different strain rate in the high velocity tensile testing are shown in Figure 4.13. The specimen shows nonlinear behavior at high strain rate, which is due to the fluctuation of the stress caused by the vibration of the Instron machine. The Young's modulus is taken as the slope of the stress-strain curve from the origin to the failure point in this study. At the strain rate of 2.88 s^{-1} , the tensile strength is 316.58 MPa and the failure strain is 3.35% . The tensile strength and failure strain increase with the increasing strain rate. When the strain rate increases to 105.02 s^{-1} , the tensile strength rises to 423.40 MPa and the failure strain is 4.15% , which indicates the increments of 33.9% and 23.9% , respectively. The detailed testing results are given in Table 4.2.

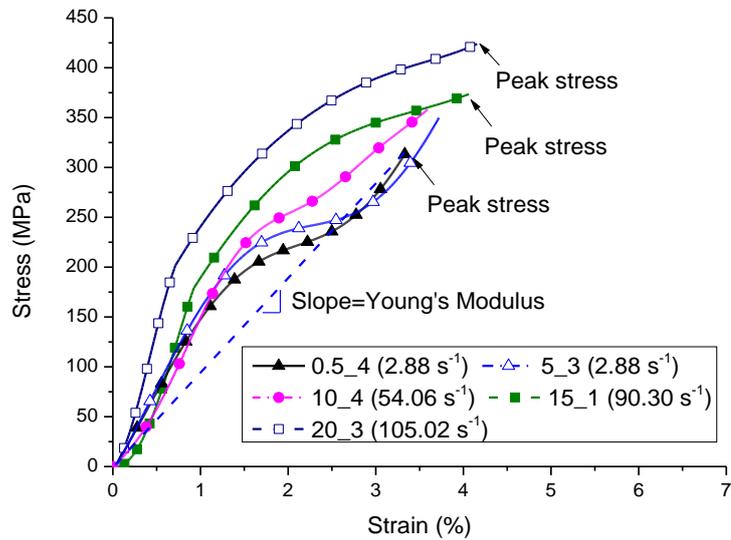
Figure 4.13 Representative stress-strain curves at different strain rates

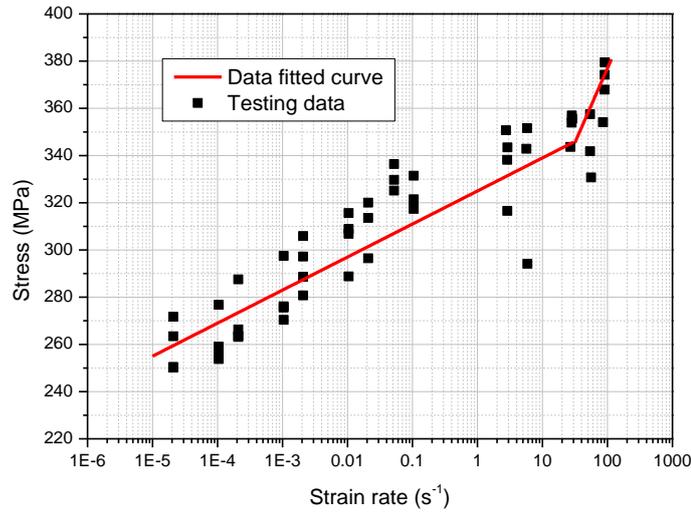
Figure 4.14 Tensile strength vs. strain rate

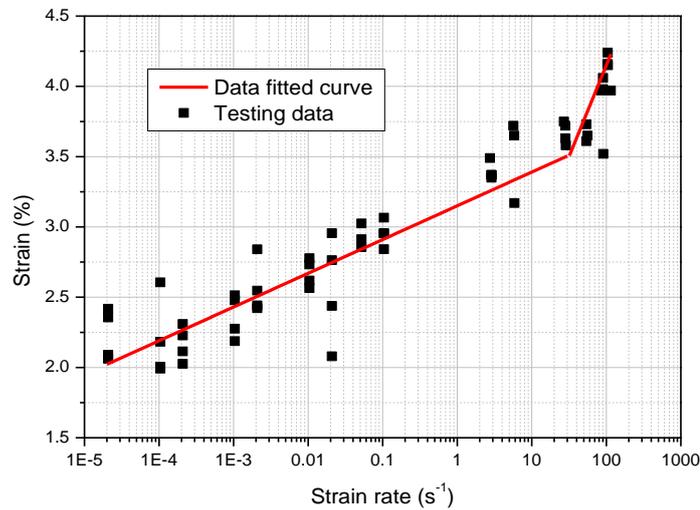
Figure 4.15 Failure strain vs. strain rate

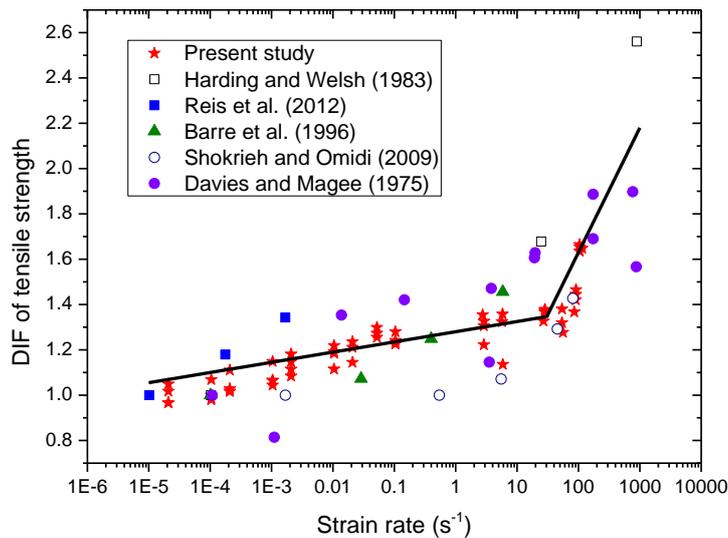
Figure 4.16 DIF of tensile strength vs. strain rate

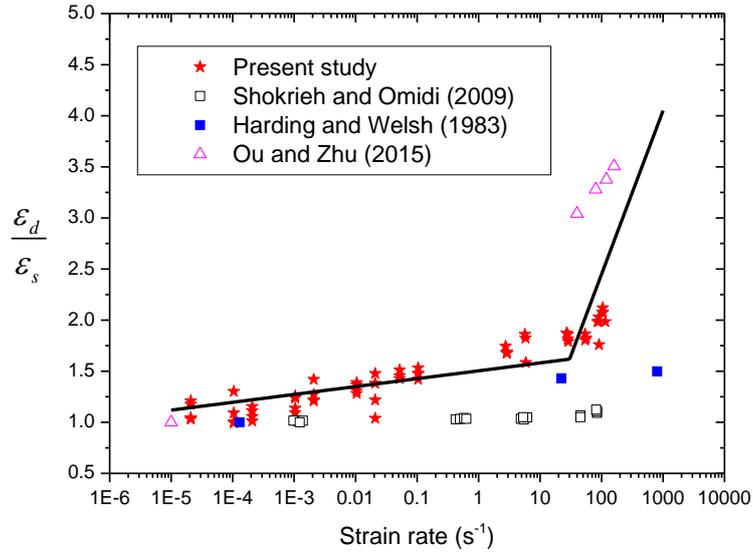
Figure 4.17 Ratio of dynamic to static failure strain ($\frac{\epsilon_d}{\epsilon_s}$) vs. strain rate

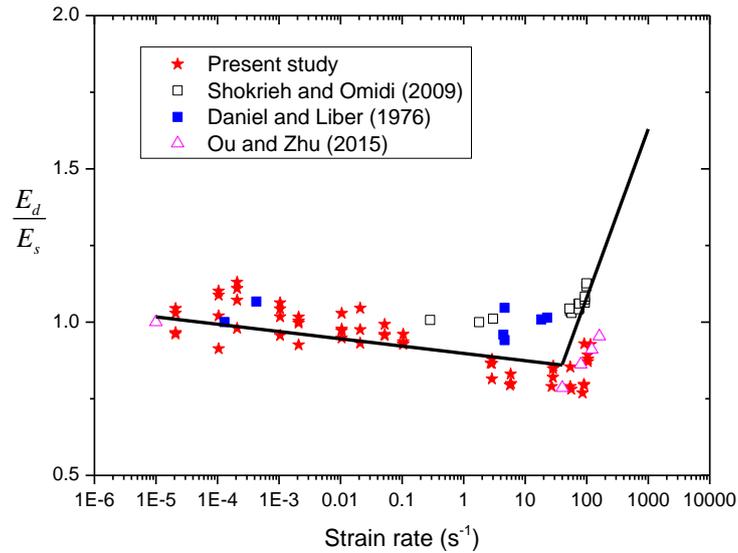
Figure 4.18 Ratio of dynamic to static Young's Modulus $\frac{E_d}{E_s}$ vs. strain rate

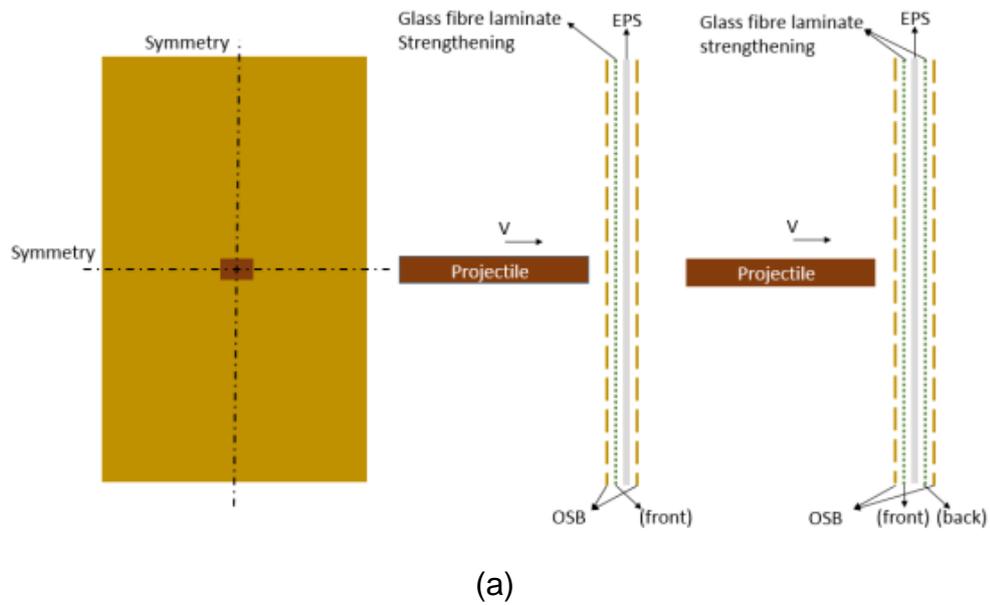
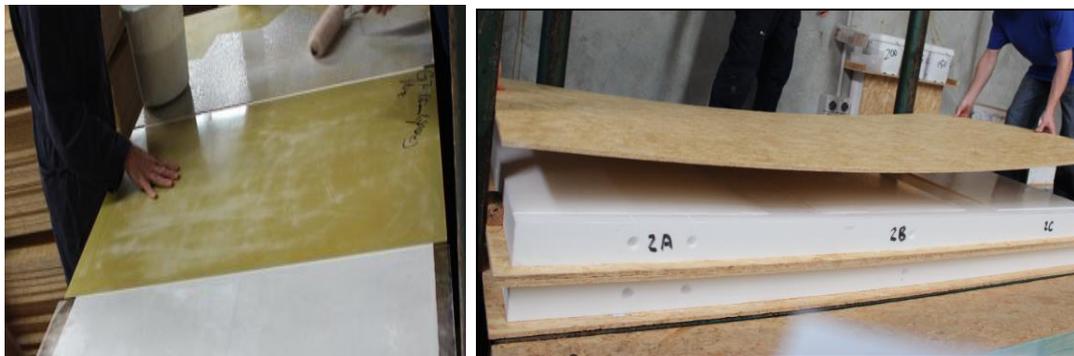
Figure 5.2 (a) Schematic diagram of Glass fibre laminate strengthening position (L) Plan view (M) Interlayer strengthening (Panel B/C/D/G); (R) Double interlayer strengthening (Panel E/F); (b) Manufacture of the Glass fibre laminate strengthened OSB skin SIP

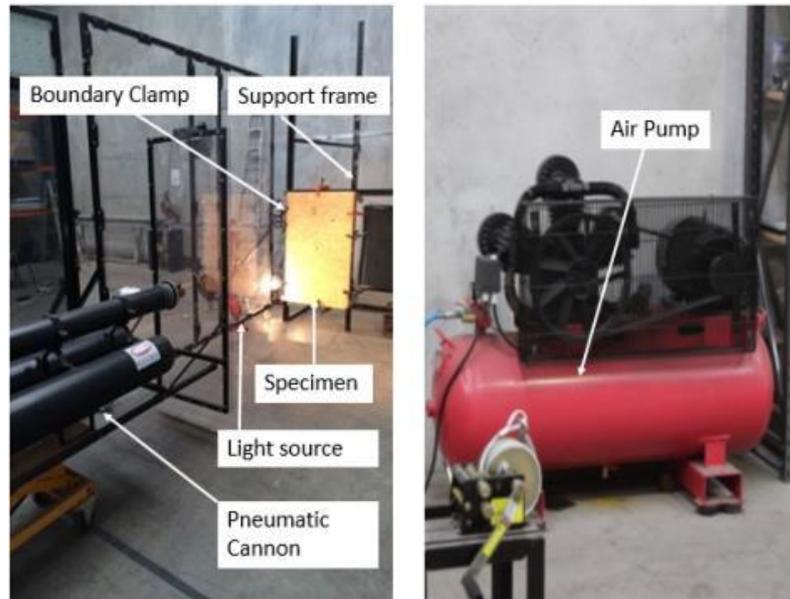
Figure 5.3 Testing apparatus

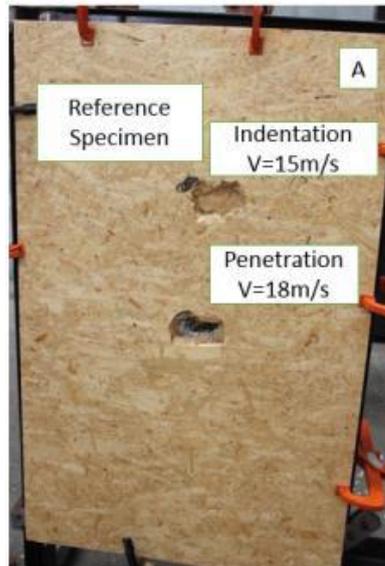
Figure 5.4 Photograph of specimen A

The specimen A was tested and used as a reference panel to identify the penetration resistance capacity of the commercial SIP with OSB skins, and to demonstrate the effectiveness of the glass fibre laminate strengthening measures proposed in this study. Four projectile impacts with the velocities of 15, 21.2, 18, and 20 m/s were applied on the panel, respectively. The test results for each impact were “pass”, “fail”, “fail” and “fail”, respectively. The failure mode was typical punching shear failure. The projectile impact at the velocity of 18m/s caused an opening with the projectile staying on the panel. The velocity of 18m/s was therefore deemed as the critical velocity to penetrate the reference panel. As shown in Figure 5.4, the damage was limit to a localised area as the typical punching shear failure. No obvious bending or shear failure response was observed on the panel. Therefore, each impact could be assumed as an independent strike and the existing localized failure has limited influence on the subsequent impact at other impact locations.

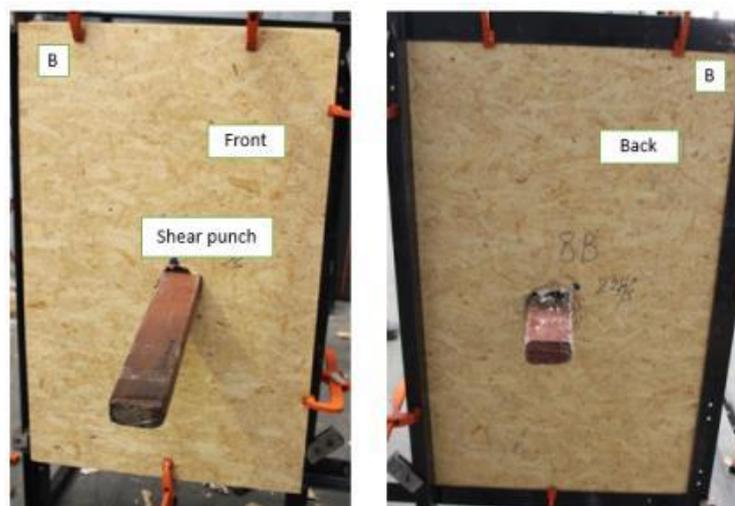
Figure 5.5 Photograph of specimen B (L) Front view; (R) Back view

The specimen B was strengthened with one 1mm-thick glass fibre laminate sheet at position (a), as shown in Figure 5.5. The panel was subjected to the 4 kg timber projectile impact at velocity of 22.4 m/s. The test result was “fail” with the projectile penetrated but stayed in the panel as shown in Figure 5.5. The failure mode was typical shear punch failure. No crack or global structural response was observed on the panel. As the projectile stayed in the panel, 22.4 m/s was deemed the critical impact velocity to penetrate the specimen B. The testing results indicate that strengthening the commercial SIP with one 1 mm glass fibre laminate increased the critical impact velocity from 18 mm/s to 22.4 mm/s.

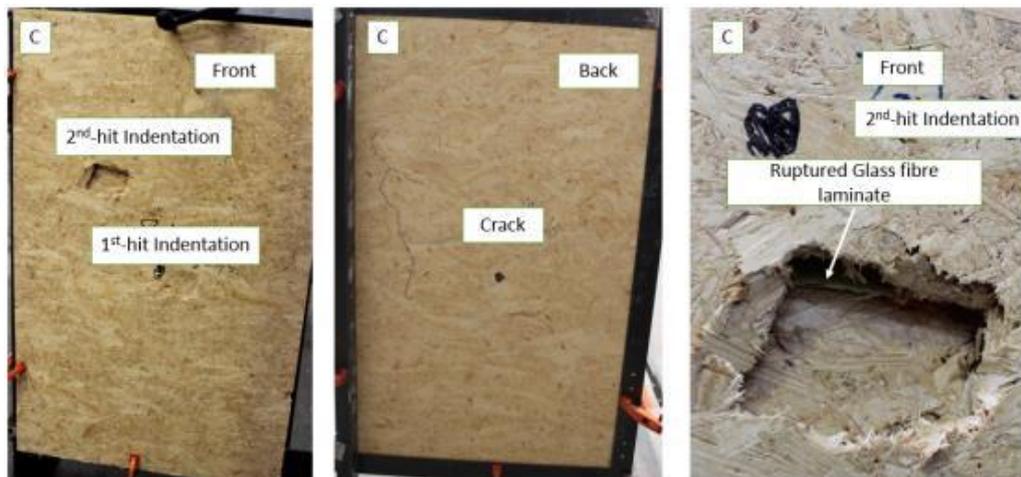
Figure 5.6 Photograph of specimen C (L) Front view; (M) Back view; (R) 2nd-hit Indentation point

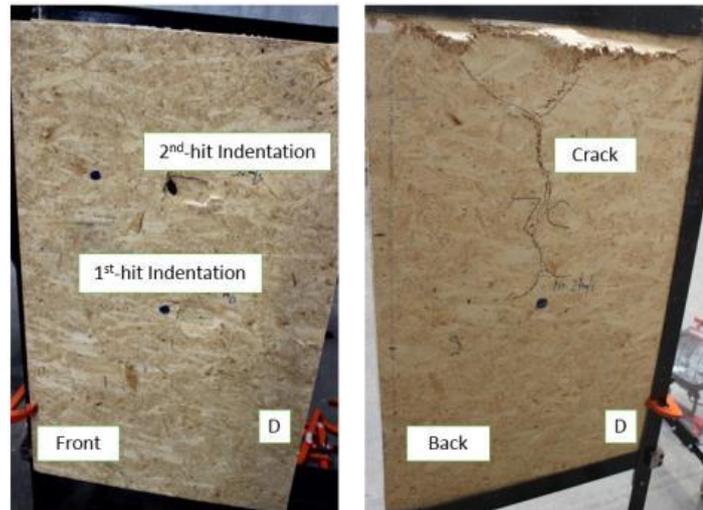
Figure 5.7 Photograph of specimen D (L) Front view; (R) Back view

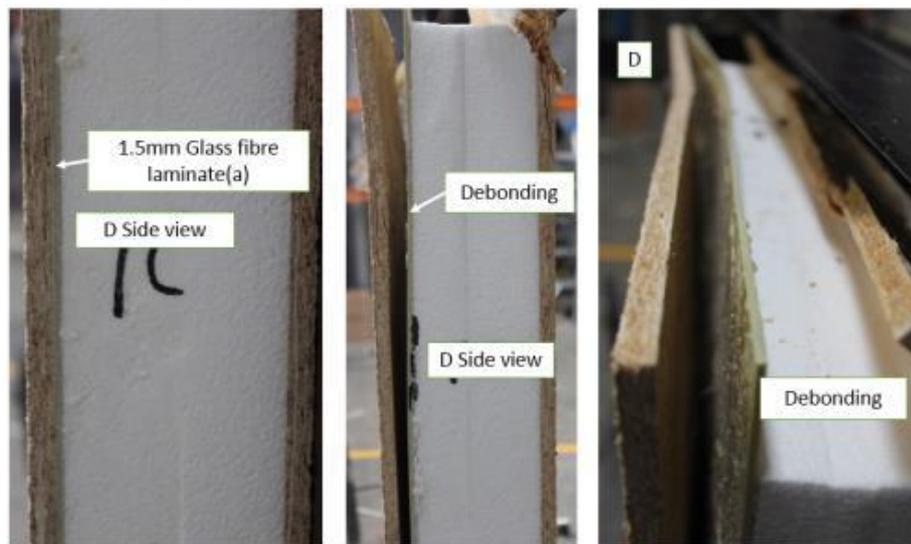
Figure 5.8 Photograph of specimen D (L) Side view (before test); (M) Side view (after test); (R) Top side view (after test)

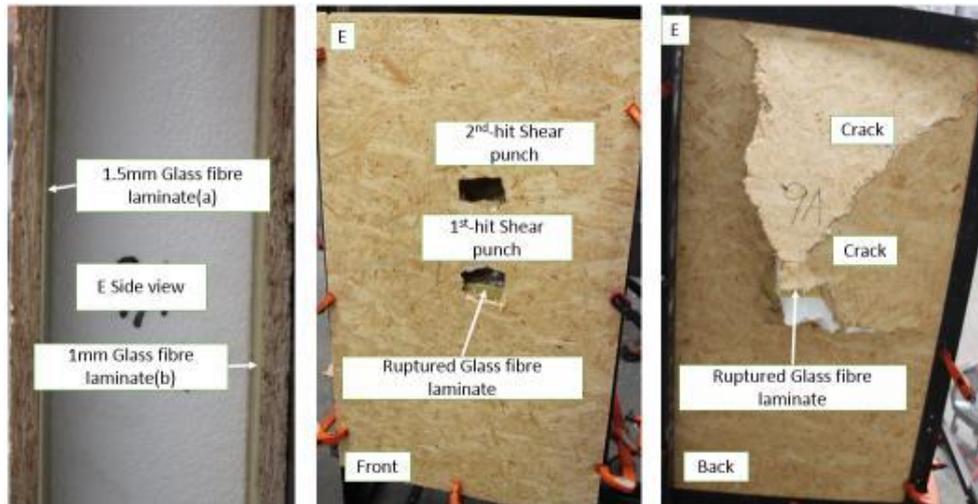
Figure 5.9 Photograph of specimen E (L) Side view; (M) Front view; (R) Back view

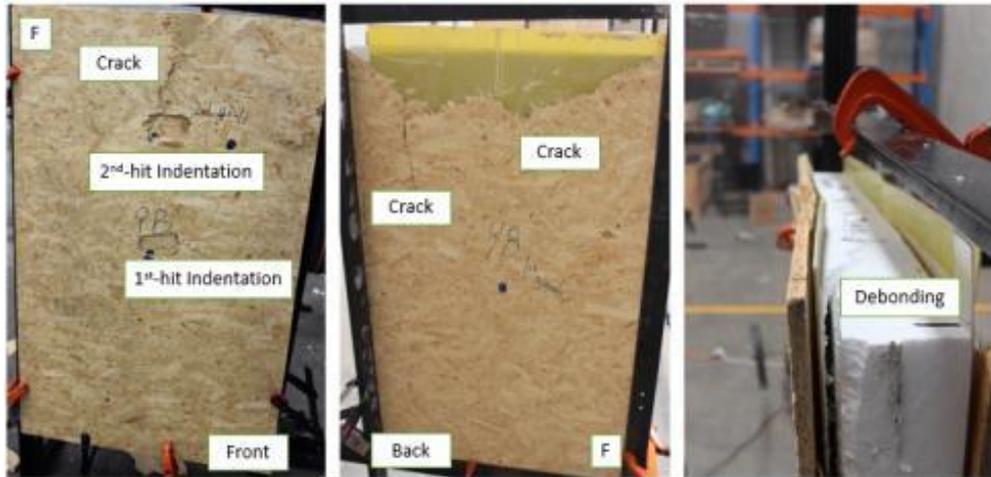
Figure 5.10 Photograph of specimen F (L) Front view; (M) Back view; (R) Side view

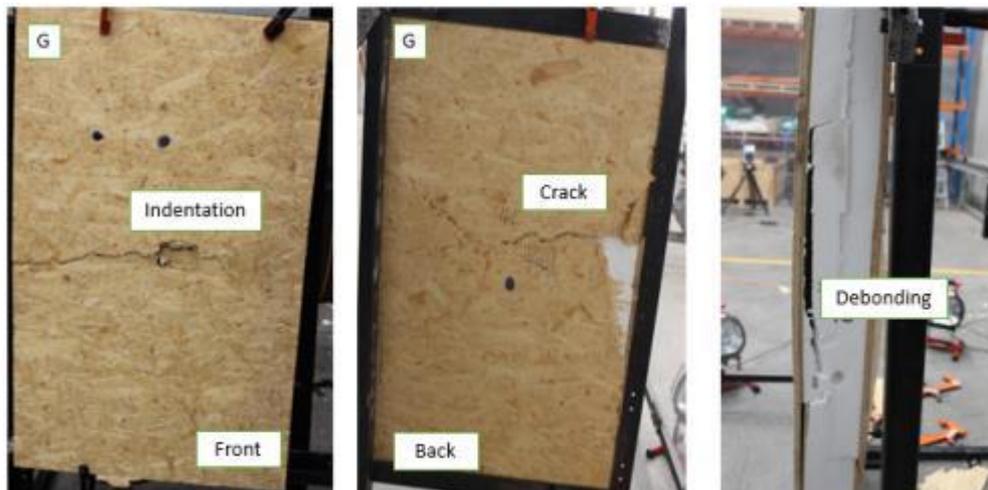
Figure 5.11 Photograph of specimen G (L) Front view; (M) Back view; (R) Side view

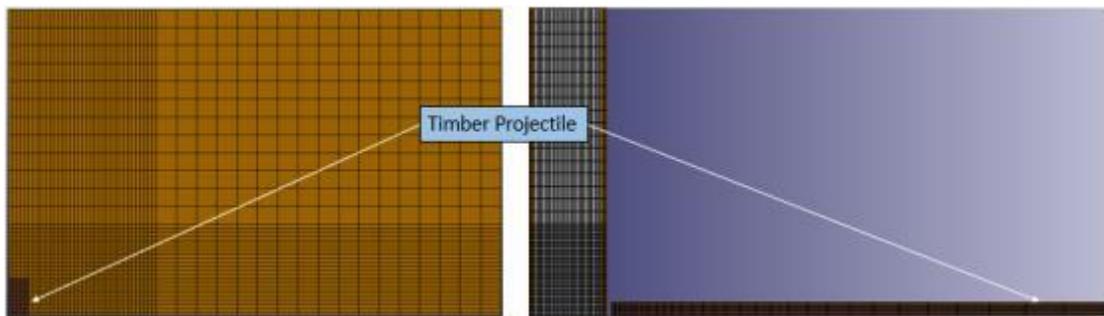
Figure 5.12 Numerical model of a quarter panel (L) Plan view; (R) Side view

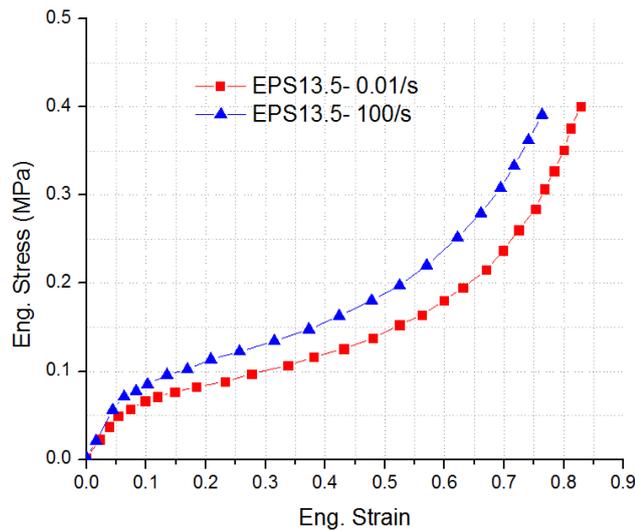
Figure 5.13 Stress–strain curves of EPS foam (density 13.5 kg/m3)(165)

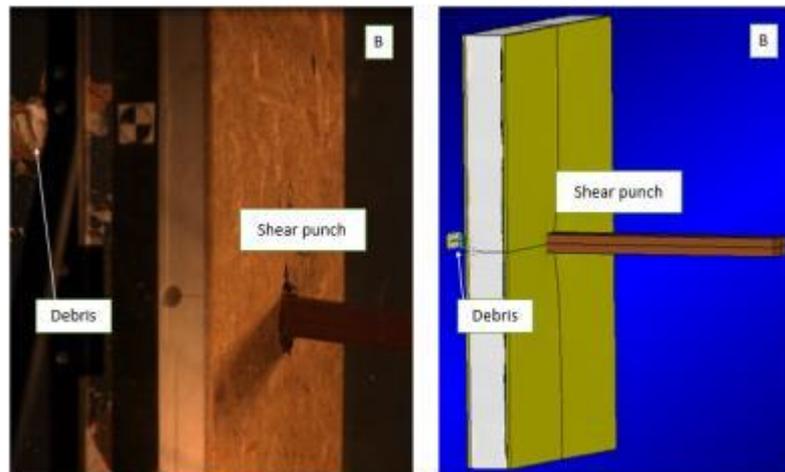
Figure 5.14 Comparisons of damage mode of specimen B (L) Test; (R) Numerical

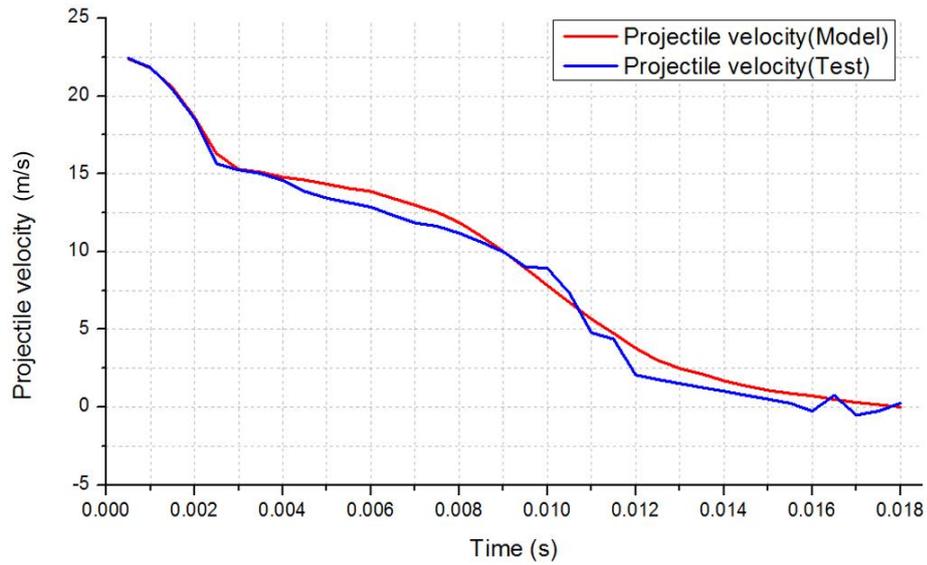
Figure 5.15 Comparisons of projectile velocity obtained from laboratory test and numerical simulation during the 1st-hit on specimen B

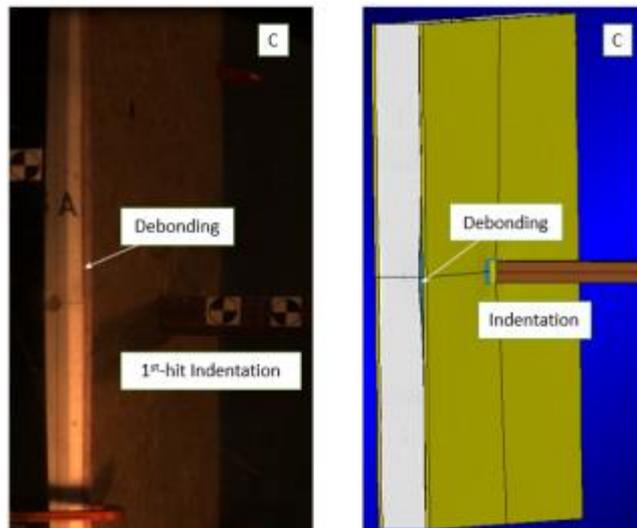
Figure 5.16 Comparison of damage mode of 1st-hit on specimen C (L) Test; (R) Numerical

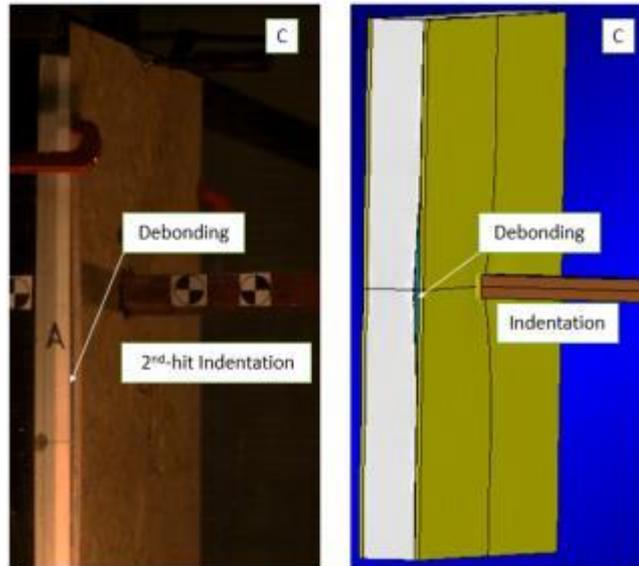
Figure 5.17 Comparison of damage mode of 2nd-hit on specimen C (L) Test; (R) Numerical

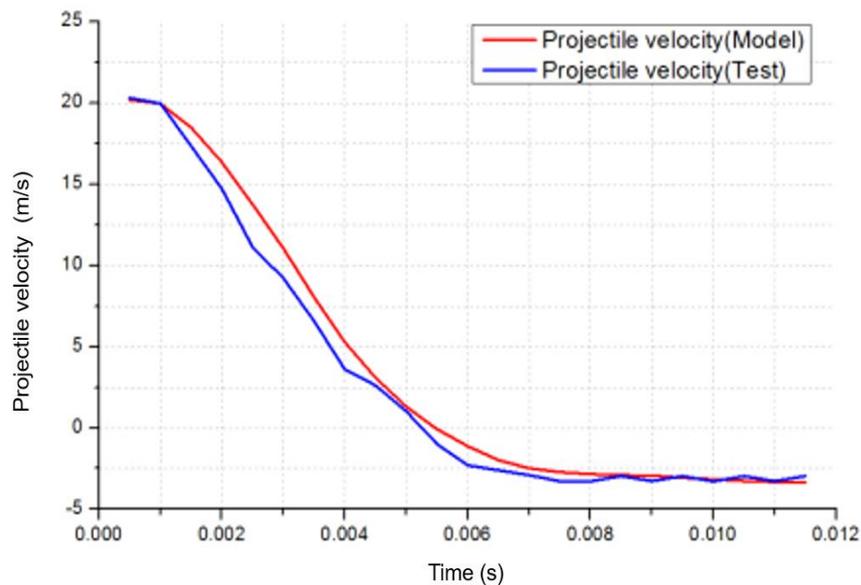
Figure 5.18 Comparisons of projectile velocity obtained from laboratory test and numerical simulation during the 1st-hit on specimen C

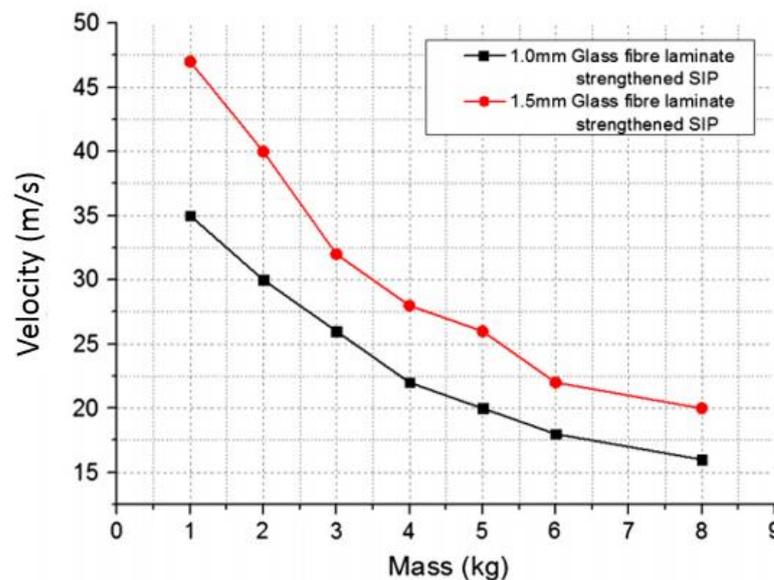
Figure 5.19 Vulnerability curves of OSB skin SIP panel strengthened with 1 mm (Specimen B) and 1.5 mm (Specimen C) glass fibre laminate subjected to windborne debris impact

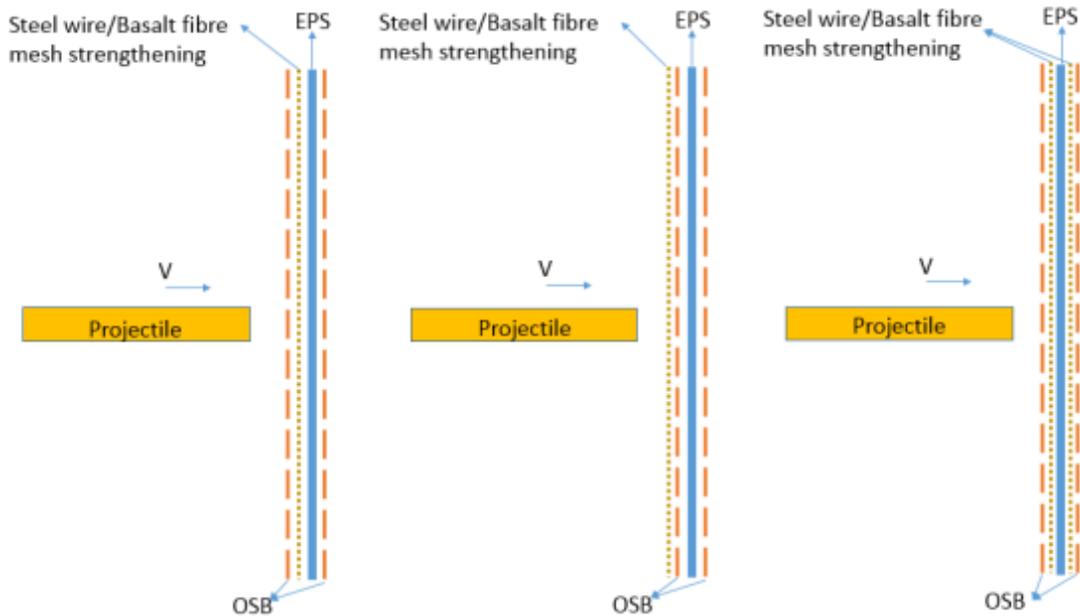
Figure 6.3 Schematic diagram of steel wire mesh and basalt fibre mesh strengthening position (L) Interlayer strengthening (Specimen A/B/D/E); (M) Front strengthening (Specimen C); (R) Double interlayer strengthening (Specimen F/G)

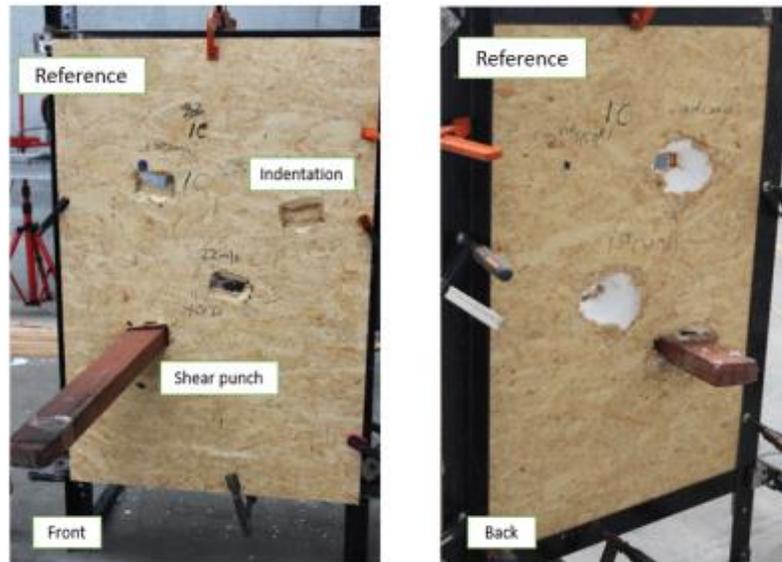
Figure 6.4 Damage mode of the reference panel (97) (L) Front view; (R) Back view

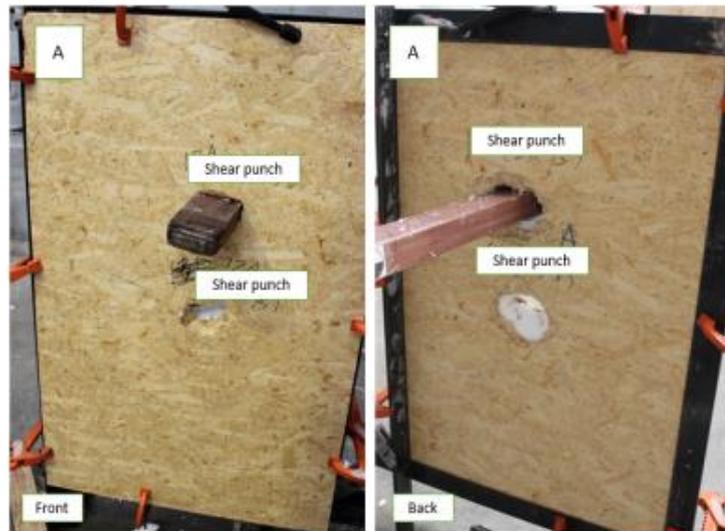
Figure 6.5 Damage mode of specimen A strengthened with a steel wire mesh interlayer (L) Front view; (R) Back view

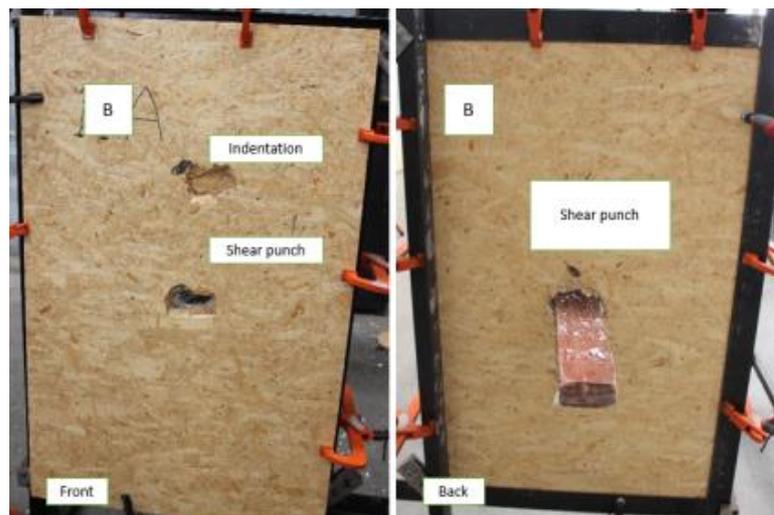
Figure 6.6 Damage mode of specimen B strengthened with an adhesive coated basalt fibre mesh (10×10 mm spacing) interlayer (L) Front view; (R) Back view

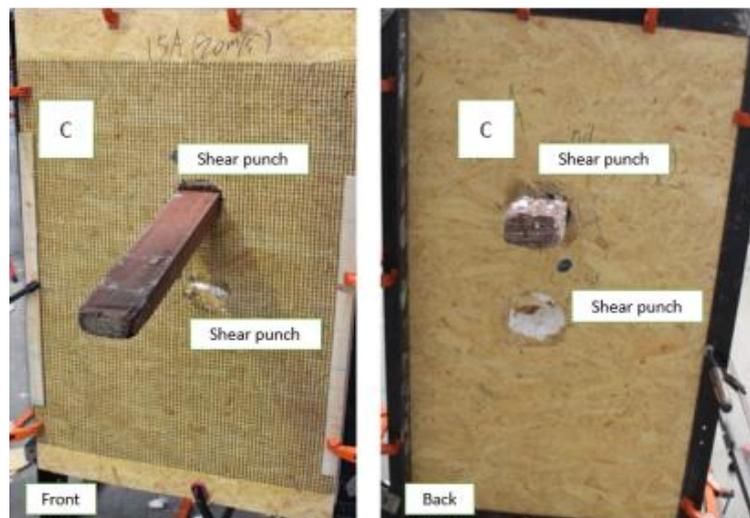
Figure 6.7 Damage mode of specimen C strengthened with adhesive coated basalt fibre mesh (10×10 mm spacing) at front (L) Front view; (R) Back view

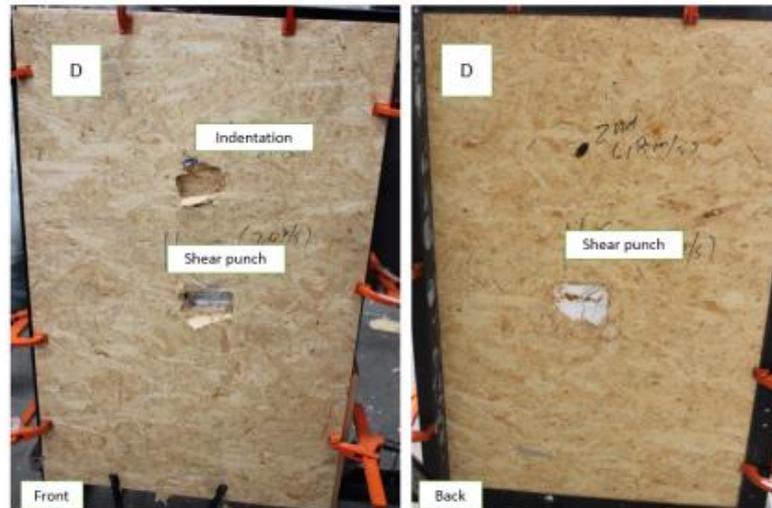
Figure 6.8 Damage mode of strengthened specimen D with an uncoated basalt fibre mesh (10×10 mm spacing) interlayer (L) Front view; (R) Back view
