**Capacity of OSB Skin Structural Insulated Panels with
Strengthening to Resist Windborne Debris Impact**

**This thesis is presented for the Degree of
Doctor of Philosophy
of
Curtin University**

April 2018

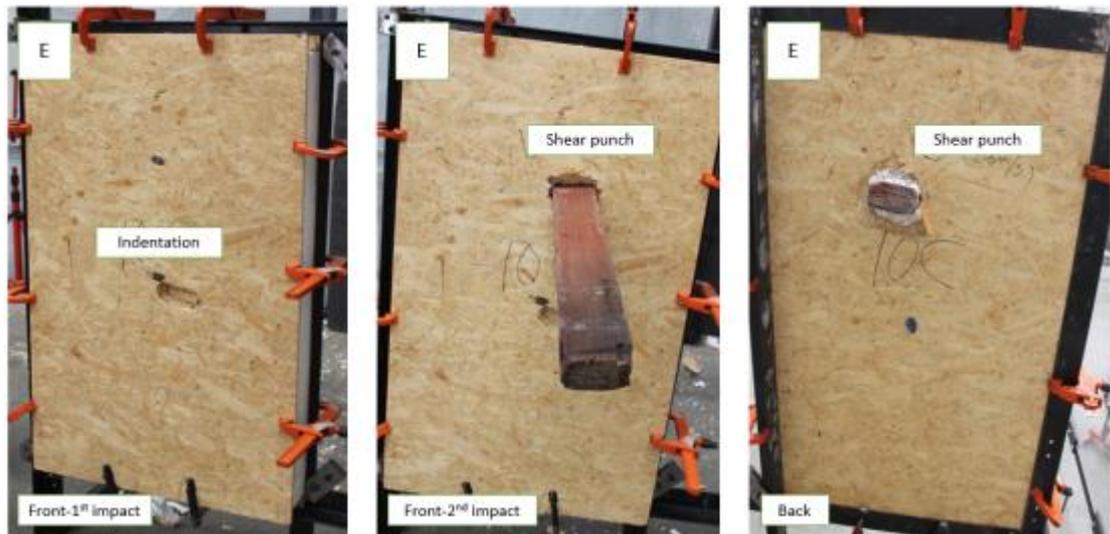
Figure 6.9 Damage mode of specimen E strengthened with an adhesive coated basalt fibre mesh (5×5 mm spacing) interlayer (L) Front view-1st Impact 16 m/s; (M) Front view-2nd Impact 20 m/s; (R) Back view

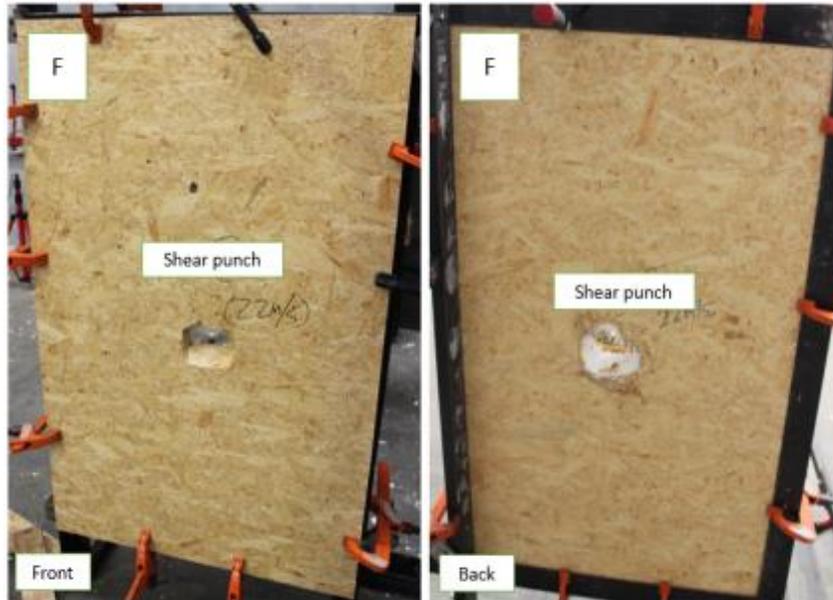
Figure 6.10 Damage mode of specimen F strengthened with double steel wire mesh interlayers (1st impact 23 m/s) (L) Front view; (R) Back view

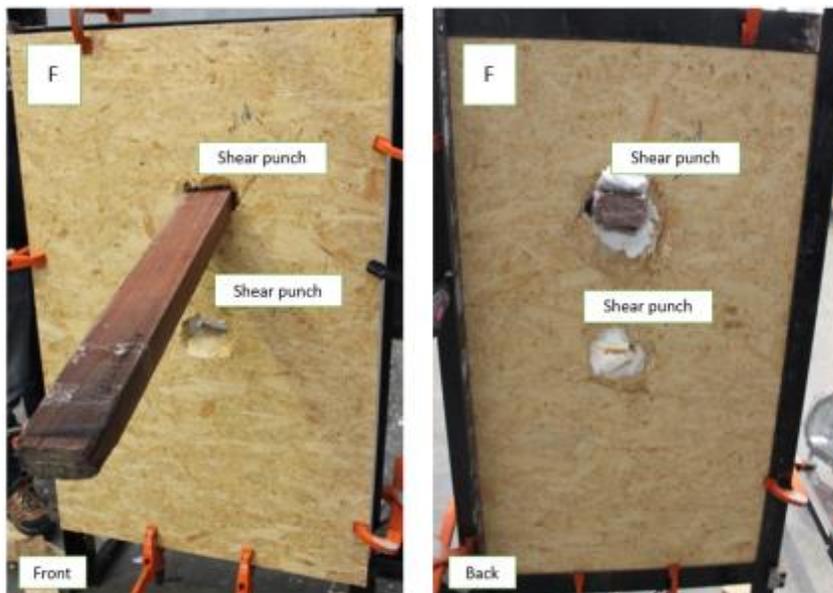
Figure 6.11 Damage mode of specimen F strengthened with double steel wire mesh interlayers (2nd impact 20 m/s) (L) Front view; (R) Back view

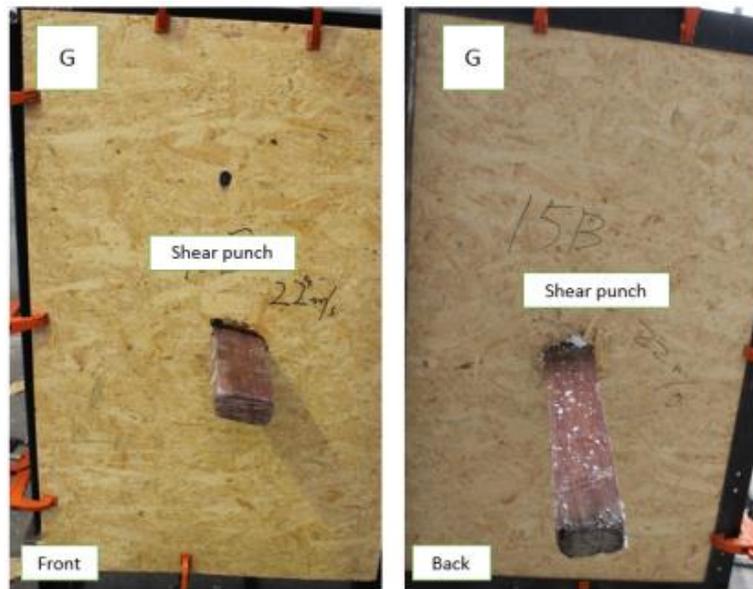
Figure 6.12 Damage mode of specimen G strengthened with double uncoated basalt fibre mesh (10×10 mm spacing) interlayers (1st impact 23.0 m/s) (L) Front view; (R) Back view

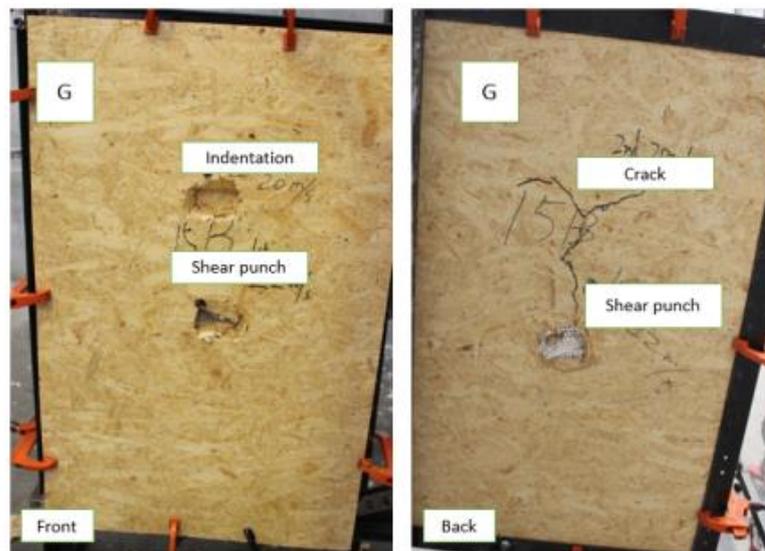
Figure 6.13 Damage mode of specimen G strengthened with double uncoated basalt fibre mesh (10×10 mm spacing) interlayers (2nd impact 20.2 m/s) (L) Front view; (R) Back view

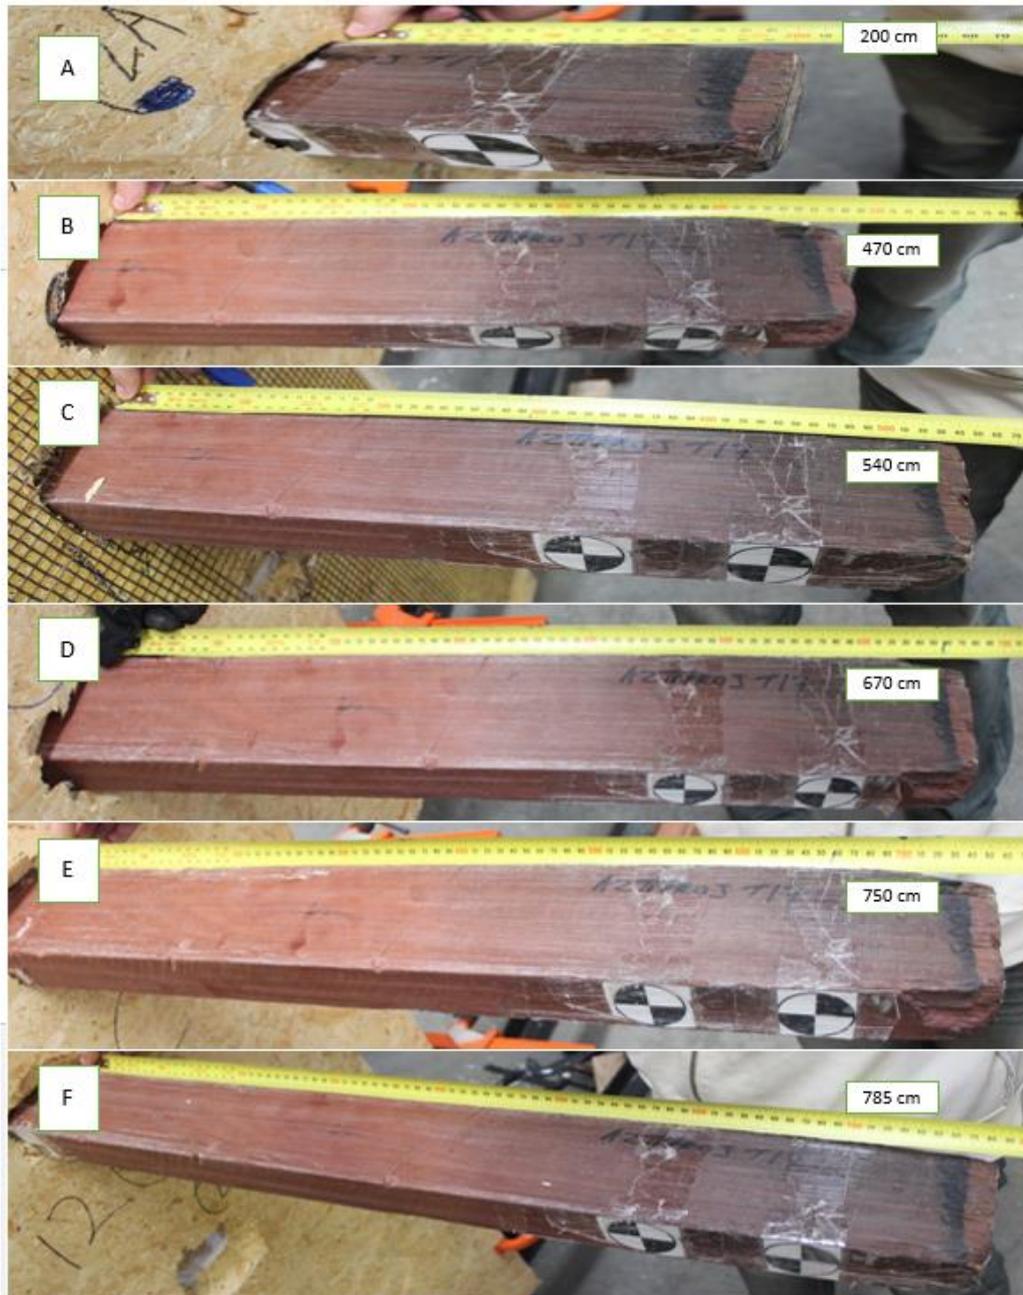
Figure 6.14 Unpenetrated length of projectile (A/B/C/D/E/F) at the critical velocity of 20 m/s

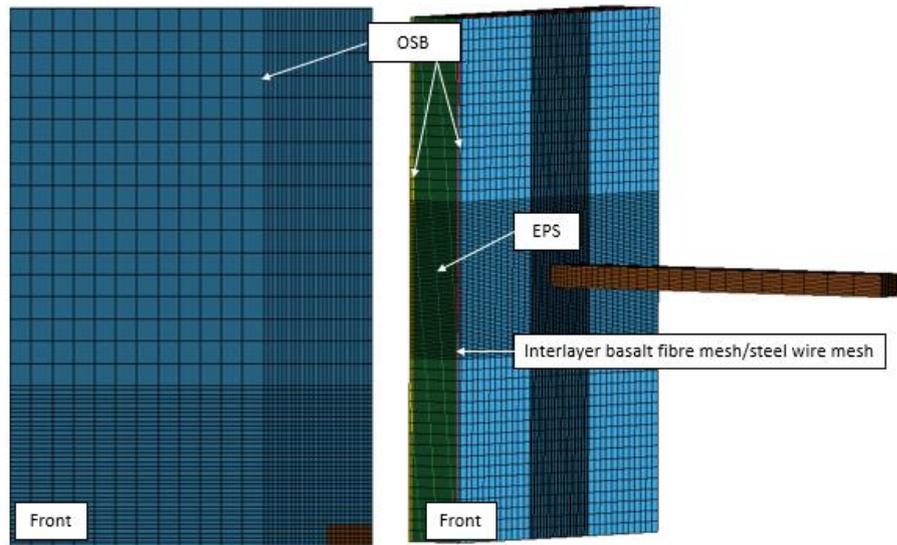
Figure 6.15 Numerical model (L) Quarter model (front view); (R) Reflected full model (angled view)

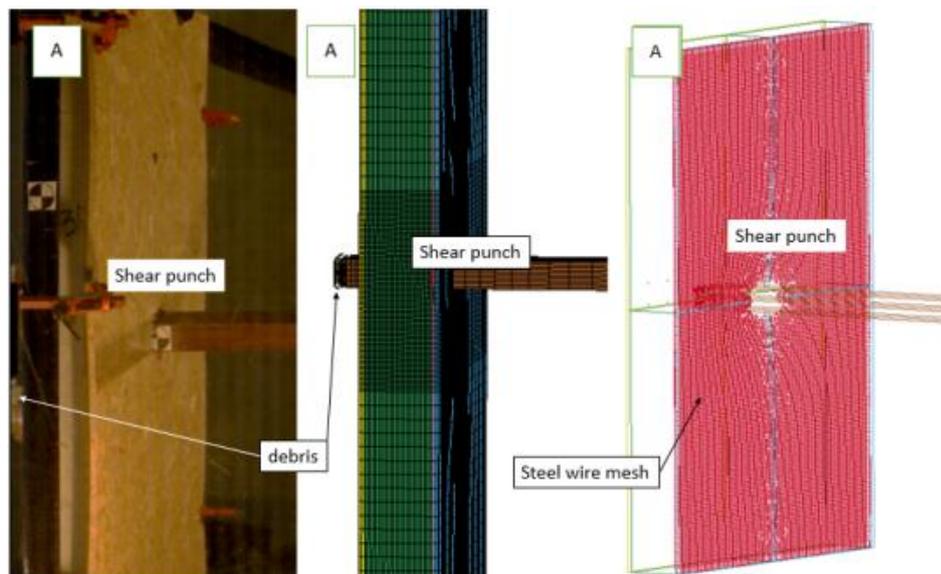
Figure 6.16 Comparisons of damage mode of the specimen A (1st impact 22.8 m/s); (L) Test; (M) Numerical; (R) Numerical (the layer of steel wire mesh)

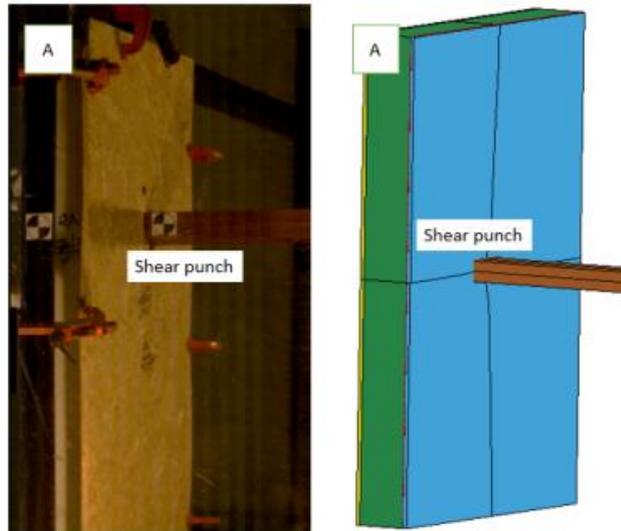
Figure 6.17 Comparisons of damage mode of the specimen A (2nd impact 20 m/s); (L) Test; (R) Numerical

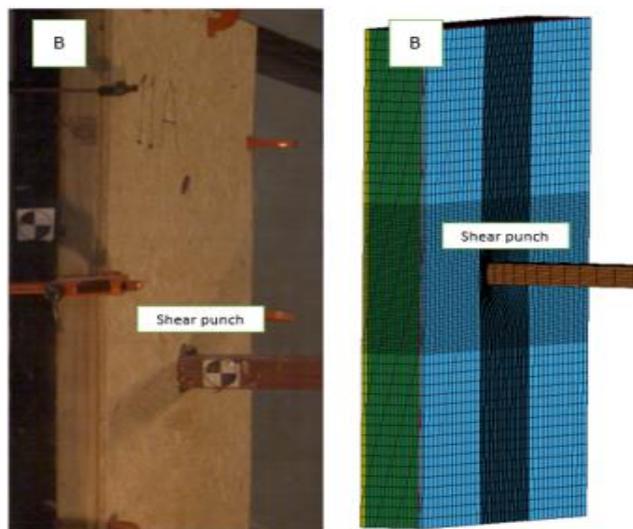
Figure 6.18 Comparisons of damage mode of specimen B (1st impact 20 m/s); (L) Test; (R) Numerical

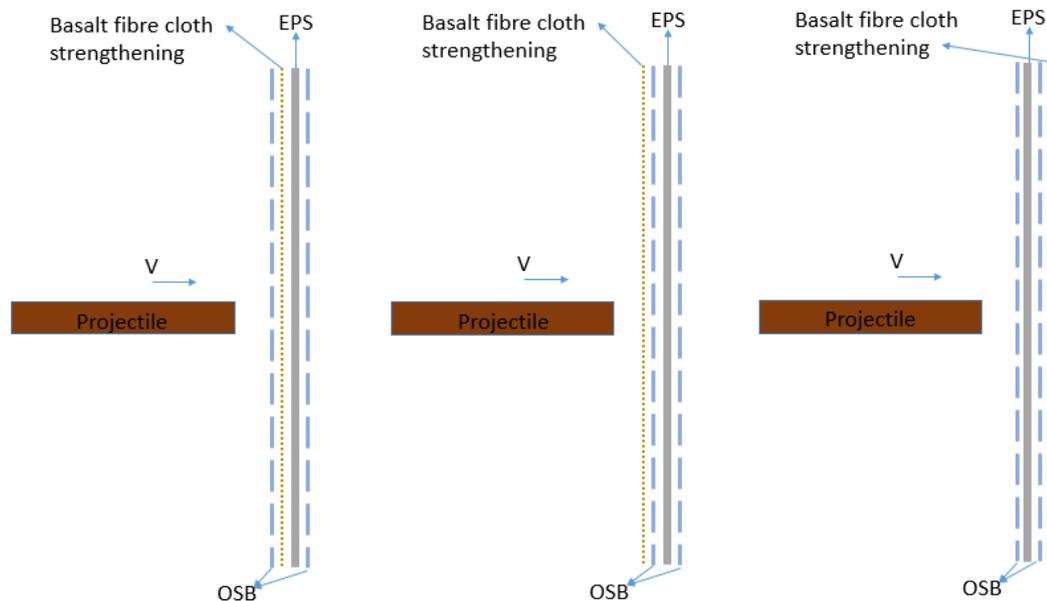
Figure 7.1 Schematic diagram of Basalt fibre strengthening (L) Interlayer strengthening (Panel B/C) (M) Front surface strengthening (Panel D); (R) Back surface strengthening (Panel E)

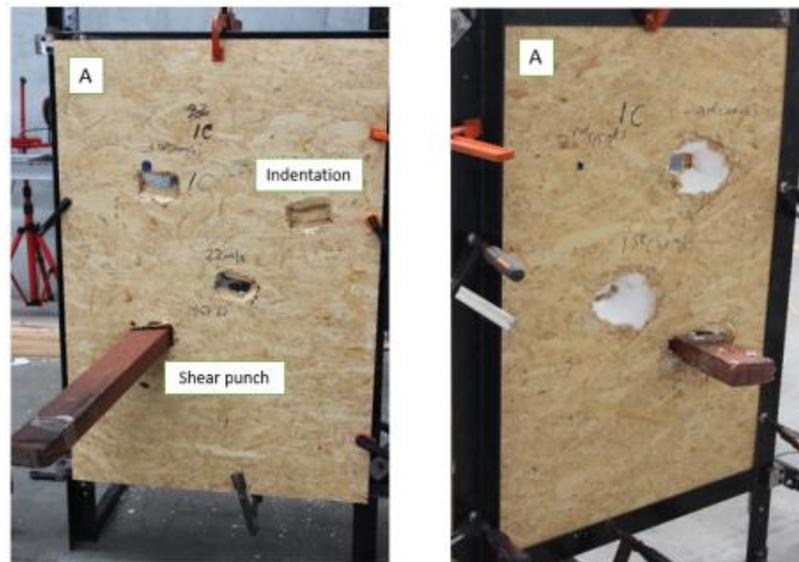
Figure 7.2 Photograph of specimen A (L) Front view; (R) Back view

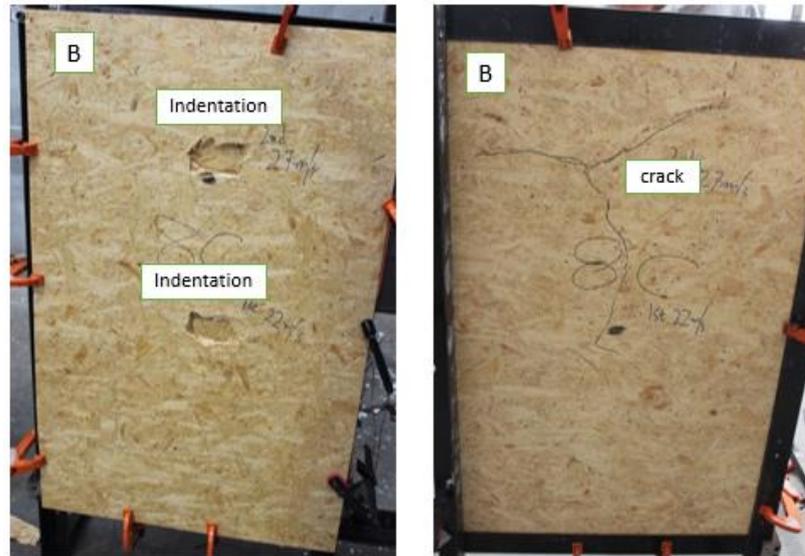
Figure 7.3 Photograph of specimen B (L) Front view; (R) Back view

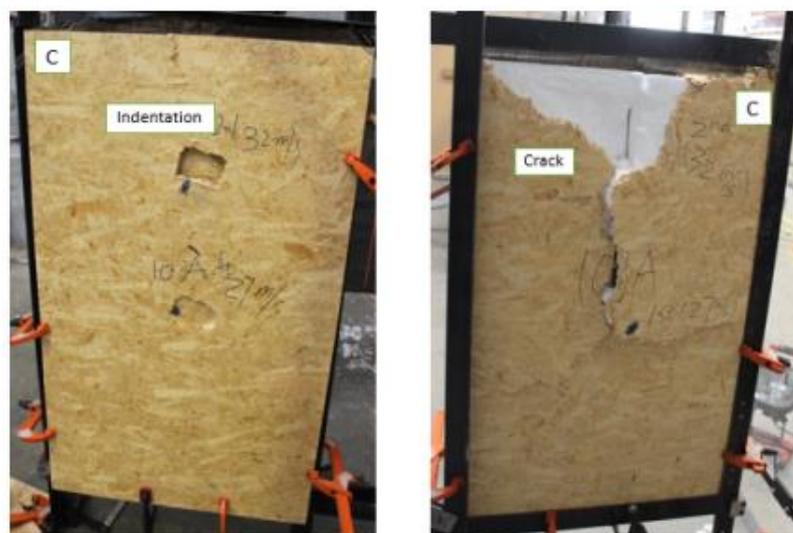
Figure 7.4 Photograph of specimen C (L) front view; (R) Back view

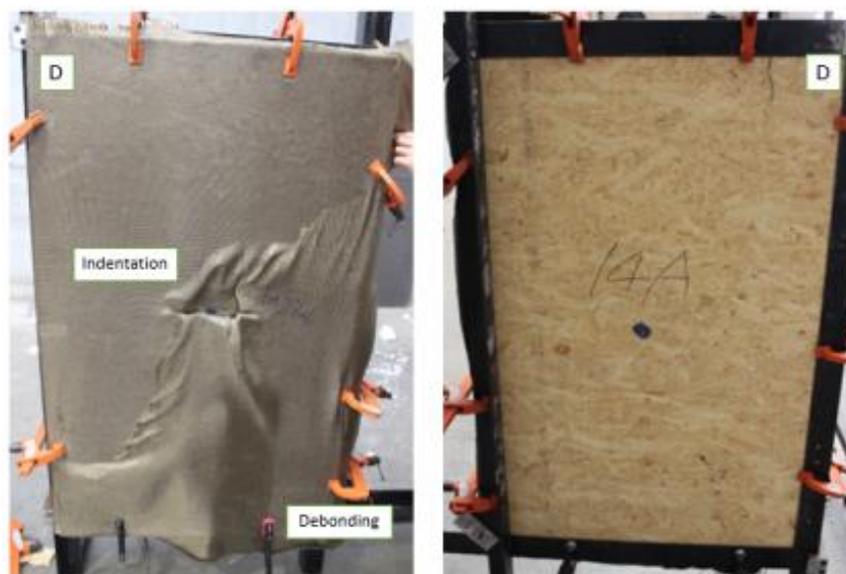
Figure 7.5 Photograph of specimen D-1st strike (L) Front view; (R) Back view

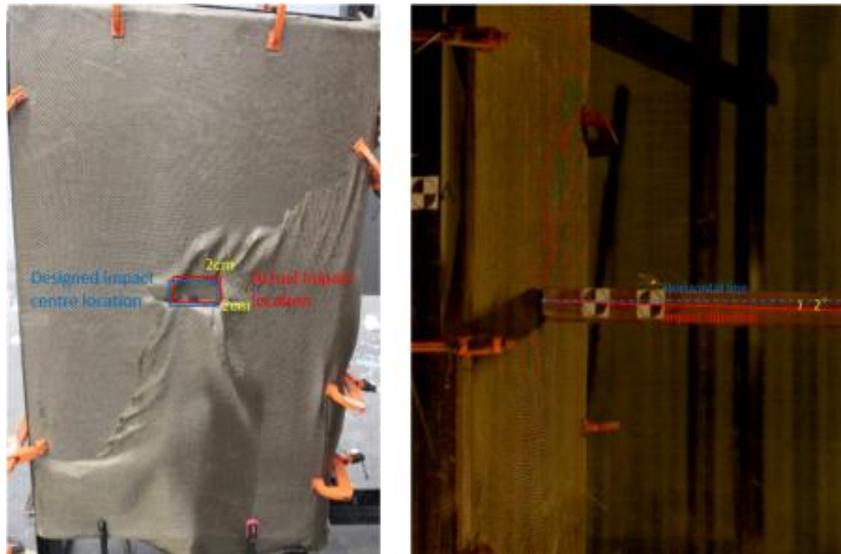
Figure 7.6 Comparison of designed test and actual test condition (L) eccentricity; (R) tilted projectile impact angle

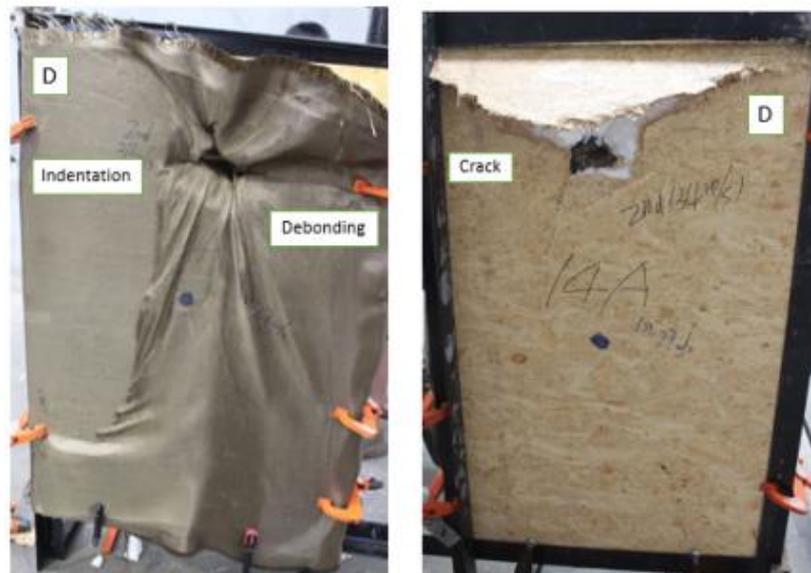
Figure 7.7 Photograph of specimen D-2nd strike (L) Front view; (R) Back view

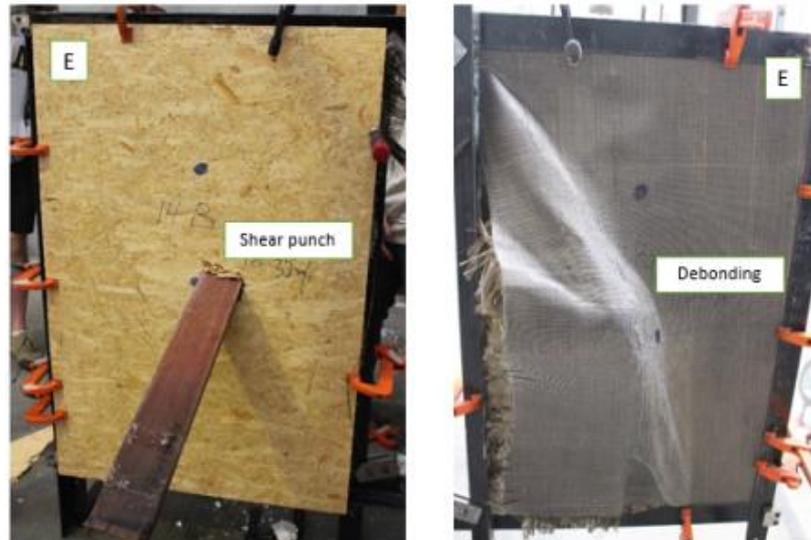
Figure 7.8 Photograph of specimen E (L) Front view; (R) Back view

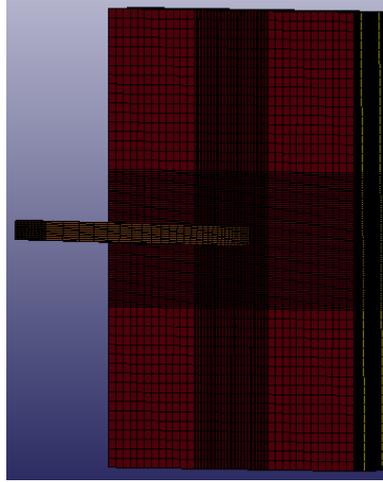
Figure 7.9 Numerical model

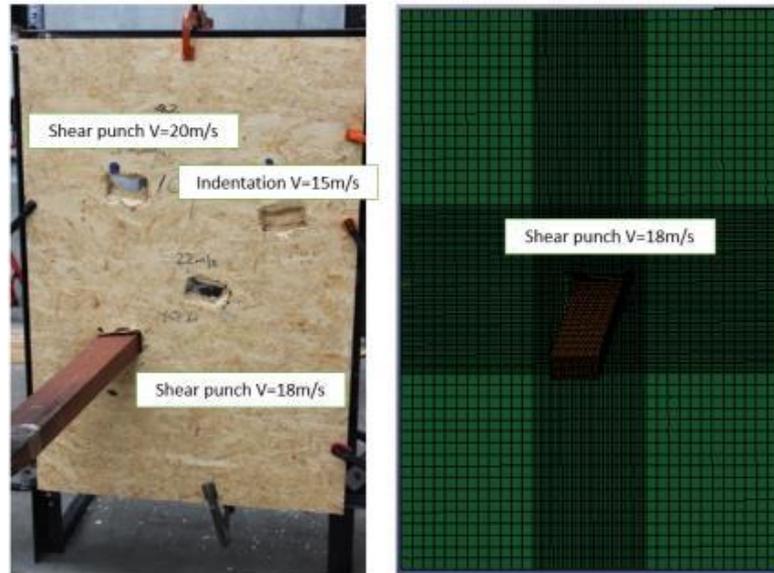
Figure 7.10 Comparisons of damage mode of specimen A (Front view) (L) Test; (R) Numerical

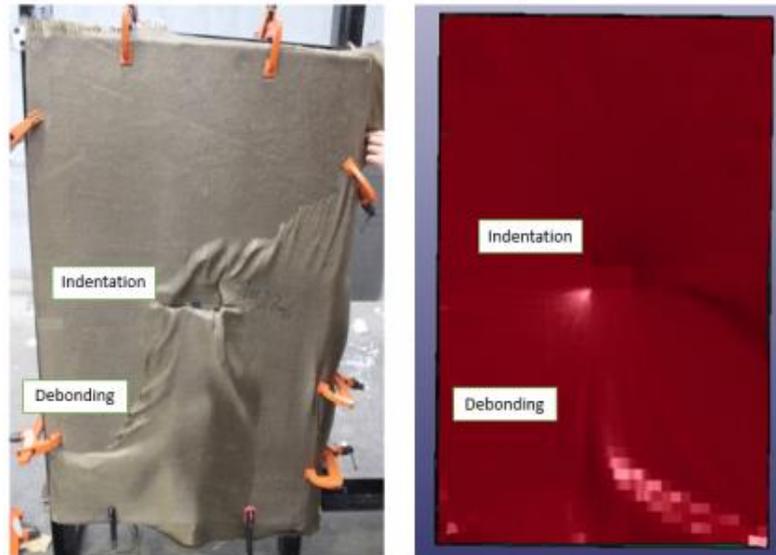
Figure 7.11 Comparison of damage mode of specimen D (Front view) (L) Test; (R) Numerical

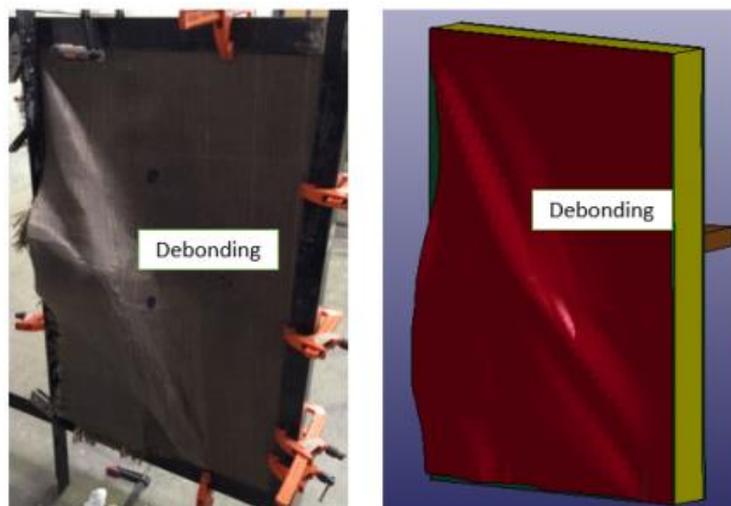
Figure 7.12 Comparison of damage mode of specimen E (Back view) (L) Test; (R) Numerical
