Preliminary Report:

Conservation Concerns for the Lalibela

Rock Hewn Churches

Dr Yirga Gelaw Woldeyes
Curtin University, Australia
Version 3, 14 October 2018

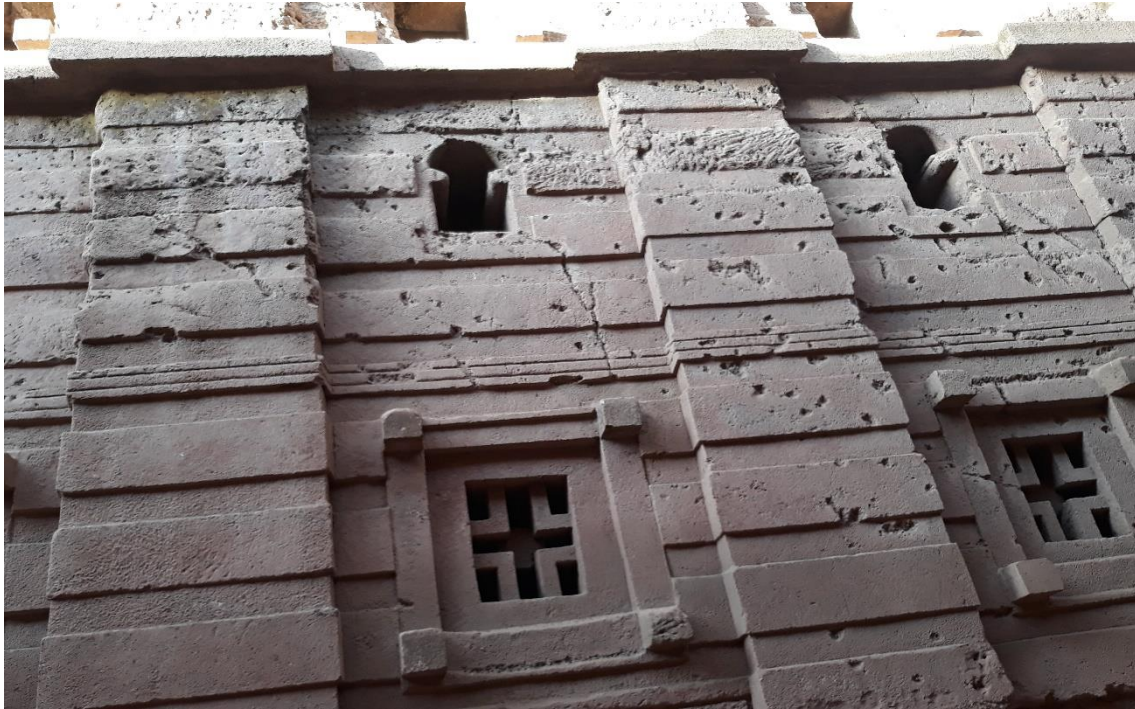
Modern restoration methods introduced foreign objects to the churches. The most intrusive method was applied in 1954 when some of the walls of the churches were nailed to accept cement and red paint. On Bete Amanuel and Bete Medhanialew churches, the restorers applied a bituminous layer and red ochre ink. The paint smelt profusely and the bituminous layer started to swell and fall off the wall, so a new technique was called for. Under a massive restoration project led by the Italian architect Angelini, the paint and cement were scrapped and the nails forcefully pulled out. This process left massive fractures and cracks especially on the Bete Amanuel and Bete Medhanialew churches (Ayalew, 2016). Some people call Bete Amanuel the most tortured of all the churches, with the insertion and removal of the nails leaving the church severely pockmarked and cracked (see Figure 3 and 4).

Figure 3: Bete Amanuel, the tortured church. The holes in the surface were caused by the insertion and removal of nails.

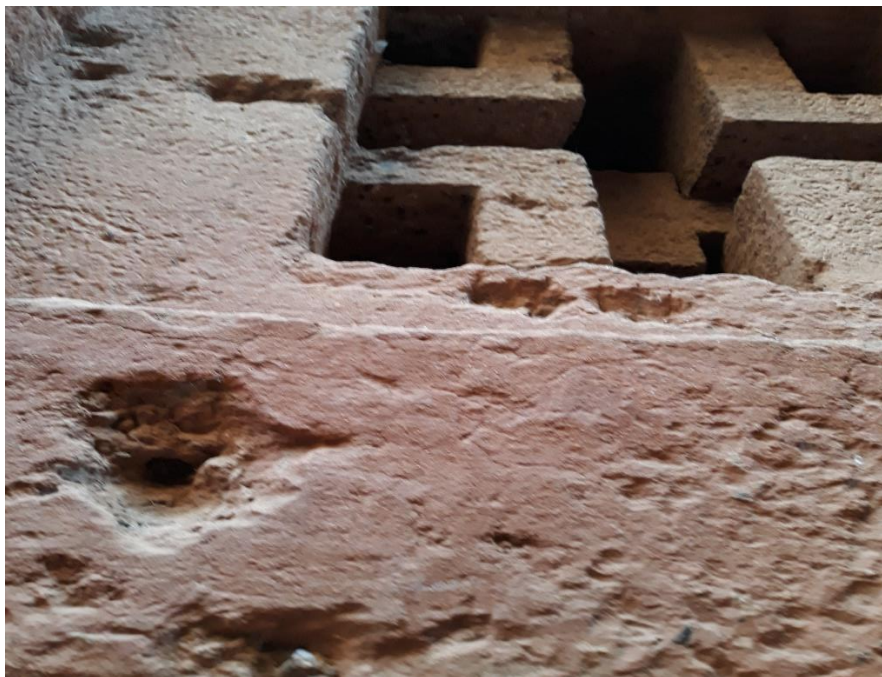
Figure 4: Close up of pockmarks on Bete Amanuel caused by nails.

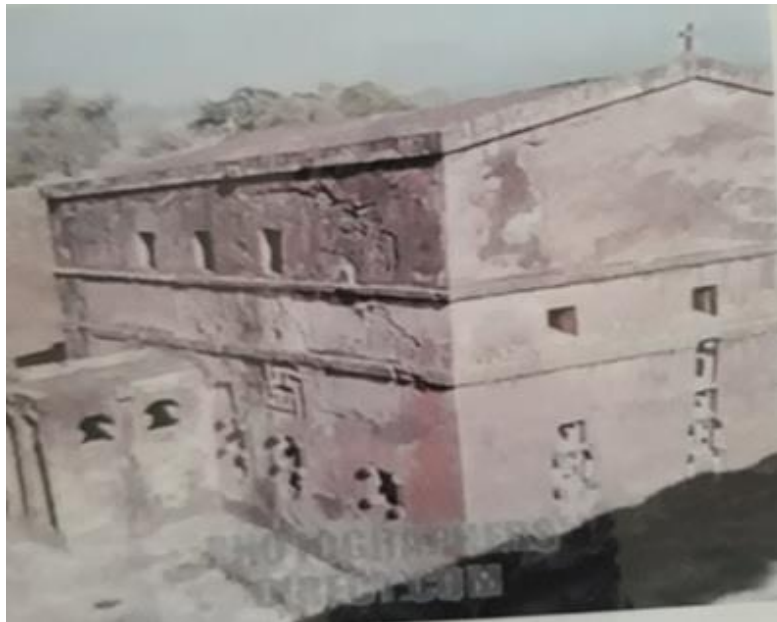
Angelini's restoration project was extremely intrusive and damaging. Alongside the significant damage to Bete Amanuel and Bete Medhanialem, the two crosses that stood on top of the roof of the Bete Mariam church were completely destroyed (Ayalew, 2016) (See

Figure 5: Bete Mariam church with the original crosses on the top. The church today, with the crosses missing, can be seen on the front cover of this report.

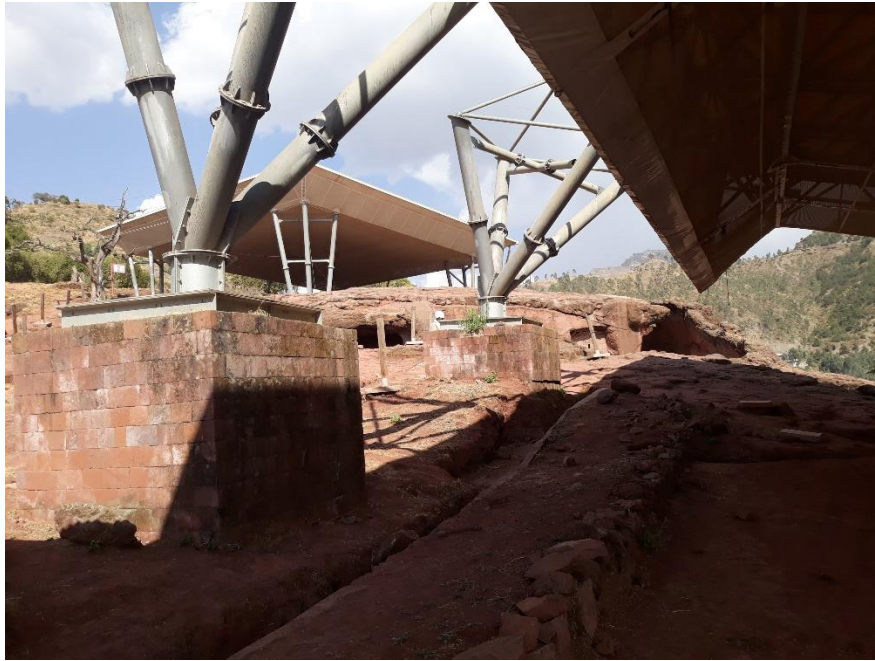
- At Bete Amanuel church, one of the feet of the shelters rests directly on the roof of an underground tunnel and this poses a similar threat.
- The shelter over Bete Libanos poses a similar challenge. The two heavy feet that carry the shelter stand very close to the top of the church itself (see Figure 9). Even before the shelters were made, Bete Libanos was identified by UNESCO as having a high land sliding risk and requiring emergency conservation measures (UNESCO, 2007b, p. 22). Given the churches are made from a single rock structure, there are fears that any pressure to any part of the rock would have a serious impact on the entire structure.

Figure 9: The two metal foundations standing near the top of Bete Libanos.

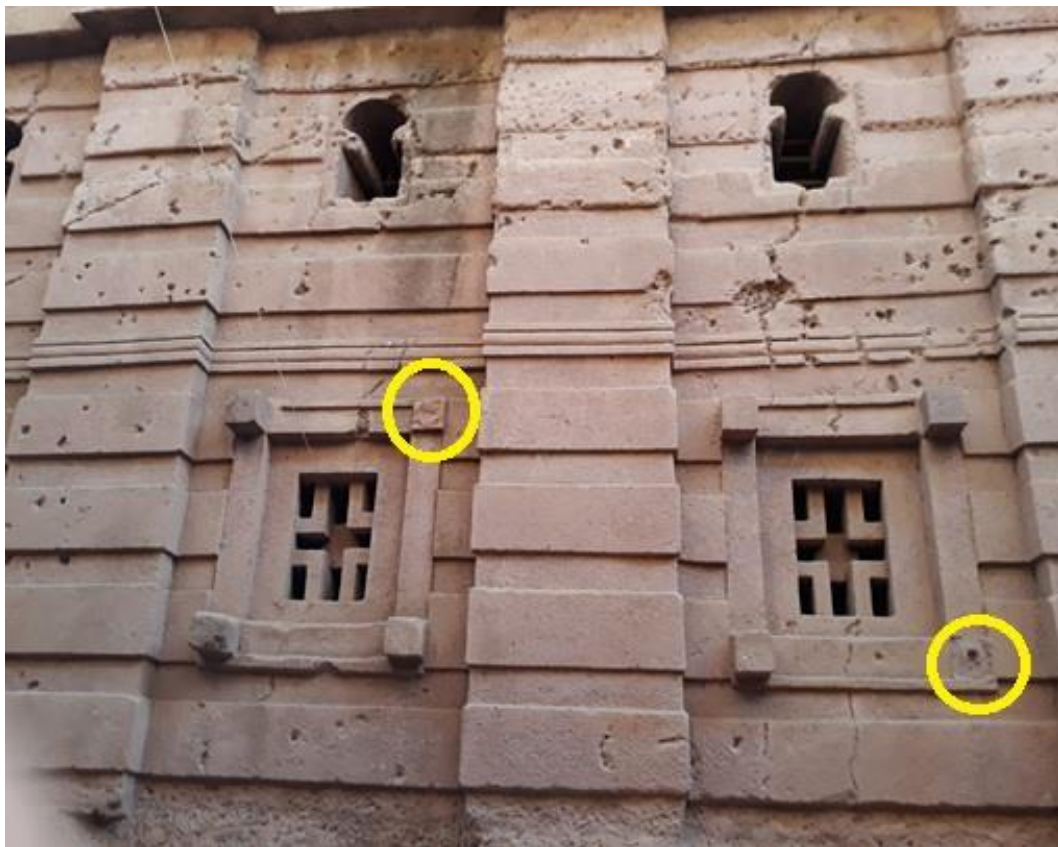
5. During the construction of the shelters, damages occurred to the churches. Local residents report that damages occurred when the previous shelters were removed in order to install the EU shelters. Others have told me that further damage occurred during construction. For example, during the construction of the shelter at Bete Amanuel, an accidental falling of construction materials cut two monkey-head style protruding beams from two windows on the north facing side of the church (see Figure 10). Another falling of construction material caused a crack on the Bete Medhanialem church. Moreover, there are local reports of hidden or unreported damages caused during the construction process. No attempt was made to assess known or unknown damages or hold the actors accountable for the damages they caused to the churches.

Figure 10: Monkey-head style protruding beams on Bete Amanuel. Severed beams (circled) were broken during the shelter construction.
