Guidelines for Safe Cable Crossing over a Pipeline

Abstract

This paper documents a recent case study of damage of a field joint coating at a crossing of an existing pipeline by a 132 kV subsea cable of 191 mm outside diameter. Investigation of the damage on site revealed that it was caused by lateral movement of the cable under the influence of hydrodynamic forces.

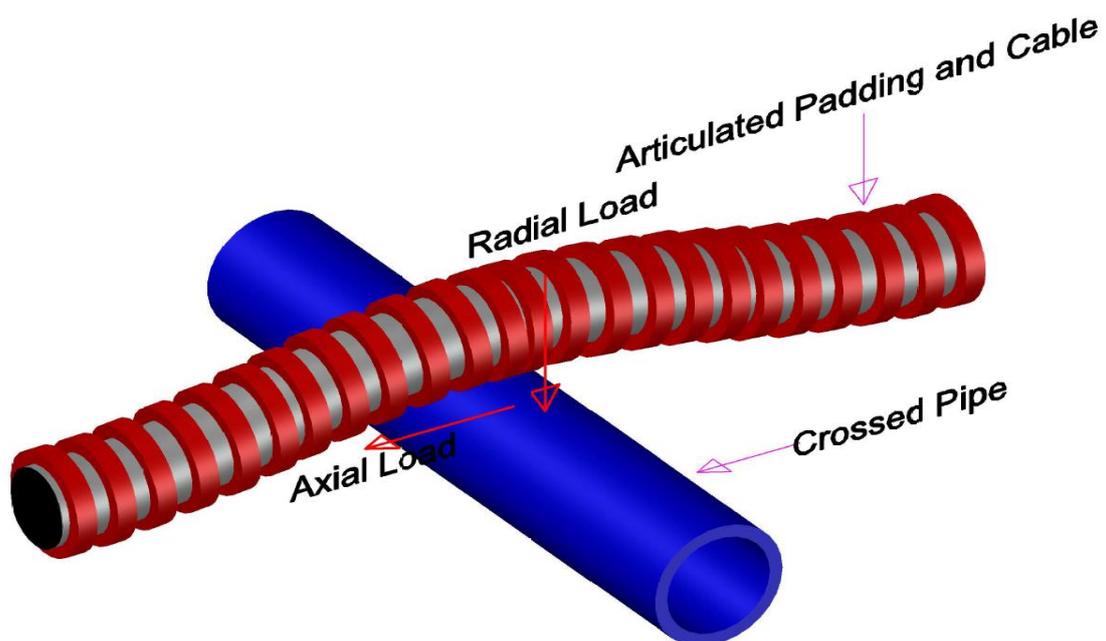
This paper describes a case study of recent failure of a field joint coating of crossed pipelines due to installation of a 132 kV submarine cable, along with the subsequent underwater repair. The cause of the damage was assessed and found to be a combination of increased hydrodynamic loads plus excessive lateral cable movement associated with the hydrodynamic forces, resulting in unexpected level of radial and axial loads on the field joint coating of the crossed pipeline as depicted in Figure 1.

Figure 1: Radial and axial loads applied on the field joint by the cable and articulated padding

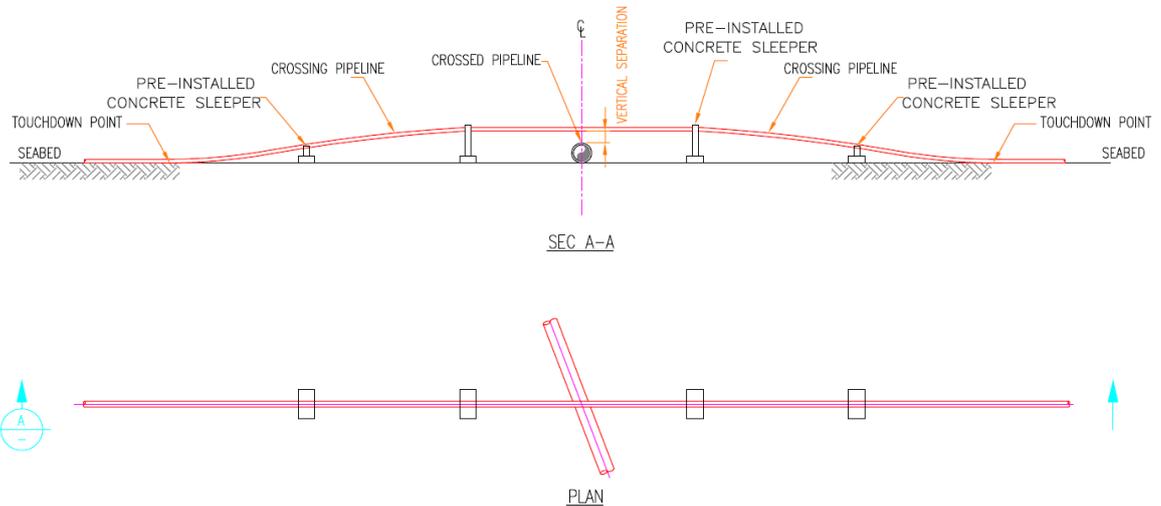
Figure 2: Discrete supports

It should be noted that the crossing angle shown in Figure 2 is less than 90 degrees. Many pipeline industry sources recommend the included angle between the crossing and crossed pipelines be at a minimum of 30°. This is not based on technical integrity concerns but rather to simplify the construction of the crossing.

If the crossing design concept uses discrete supports or a ramp as shown in Figure 2, a geotechnical survey is also required at the crossing point to enable characterisation of the soil type and its shear strength parameters. However, this survey is not required if the design is based on articulated padding, since the positive separation is maintained irrespective of the settlement of the crossing configuration.

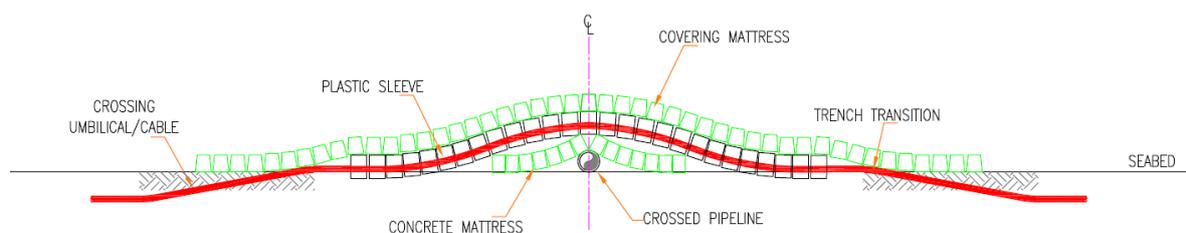
3. Using the existing crossed pipeline as a support. Provided that:
 - The loads imposed on the crossed pipeline are within the allowable limits.
 - The crossing cable does not bear directly on the crossed pipeline (i.e. the required vertical separation between the crossed and crossing assets are maintained).
 - The integrity of the coating of the crossed and crossing assets are not impaired.
 - The cathodic protection of the crossed and crossing assets are not jeopardised.

Figure 3: Using the crossed pipeline as a support

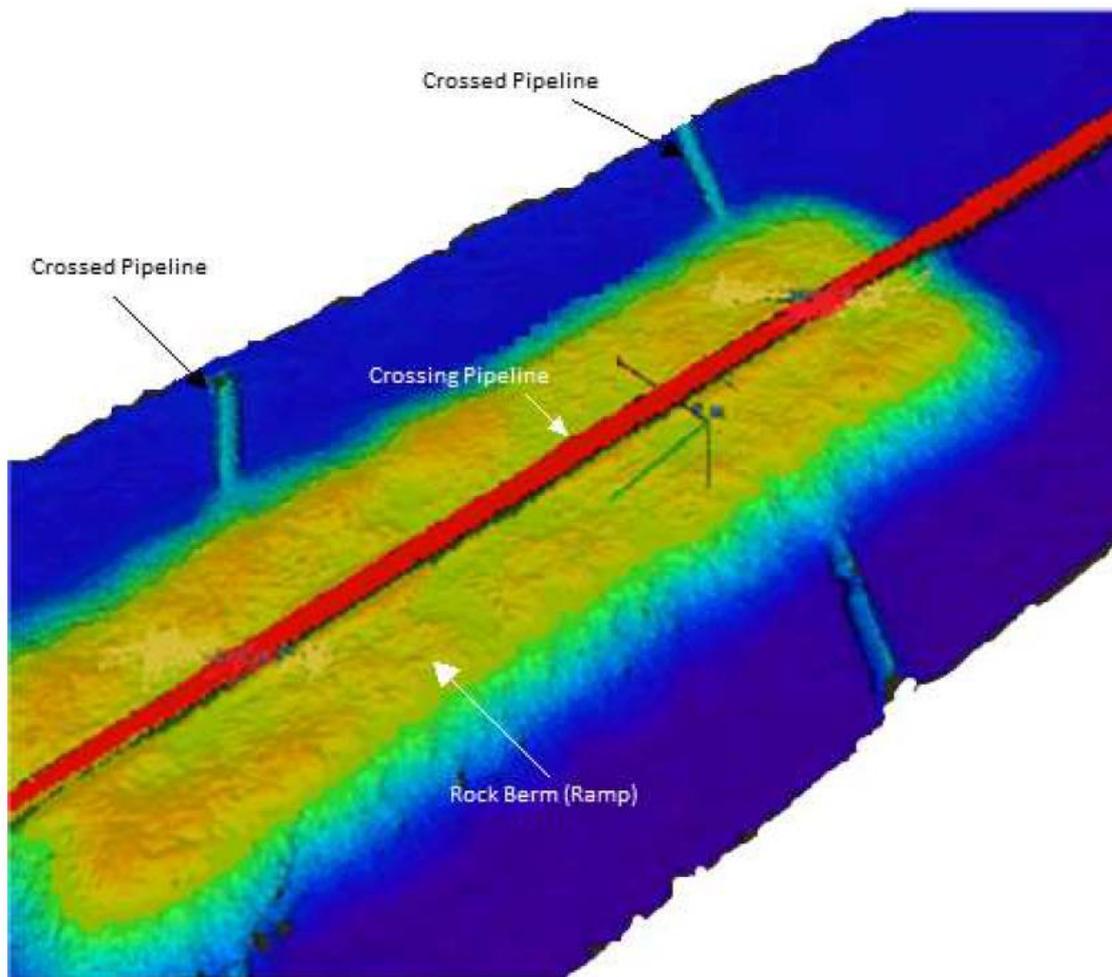
Figure 4 shows a rock cover placed on an existing crossed pipeline with the new pipeline laid on the rock cover. Some designs may subsequently add rock cover over the crossing pipeline. Design of this top rock cover reflects the requirements of secondary stabilisation of the crossing pipeline, upheaval buckling hold down and protection against trawl board or dragging anchor. Design of the rock cover will account for the stability of the rock as well as the potential settlement of the rock.

Figure 4: Rock dump concept [Ref. [6]]

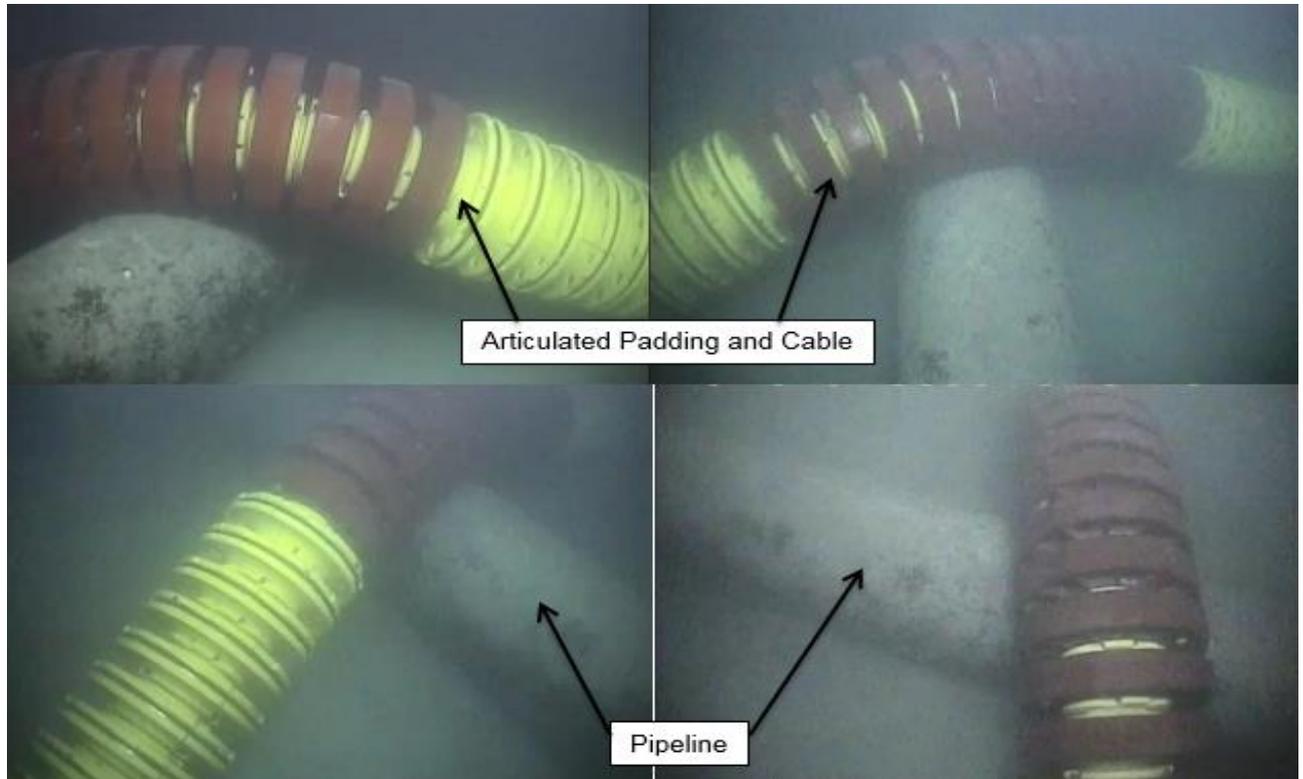
The articulated padding disc unit is typically made of polyurethane. In this application, it was comprised of two half-shells installed around the bend restrictors at the crossing location. The half-shells were secured by bolting or using pre-cut corrosion resistant banding. The articulated padding outside diameter was 1010 mm, so when the articulated padding was placed over the crossed pipeline at the crossing point, the required separation of 410 mm was maintained over the design life.

Figure 5: General arrangement of the articulated padding crossing system [Ref.[1]]

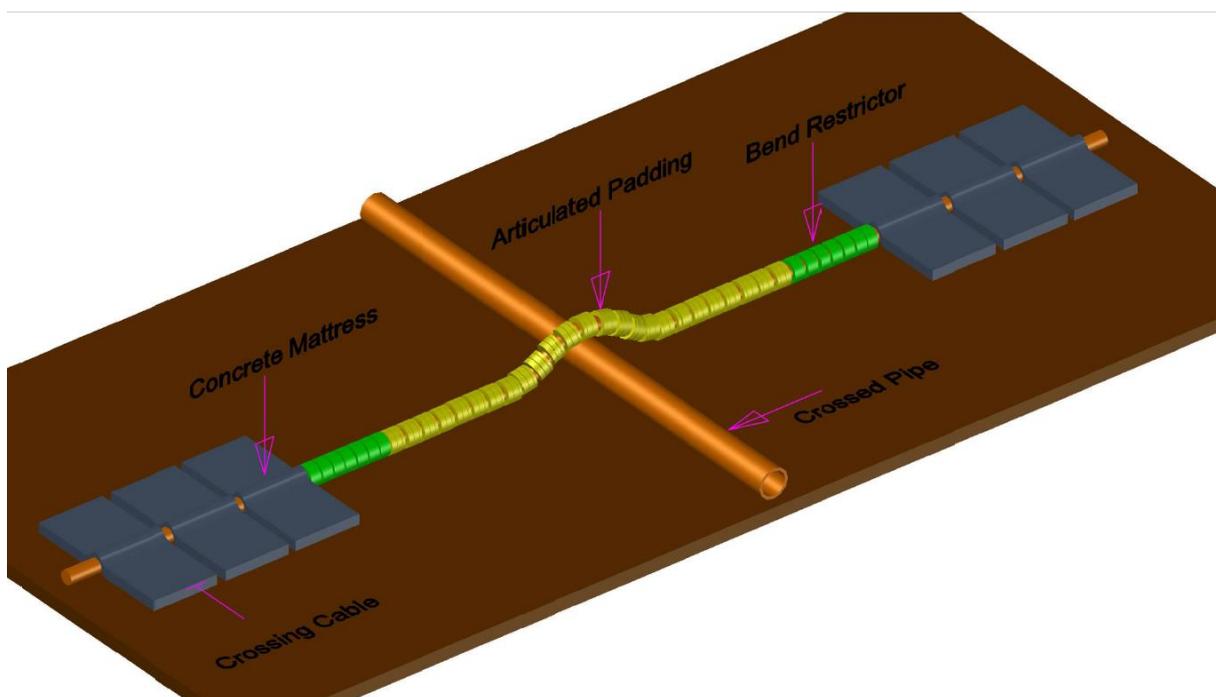
Figure 6: Schematic showing the general arrangement of the articulated padding crossing system.

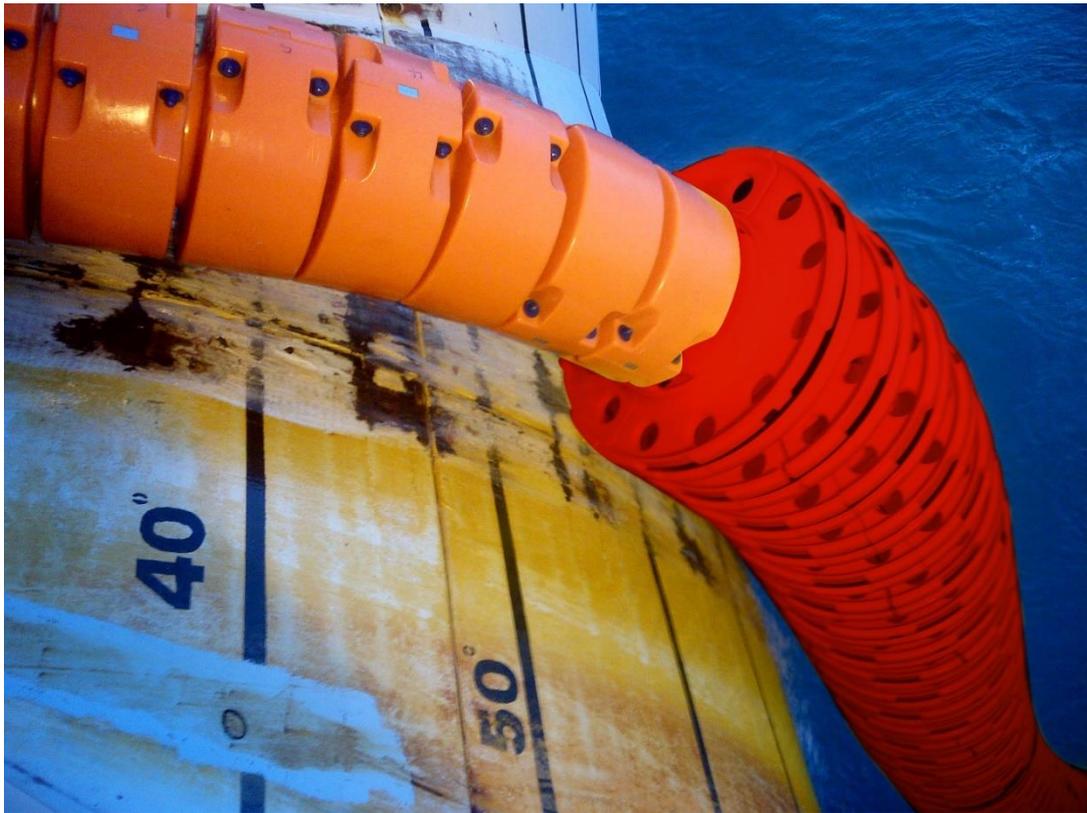
Figure 7 shows deployment of the articulated padding system during the cable installation.

Figure 7 Deployment of the articulated padding

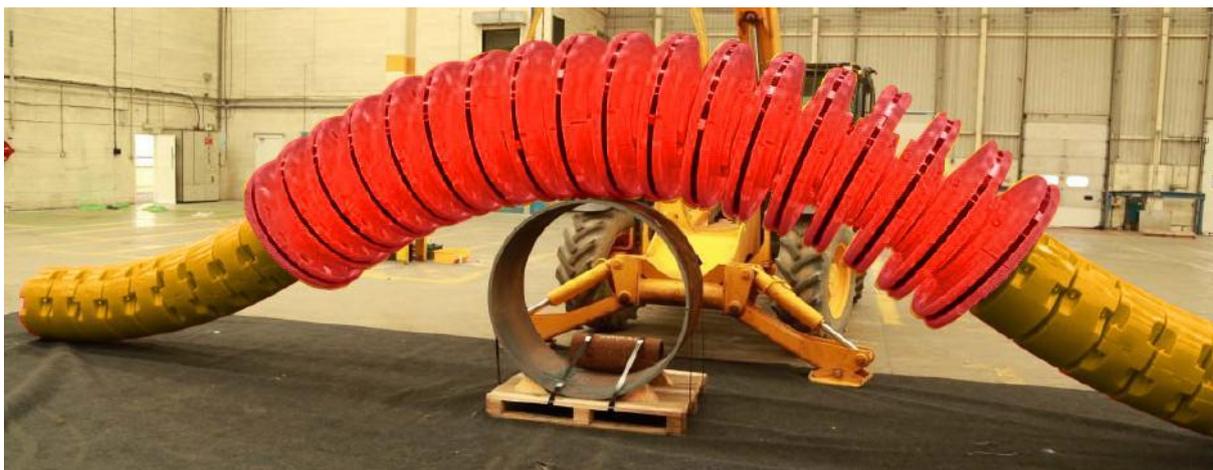
Figure 8 shows the mock-up trial undertaken on the articulated padding and bend restrictors. The mock-up test was performed to ensure efficiency of the offshore installation procedure during the actual operation.

Figure 8: Mock-up test undertaken at the factory.

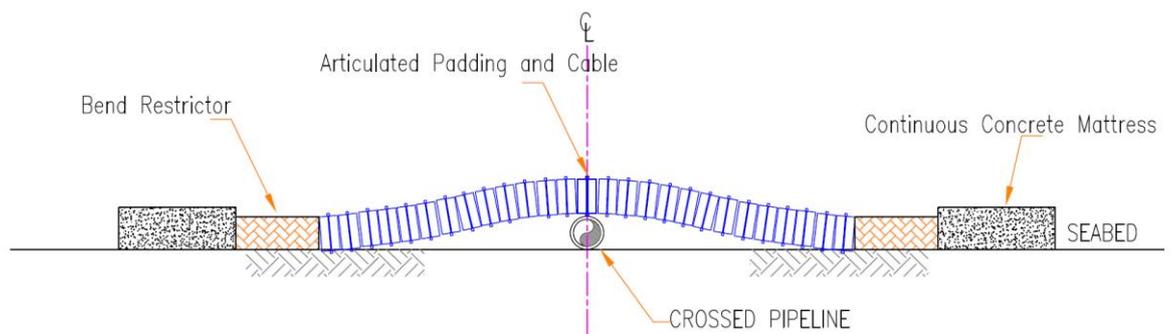
The schematic in Figure 9 illustrates elements of the crossing design adopted for the subsea power cable using the articulated padding system and the crossed pipeline as a support. Fitted around the crossing cable, the articulated padding provides the required positive vertical separation and prevents the cable itself from bearing directly on the crossed pipeline. The vertical separation is measured from the top of the crossed pipe to the bottom of the cable's body, as illustrated in Figure 10. The diameter of the articulated padding is designed and moulded to provide a design vertical separation of 410 mm. The design vertical separation depends on the voltage induced by the cable in the crossed pipeline. The separation is sufficient to ensure that the induced currents from the power cable will not cause any interaction with existing cathodic protection of the crossed pipeline.

Figure 9: General arrangement of the articulated padding crossing system

- Finite element dynamic analysis was undertaken on the crossing arrangement shown in Figure 9. Results of the dynamic analysis showed that the predicted lateral movement of the subsea cable was excessive. Further work showed that the movement could be reduced to within acceptable levels by placing a concrete mattresses outside the touchdown points, as shown in Figure 9, ensuring that the limit states listed in Table 1 are satisfied.

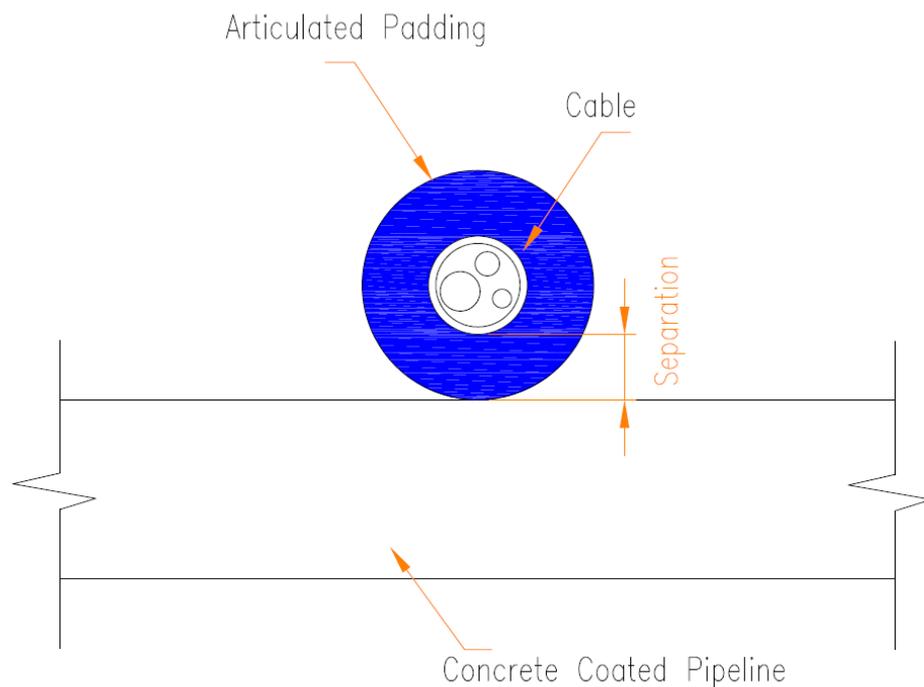
Figure 10: Positive Separation between the crossing cable and the crossed pipeline.

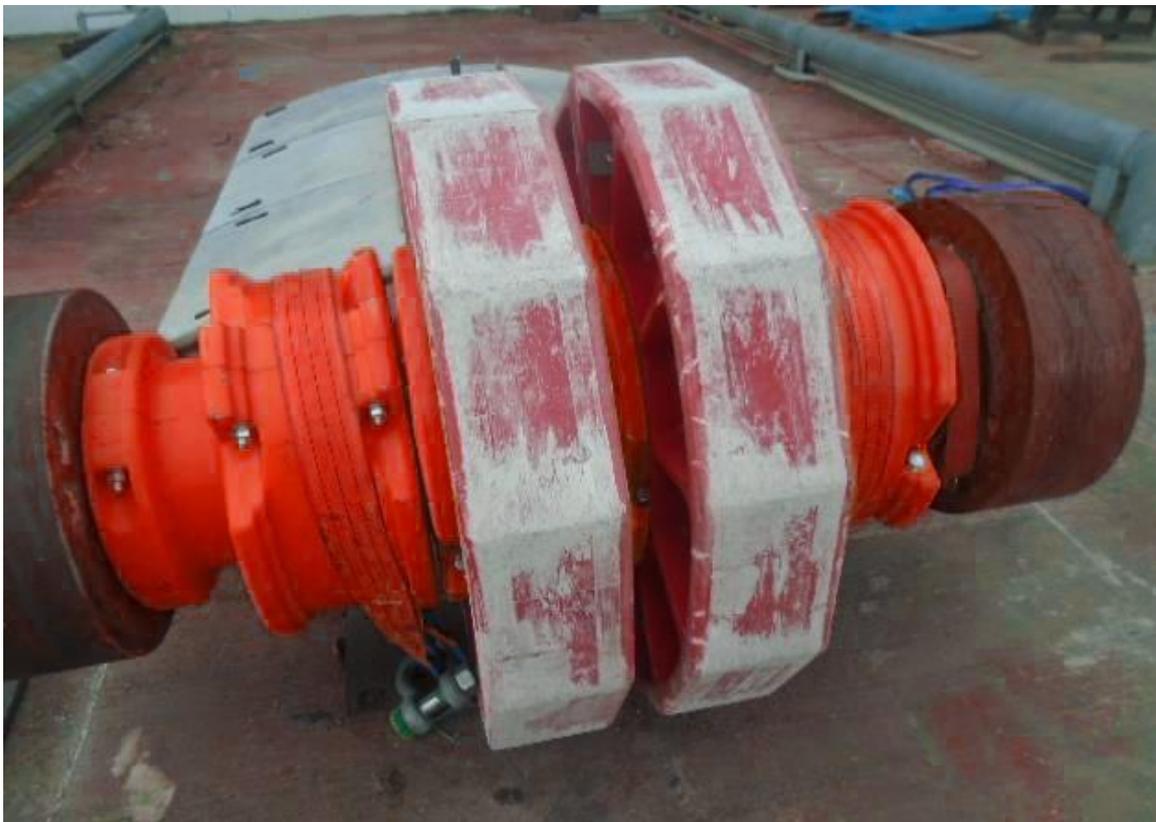
- An abrasion test (see Figure 11) was conducted to ensure that the material loss due to abrasion of the articulated padding will comply with the design life of the cable. Value of the span length between the two cable touchdown points will be such that in-line or cross-flow VIV will not take place as per the criteria given in DNVGL-RP-F105 [Ref. [12]] and Ref.[14]. VIV refers to Vortex induced vibration.

Figure 11 Abrasion Test outcome

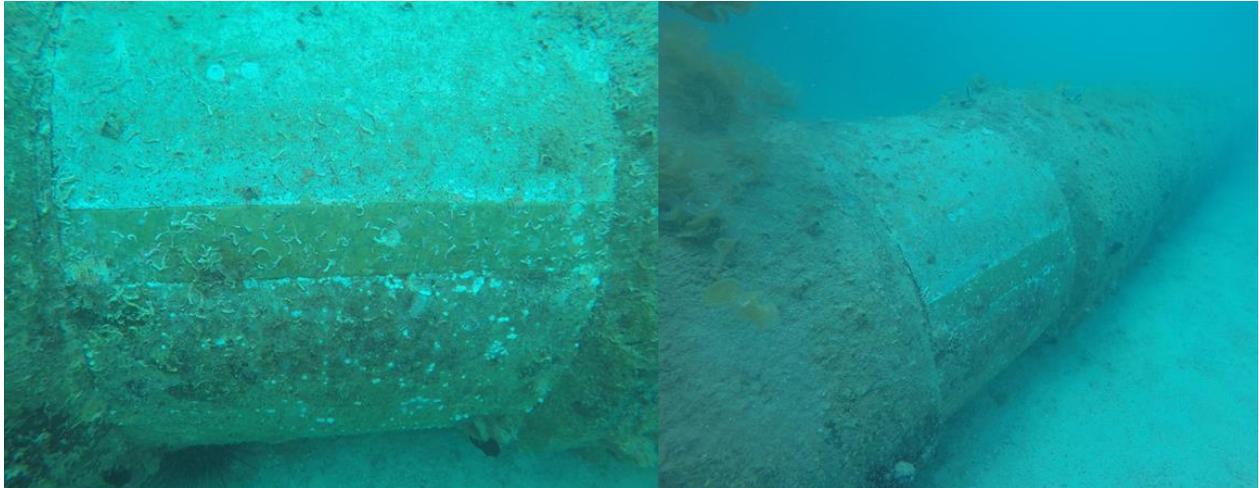
During the visual survey, the anodes in the proximity of the crossing point were identified as shown in Figure 12. Design of the crossing ensured that any lateral cable movement due to hydrodynamic forces would be away from the existing sacrificial anodes. To ensure that the cathodic protection of the crossed pipeline is not compromised, the cable lay was arranged so that the cable crossing was mid-way between the anodes as per [Ref. [14]].

Figure 12: Anodes in the proximity of the crossing point

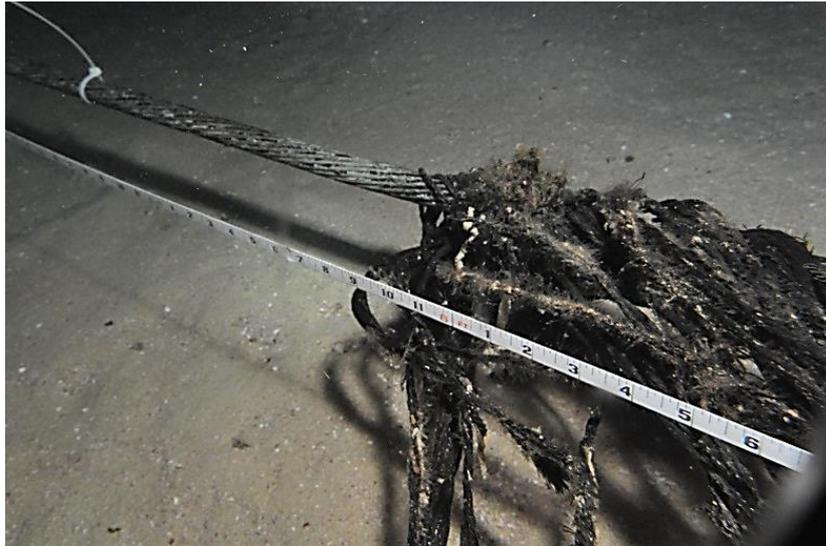
- Excessive and repeated lateral movement of the cable that could lead to abrasion to the outer sheathing of the cable, as shown in Figure 13. Once the outer sheath is abraded, the galvanized armour will also gradually abrade, and consequently the armour will corrode. Abrasion of the subsea cable takes place due to relative motion of the cable against rough surfaces such as a rocky seabed. [Ref. [16]] explained that cable abrasion over time, associated with the lateral movement, will inevitably lead to cable failure as shown in Figure 14. It is indicated by [Ref. [16]] that abrasion of the outer sheath of the cable could possibly lead to fibre failure and a cable break.

Figure 13: Outer sheathing damage and armour exposure due to instability

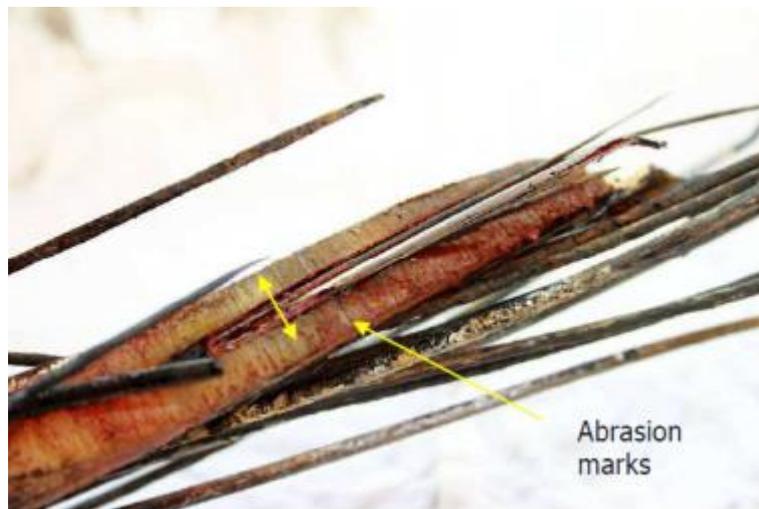
Figure 14: Example of cable break due to abrasion [Ref.16]

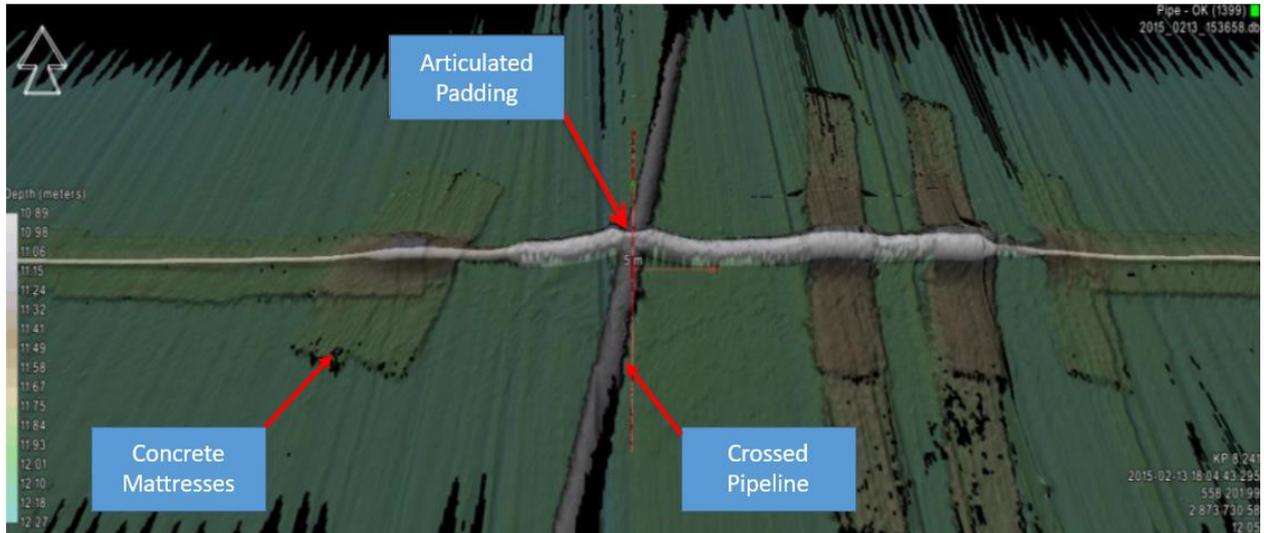
The 132 kV subsea power cable and the crossing arrangement shown in Figure 15 were installed successfully in 2012. Figure 15 presents a snapshot from the as-built survey undertaken upon completion of the concrete mattress installed to reduce lateral cable movement.

Figure 15: Snapshot from the as-built survey of the 132 kV -0.191 m power cable at the crossing area

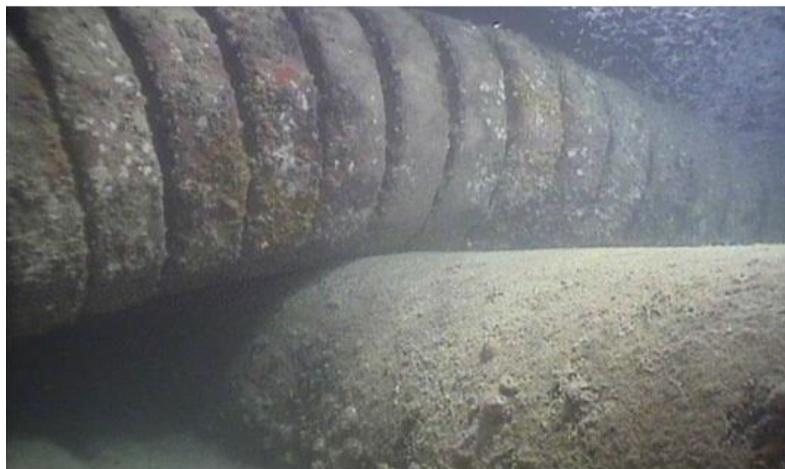
Figure 16: ROV Survey at the crossing locations- Note the articulated padding installed on the crossed pipeline away from the field joint

A post-installation survey was undertaken one year after the cable installation. The survey included three dozen crossing locations similar to that shown in Figure 16. Visual inspection revealed that coating damage had occurred in the pipeline field joint at two crossing sites.

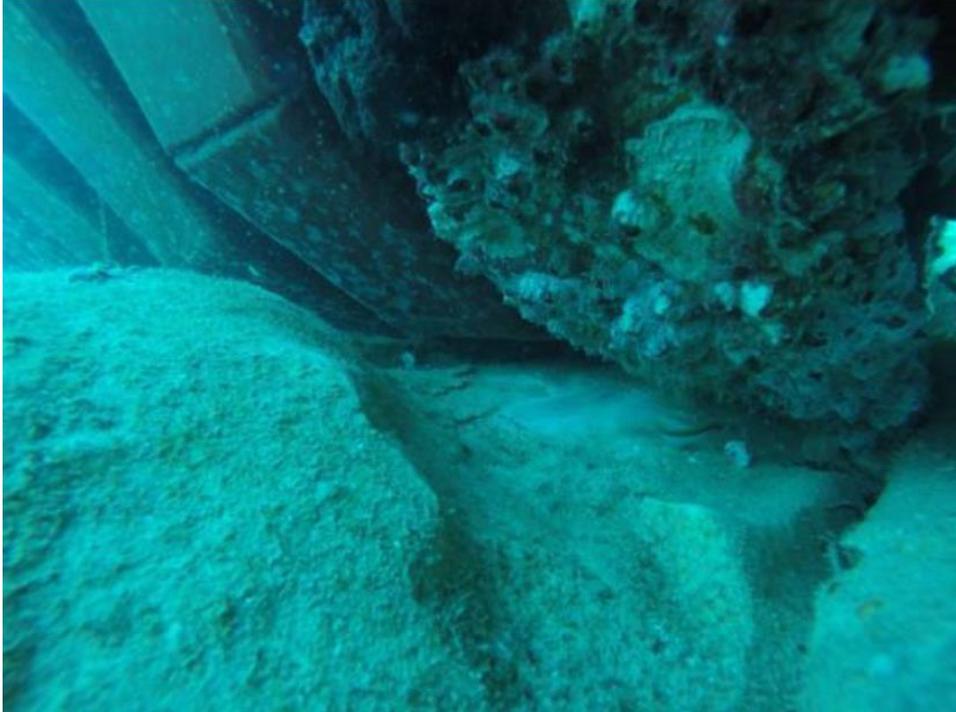
Furthermore, Figure 17 and Figure 18 show damage in the concrete weight coating cutback. This indicates that the cable/padding was moving laterally and the concrete cutback acted as a stopper (to some extent).

Figure 17: Damaged Field Joint Coating-Pipeline # 1. Note that the cable is not yet lifted for the purposes of inspection in this photograph.

From the root cause study, it was concluded that the damage of the field joint coating is attributed to the combined effect of installation works, lateral cable movement and repeated dynamic impact.

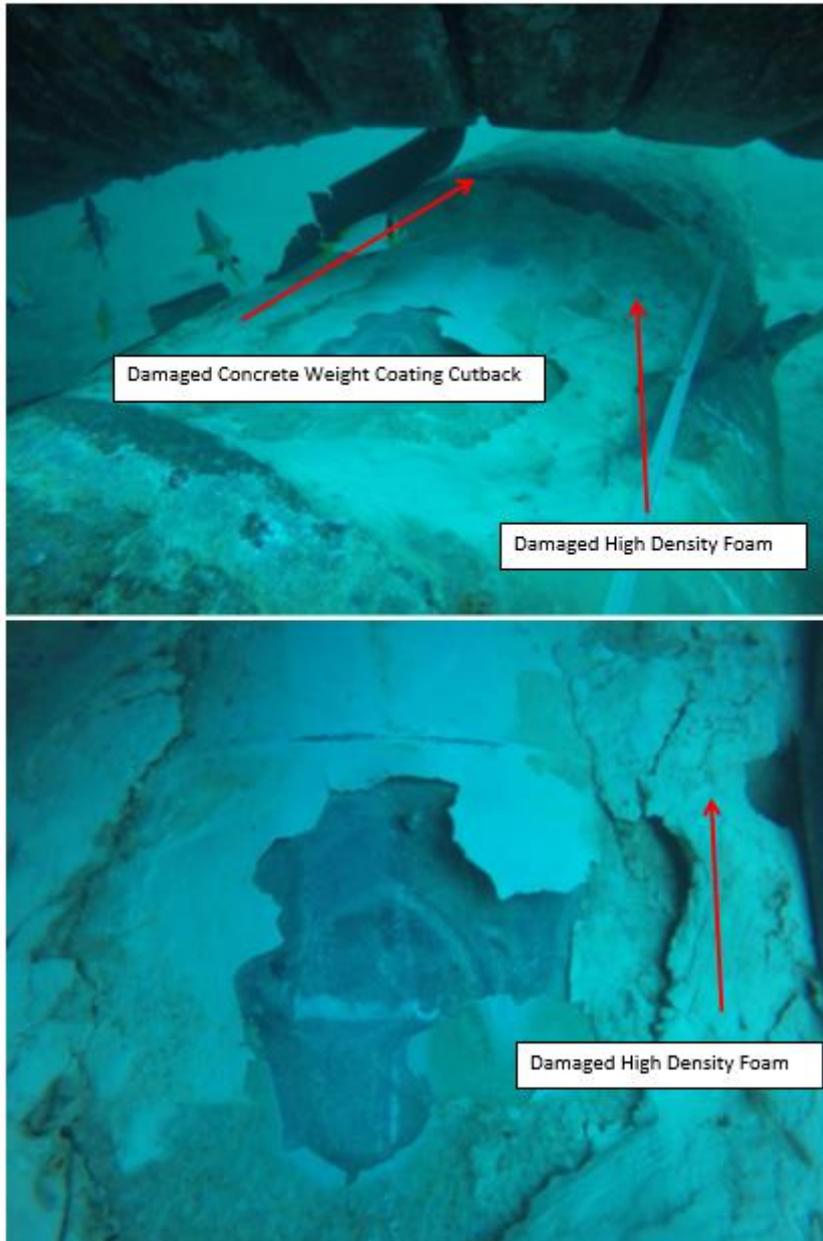
Figure 18 and Figure 19 reveal the damage resulting from the lateral movement of the cable and the articulated padding, combined with the contact load exerted by the cable/articulated padding on the field joint coating.

Figure 18: Damaged Field Joint Coating-Pipeline # 1. Note that the cable was lifted for the purposes of inspection in this photograph.

The damage occurred along the entire width of the field joint coating (approximately 0.8 m), confirming that the damage spread across both sides due to cyclic lateral movement.

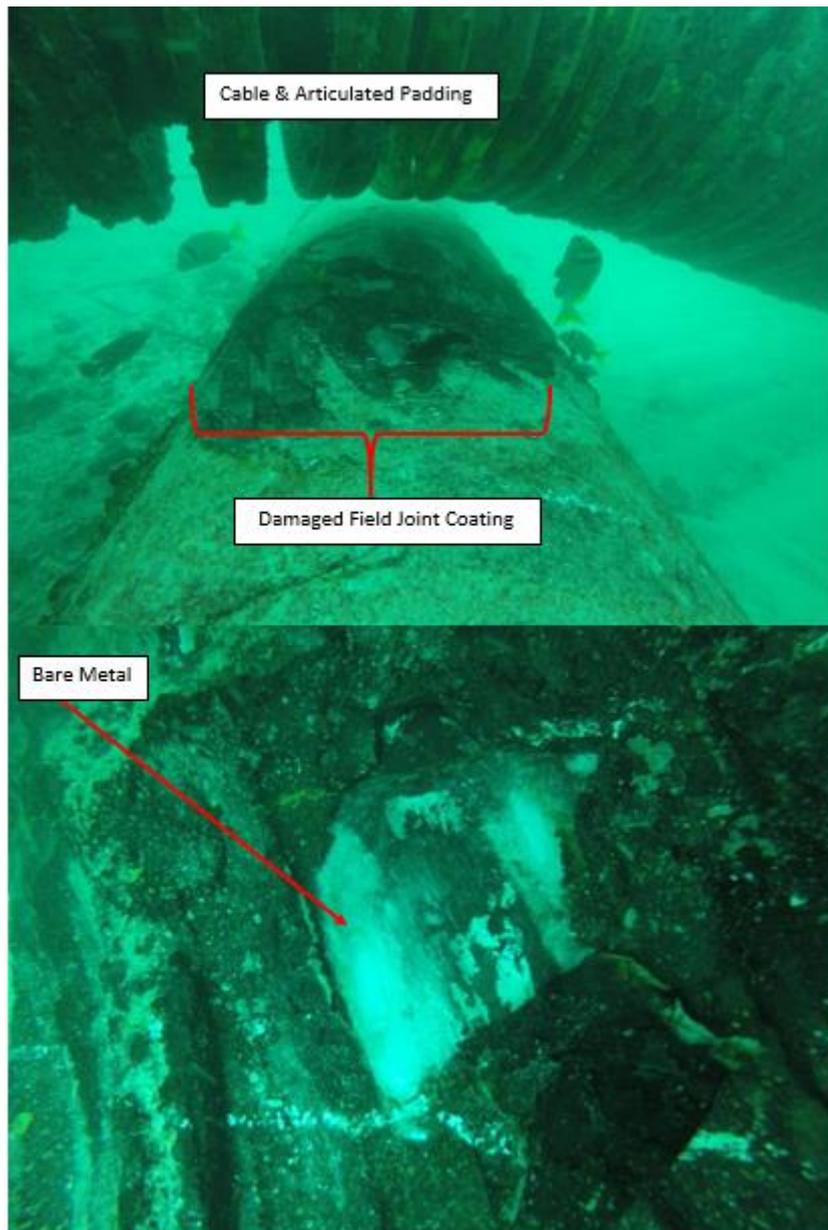
Figure 19: Damaged Field Joint Coating-Pipeline # 2

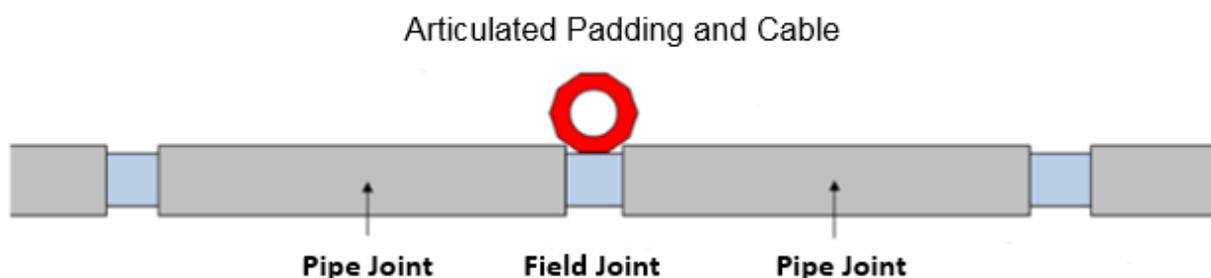
In the case study presented here, the cable with the articulated padding was unintentionally laid on the field joint location during the cable installation works, as illustrated in Figure 20.

Figure 20: Location of articulated padding in relation to field joint

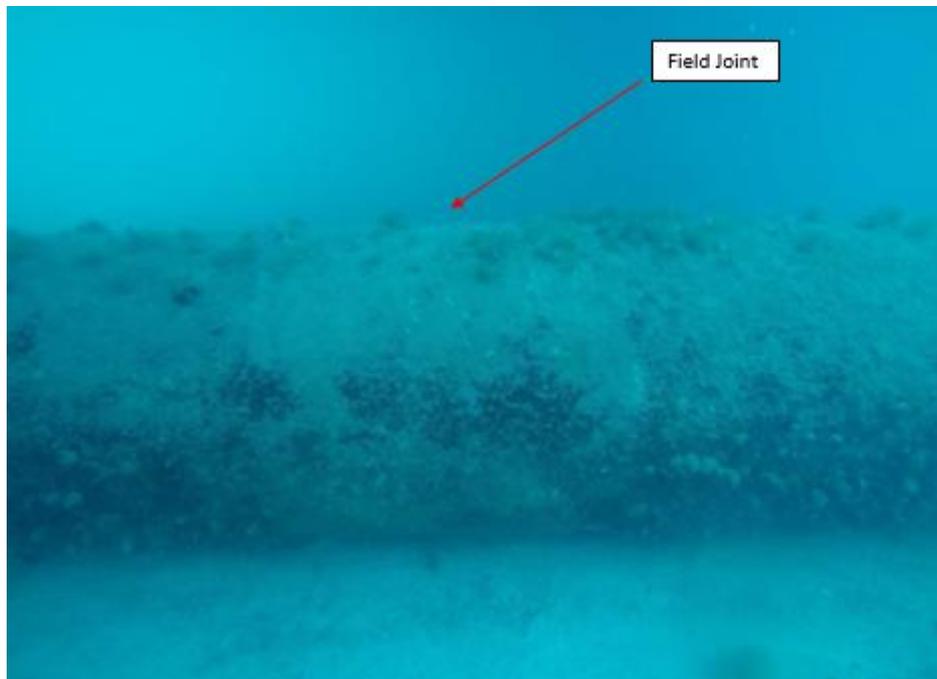
The investigation also indicated that during the cable installation, it was difficult to identify the field joint due to presence of marine growth. Figure 21 and Figure 22 show images for the first field joint downstream from the damaged field joints for pipeline # 1 and pipeline # 2. From these figures it is

evident that the field joints were indeed fully covered with the marine growth. This made it impossible to differentiate between the pipeline and the field joint.

Figure 21: Field joint coating downstream the damaged joint- Pipeline # 1 (note the overgrowth)

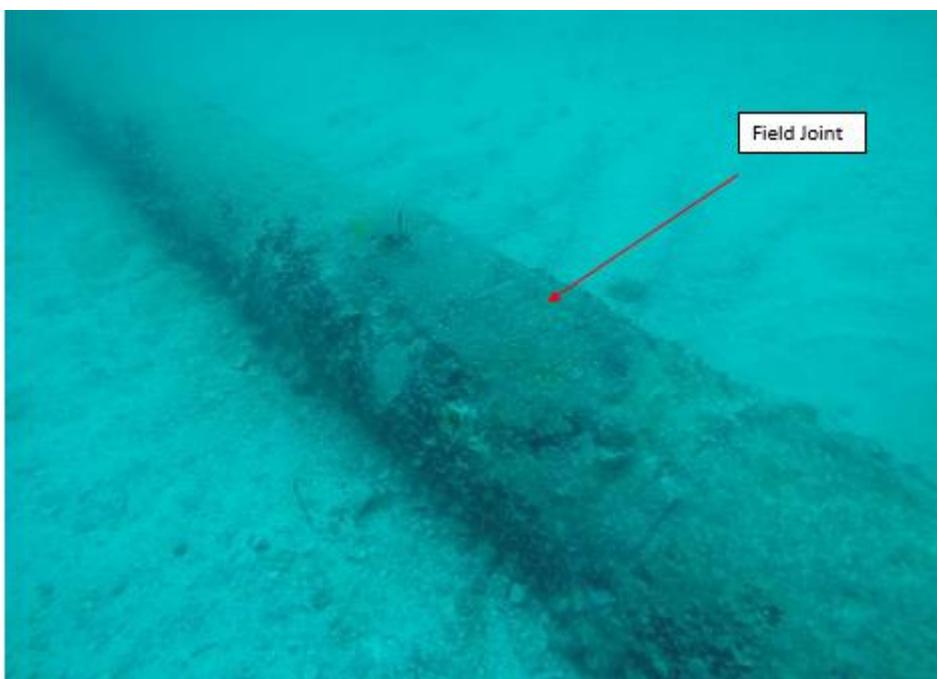
Figure 22: Field Joint downstream of the damaged field joint- Pipeline # 2 (note the overgrowth)

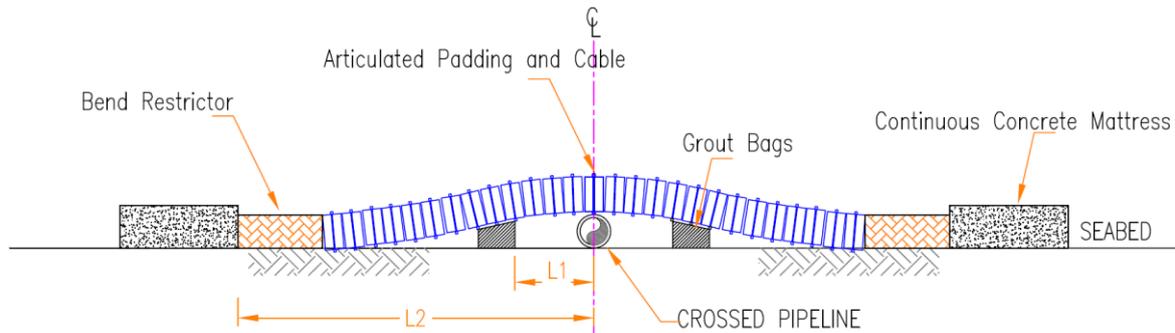
Numerical simulations using ABAQUS [Ref. [11]], were undertaken to estimate the contact loads generated by the articulated padding on the field joint. The finite element model used in the investigation is shown in Figure 23 and the results are provided in Table 2. The radial and axial loads are reported at the crossing point as shown in Figure 1. The lateral displacement presented in Table 2 is for the articulated padding at the crossing location (i.e. for the articulated padding resting on the crossed pipeline).

Figure 23: Finite Element model

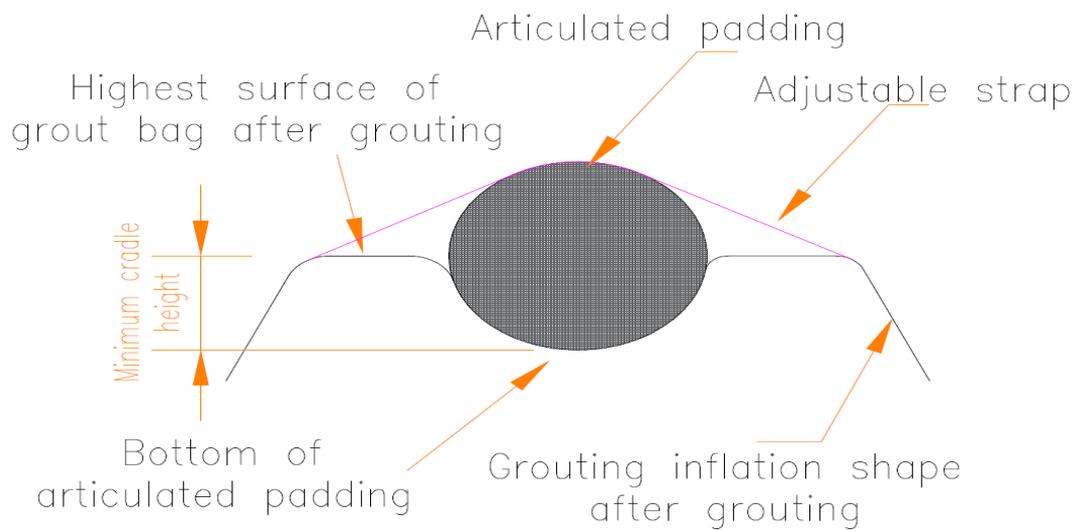
Figure 24: Minimum height of the cradle

The finite element simulations undertaken demonstrated that if the cable free span length and lateral movement are reduced by adding vertical and horizontal constraints as close as possible to the pipeline, the global reaction forces due to self-weight and environmental factors (waves and current) will be reduced. Accordingly, it was decided to install two large cradle grout bags (Figure 27) to prevent contact between the pipeline field joint and the cable. The distance between the crossed pipeline and the edge of the grout bag and the edge (X in Figure 27 and L1 in Figure 23) was set to 2 m.

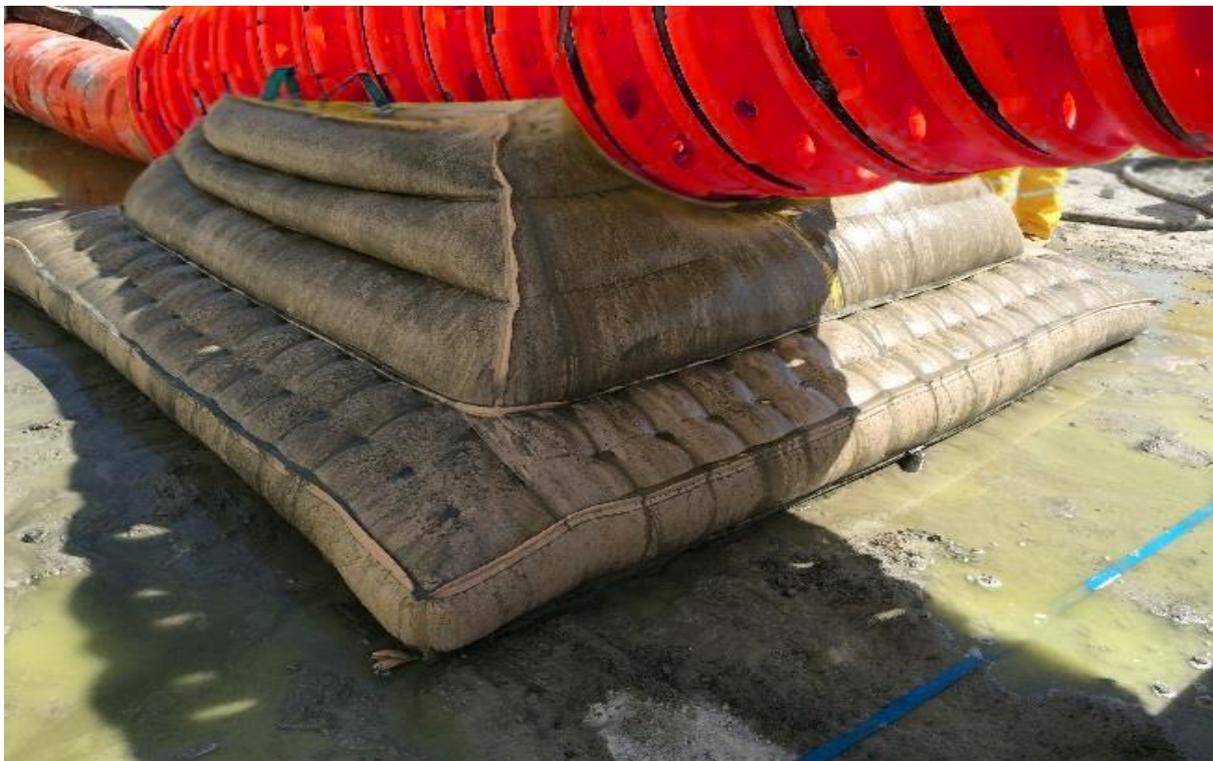
Figure 25: Mock-up trial for the cradle support

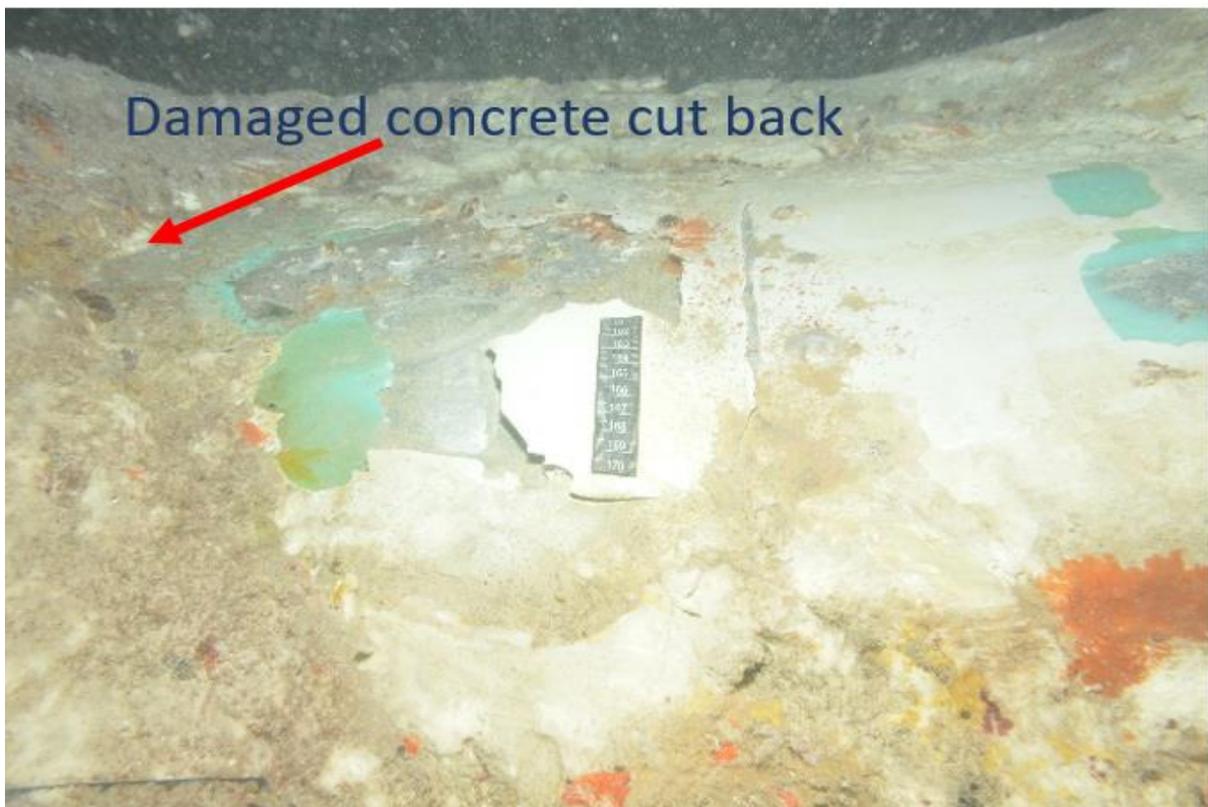
Dynamic loads due to rolling or sliding of the articulated padding across the rough surface of the round pipeline are difficult to quantify, because of the complexity of the lateral motion and involvement of many unknown force components. However, the damaged concrete at the cutback area shown in

Figure 26 appears to have resulted from significant rolling and sliding loads.

Figure 26: Damaged concrete cut back

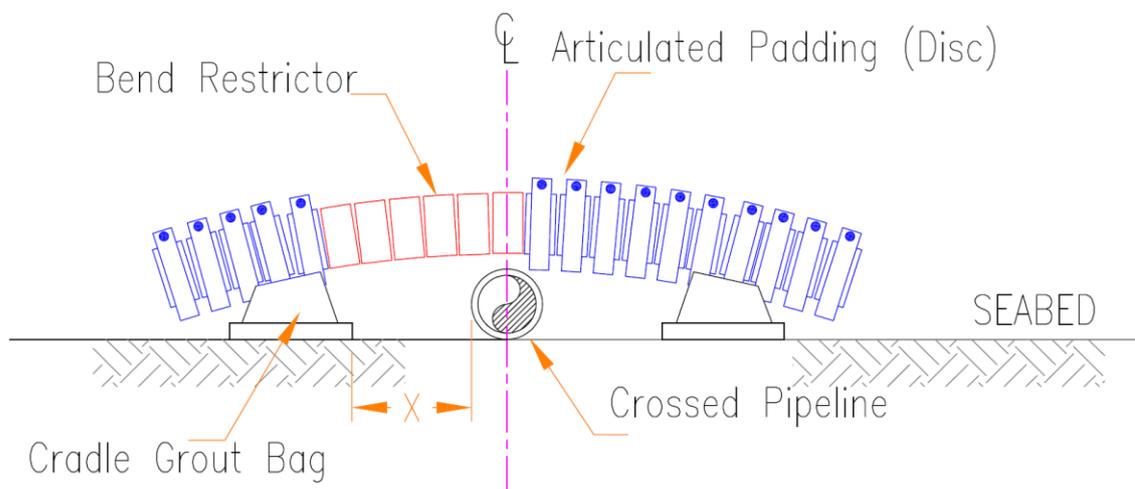
Figure 27: Installation of cradle grout bags.

The inspecting diver confirmed location of the grout bag via the locating transponder unit. This installation location was recorded during the rectification by the survey team. Figure 28 shows that the bags were inflated with concrete, and air bags were used to lift the cable off the grout bags. The discs were then installed around the bend restrictor are removed and seafloor excavated underneath the crossed pipeline to facilitate repair of the field joint coating. Also, some of the concrete mattresses installed originally at the touch down points were removed to ease lifting the cable using the air bags. Once the cradle grout bags were inflated and in place, then the divers used the adjustable straps and tighten the cradle up onto the discs. Then the concrete mattresses were returned to their locations at the touch down points.

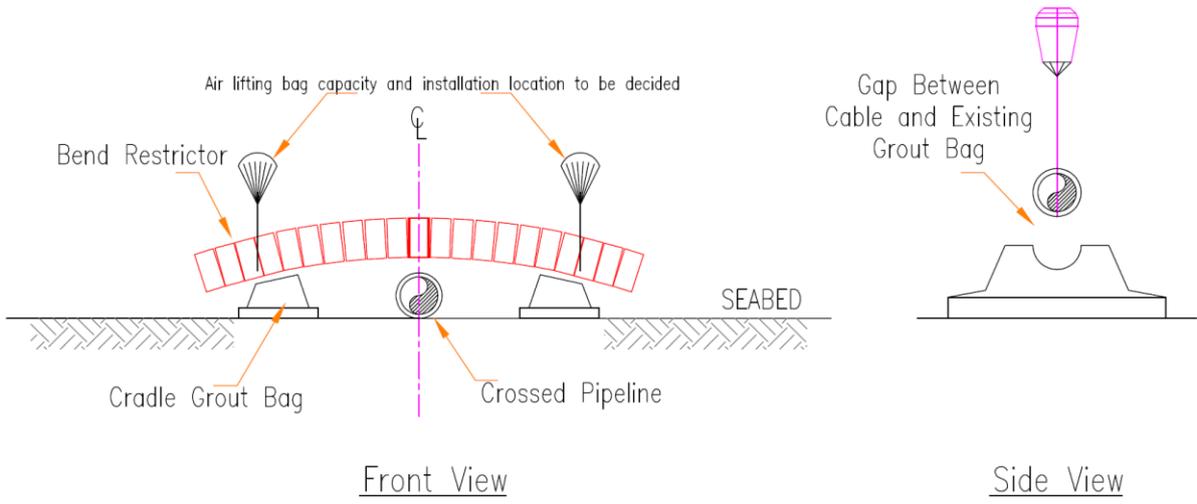
Figure 28: Lifting of subsea cable

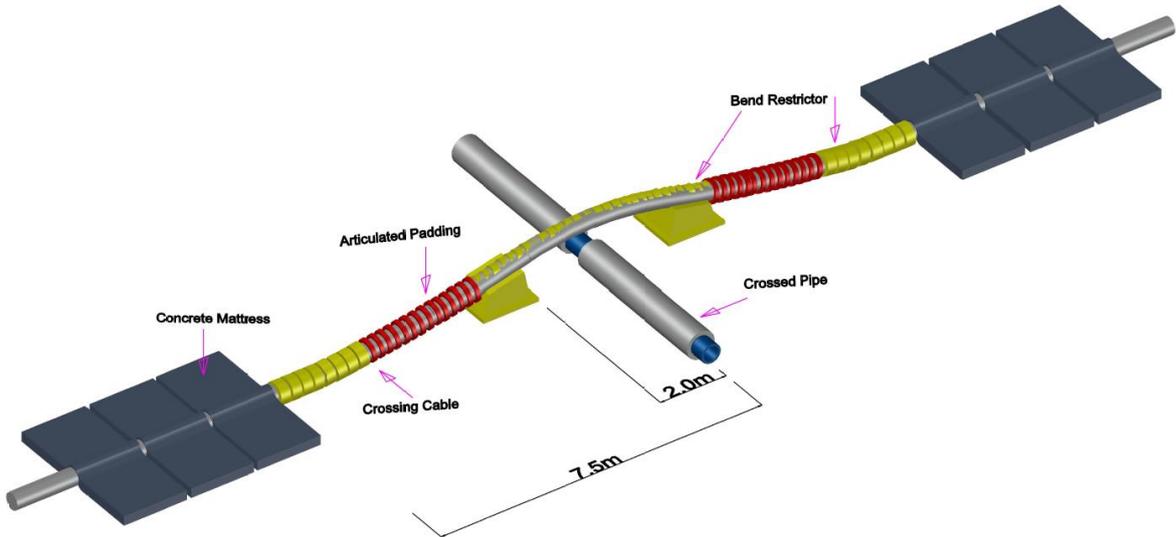
Figure 29: Final Position

Figure 29 shows a schematic of the situation after the repair was completed, the air bags removed and the cable supported by the grout cradle bags. The required vertical distance of 410 mm from the bottom of the cable to the top of the field joint was achieved by the design-specific grout bag.
