Guidelines for Safe Cable Crossing over a Pipeline

Abstract

This paper documents a recent case study of damage of a field joint coating at a crossing of an existing pipeline by a 132 kV subsea cable of 191 mm outside diameter. Investigation of the damage on site revealed that it was caused by lateral movement of the cable under the influence of hydrodynamic forces.

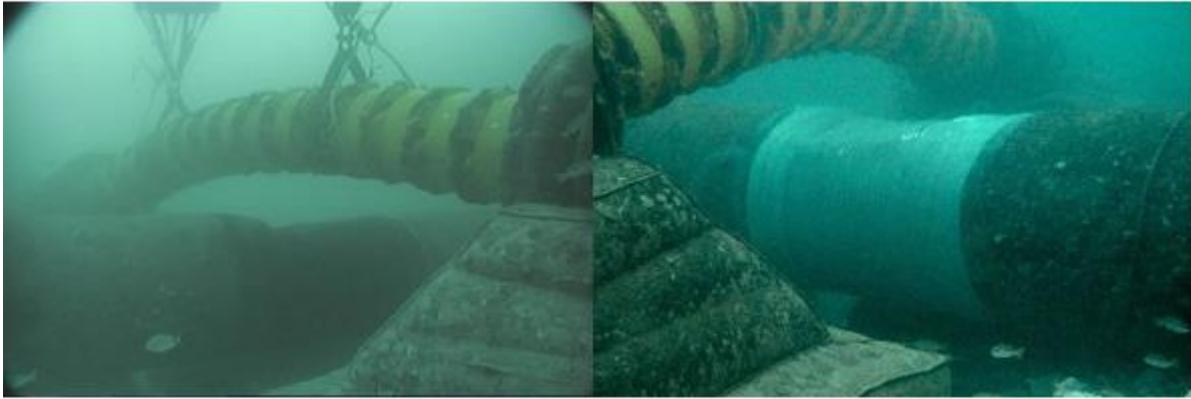
Figure 30: Actual Footage showing air bags lifting the cable

Figure 30 shows photos of the air bags lifting the cable where the articulated padding system was lifted. The right-hand side photo shows the field joint after repair.

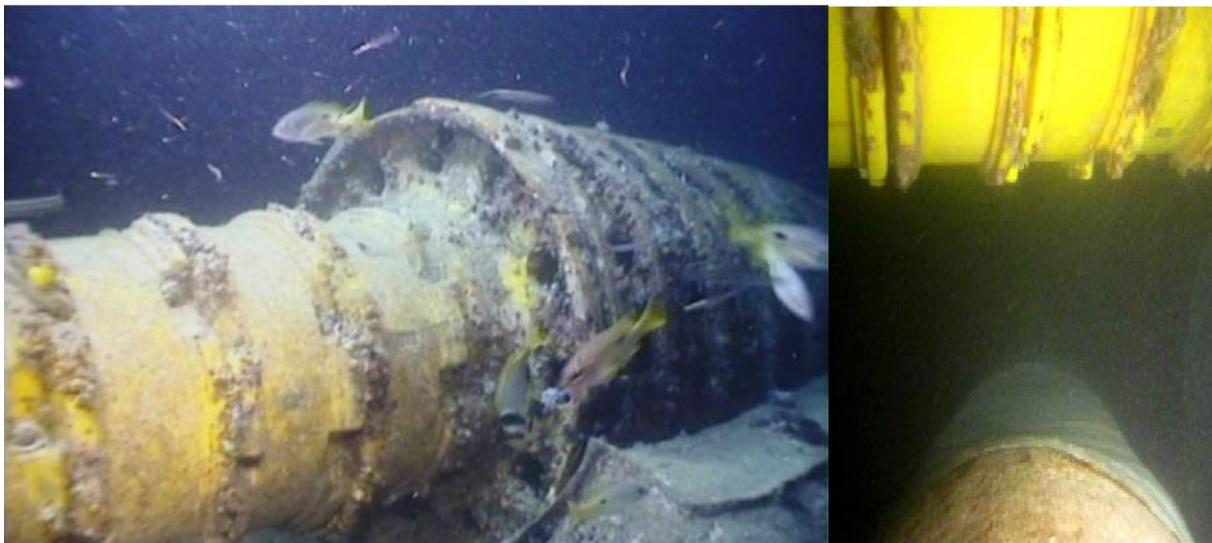
Figure 31: Photo showing the as-built vertical separation and cradle grout bag support.

The right-hand side the photo of Figure 31 shows the as-built vertical separation between the bottom of the cable/bend restrictor and the top of the field joint. The left-hand side photo of Figure 31 shows the cable/bend restrictor sitting on the cradle grout bag. It can be seen from the same figure that the bend restrictor prevents the cable from sagging at the crossing point.

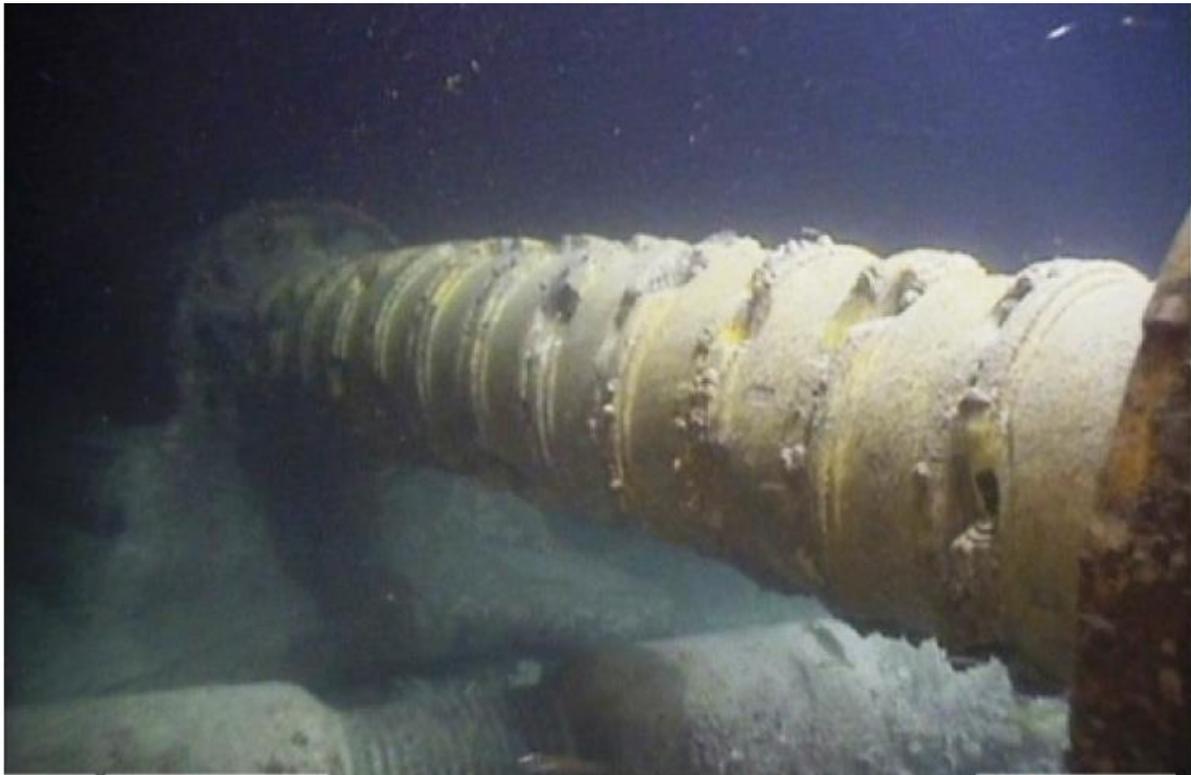
Figure 32: ROV survey for the cable and the bend restrictor

It is evident from Figure 32 that the bend restrictor is intact and still preventing the cable from sagging at the crossing point and the vertical separation between the bottom of the bend restrictor to the top of the crossed pipeline is maintained.

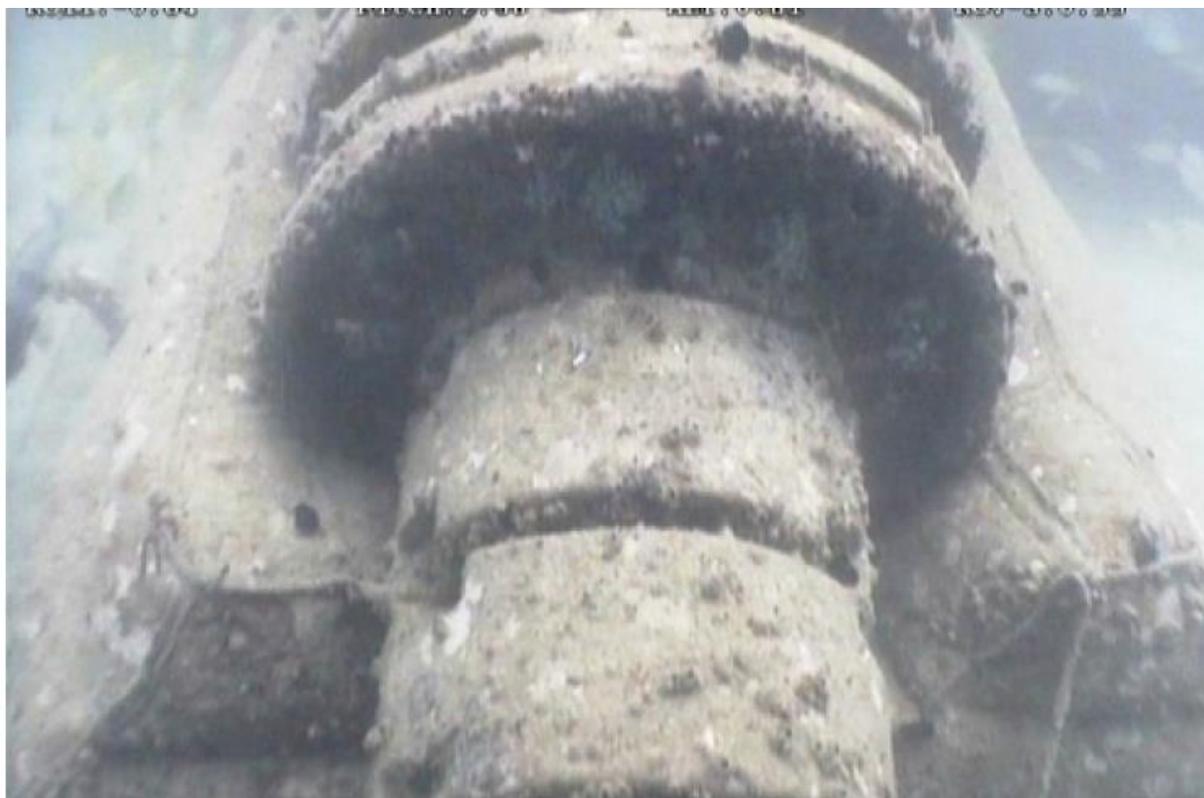
Figure 33: ROV survey for the cable and the cradle support.

Figure 33 demonstrates that the discs rest on the cradle and the discs are restrained by the cradle. There is no sign that the discs broke through the cradle. Furthermore, there is no sign of damage of the cradle.

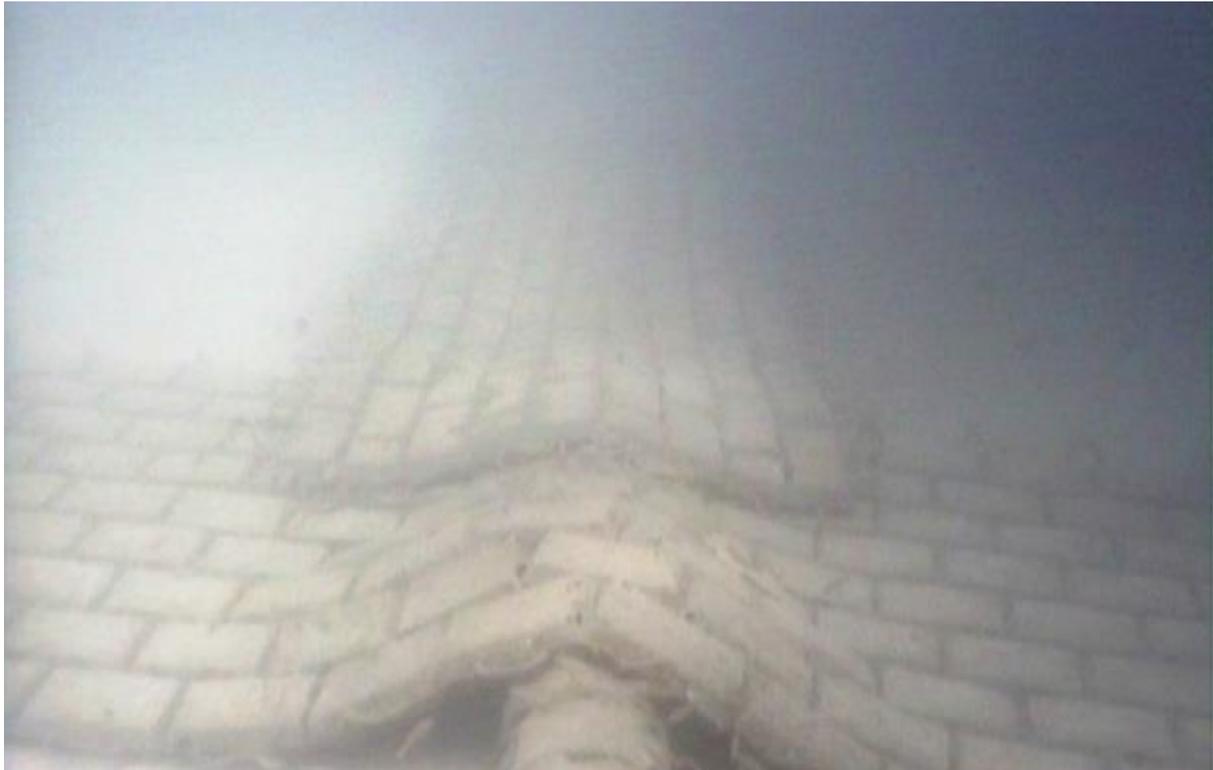
The ROV survey also covered the mattresses at the touchdown point to investigate if the cable was washed away from the mattresses. This is shown in Figure 34.

Figure 34: ROV survey showing the mattresses at the touch point.
