Western Australian School of Mines

**Scaled Down Tunnel Testing for Comparison of Surface Support
Performance**

**This thesis is presented for the Degree of
Doctor of Philosophy
of
Curtin University**

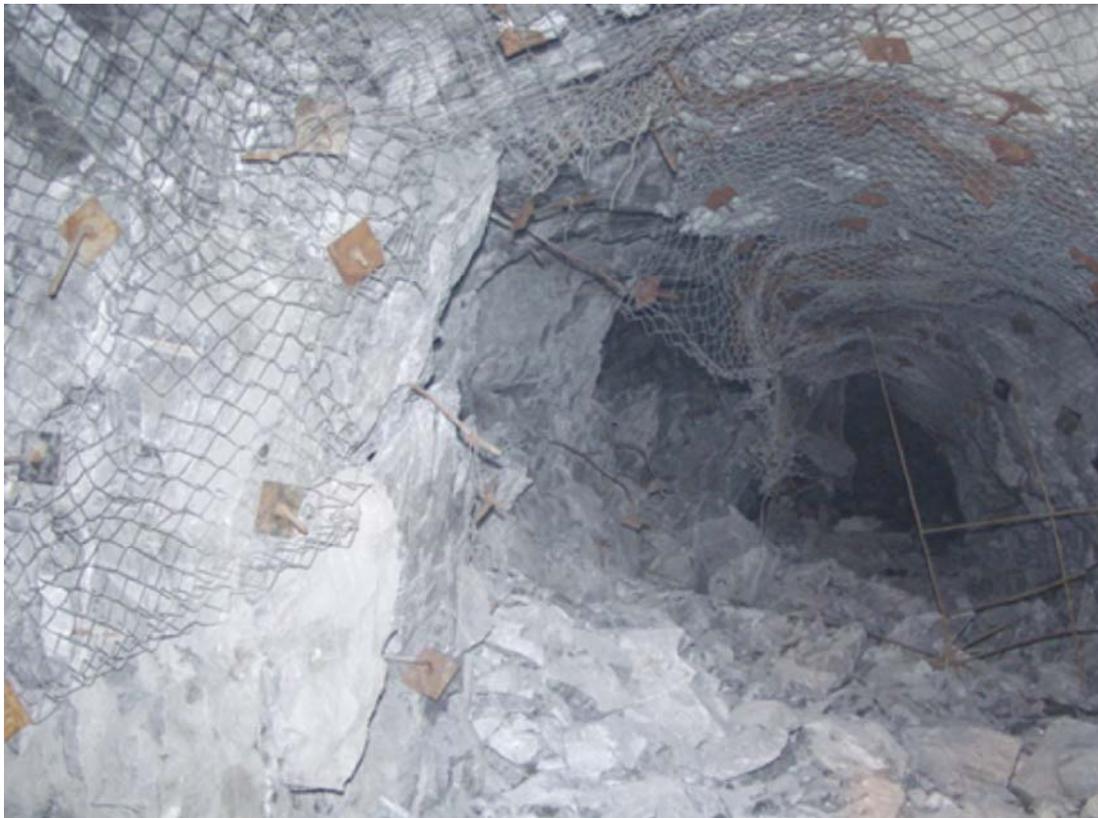
Figure 2.1 Stress-driven failure near the boundary of an excavation.

As mining excavations go deeper, there is an increase in stress magnitude. In addition to structural failure, massive or moderately jointed rock mass faces serious stress driven failure at a great depth (Figure 2.1).

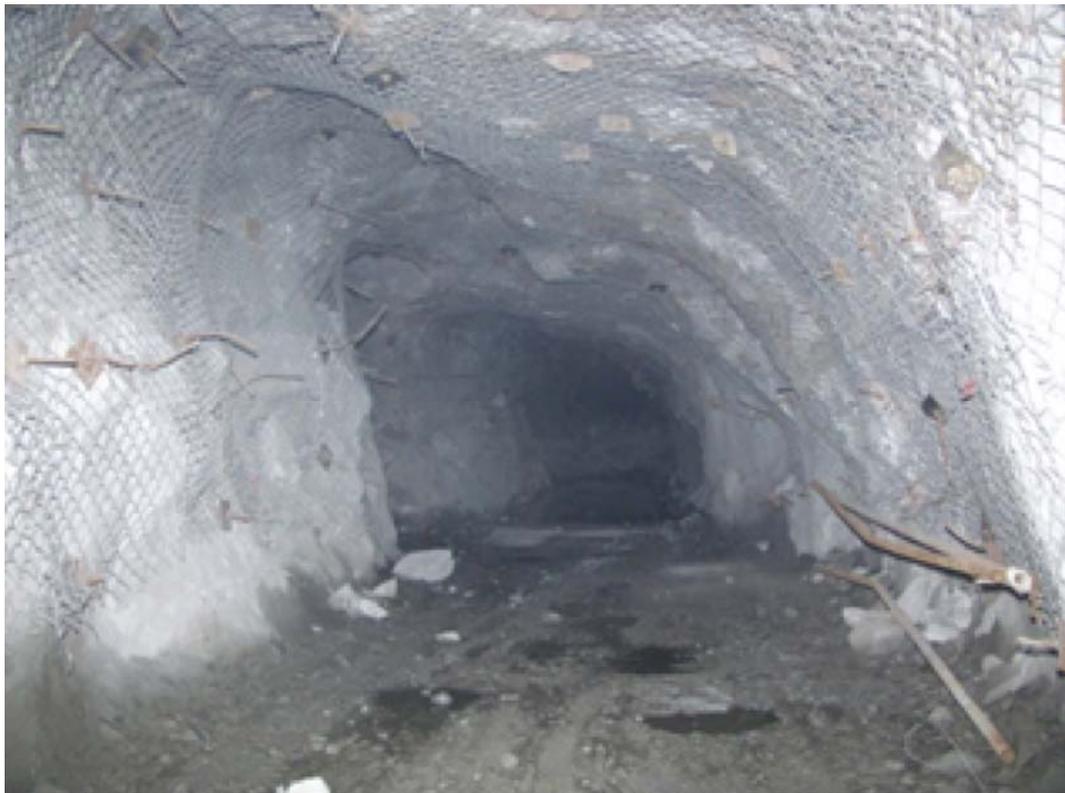
Figure 2.2 Notch created following stress-driven failure in a hard rock mine.

and rock slabs are split at the stress concentration areas. The phenomena is called spalling and frequently observed under a high stress conditions (Hoek & Brown, 1980; Hoek, Kaiser, & Bawden, 1995). When stress is high around an excavation, the restrained energy releases as with spalling and induced violent failure. In addition, it eventually results in an excavation shape change with related instability issue (Figure 2.2).

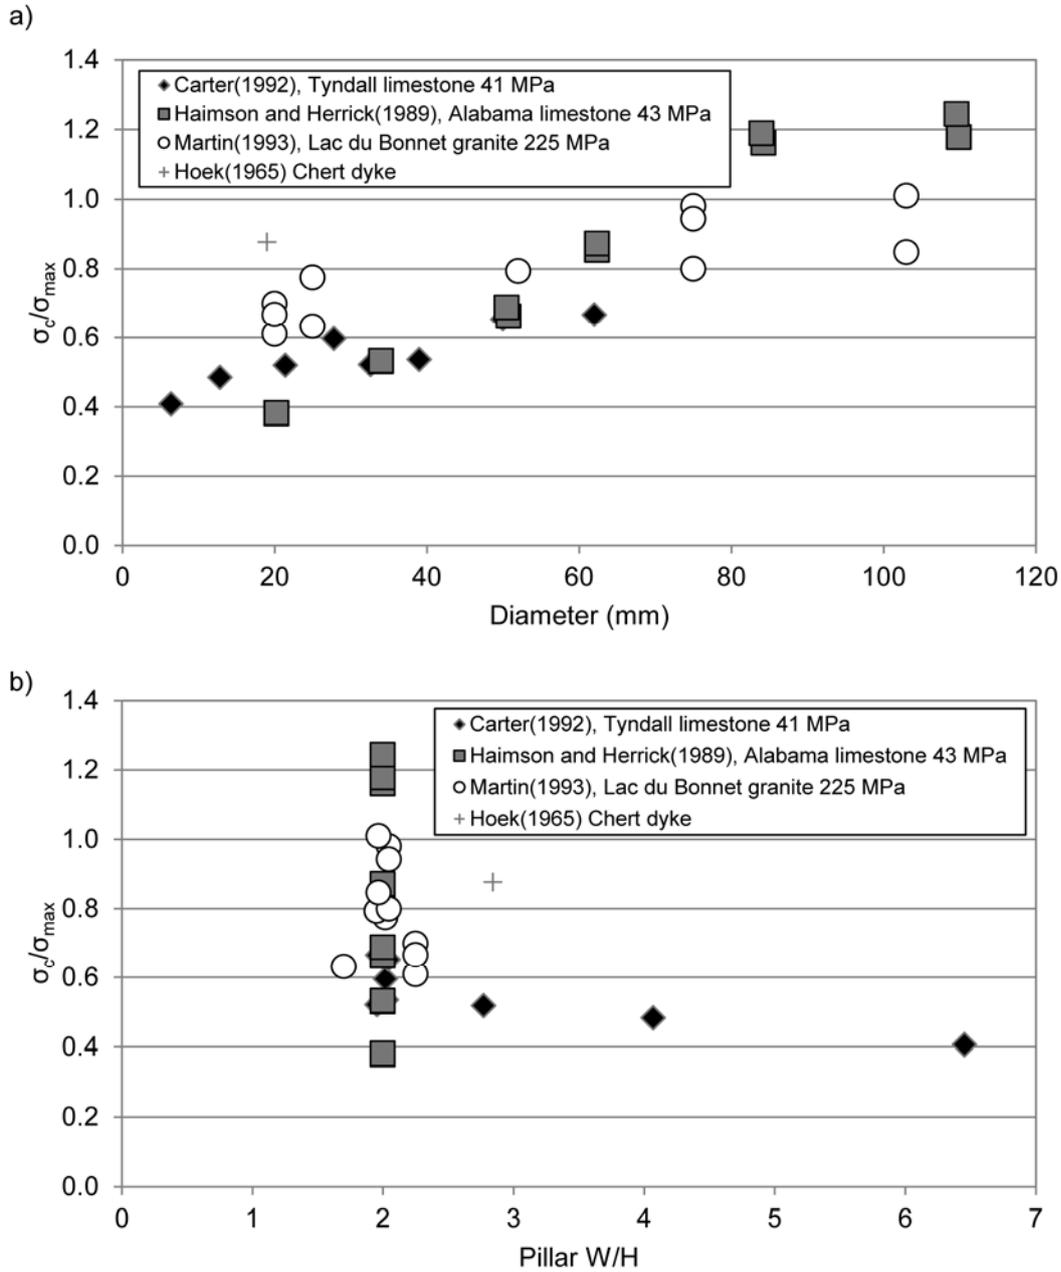
Figure 2.3 Summary of physical model tests a)plotted via diameter b)plotted via pillar width and height ratio (after Martin (1993)).

Martin (1993) conducted physical model tests using rectangular granite block (average UCS 225 MPa). Circular holes with diameter ranging from 20 to 103 mm were drilled in the centre of the block and an uniaxial loading was applied with strain gauges on the surface. He compared the obtained results with past studies (Figure 2.3). Figure 2.3a shows the ratio of the material strength and tangential stress at the failure initiation with diameter of the hole. As can be seen, the result was affected by a hole diameter. The stress required to induce the stress becomes higher especially when a diameter of less than 75 mm is used (Martin, 1997). The ratio is also seen as affected by the ratio of pillar width to height.

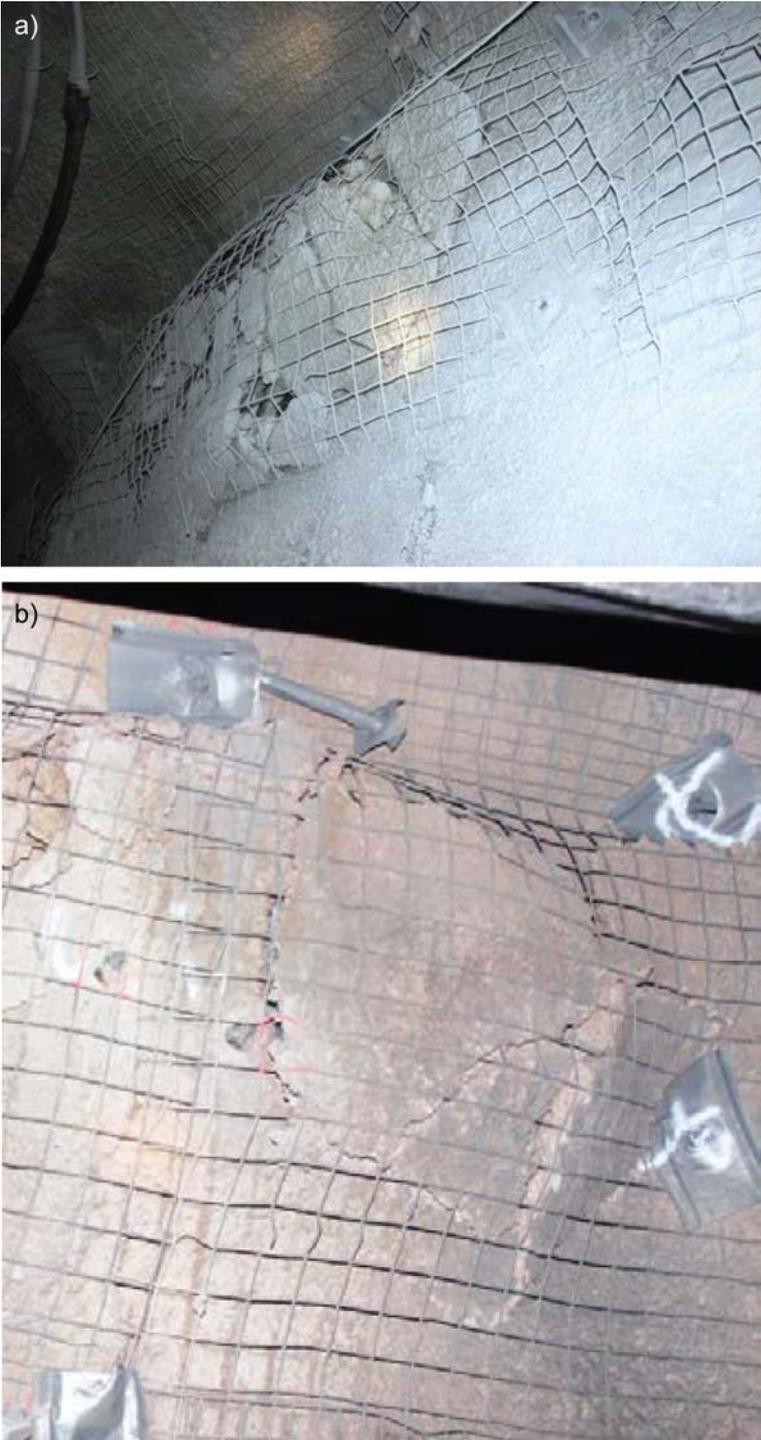
Figure 2.5 Flexural failure of shotcrete with external welded mesh (Drover & Villaescusa, 2015).

Drover and Villaescusa (2015) suggested that the total energy dissipation capacities of surface support have improved when mesh is embedded under shotcrete layer rather than mesh exposed outside the shotcrete layer. When mesh was exposed outside the shotcrete layer, each surface support element functioned individually (Figure 2.5). Mesh simply restrained the broken materials and helped to reduce the severity of a failure. Reinforced shotcrete by mesh performed as an integrated systems and showed higher toughness compared with fibre reinforced shotcrete (Figure 2.6).

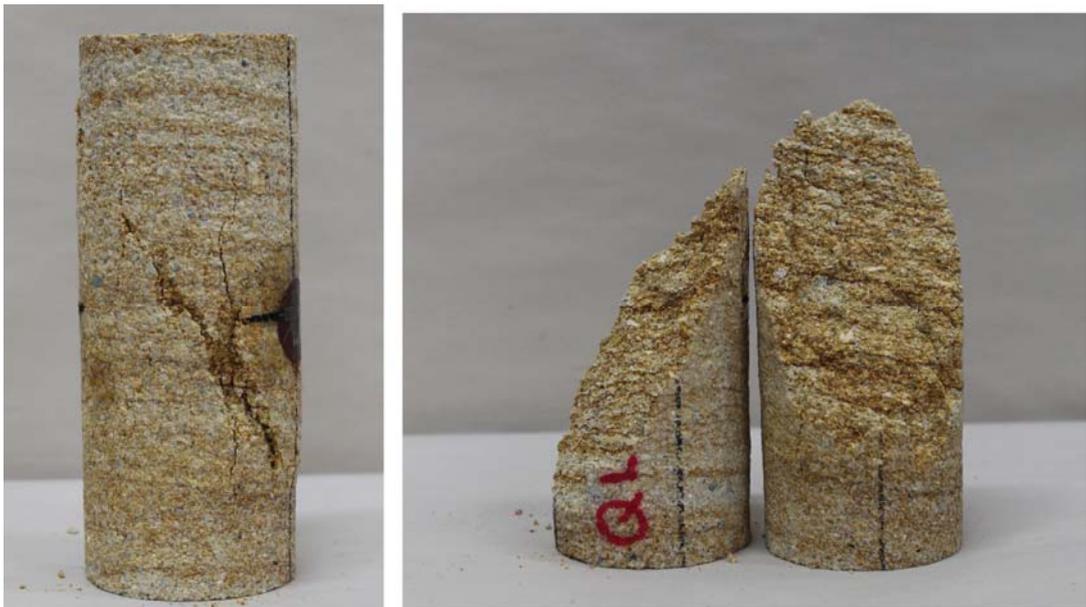
Figure 3.4 Example of moderately strong sandstone sample after uniaxial compressive strength test.

The result of uniaxial compressive testing for the three materials is plotted in Figure 3.3. The average uniaxial compressive strength σ_c of the two different types of sandstone is 19 MPa (Figure 3.4) and 82 MPa (Figure 3.5), which is categorised as moderately strong and the strong rock respectively, while the uniaxial compressive strength of granite is 182 MPa (Figure 3.6) which is categorized as very strong rock. As seen on the result, there are some varieties in the strength among the same materials. Violent failure occurred only with strong to very strong materials.

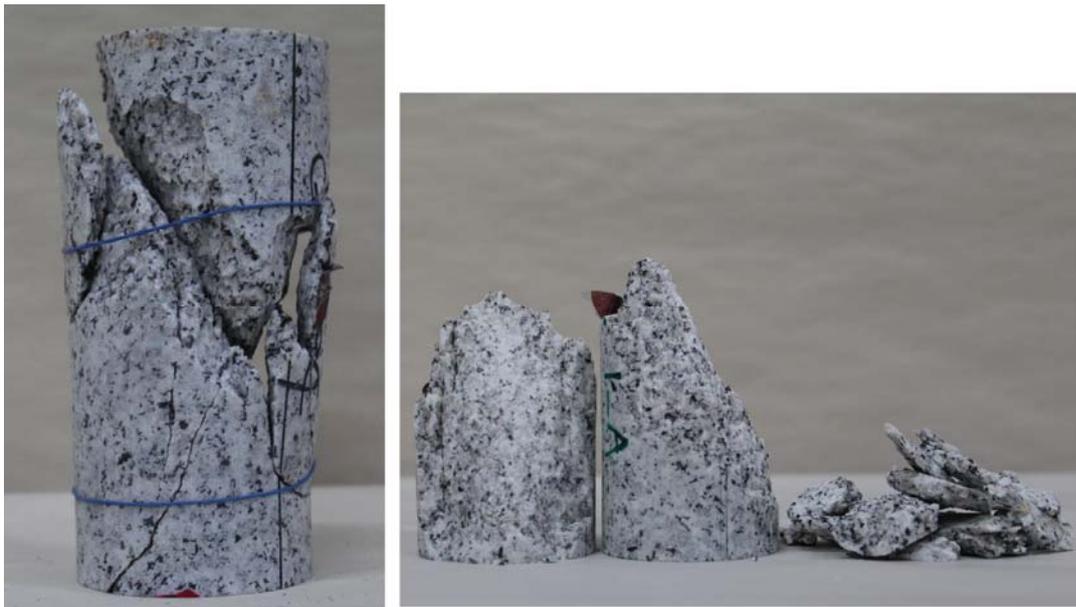
Figure 3.6 Example of granite sample after uniaxial compressive strength test.

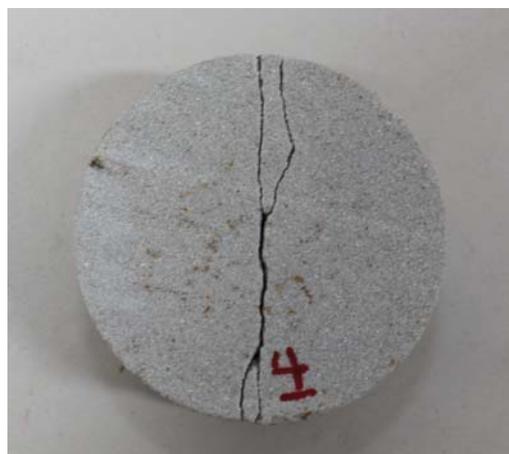
Figure 3.9 Example of strong sandstone sample after Brazilian test.

The tensile strength of the strong sandstone was investigated by the Brazilian test to obtain the input parameter for subsequent numerical modelling (Figure 3.9). The sample specimens were prepared according to the ISRM suggested method (Brown, 1981). The scatter diagram of the tensile strength and uniaxial compressive strength were plotted in Figure 3.10. The average tensile strength of the Strong sandstone is 4.6 MPa, which is approximately 1/16 of the average uniaxial compressive strength.

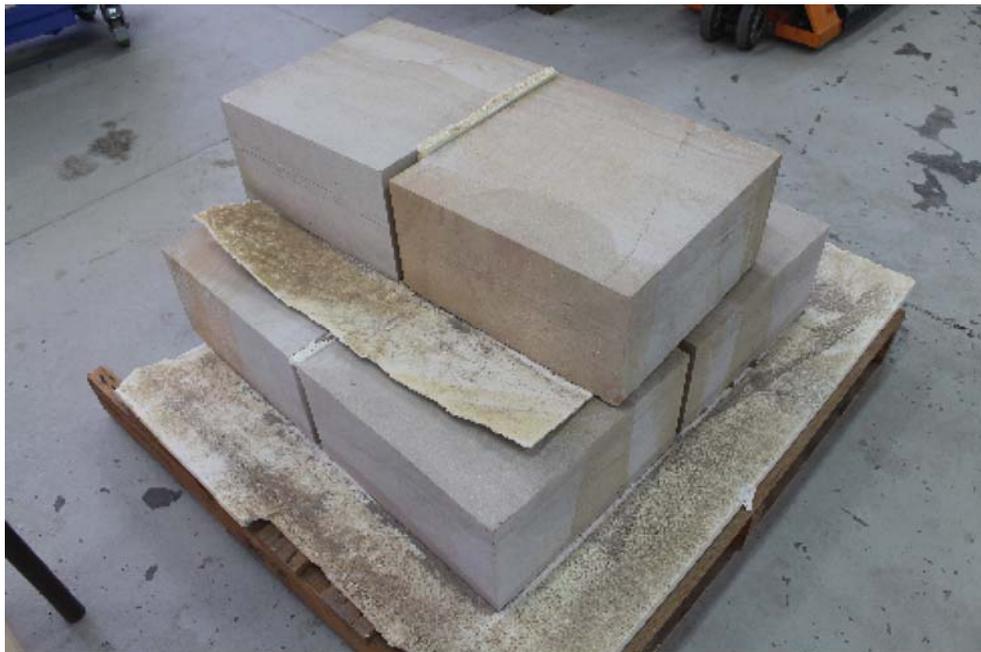
Figure 4.1 Sandstone block (strong) before the drilling process.

Figure 4.1 shows the blocks following delivery to WASM. The rectangular blocks were drilling using a diamond drill core as shown in Figure 4.2. Tunnel diameters consisting of 50 mm, 100 mm and 200 mm were compared to examine different pillar strengths. Figure 4.3 shows a completed tunnel following diamond drilling.

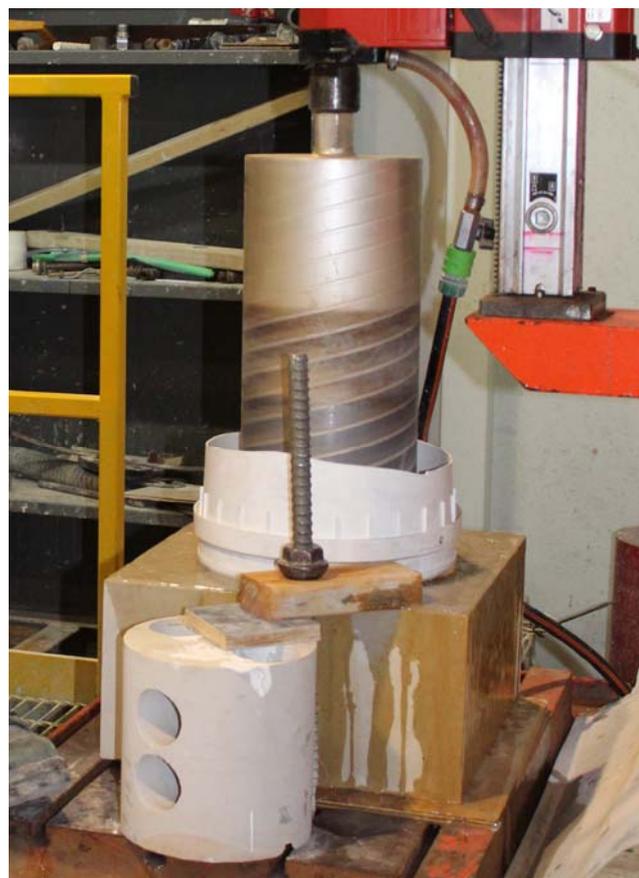
Figure 4.2 Example of 200 mm core drilling into a sandstone block.

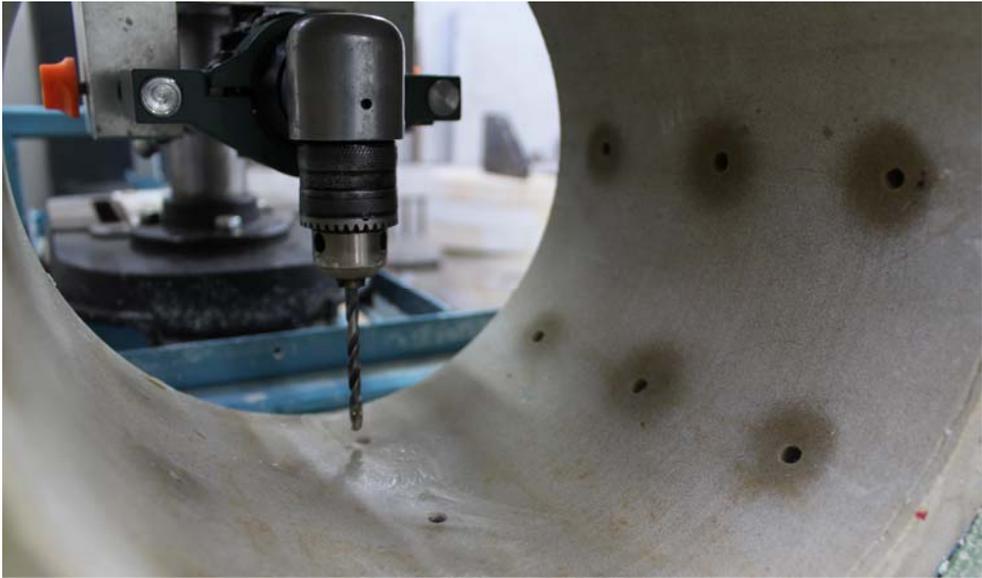
Figure 4.6 Borehole drilling process using a 5mm diamond drill bit.

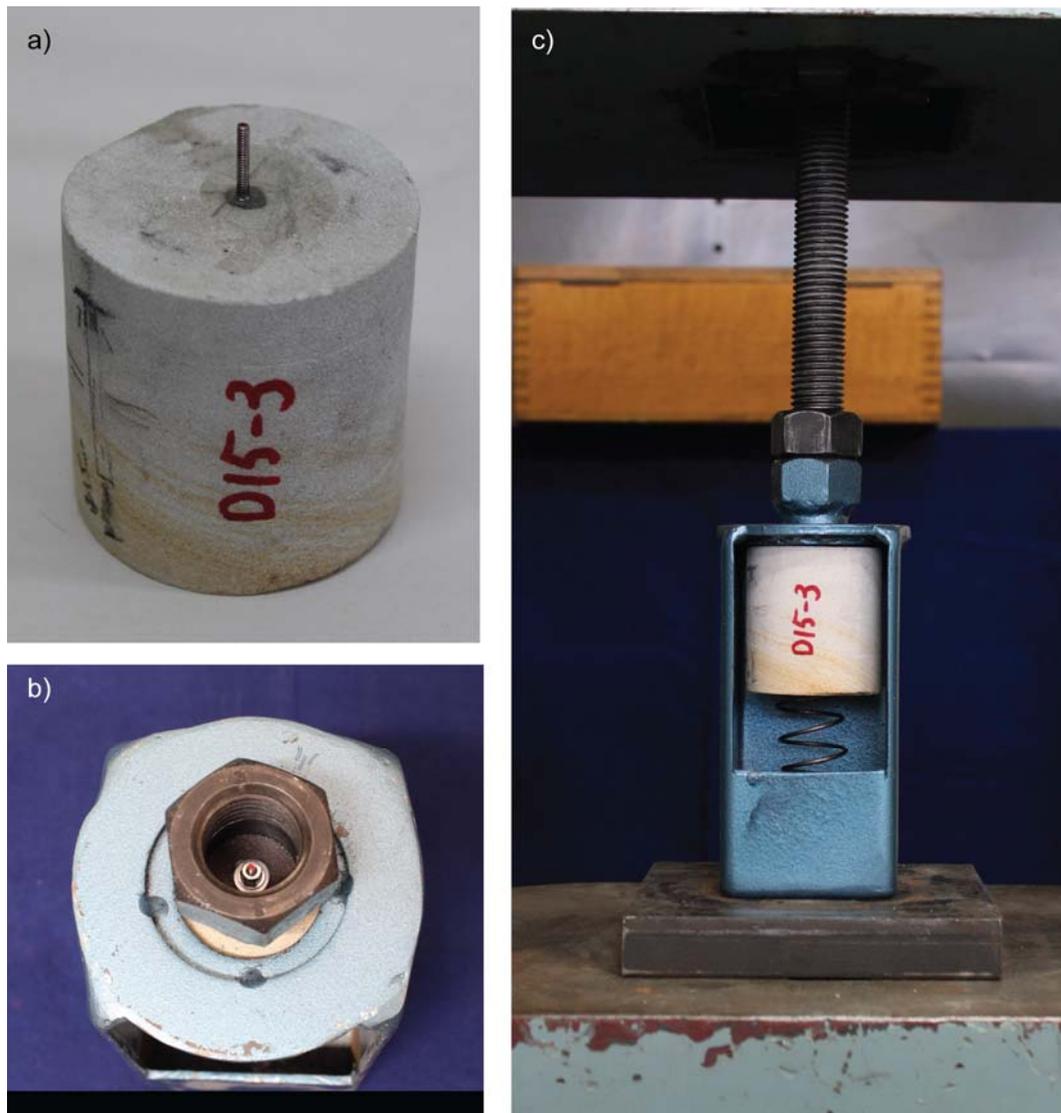
Figure 4.7 The setting for the rock bolt tensile test by Avery loading machine a) a test sample b) bolt head fixed by nut c) pull testing configuration.

Two tensile loading tests were conducted to investigate the miniature rock bolt mechanical properties. The rock bolts were installed into strong sandstone, which was the same material as used in the ground support experiments. The sample core and the end of the rock bolt were confined by a purposely built frame and pulled using a uniaxial Avery machine (Figure 4.7). The face plates were pulled until the bolt failed at the core axis.

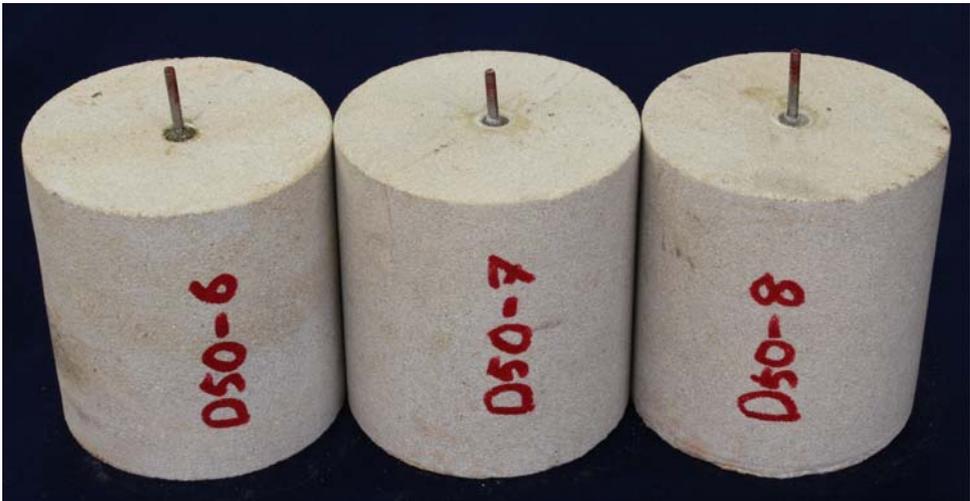
Figure 4.10 The sample specimen with the rock bolt prior to the tensile test.

The performance of the rock bolt element was examined using a tensile strength test. The fully encapsulated rock bolt was loaded from the washers until the bolt failed by breaking of the element (Figure 4.9). A 5mm borehole was drilled into a sample core using the same method as the embedment length test. As shown in Figure 4.10, a 65 mm length threaded rock bolt was embedded into the rock sample perpendicular to the rock surface. The embedment length was set as 50 mm which was the same design as

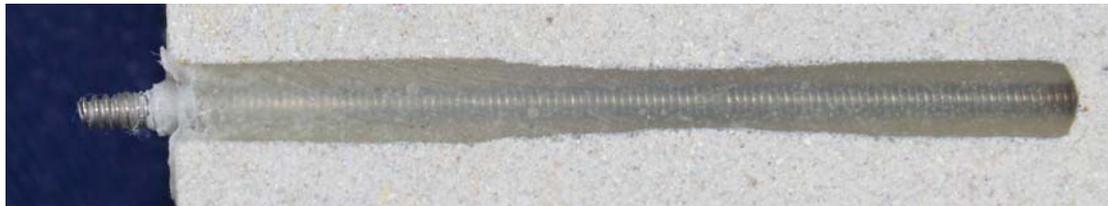
Figure 4.12 Long view of broken threaded steel bar after tensile testing.

The load-displacement curves are shown in Figure 4.11 and the test results are summarised in Table 4.1. When the load reached its peak, the rock bolt started to yield until the bolt failed. The rock bolts failed at an average load of 2.3 kN. The failure occurred at the rock bolt head as shown in Figure 4.12.

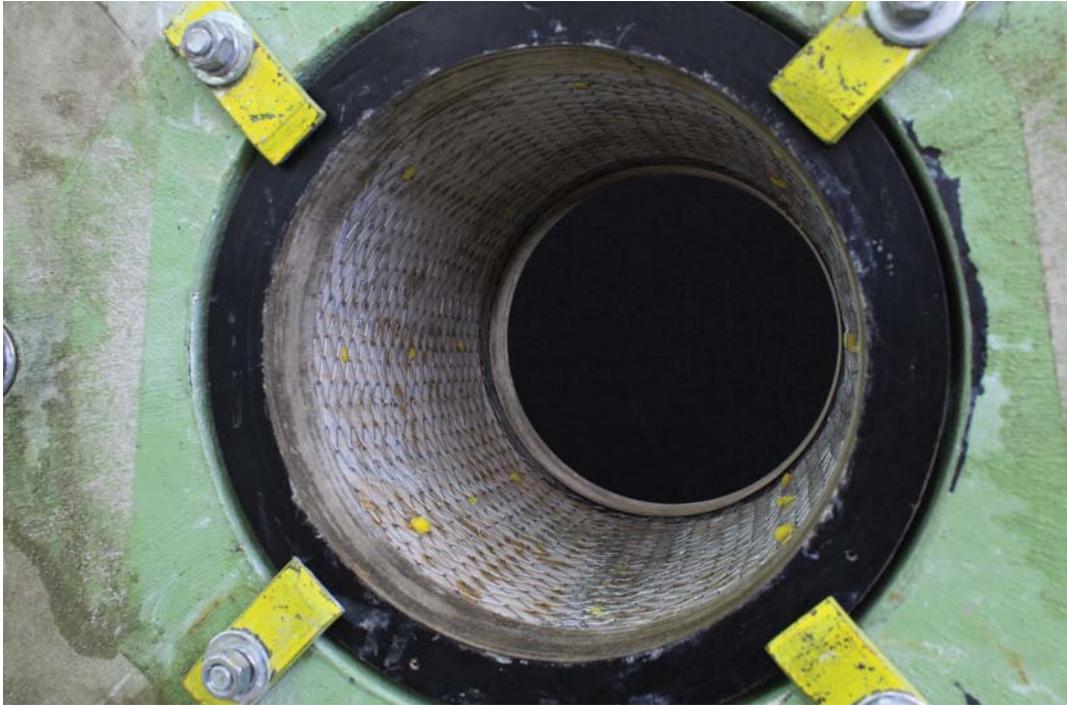
Figure 4.19 An example of a mesh installed tunnel before shotcrete application.

Since a tunnel surface needed to be wet when boreholes were drilled in order to reduce the friction heat, boreholes were drilled into tunnels before shotcrete application in all cases. Boreholes were filled with a foam material to prevent shotcrete mix penetration (Figure 4.18). Figure 4.19 shows a case of a chain link mesh sheet was applied before shotcrete spraying.

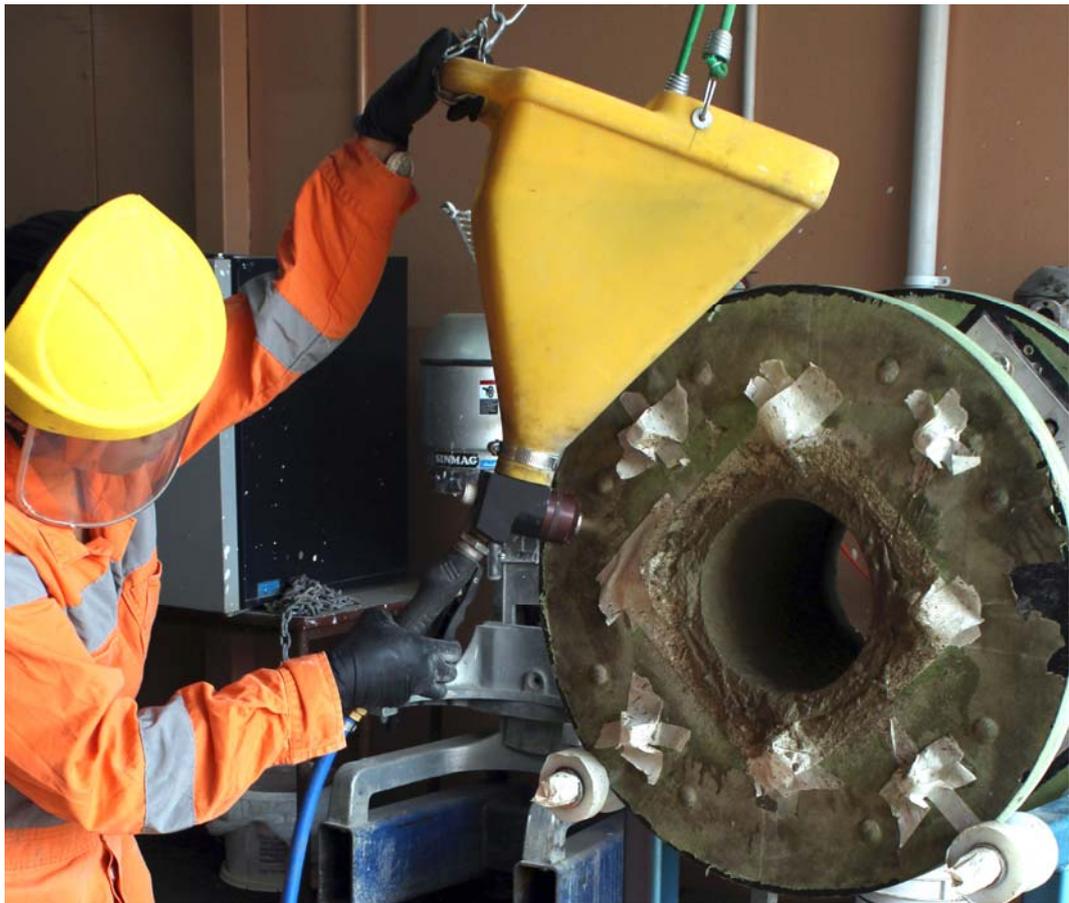
Figure 4.20 Shotcrete application by miniature spray gun.

After the preparation, the shotcrete components were mixed evenly and applied to the tunnel surface by a pneumatic spray gun as shown in Figure 4.20. This application method is similar to that used in underground mines. The shotcrete mix was compacted and applied until achieving the proposed thickness. The intact rock was mounted onto the rotation system during the shotcrete application. The shotcrete surface was smoothed after the spraying and the thickness was examined for uniformity (Figure 4.21). The shotcrete layer was cured for 7 days (Figure 4.22). The mesh and rock bolt were installed after or before the shotcrete application, depending upon the ground support scheme being tested. Figure 4.23 shows that boreholes were re-drilled over a shotcrete layer to install rock bolts.

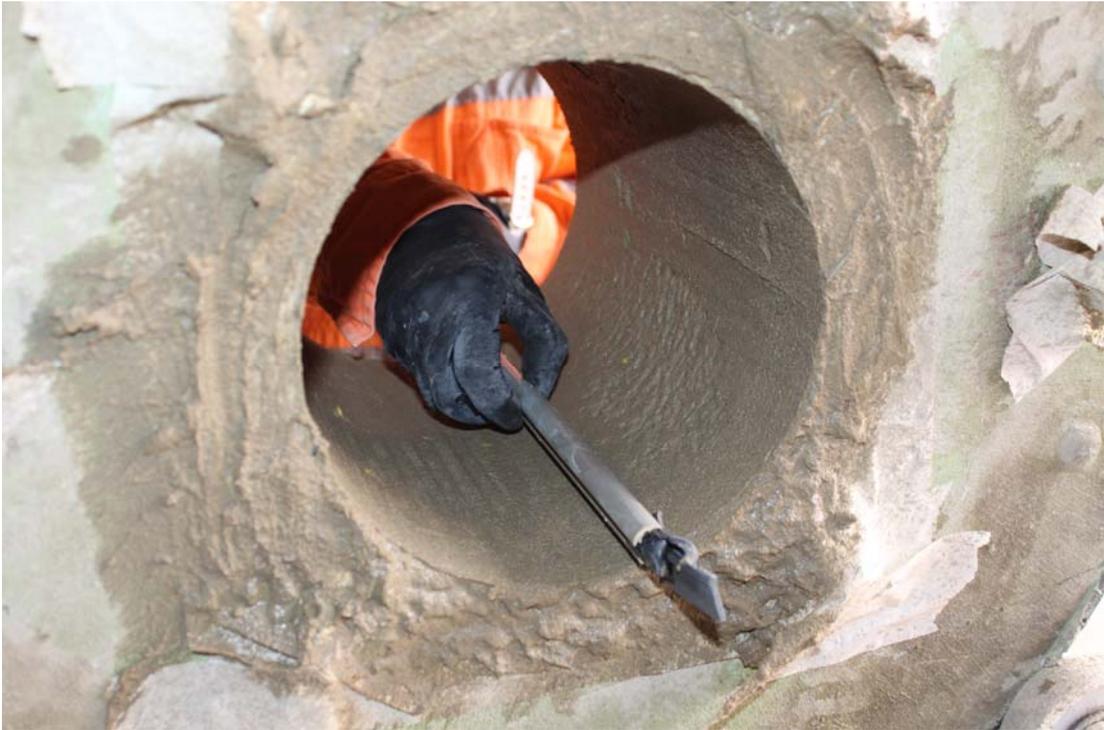
Figure 4.21 Surface smoothing process after the shotcrete spraying.

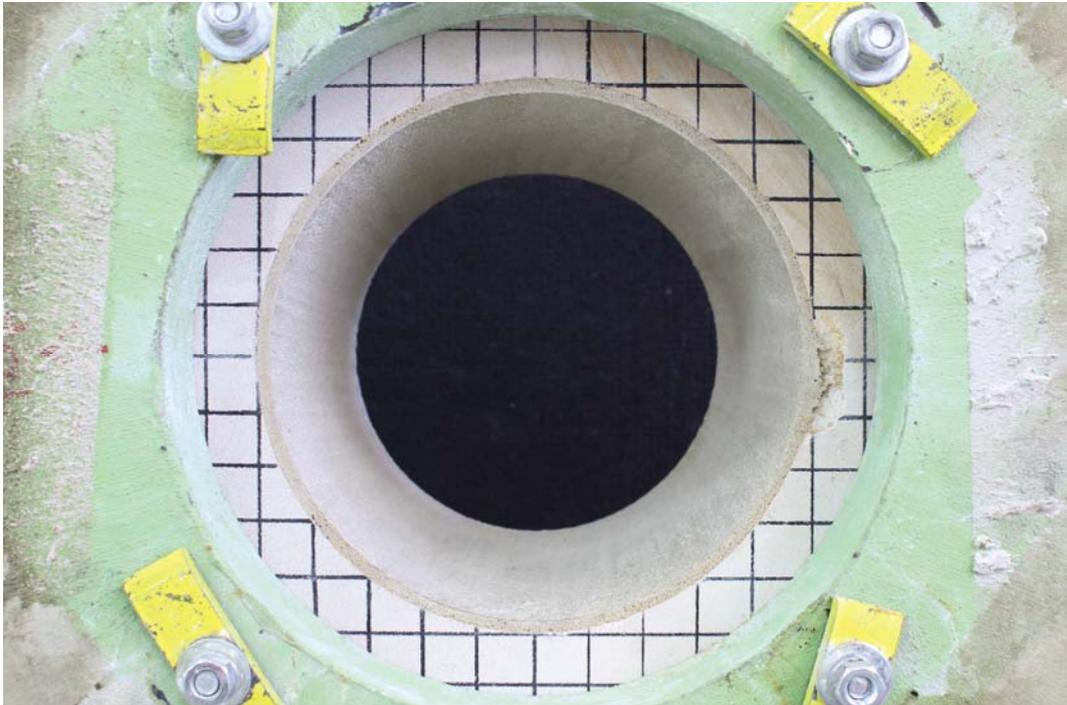
Figure 4.22 A scaled down tunnel with a 5 mm thickness shotcrete layer after curing.

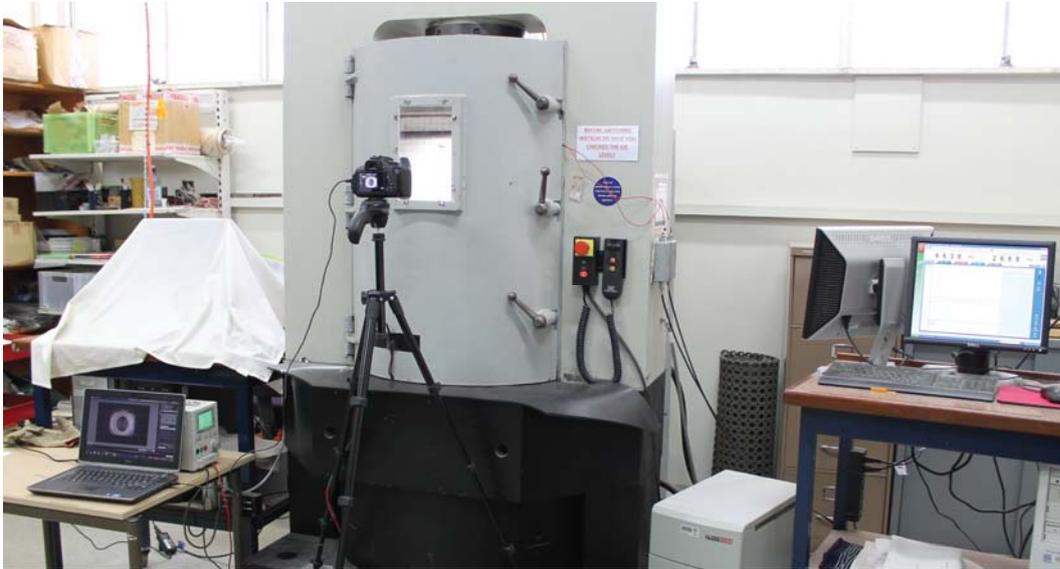
Figure 5.3 Typical experimental set up with SRL camera.

A high speed Canon EOS 650D video camera was used to monitor the tunnel walls during the progressive loading. This digital single-lens reflex camera, was set up in front of the sample and the tunnel behaviour was recorded through a special window within the INSTRON loading machine protective door (Figure 5.3). The camera is capable of capturing up to 50 frames per second. A set of special lights and a suitably

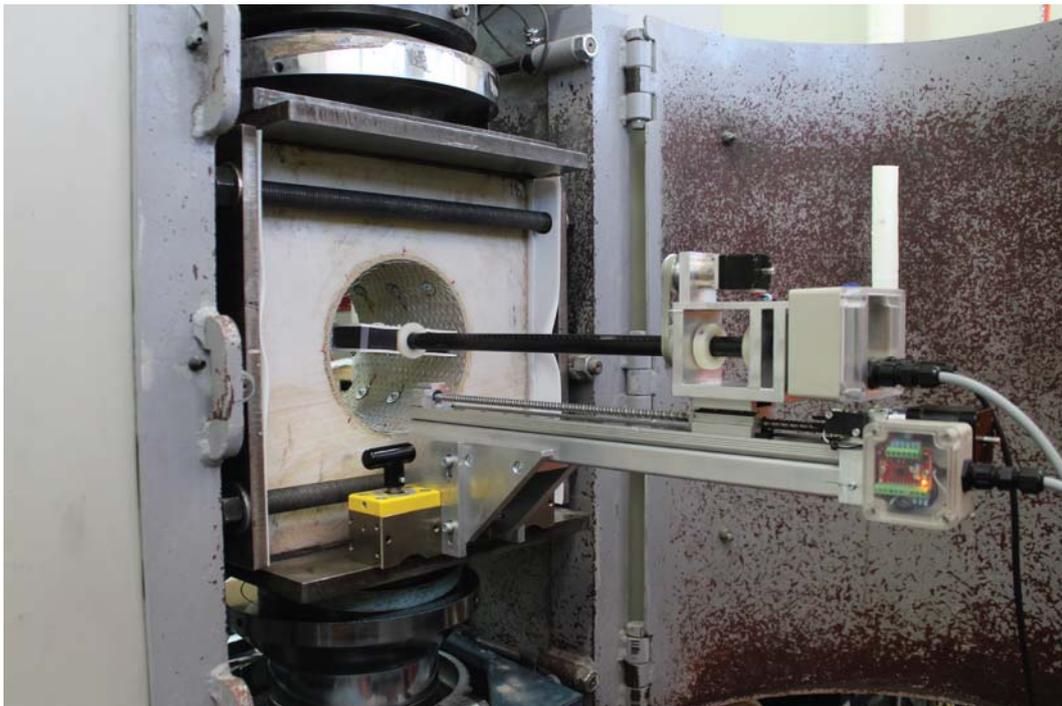
Figure 5.10 An example of the laser scanner setting within a specimen sample.

The scanning unit is mechanical and composed of a linear actuator driven by a step motor to move the laser head a precise amount of distance along the tunnel linear axis (Figure 5.8). At the end of the rotary axis rod is a laser scanning head. The laser was fixed onto the linear axis to enable a measurement range of 100-125 mm from the centre of the linear axis. The laser scanning head was protected from any ejected material during testing (Figure 5.9). The laser scanner unit was mounted on the bottom steel plate and fixed by the magnet switches until the end of the test (Figure 5.10).

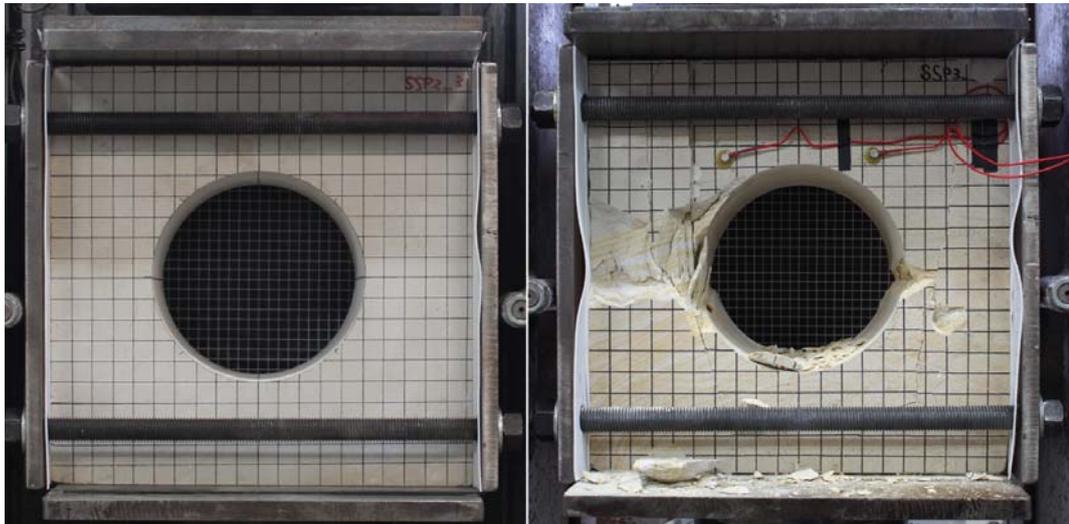
Figure 6.2 Typical unsupported tunnel and pillar geometry tested (grid size 20 mm x 20 mm), before and after failure.

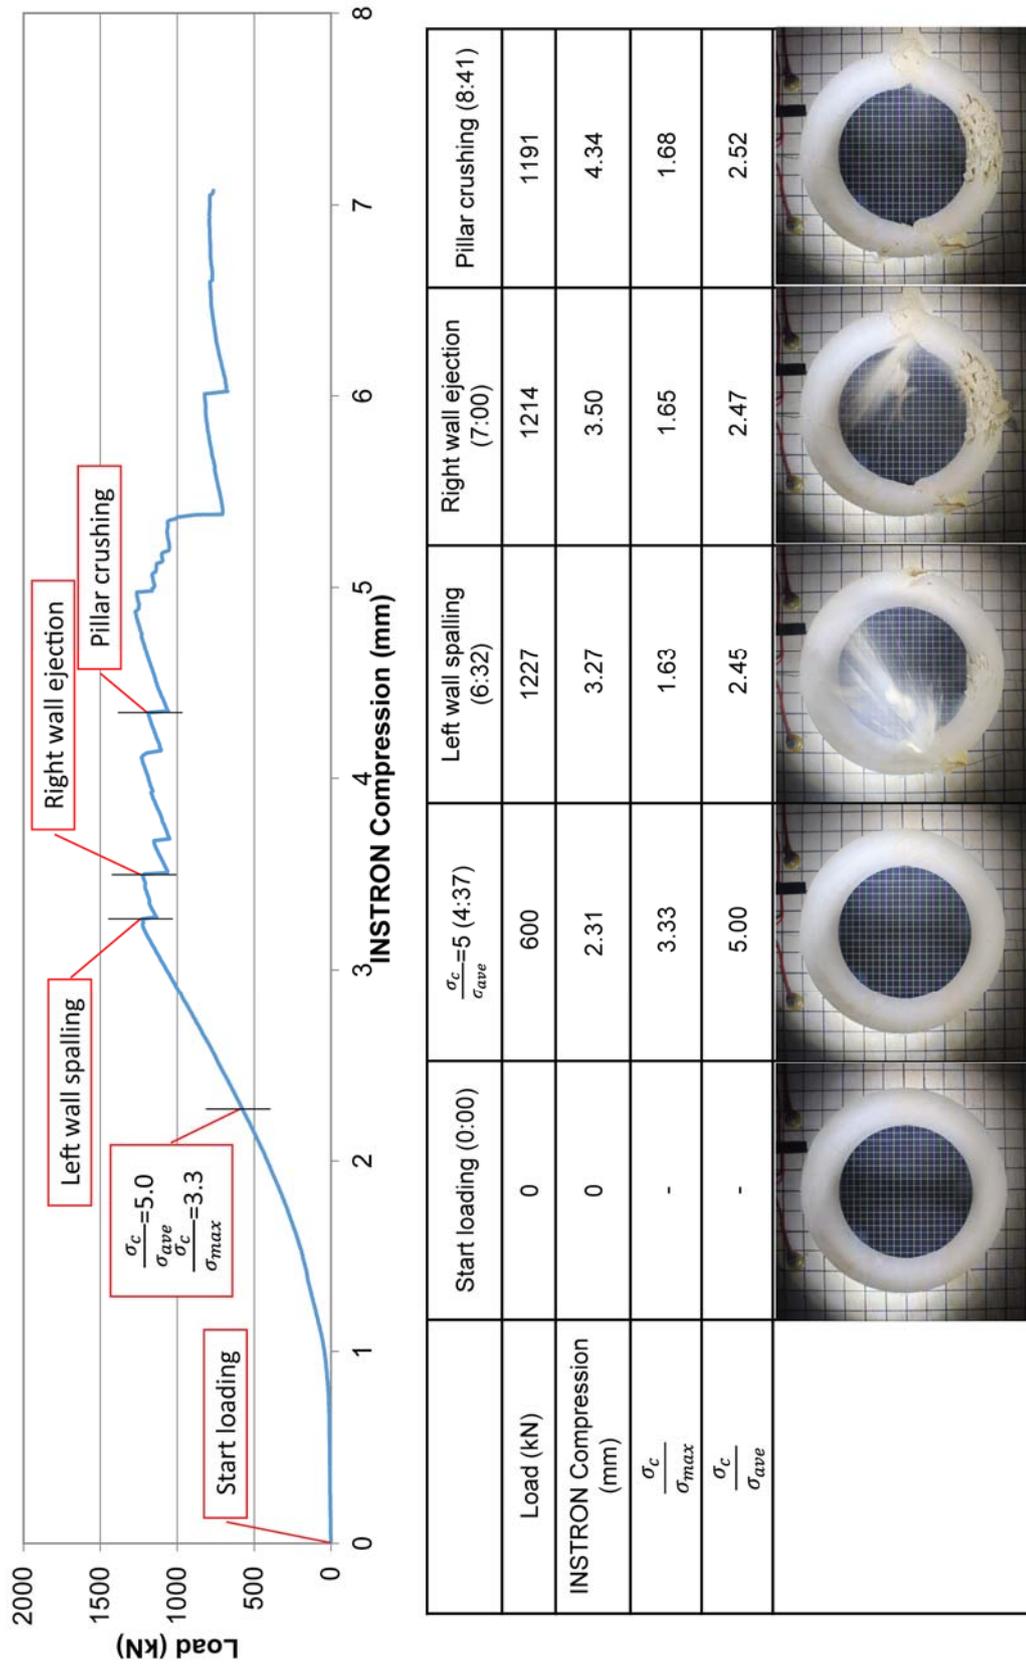
Figure 6.3 Example of load displacement curve with unsupported sandstone tunnel behaviour.

between the loading plates of the top and bottom of the specimen. When the load reached a certain level, spalling was experienced at both sidewall of tunnels with a sudden load decrease. Figure 6.4 shows a typical process of spalling within an unsupported tunnel. The ratio of σ_c/σ_{max} is shown for a number of instability stages on the tunnel was being loaded to failure. When the maximum tangential stress at the tunnel boundary reached a certain level, thin slabs were formed and started to be detached from the tunnel wall surface from either side of the specimen face. The detached slabs fell off to the tunnel bottom with the crack propagating from one end of the tunnel to the other. Once the crack spread through the entire tunnel wall, broken materials were ejected violently from the damaged area. Simultaneously a vertical shear crack was formed on the specimen face which intersected the horizontal spalling area at the edge of the tunnel wall. Slabs were ejected from inside of the tunnel wall and violent ejection occurred at the edge of the specimen face. After spalling occurred in both tunnel sidewalls, the specimen behaved elastically until reaching the peak load. At the peak load, shear cracks formed within the side pillars and eventually it dominated the failure process until the end of the tests. The side confinement plates held the specimen in place after the onset of pillar crushing. The detailed unsupported tunnel failure progression is provided in Appendix A.

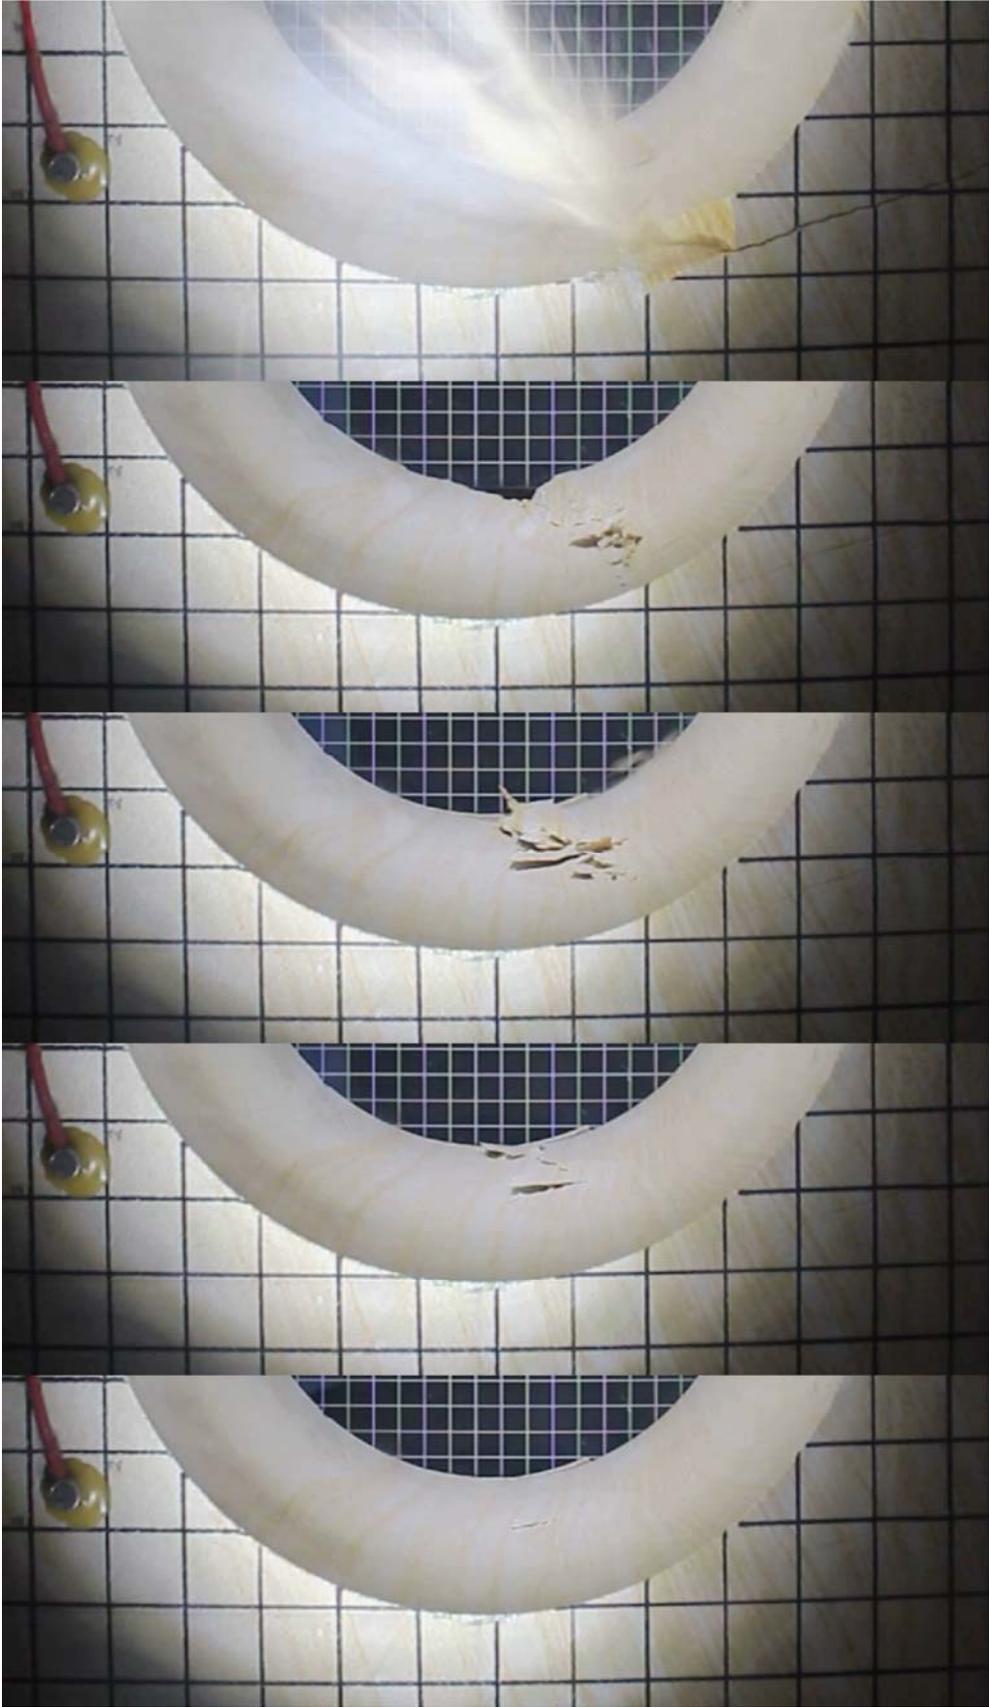
Figure 6.4 Typical spalling propagation process of unsupported strong sandstone.

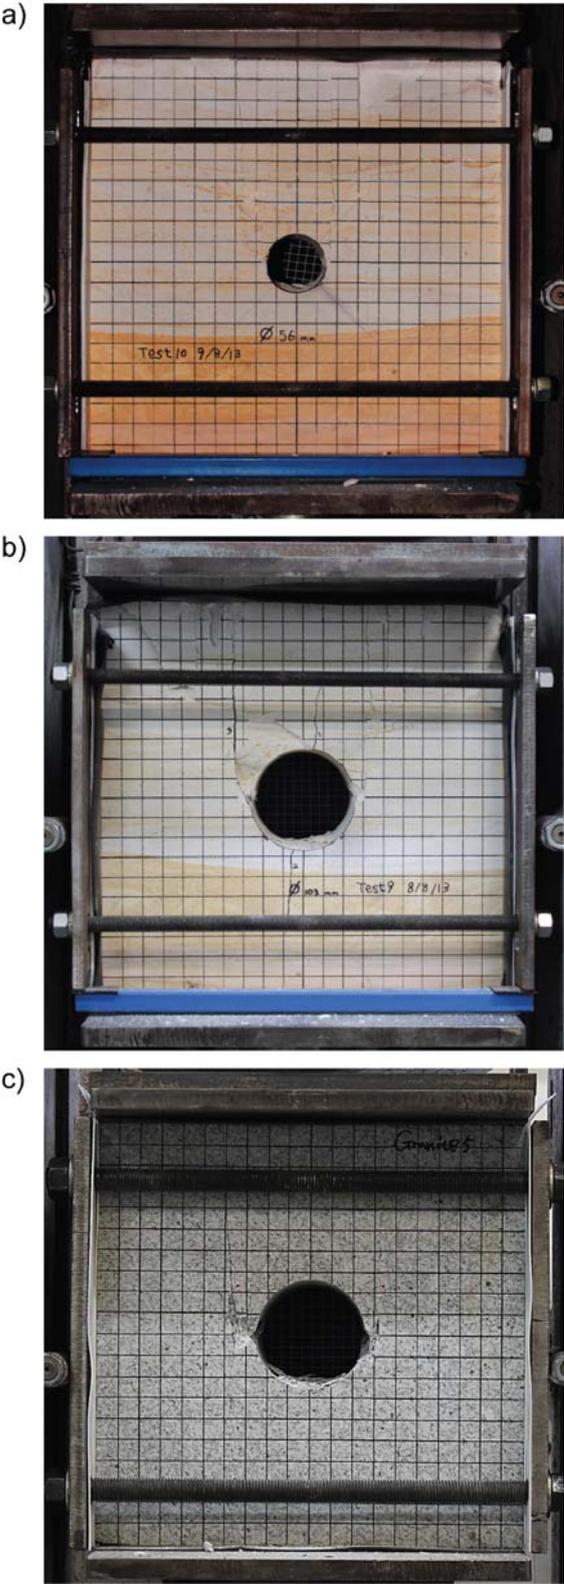
Figure 6.8 Specimens after failure a) strong sandstone (56 mm diameter), b) strong sandstone (103 mm diameter), c) granite (104 mm diameter).
