Western Australian School of Mines

**Scaled Down Tunnel Testing for Comparison of Surface Support
Performance**

**This thesis is presented for the Degree of
Doctor of Philosophy
of
Curtin University**

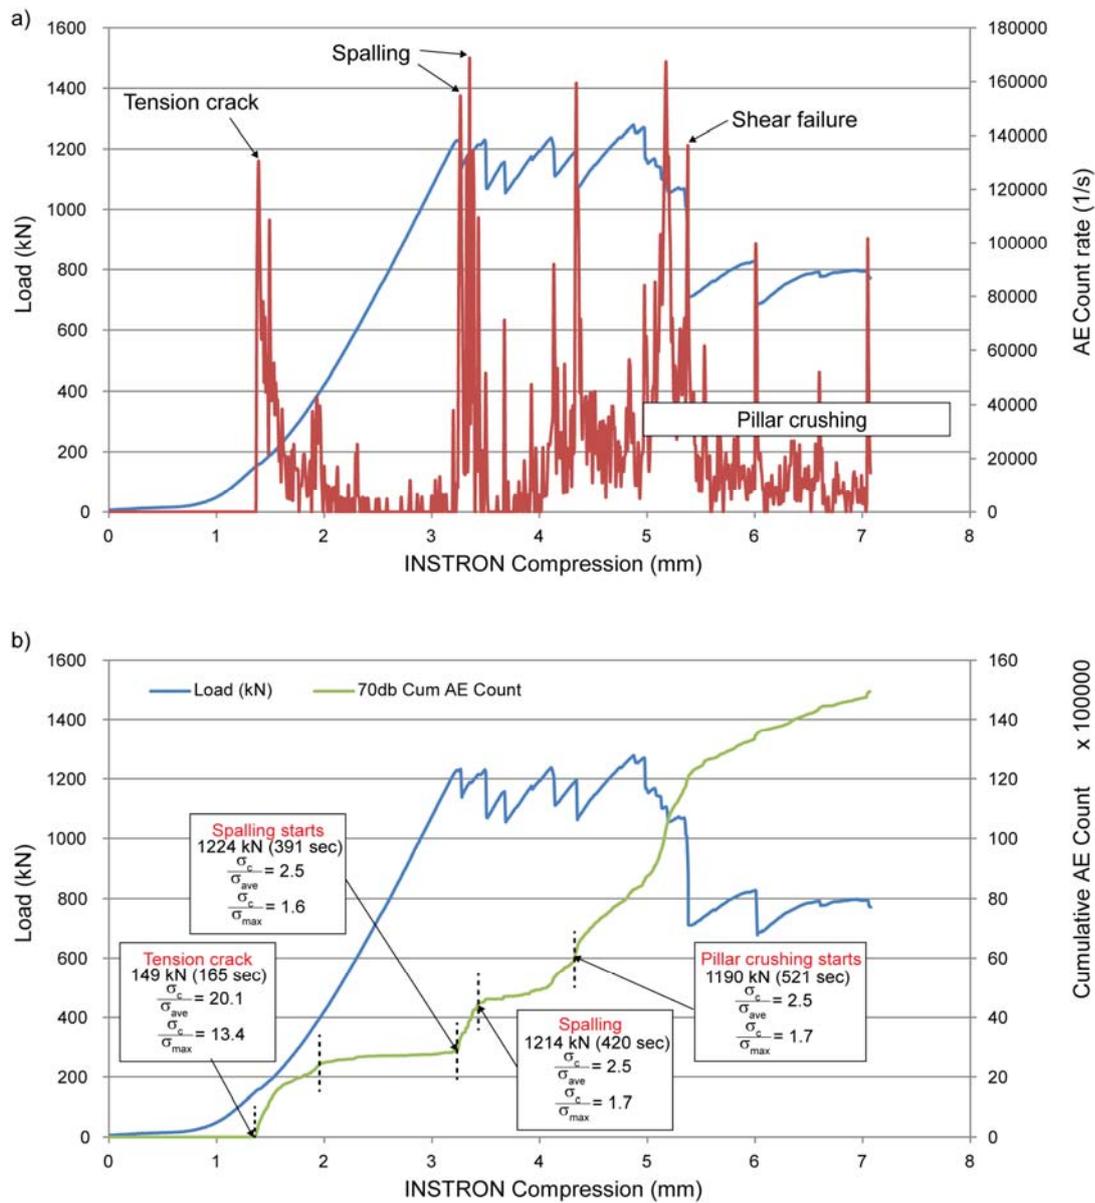
Figure 6.9 a) Failure mode and seismic response of an unsupported tunnel in strong sandstone, b) Rate of seismicity and decreasing ratios of strength/induced stress.

Figure 6.9a shows a typical seismic response of an unsupported 200 mm tunnel diameter within strong sandstone. The seismic activity starts with the creation of a vertical tension crack in the floor and roof of the circular opening as predicted by theory (Hoek & Brown, 1980). The rate of seismic activity clearly increased prior to the violent ejection in both walls. Significantly, a relatively quiet period was monitored prior to final rupture and the start of the pillar crushing mode (shear) of failure. Critical levels of strength to induced stress related to the start of any visible instability such as spalling on both walls and the start of pillar have also been identified (Figure 6.9b). A significant decrease in load bearing capacity occurs following the final shear failure of the pillar.

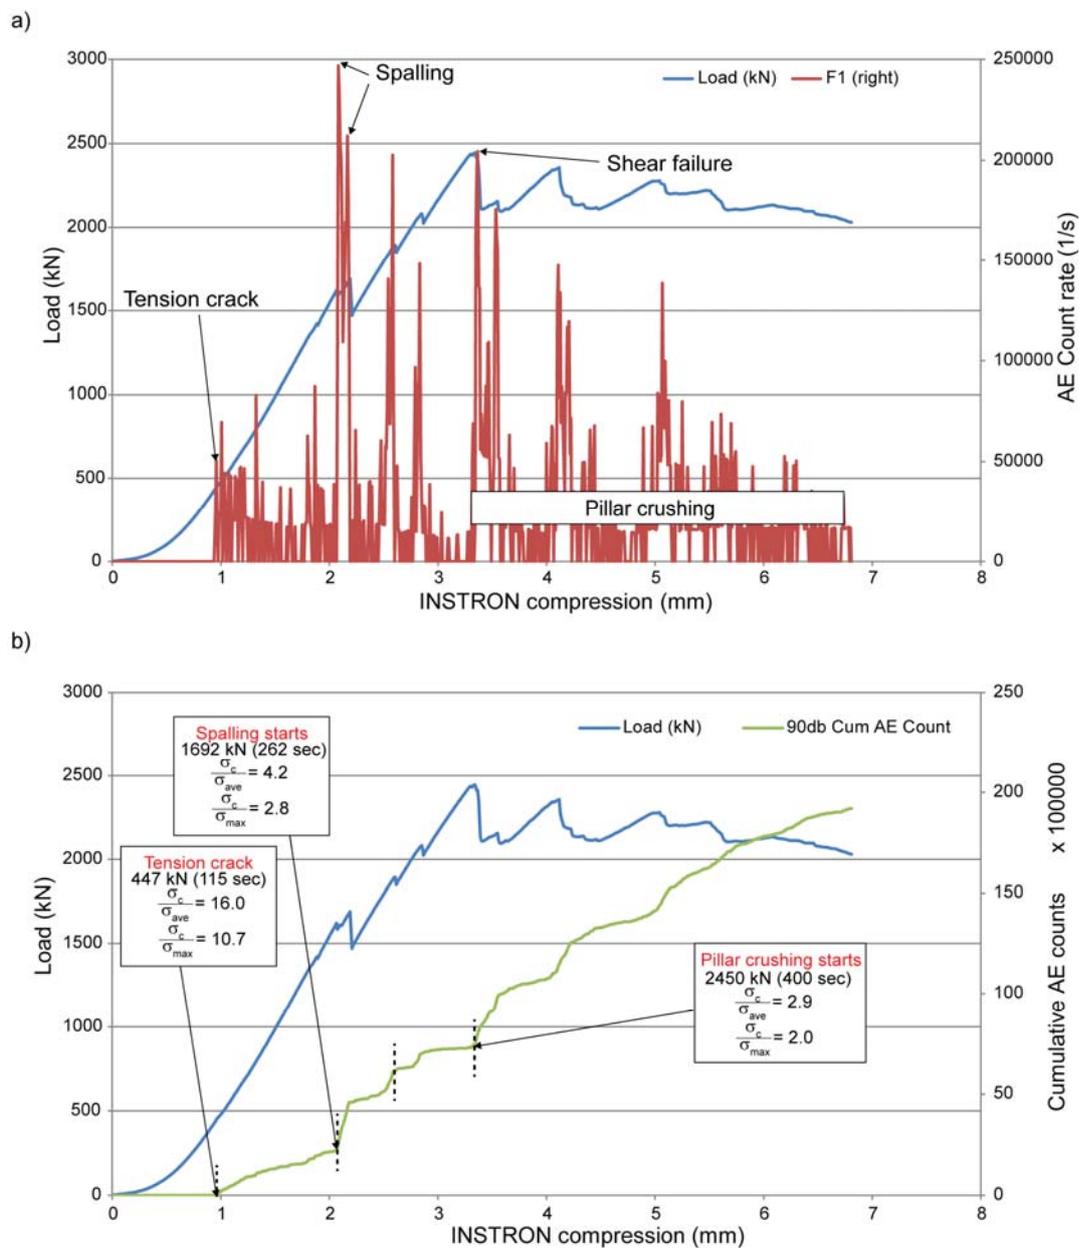
Figure 6.10 a) Failure mode and seismic response of an unsupported tunnel in granite, b) Rate of seismicity and decreasing ratios of strength/induced stress.

Seismic data revealed a distinctive difference in each failure mechanism. Although seismic activities at spalling failure was impulsive, pillar crushing failure was accumulative. After spalling occurred on both side of tunnels, seismic activities returned to a low increase rate until an onset of pillar crushing. Frequent seismic activities were recorded and continued until the end of the test.

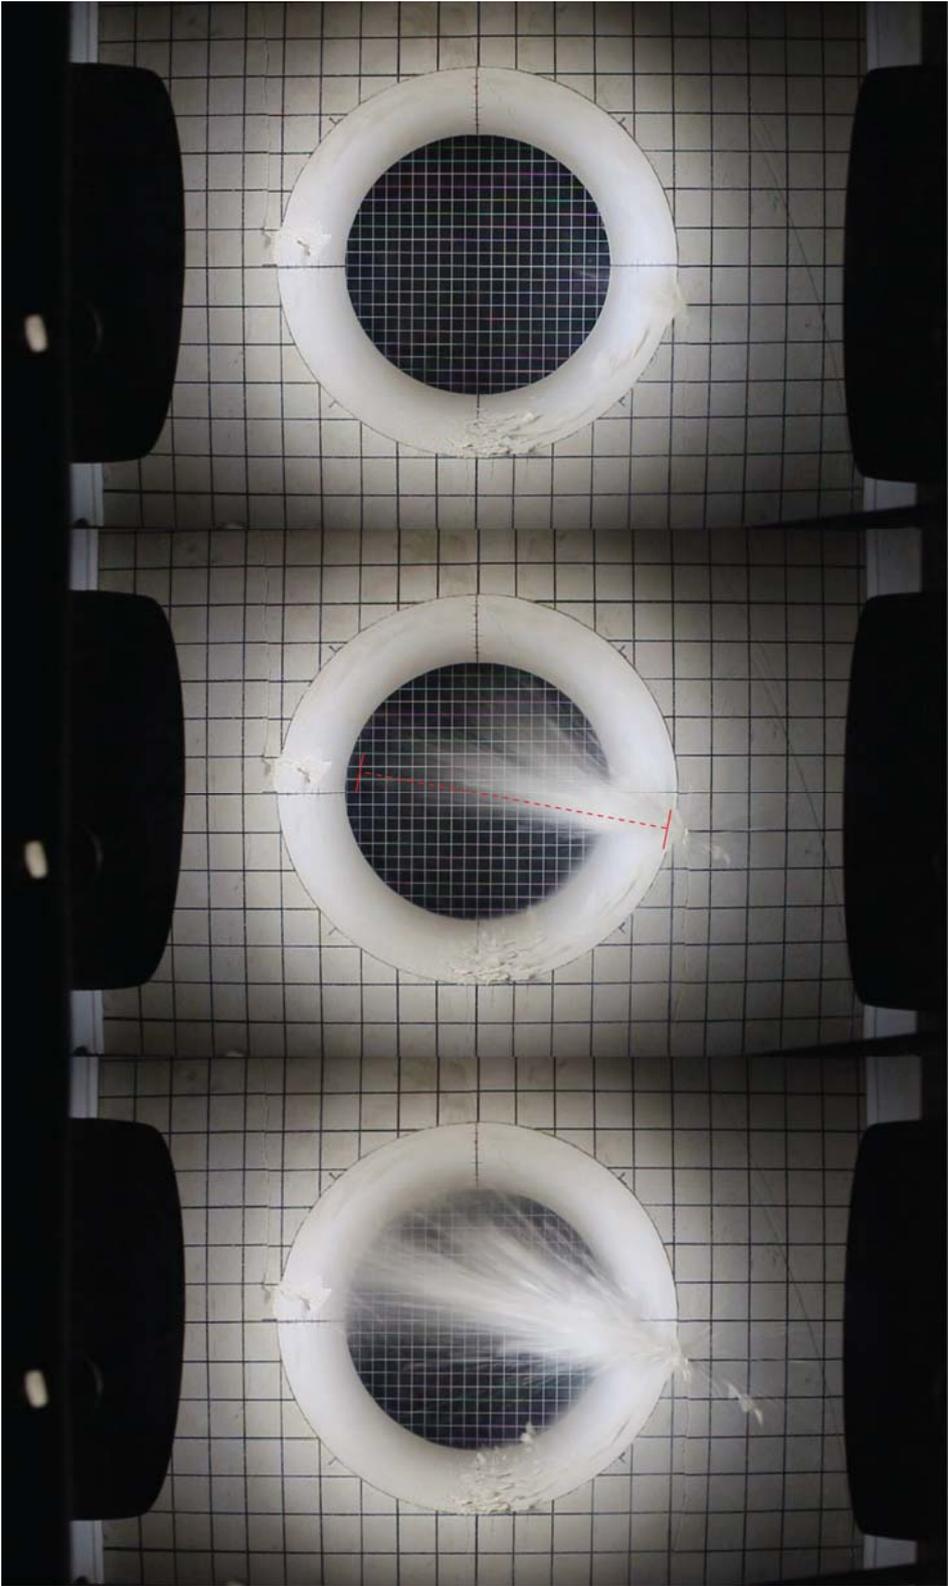
Figure 6.14 An example of a moment of material ejection (photos were taken every 0.02 sec).

Figure 6.14 shows an example of material ejection calculation. Photos were continuously filmed every 0.02 sec and a material ejection moment was selected. Material travel distance was measured on the image and converted using a measurement scale depending on a material ejection position. In Figure 6.14, since material ejection occurred at the front of the tunnel, a front measurement scale was used to obtain the actual travel distance. The calculated distance was divided by the intervals (0.02 sec) and material ejection velocities were determined.

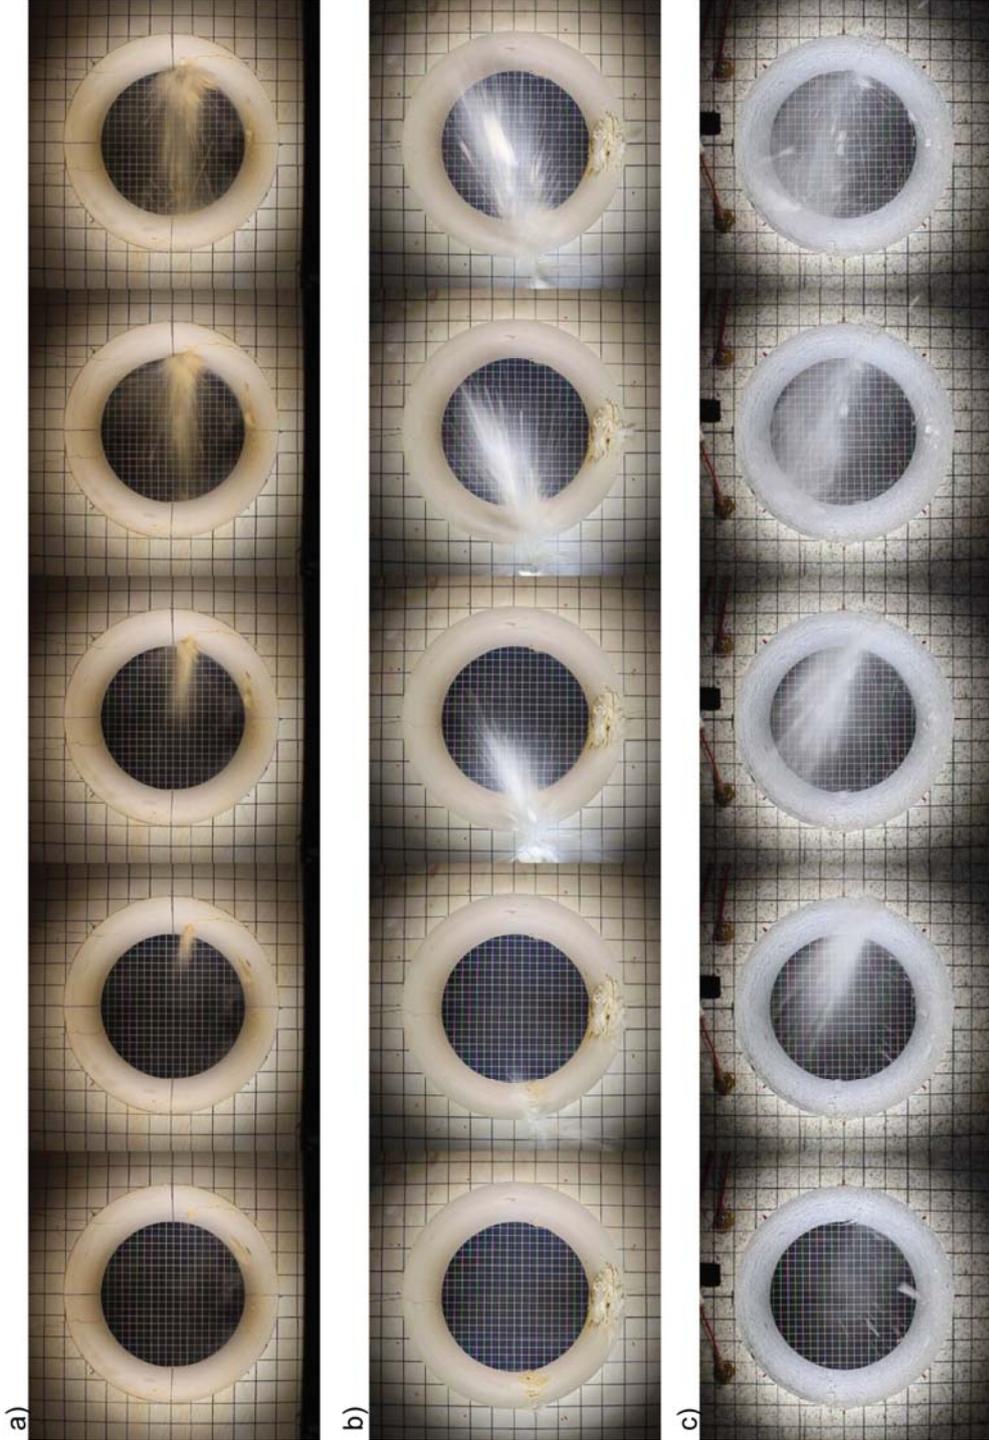
Figure 6.15 Violent ejection development at spalling (50 fps) a) strong sandstone 2.3 m/s, b) strong sandstone 6.9 m/s, c) granite 8.5 m/s.

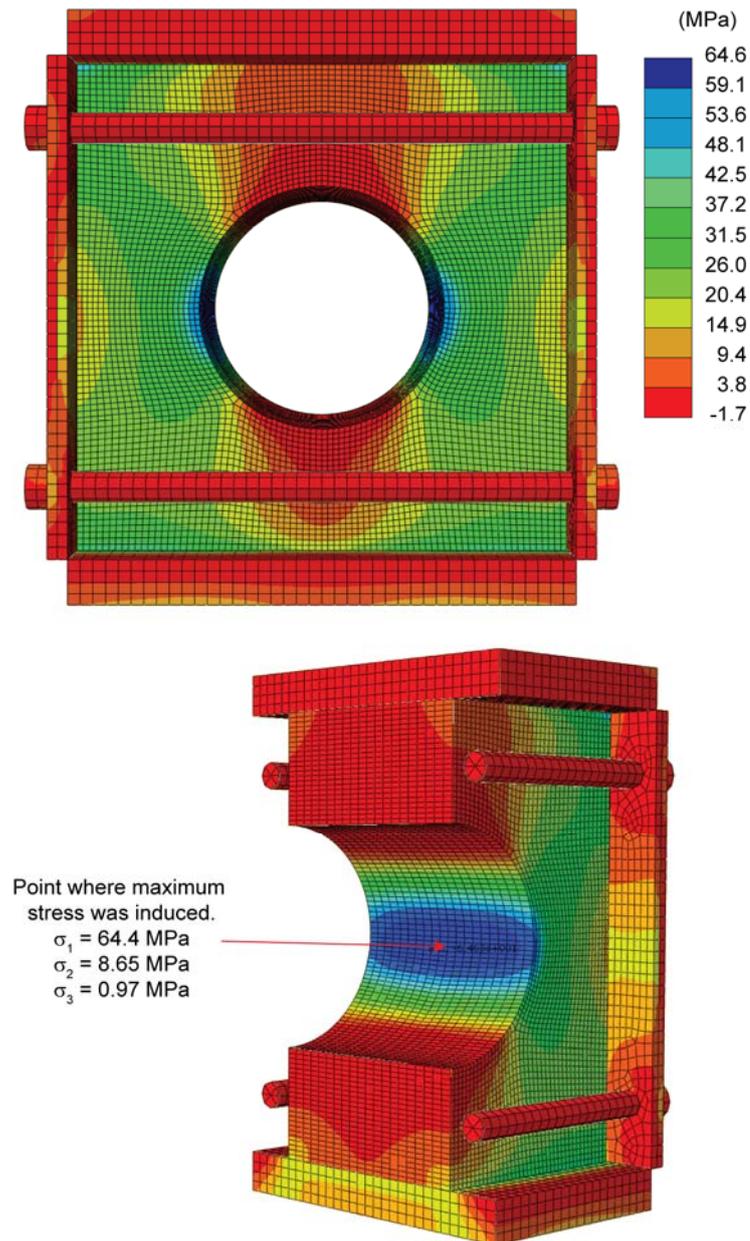
Figure 7.3 Maximum principal stress prior to failure by linear elastic finite element modelling.

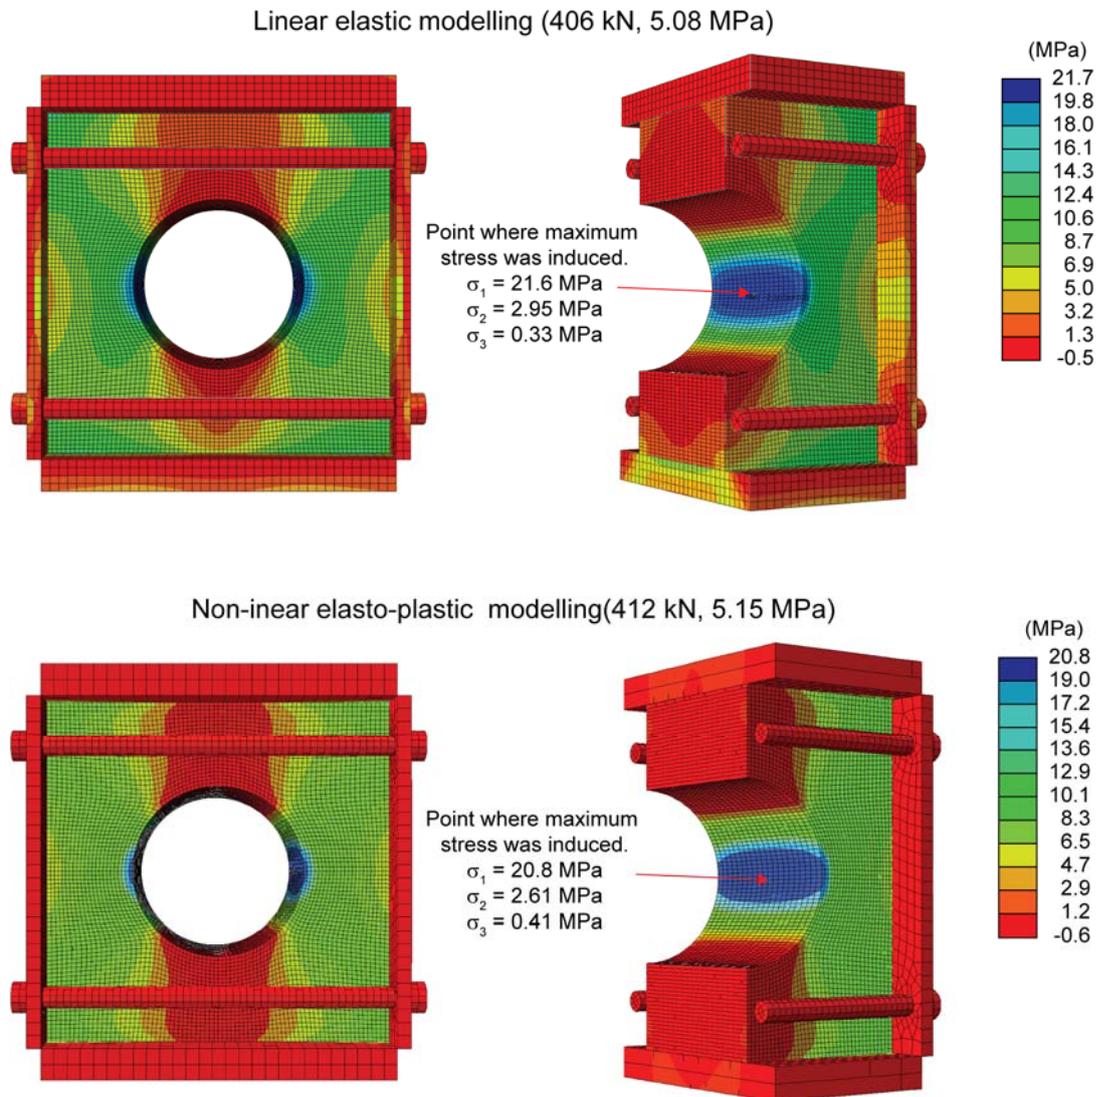
Figure 7.6 Comparison of maximum principal stress before spalling between linear elastic and non-linear elasto-plastic modelling results.

Figure 7.6 shows both linear elastic and non-linear elasto-plastic modelling results before spalling. The maximum principal distribution are similar which means the tunnel behaves in an elastic manner before spalling occurs.

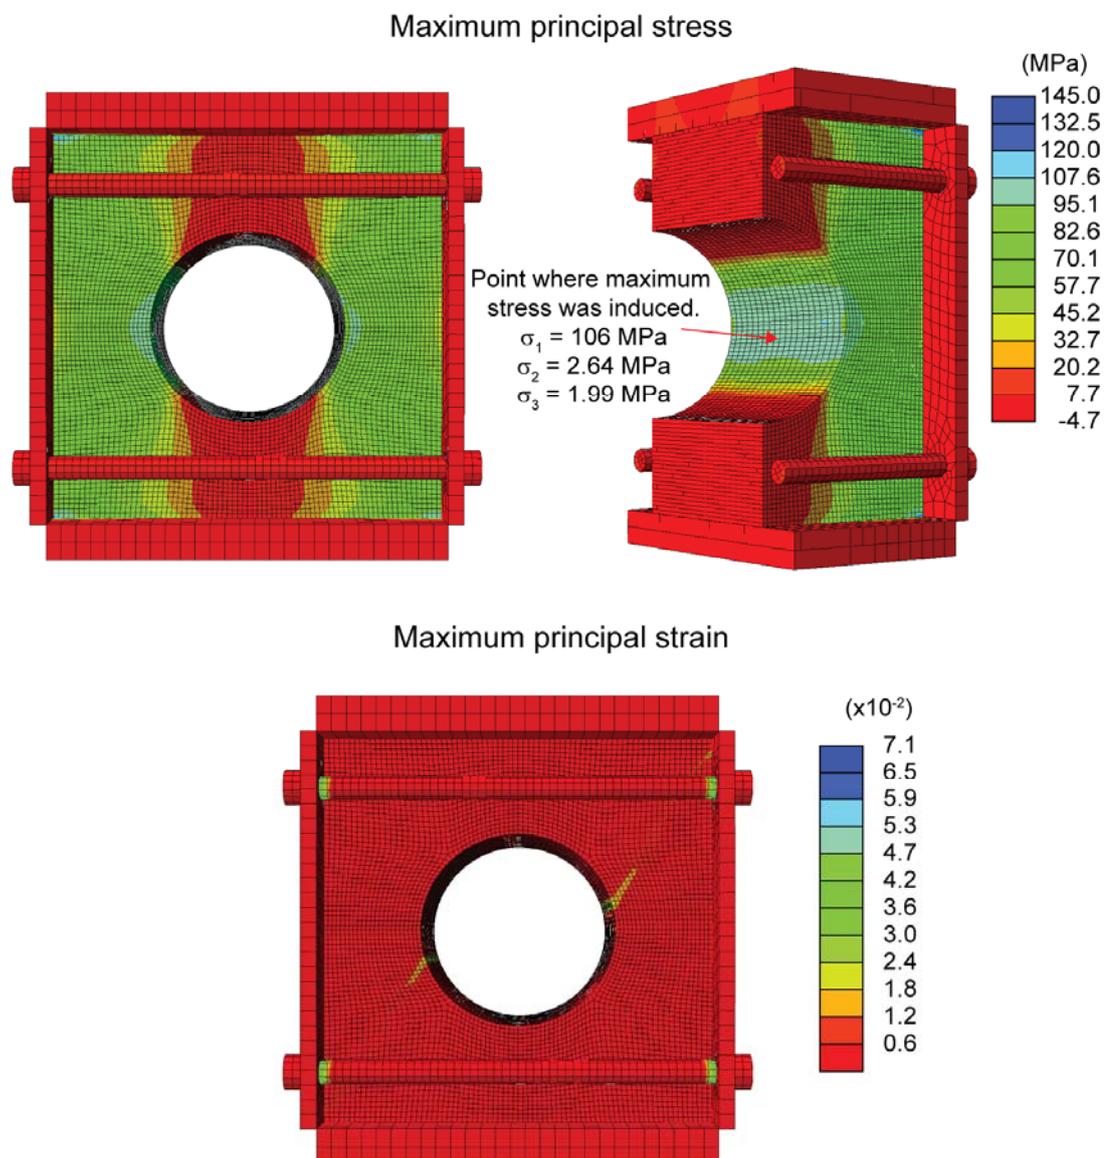
Figure 7.7 Modelling results of shear band creation by non-linear elasto-plastic modelling.

The maximum tangential stress still concentrated at the side boundary of the excavation after the plastic strain creation. The plastic strain at the boundary was observed when the maximum tangential stress reached 106 MPa.

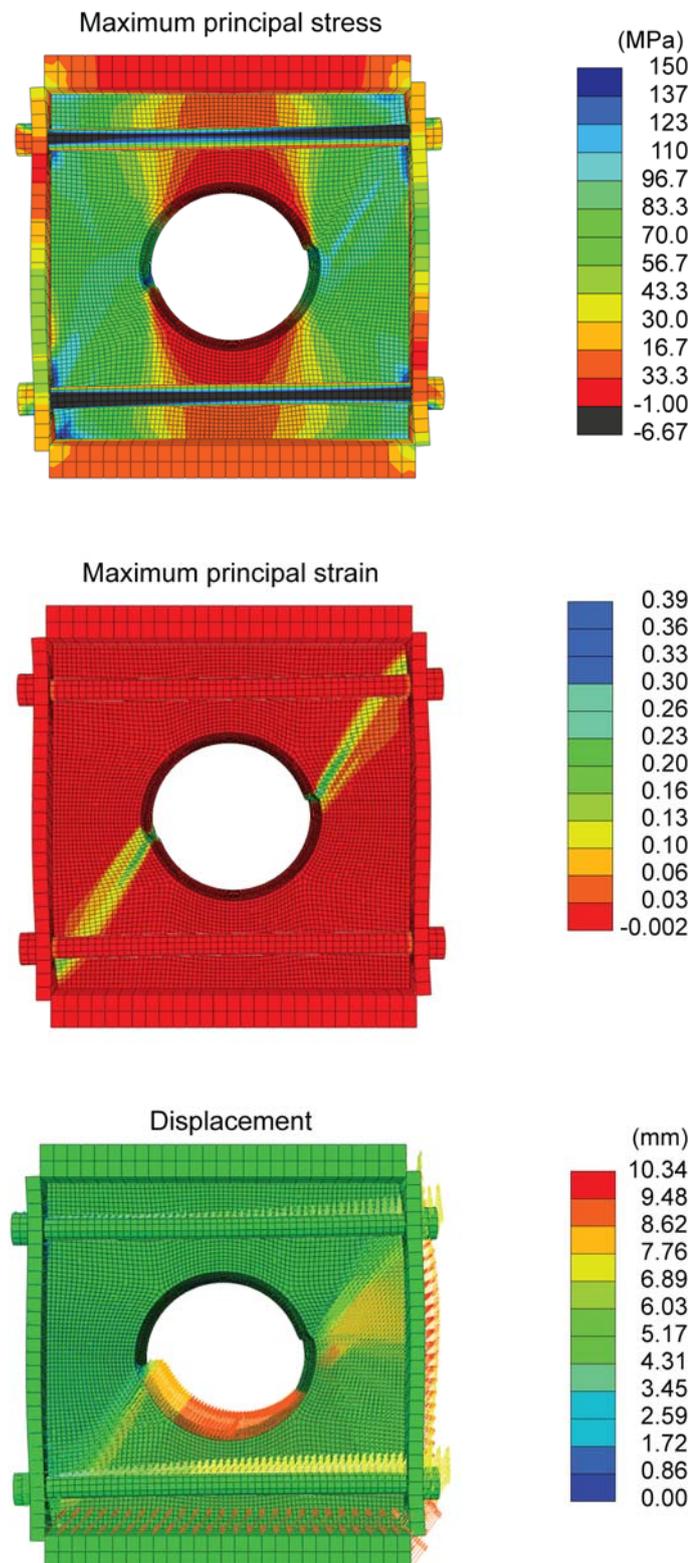
Figure 7.8 Modelling results of shear failure during pillar crushing using the program Abaqus.

The stress distribution in the final stages of pillar crushing can be seen in Figure 7.8 and summarised in Table 7.3. After the plastic strain increased, a tangential stress on the tunnel boundary decreased compared with the value calculated by the Kirsch solution. The average pillar stress calculated by non-linear numerical modelling and the average stress on the pillar (Load / Pillar area) are very similar. It also shows that the pillar stress value on the side of the specimen are similar, which means the boundary effect by the side confinement plates are not significantly influencing the level of stress used to define the threshold for spalling failure.

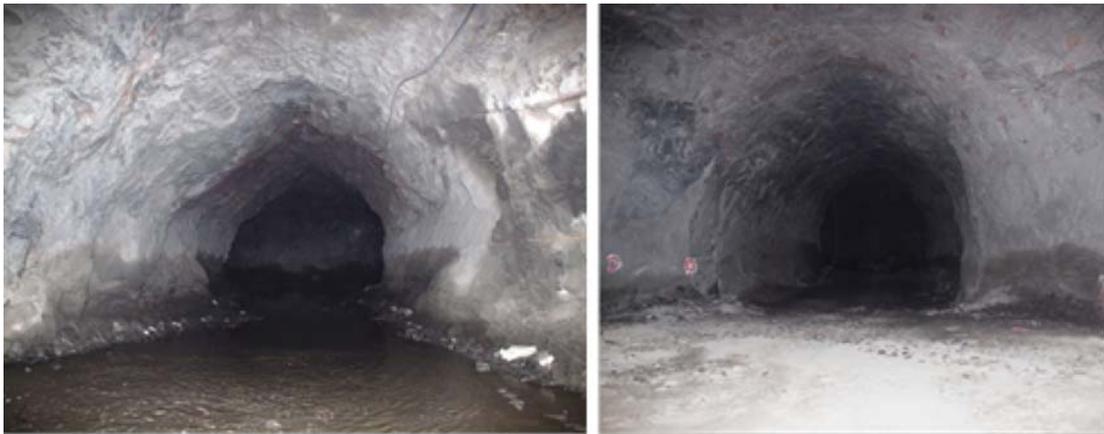
Figure 7.11 Full scale unsupported semi-circular tunnels showing on-set of brittle failure at the centre of the excavation roof due to high horizontal stress.

3.5. The mining tunnels were constructed using excellent drilling and blasting techniques. The tunnels were designed with semi-circular walls and a flat floor. Incipient back (roof) failure due to a sub-horizontally oriented main principal stress component can be seen in Figure 7.11.

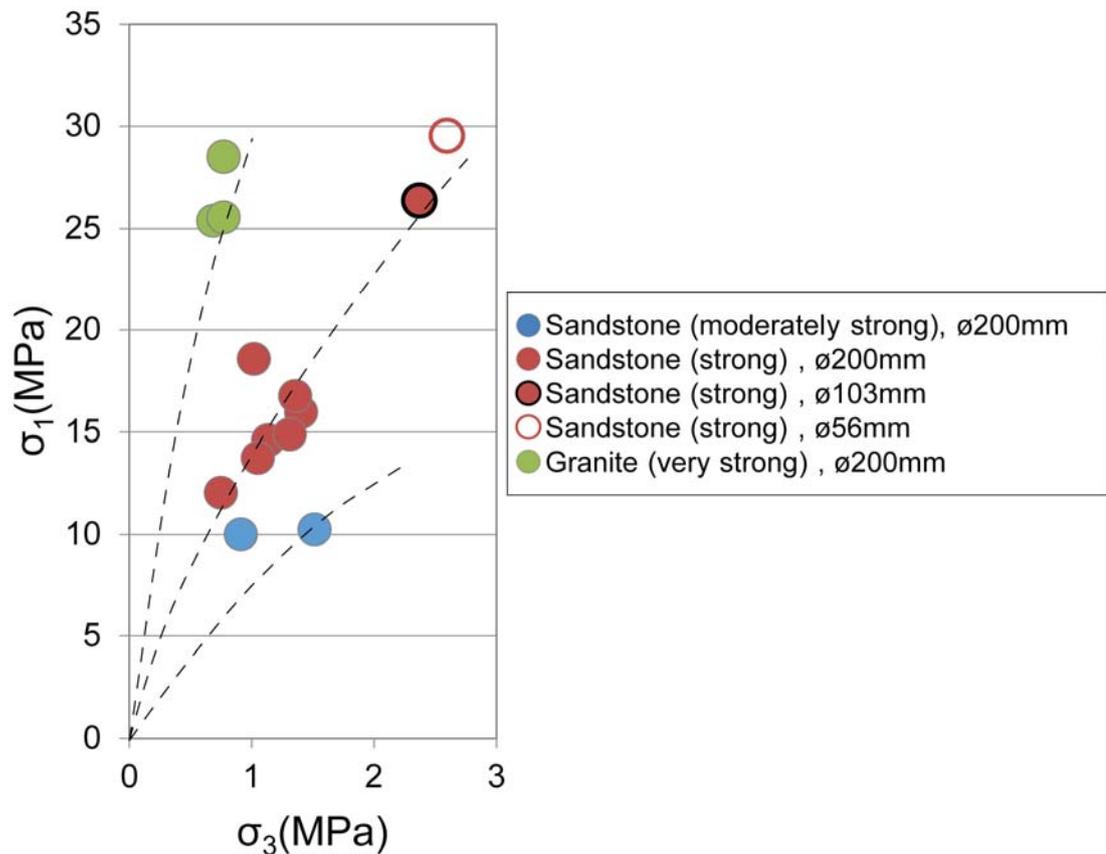
Figure 7.20 Failure envelopes for the scaled-down unsupported tunnels.

Figure 7.20 shows the failure envelope for all the unsupported tunnel tests and the three types of materials used.

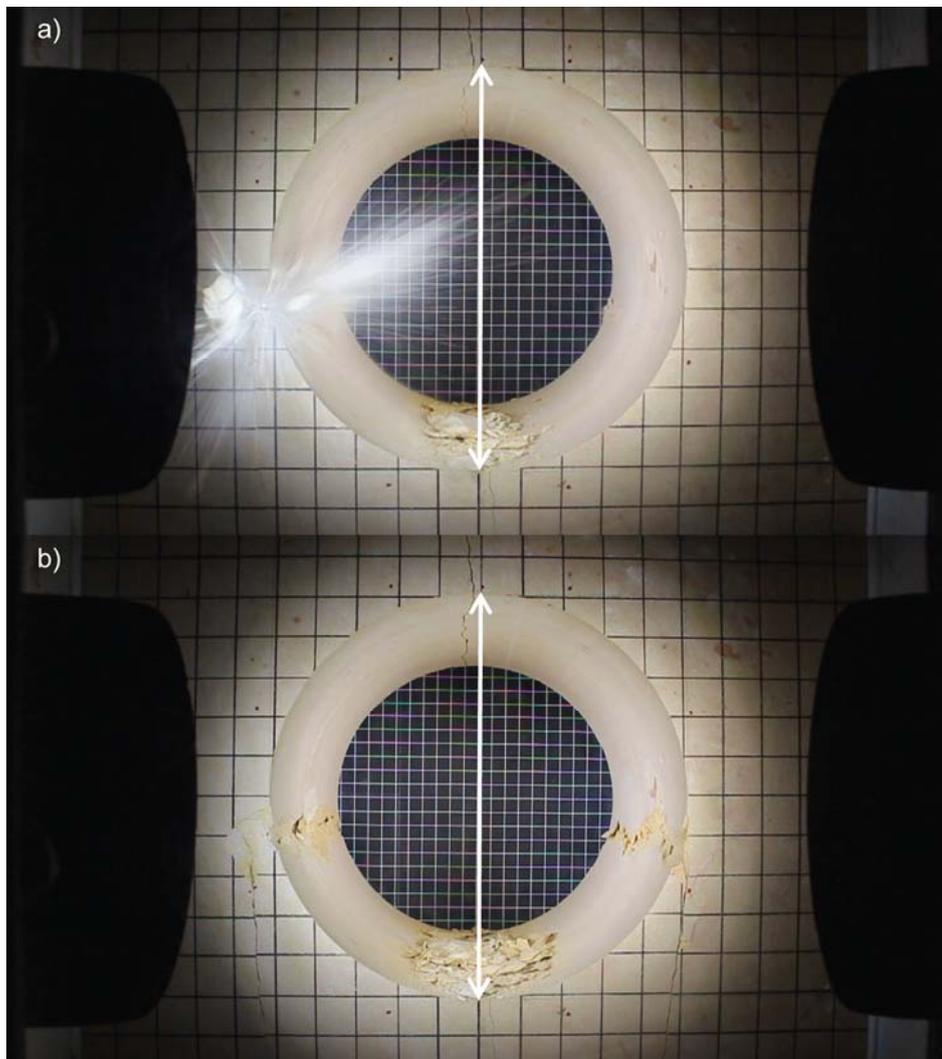
Figure 7.21 An example of strain calculation at a) spalling b) pillar crushing.

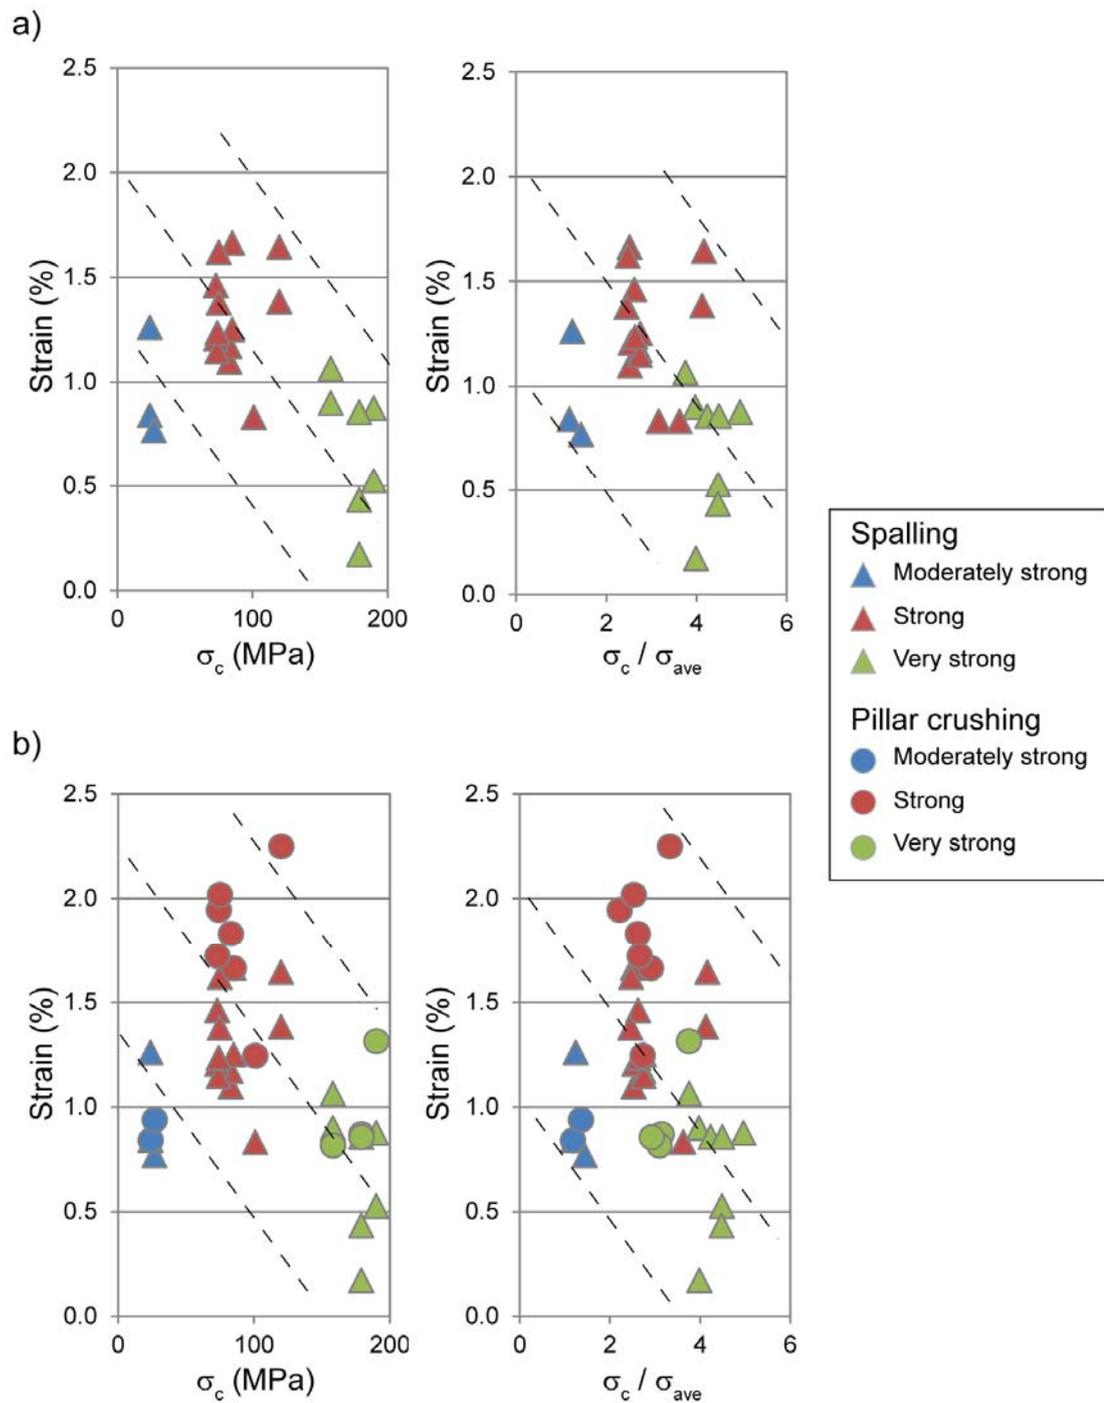
Figure 7.22 a) Strain at the spalling failure for the scaled-down unsupported tunnels, b) a comparison of strain at the spalling failure and pillar crushing for the scaled-down unsupported tunnels.

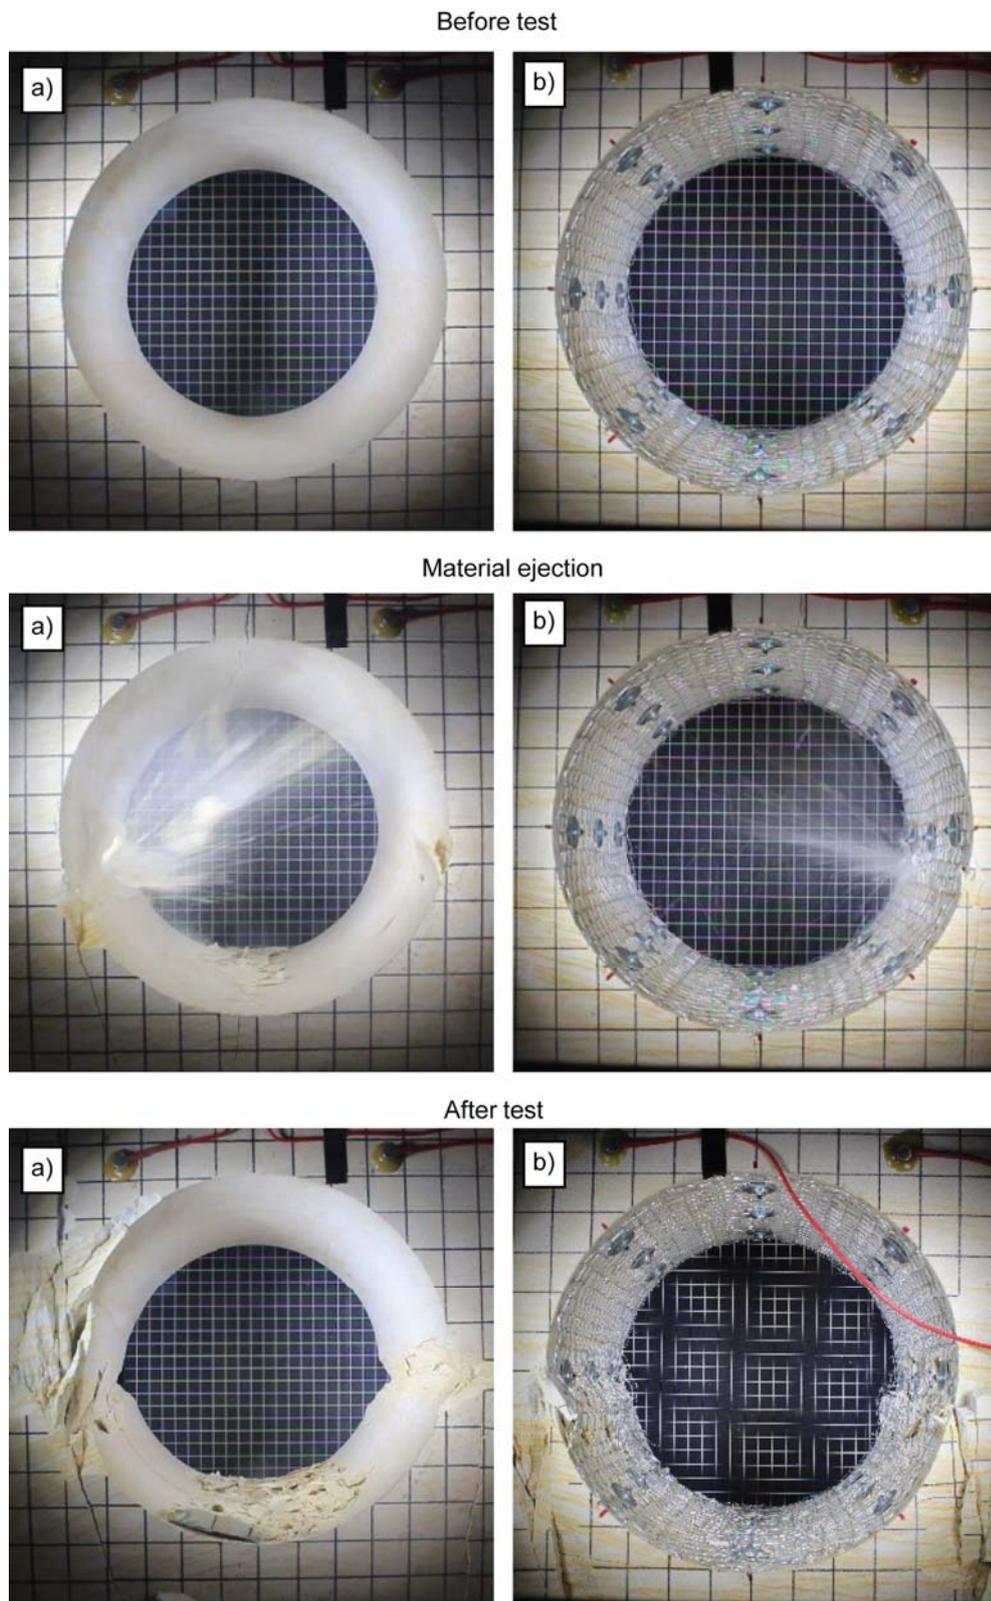
Figure 8.5 Observation of failure mechanism of a) unsupported tunnel b) chain link mesh and rock bolt (square pattern) support (Specimen No.9).

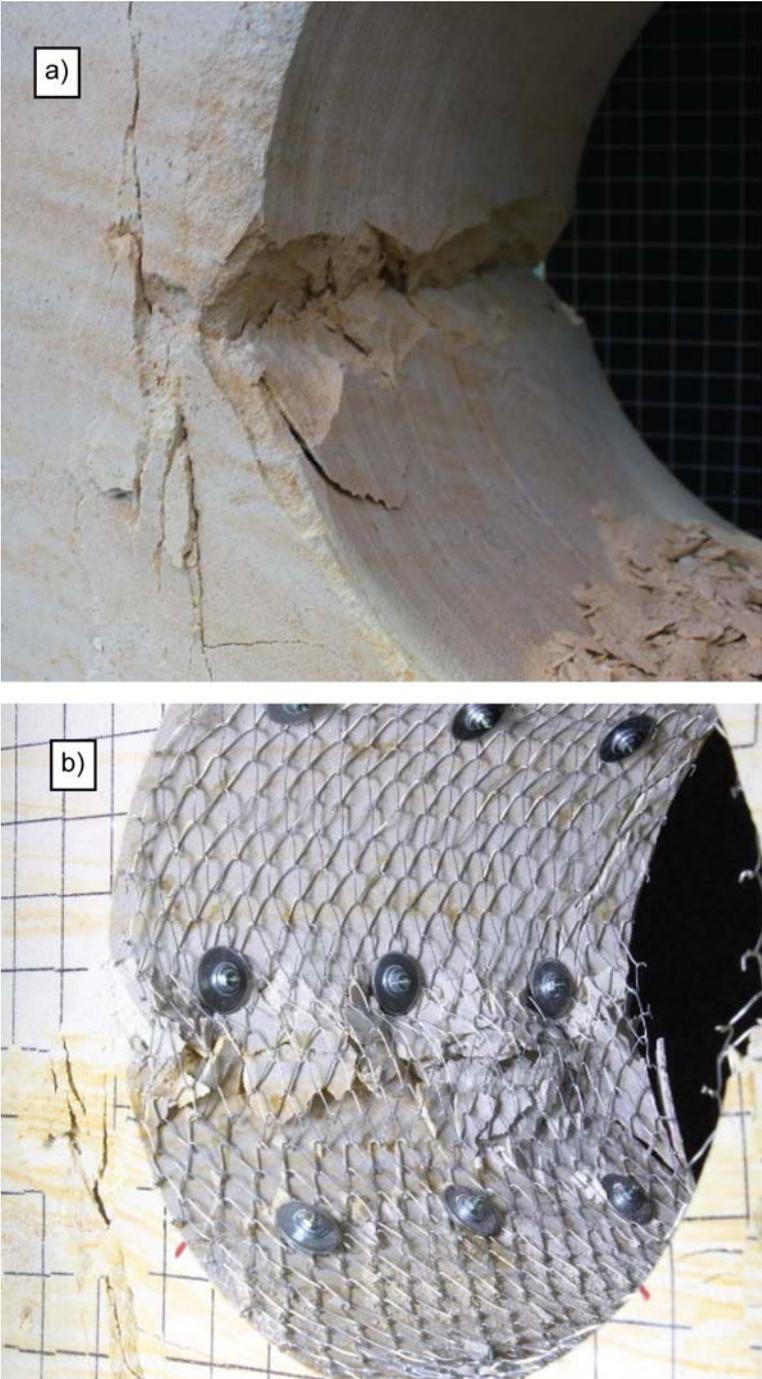
Figure 8.6 Sidewall after failure a) unsupported tunnel b) chain link mesh and rock bolt (square pattern) support (Specimen No.9).

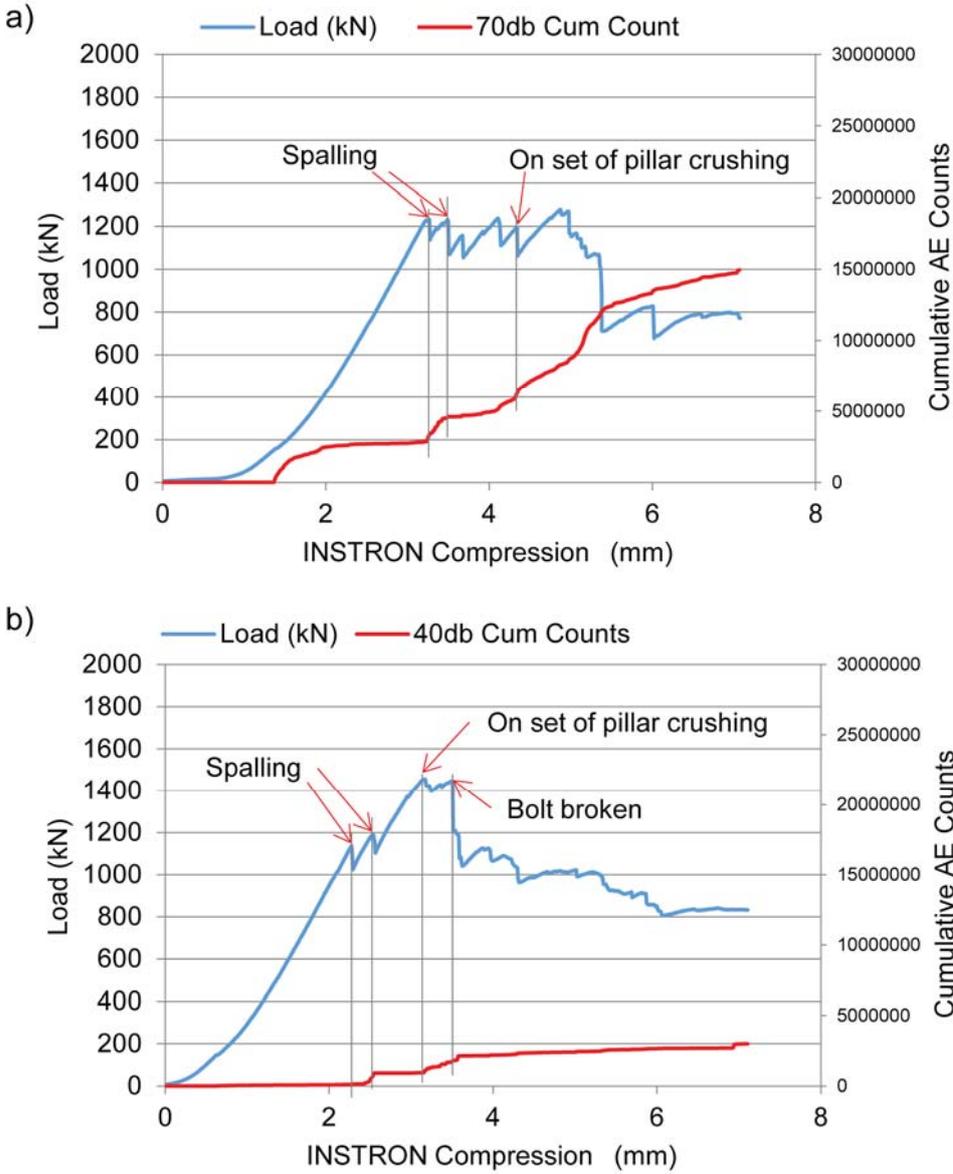
Figure 8.7 Load displacement relationship with recorded AE activities a) unsupported tunnel b) reinforcement and chain link support (Specimen No.9).

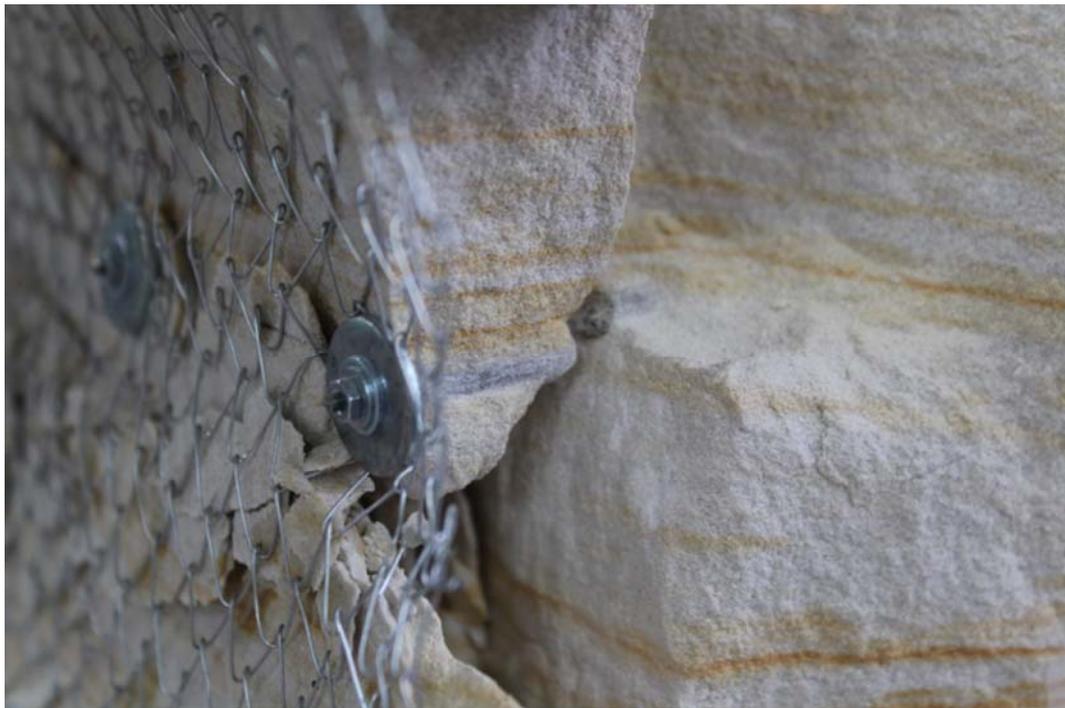
Figure 8.8 Rock bolt shear failure (after test).

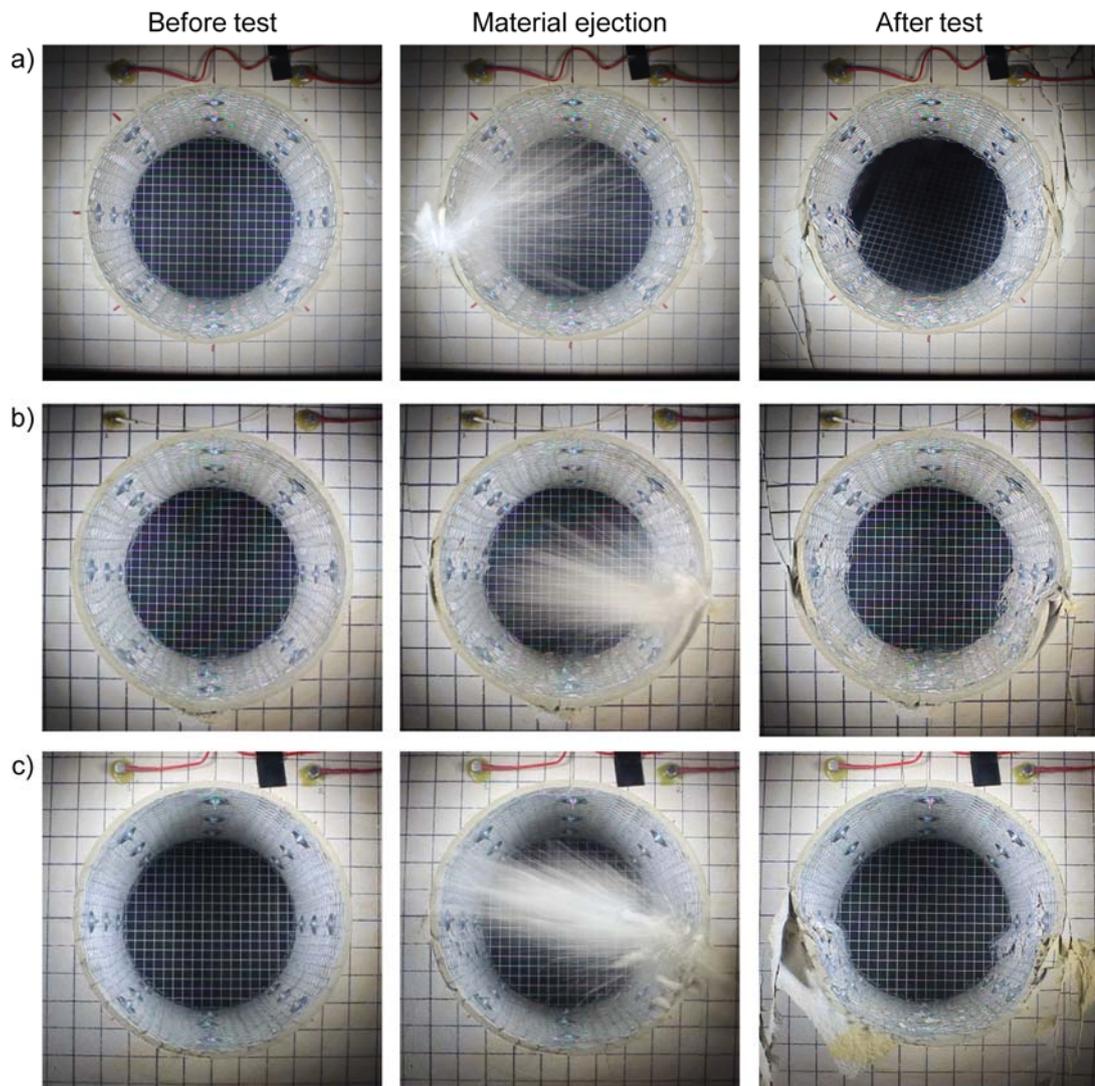
Figure 8.10 Comparison with the same ground support configuration tests, a) 68 MPa (Specimen No.10) b) 76 MPa (Specimen No.11) and c) 83 MPa (Specimen No.12).

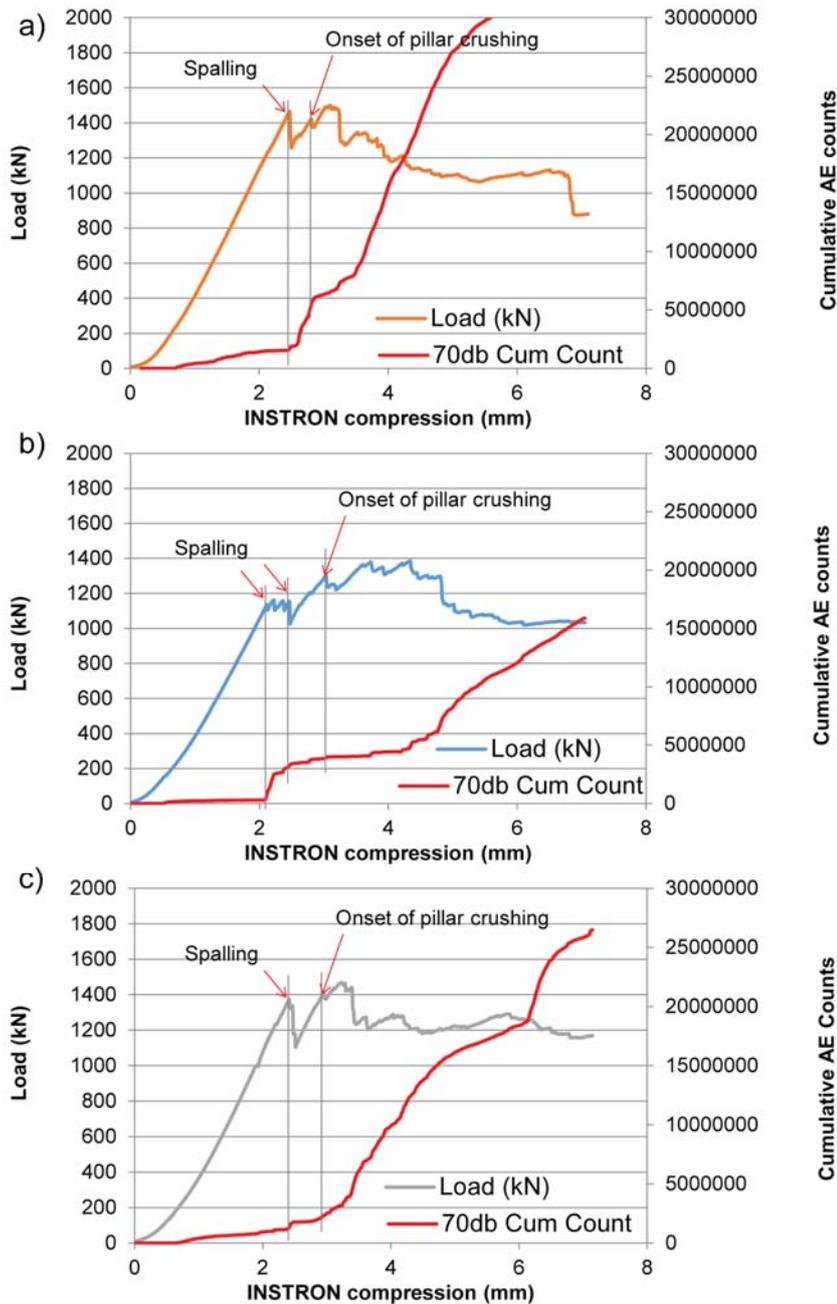
Figure 8.11 Load relationship curve of the same ground configuration test with AE data a) 68 MPa (Specimen No.10) b) 76 MPa (Specimen No.11) and c) 83 MPa (Specimen No.12).
