Western Australian School of Mines

**Scaled Down Tunnel Testing for Comparison of Surface Support
Performance**

**This thesis is presented for the Degree of
Doctor of Philosophy
of
Curtin University**

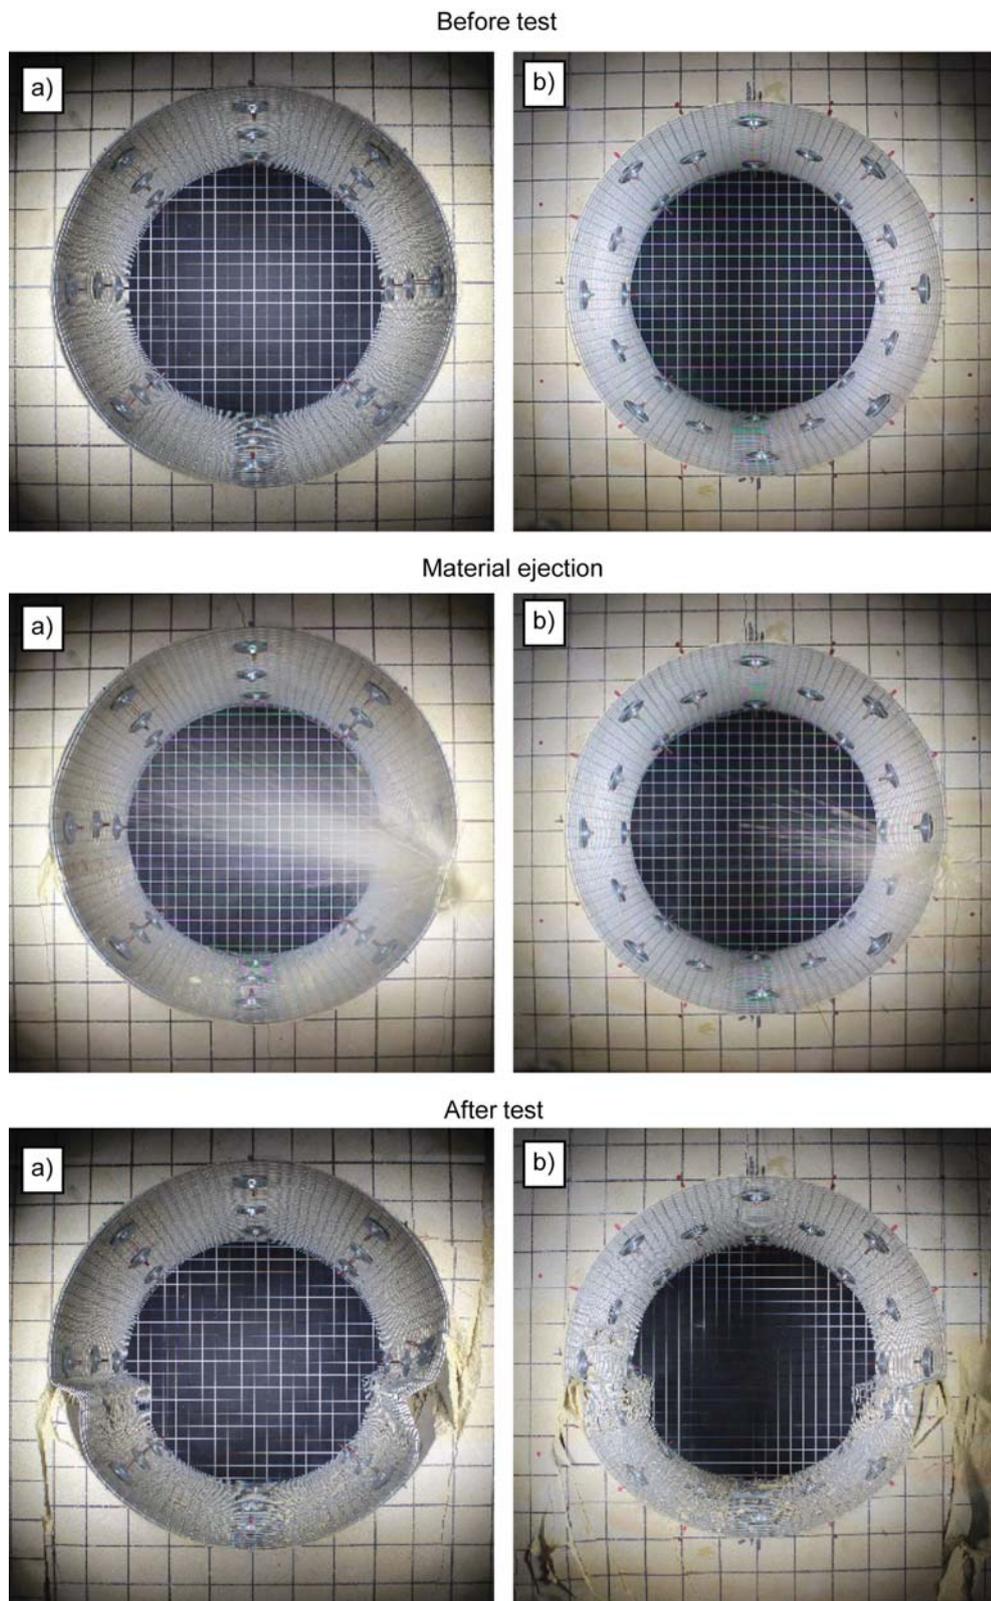
Figure 8.14 Performance comparison with different bolting pattern a) square pattern (Specimen No. 3) b) staggered pattern (Specimen No.1).

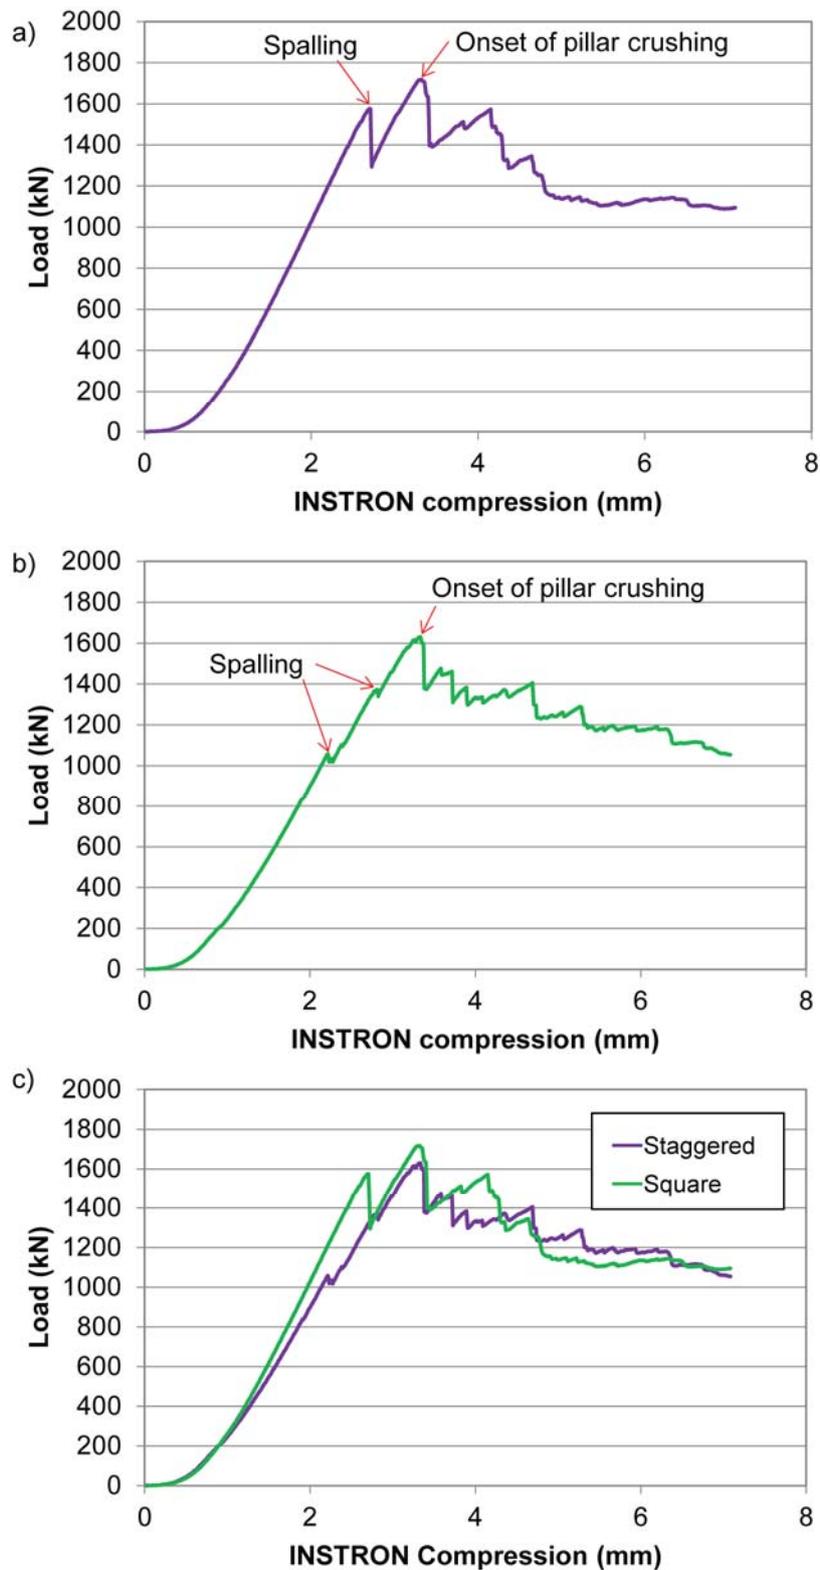
Figure 8.16 Load displacement of a) square pattern (Specimen No. 3) b) staggered pattern (Specimen No.1) c) combined plot.

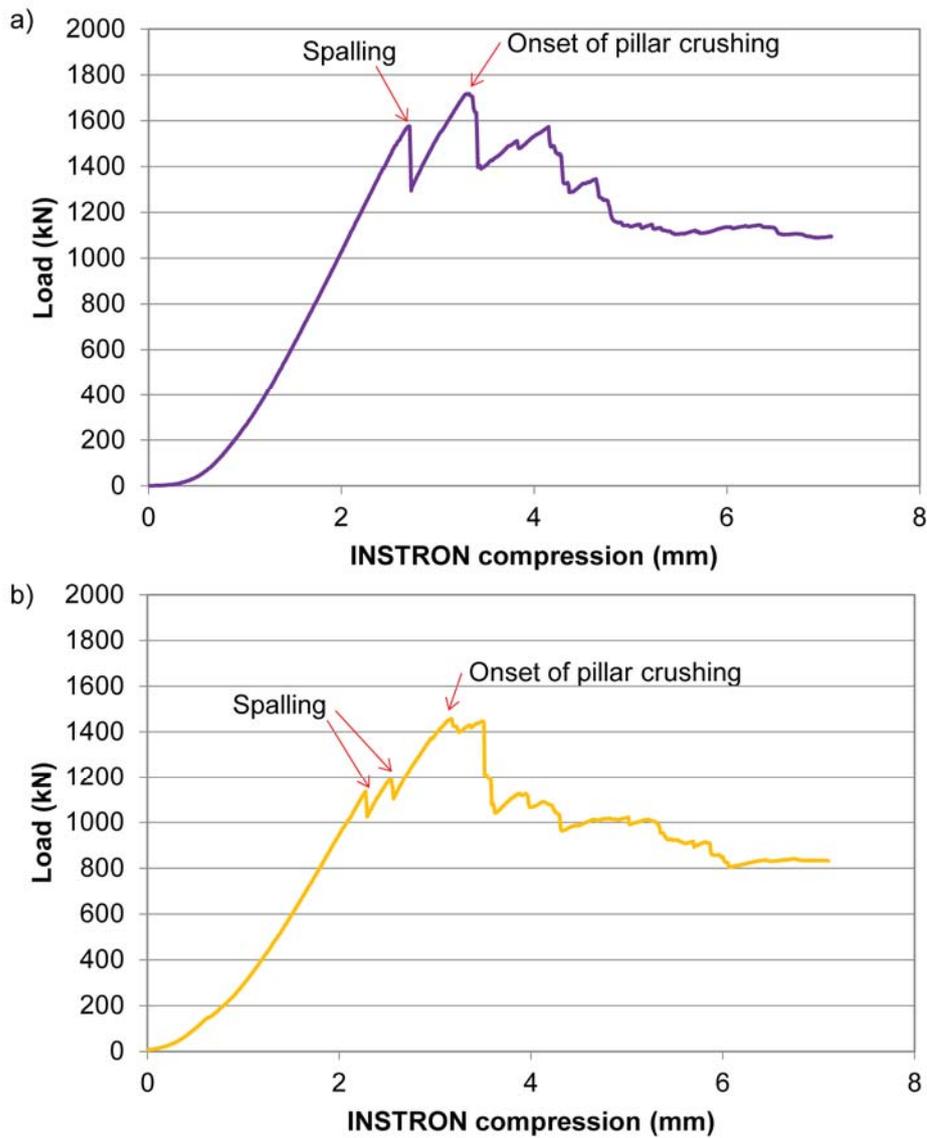
Figure 8.18 Load-displacement curve a) stiff welded mesh b) chain link mesh.

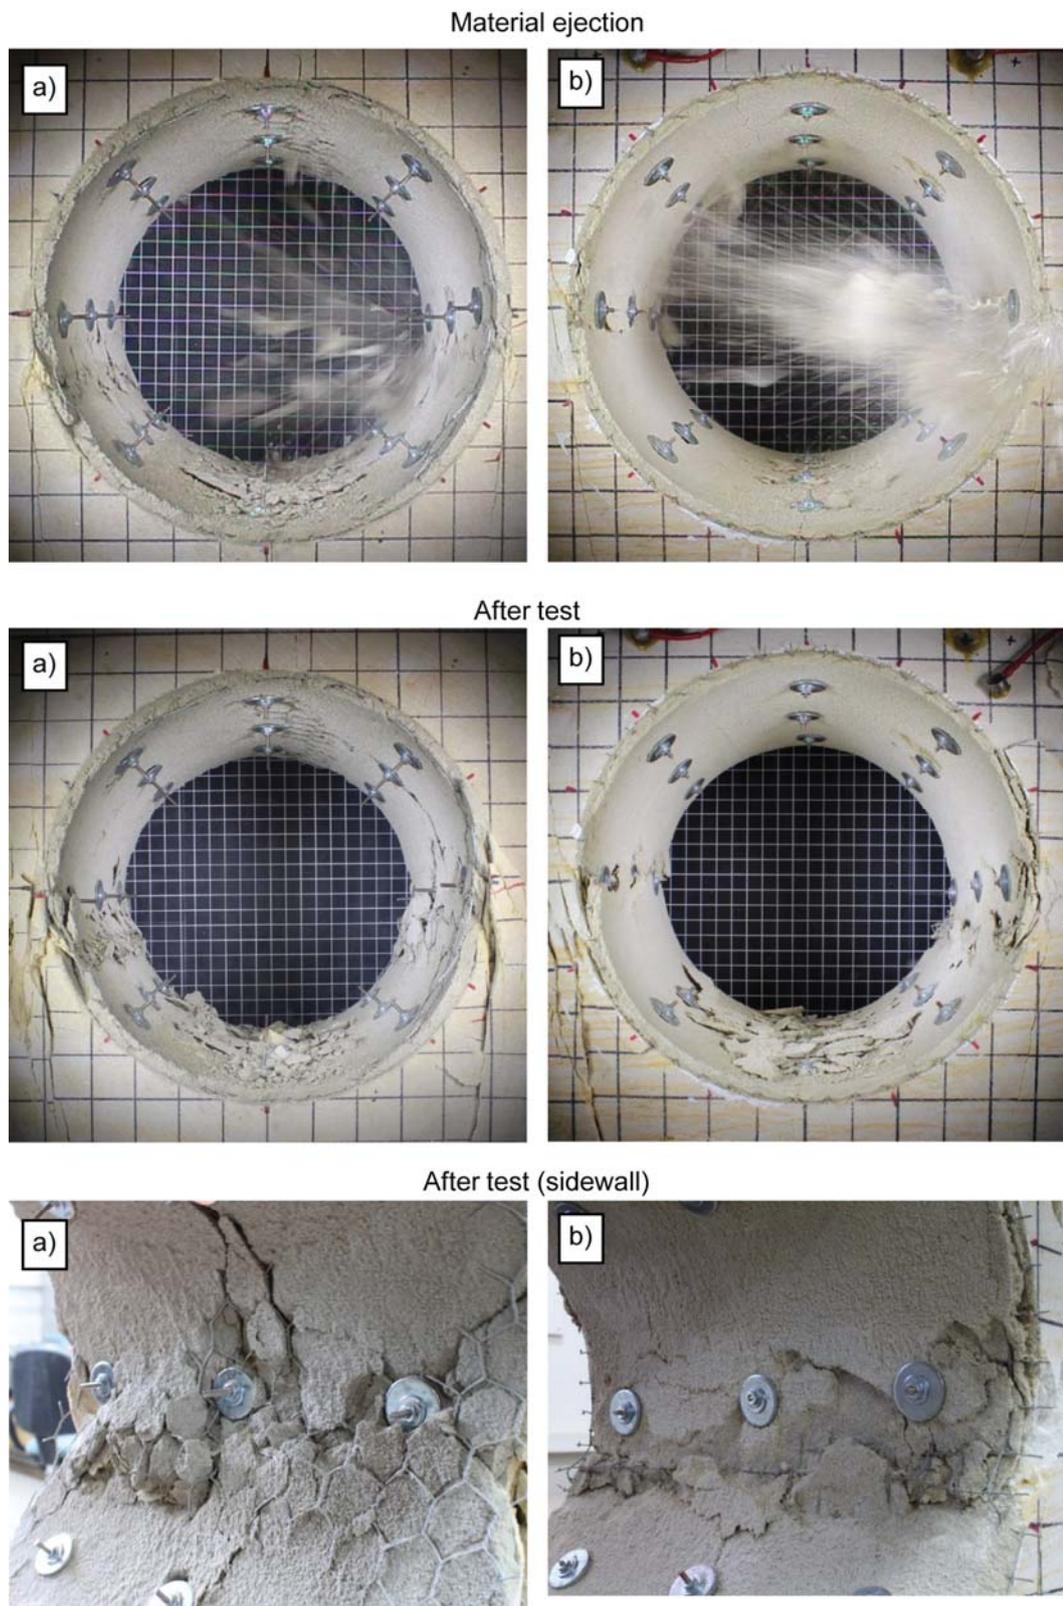
Figure 8.20 Comparison of failure mechanisms a) flexible mesh (Specimen No.5)
b) Wide-aperture stiff mesh (Specimen No.7).

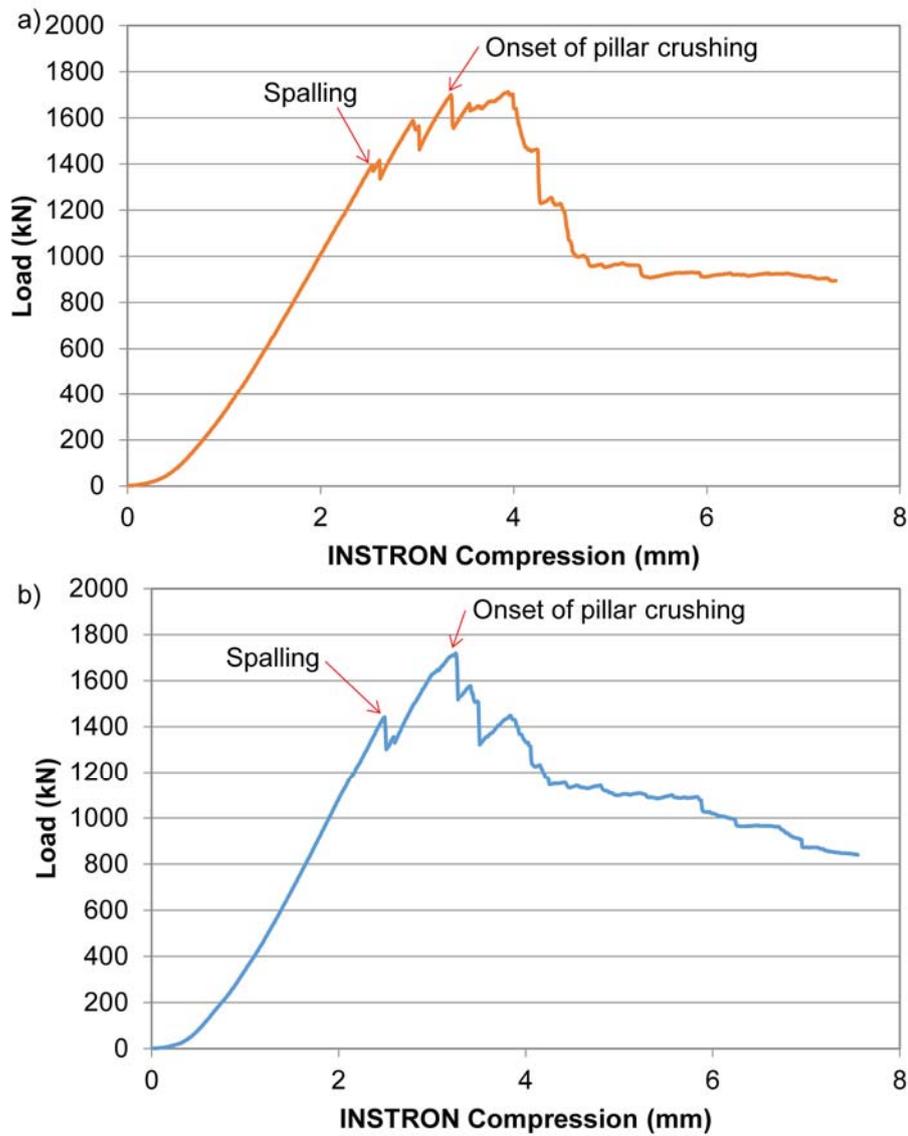
Figure 8.21 Load-displacement curve a) flexible mesh b) Wide-aperture stiff mesh.

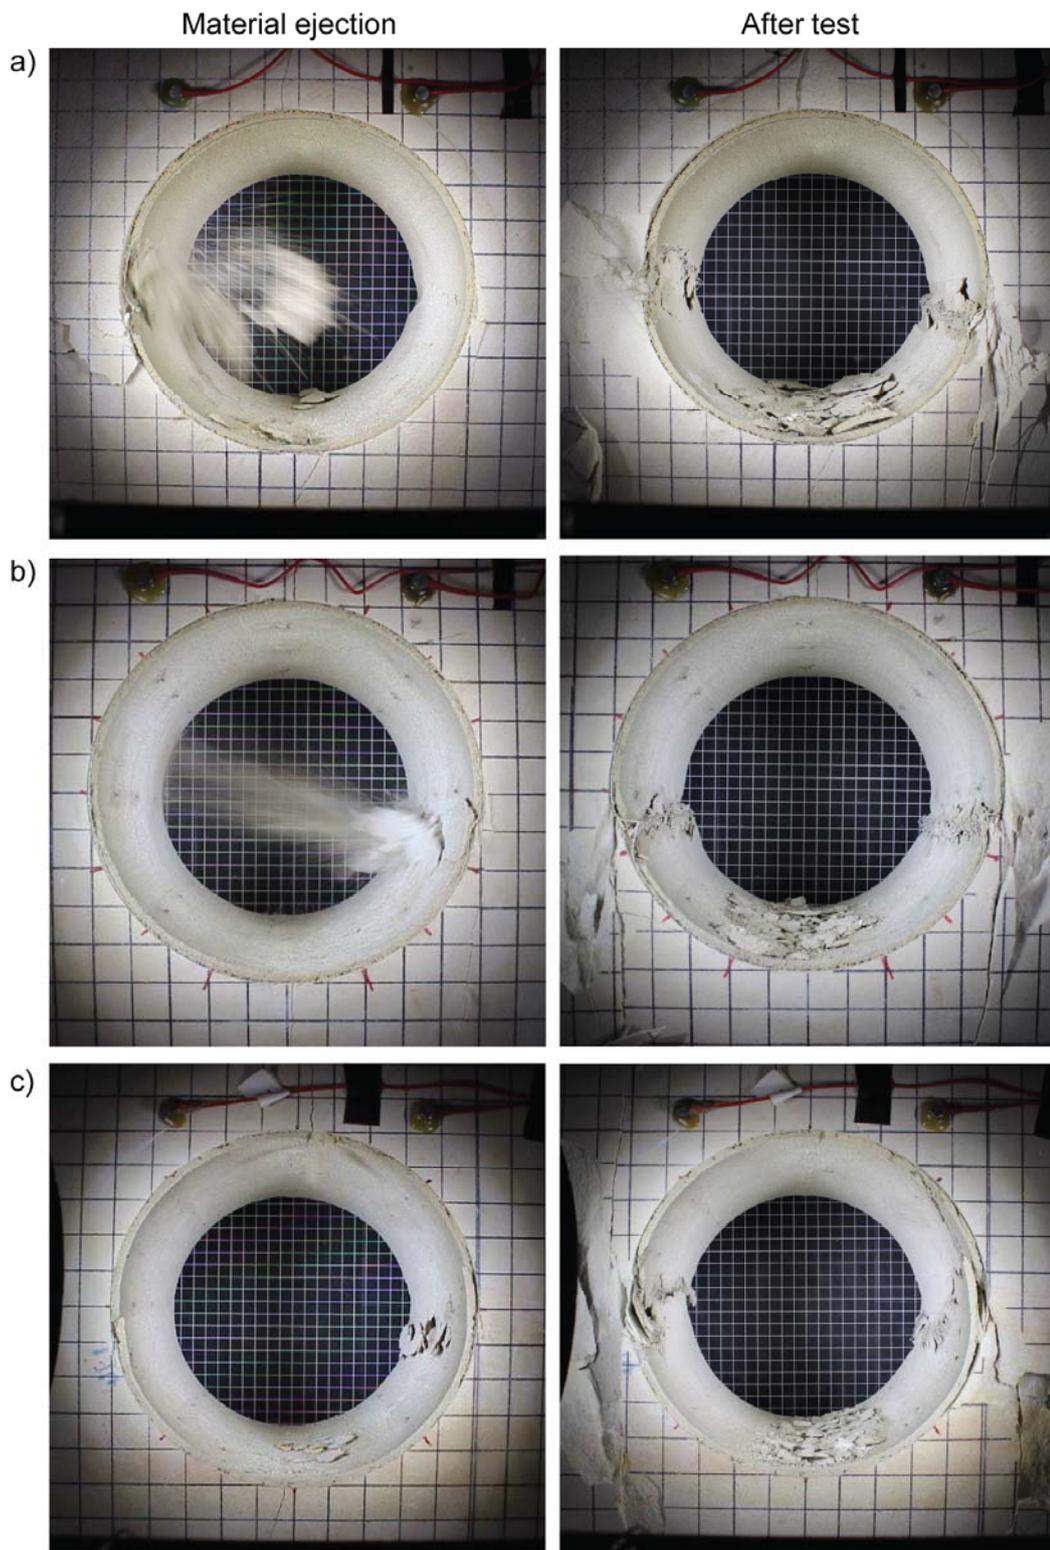
Figure 8.23 Failure on sidewall at spalling and after pillar failure a) stiff welded mesh (Specimen No.4) b) Wide-aperture stiff mesh (Specimen No.6) c) chain link mesh (Specimen No.8).

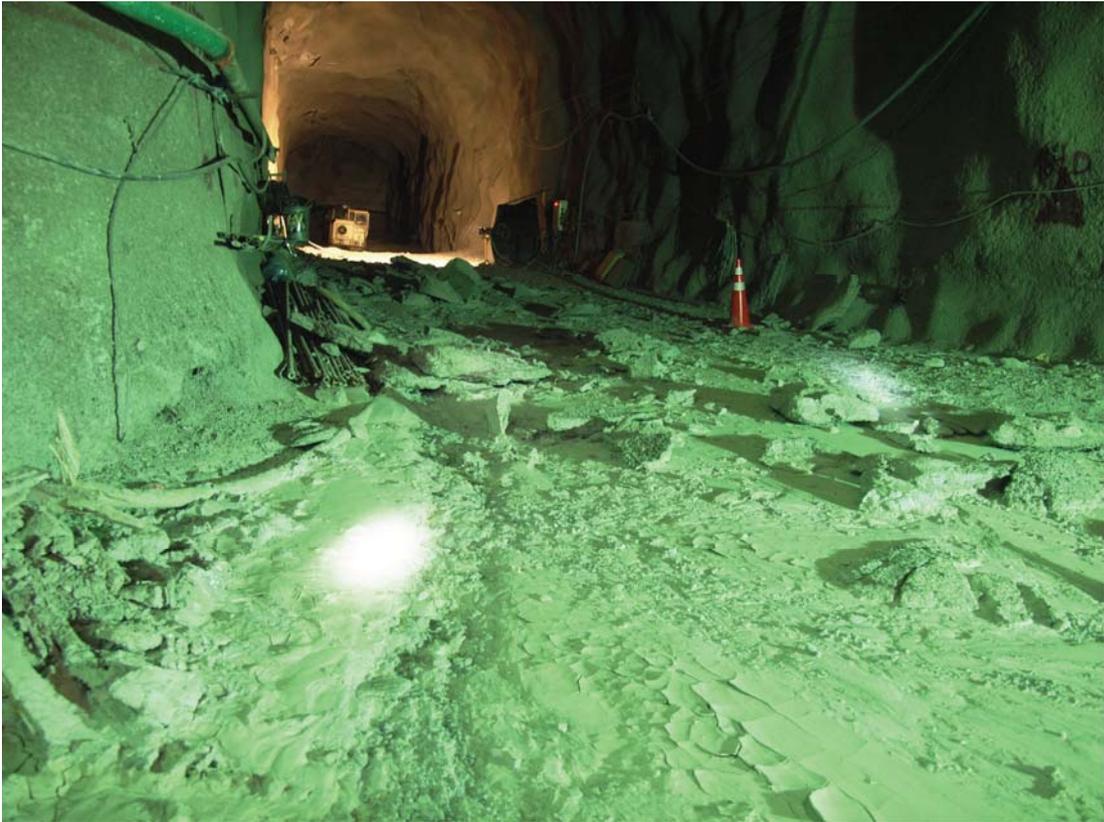
Figure 8.24 Ejected shotcrete materials on the floor at underground mine.

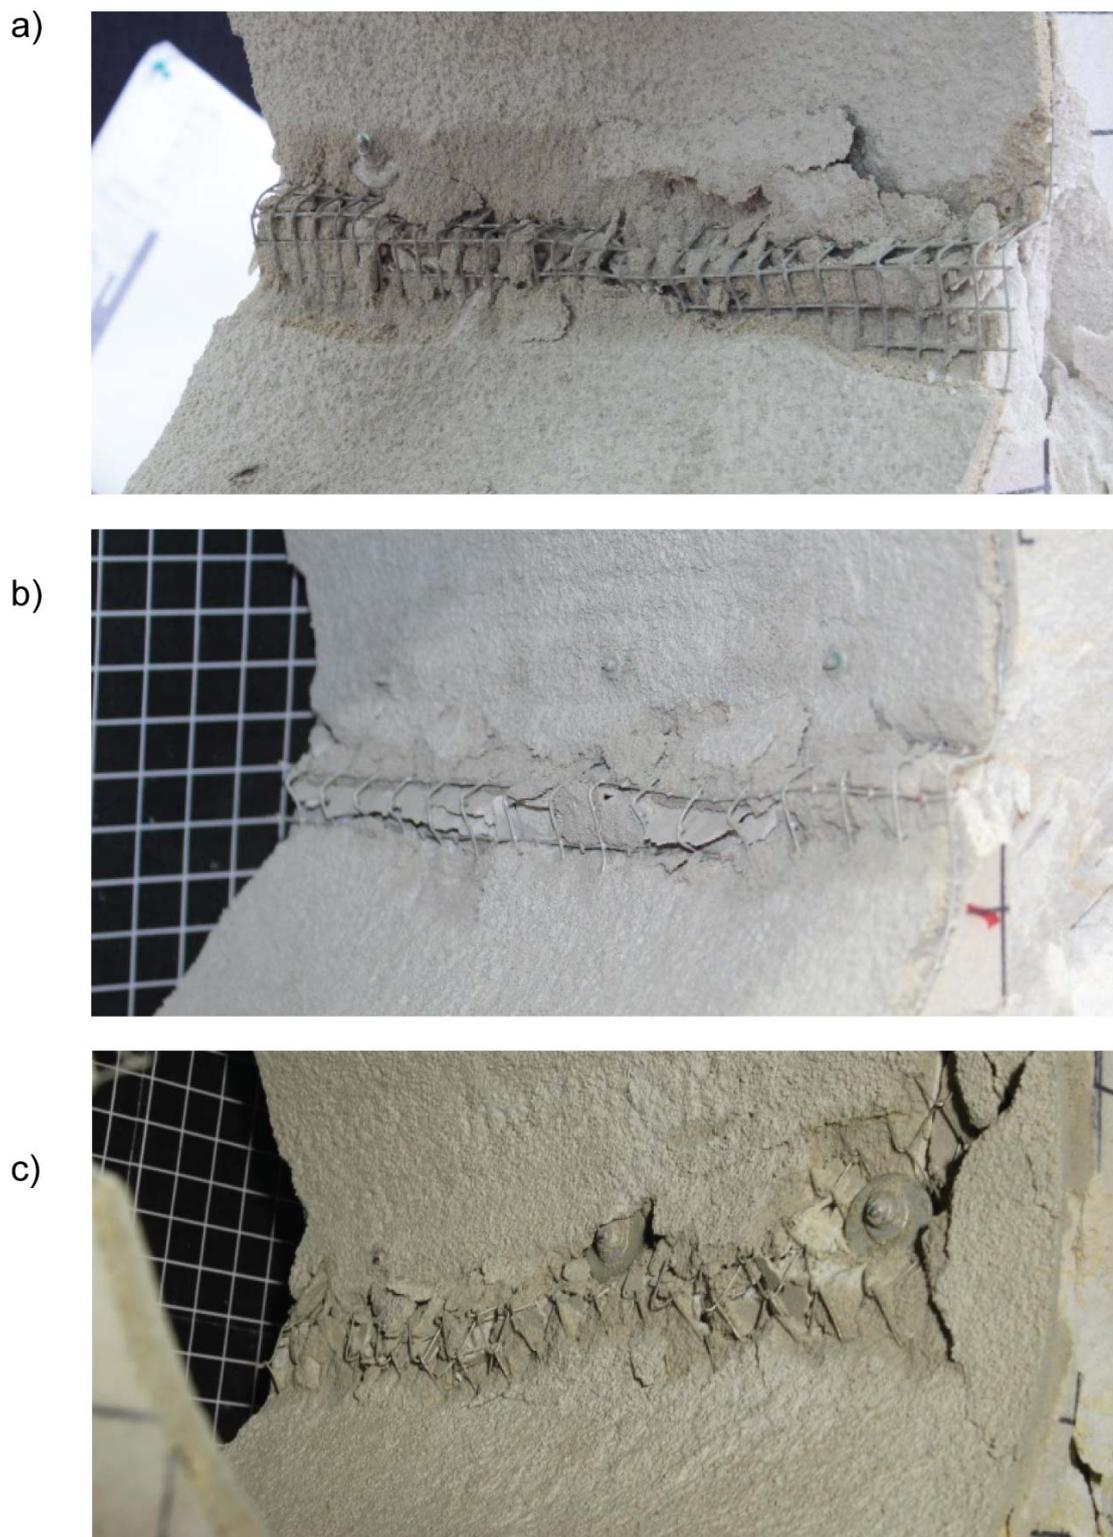
Figure 8.25 Tunnel sidewall after pillar failure a) stiff welded mesh b) Wide-aperture stiff mesh c) chain link mesh.

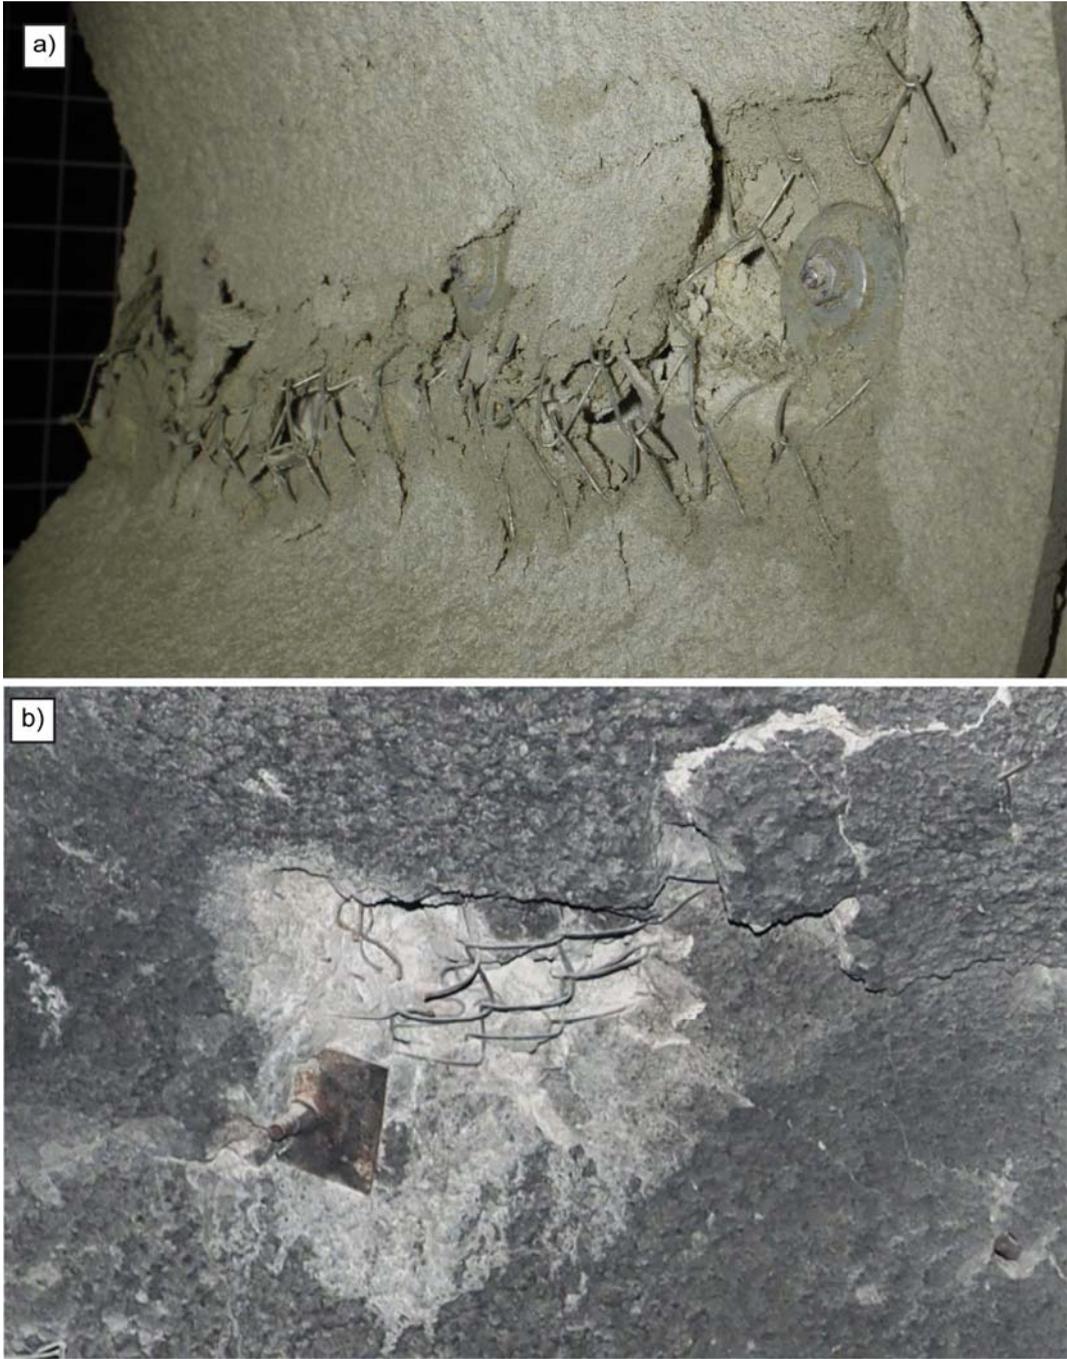
Figure 8.26 Comparison of reinforced shotcrete at failure a) scaled sized specimen
 b) full scale excavation.

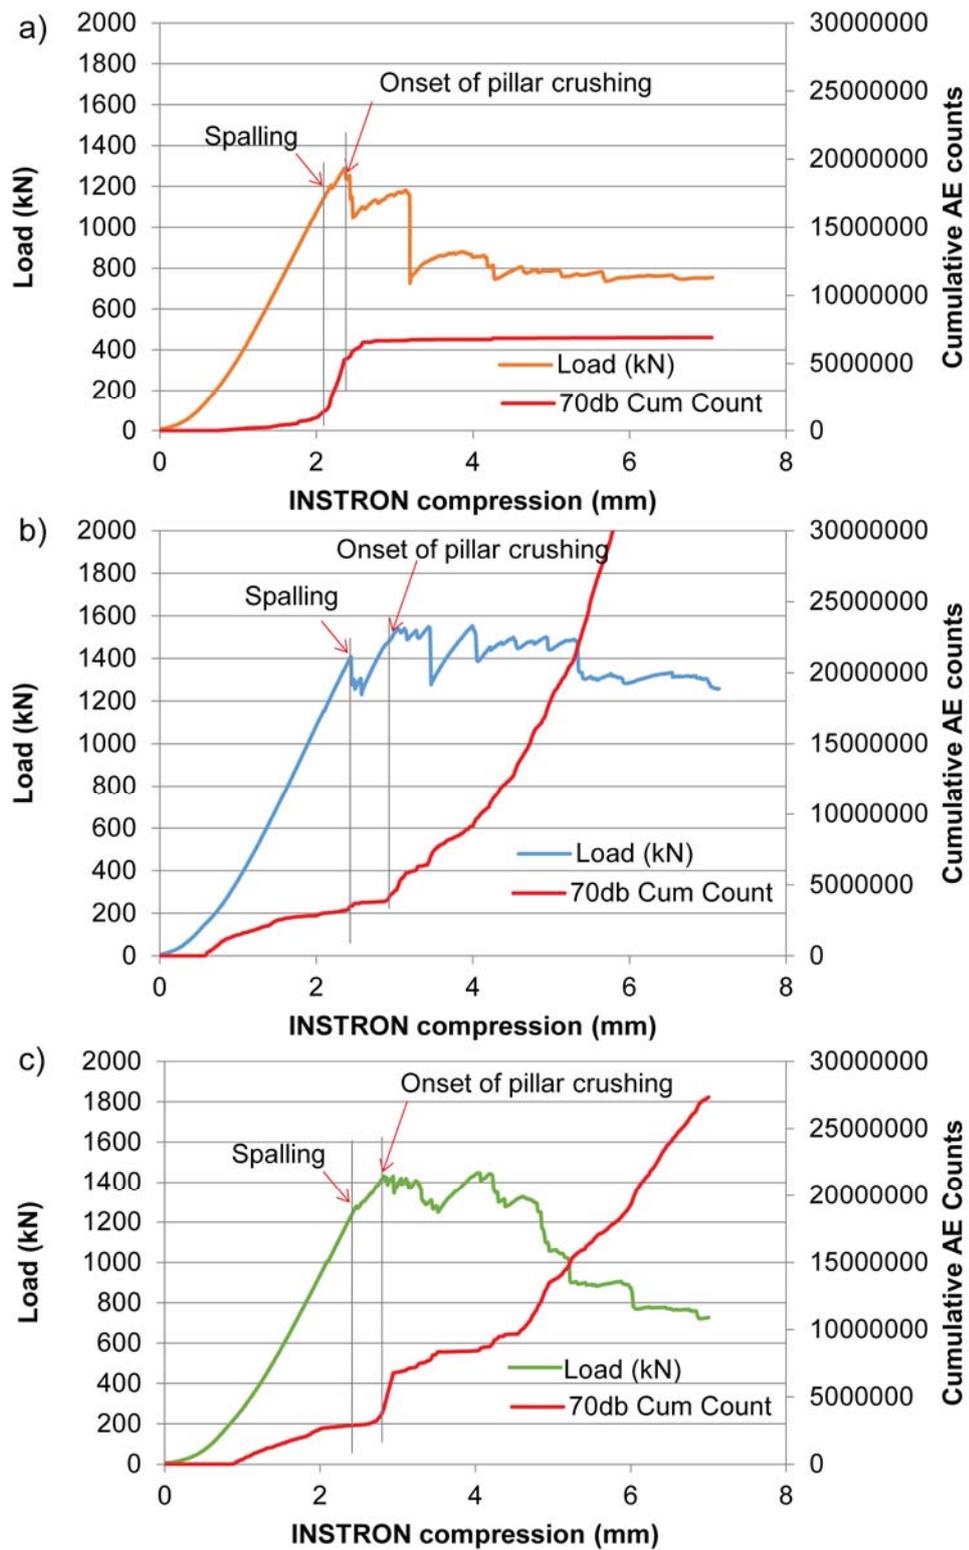
Figure 8.27 Load displacement curve a) stiff welded mesh b) Wide-aperture stiff mesh c) chain link mesh.

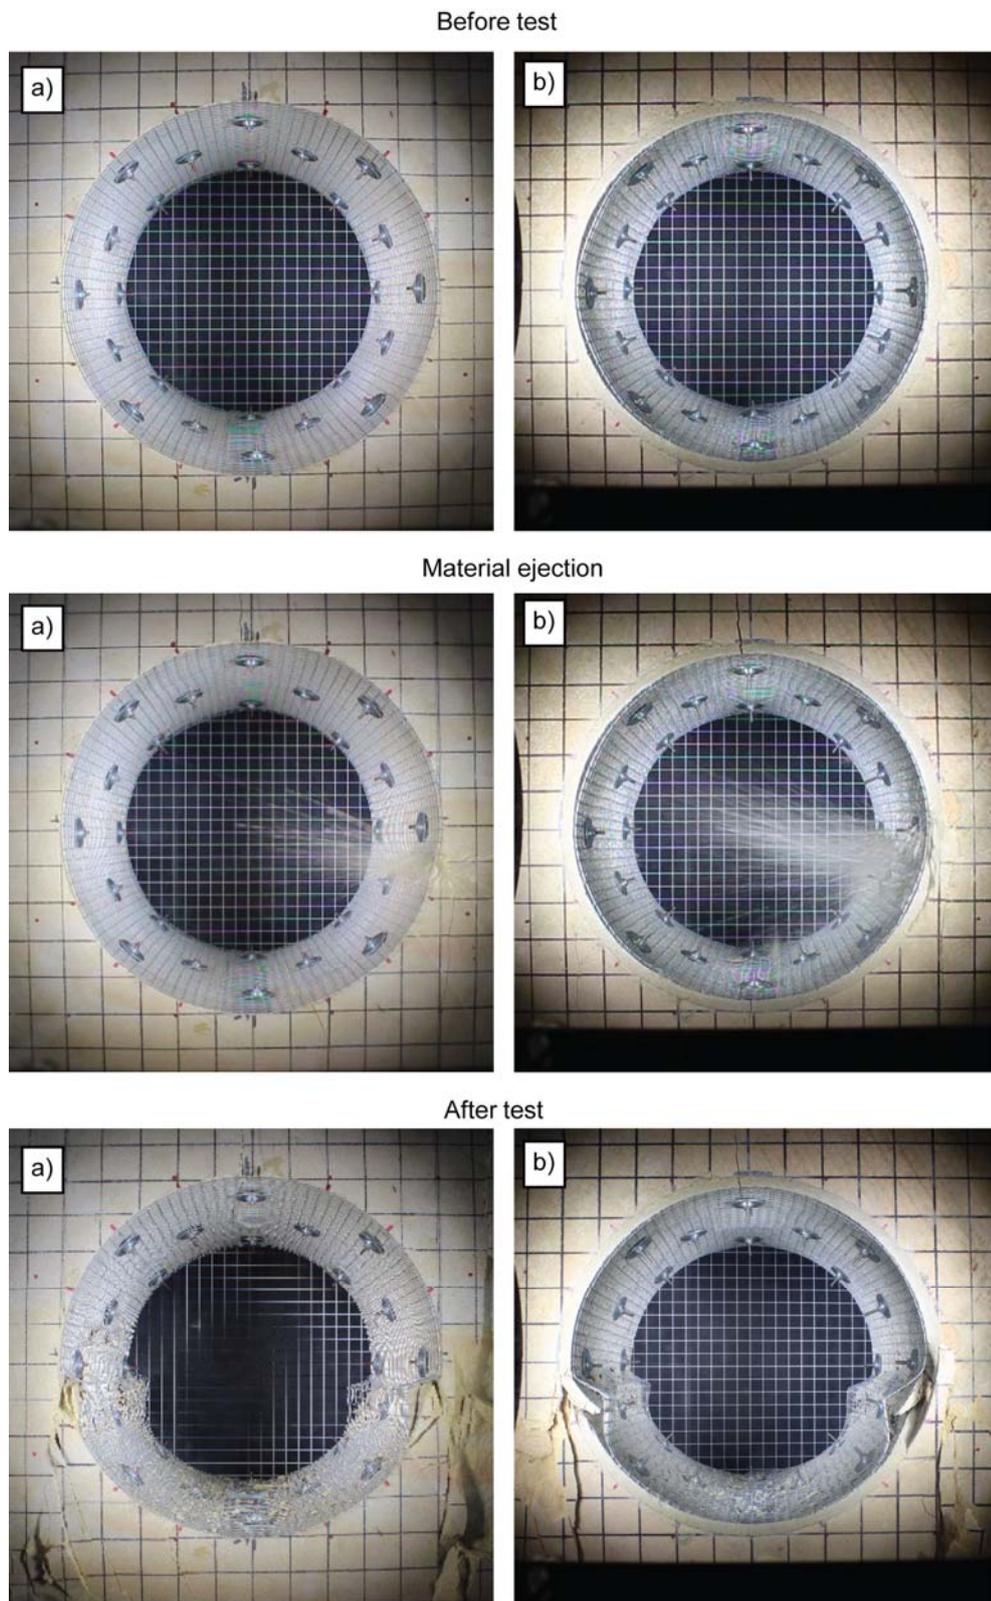
Figure 8.28 Failure progression a) stiff welded mesh and rock bolts (Specimen No.1) b) 5 mm shotcrete layer, stiff welded mesh and rock bolts (Specimen No.2).

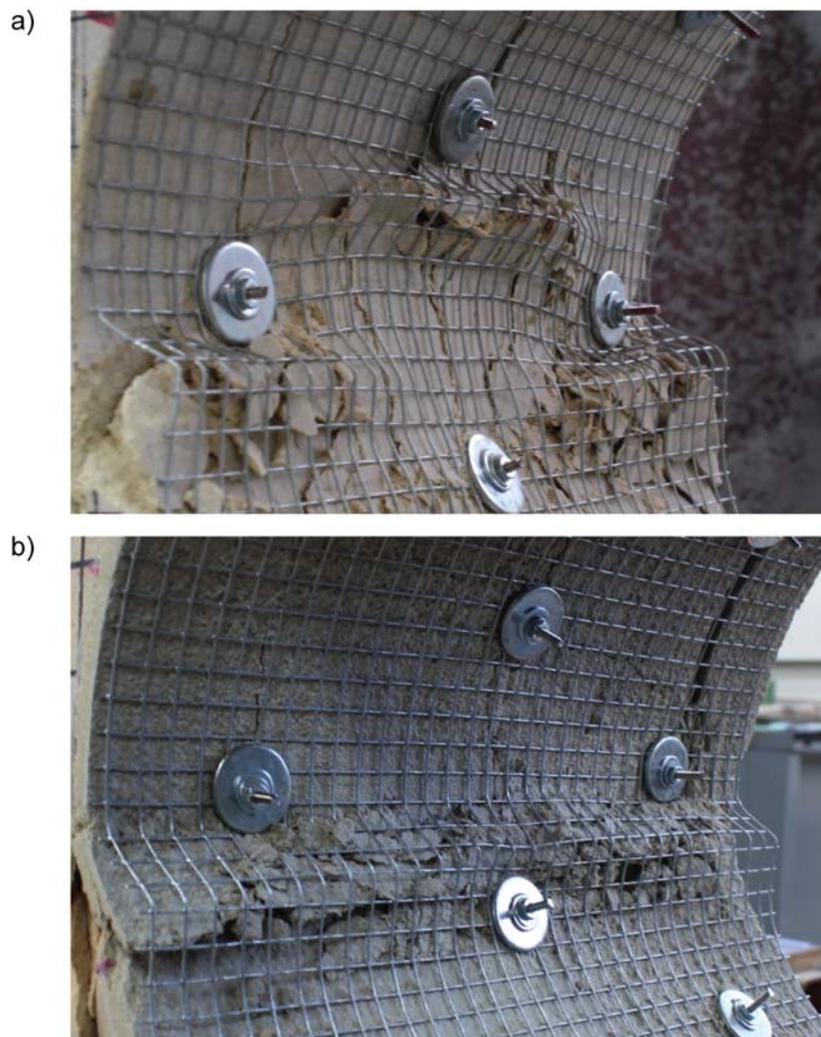
Figure 8.29 Tunnel sidewall after failure a) stiff welded mesh and rock bolts (Specimen No.1) b) 5 mm thick shotcrete layer, stiff welded mesh and rock bolts (Specimen No.2).

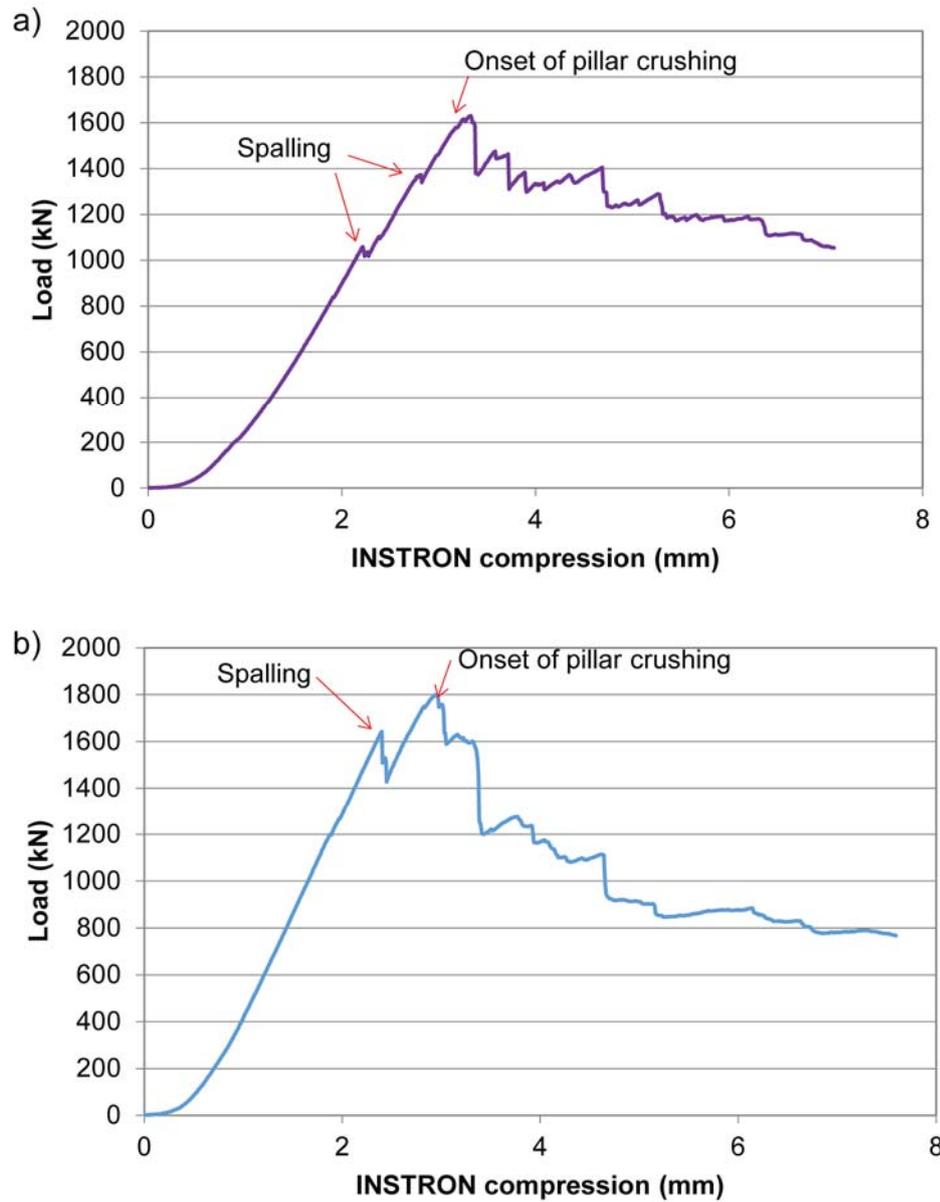
Figure 8.30 Load displacement curve a) stiff welded mesh and rock bolts b) 5 mm thick shotcrete layer, stiff welded mesh and rock bolts.

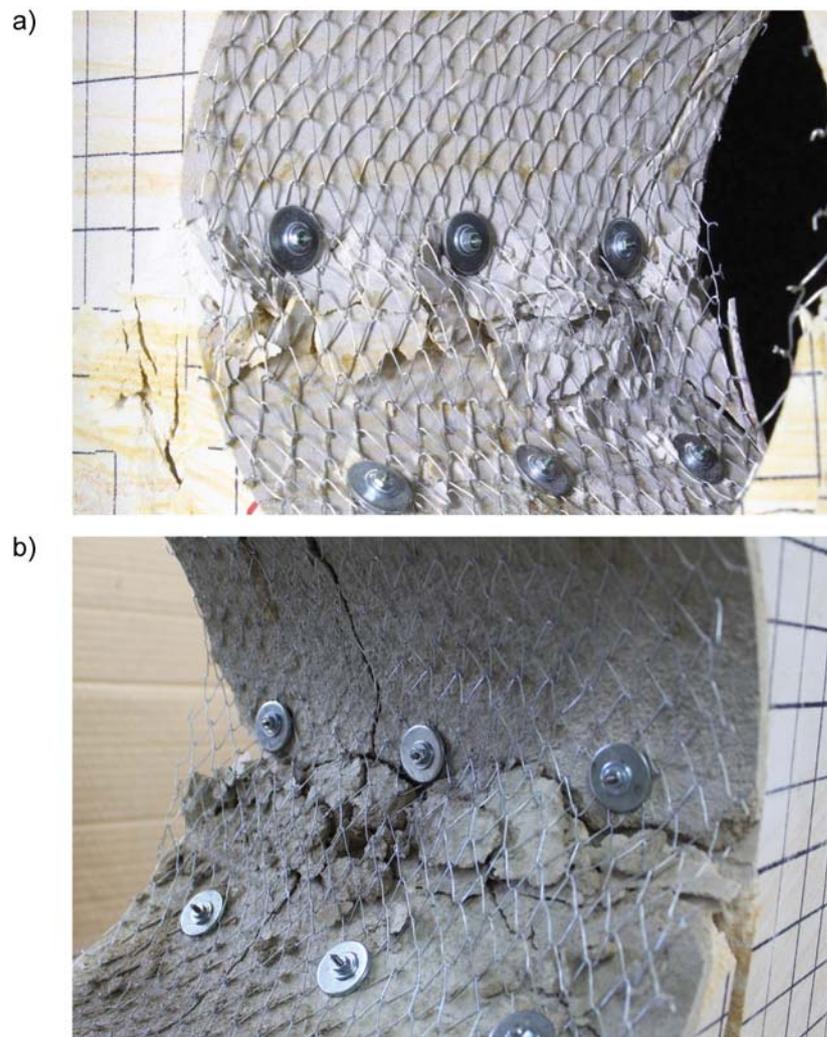
Figure 8.31 Tunnel sidewall after failure a) chain link mesh and rock bolts (Specimen No.9) b) 5 mm shotcrete layer, chain link mesh and rock bolts (Specimen No.11).

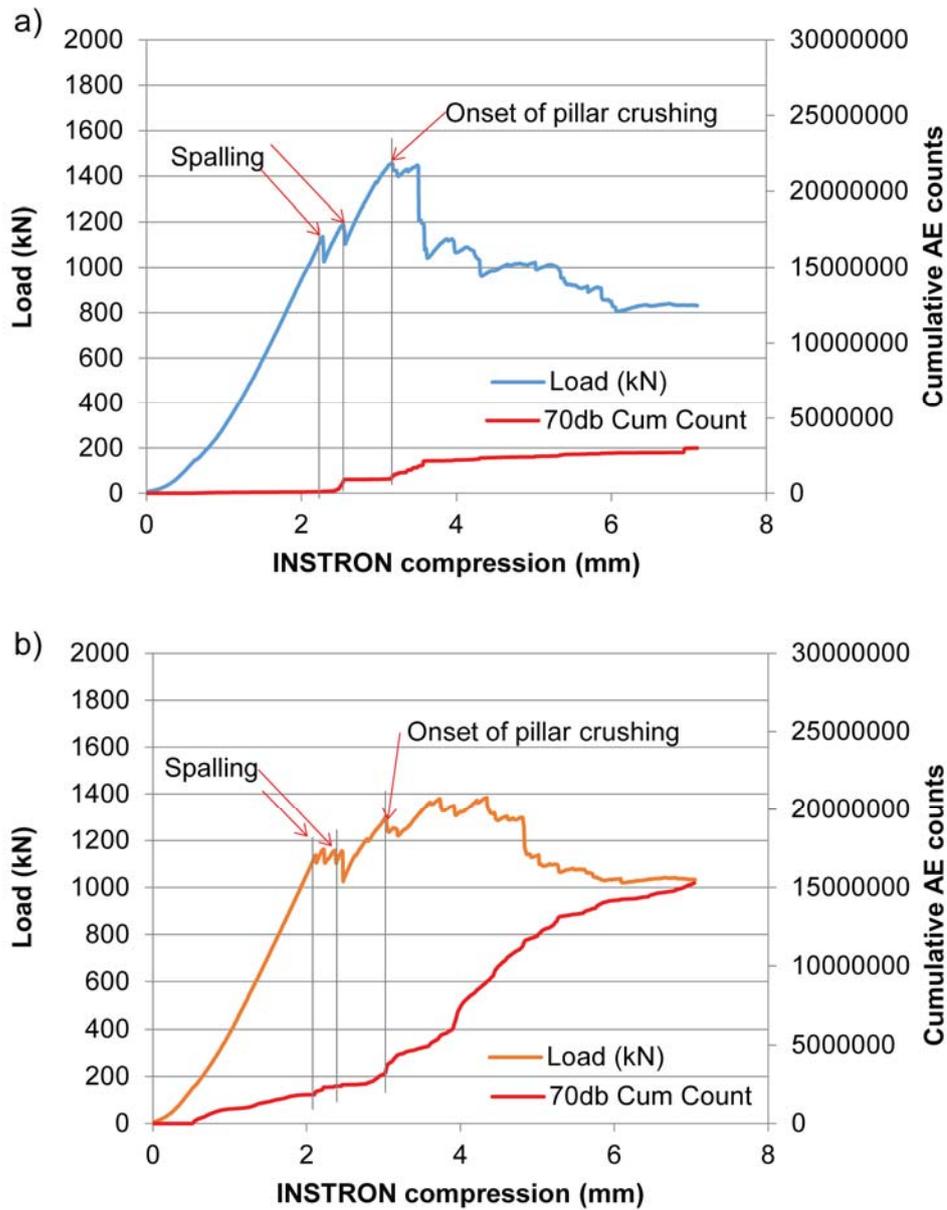
Figure 8.32 Load displacement curve failure a) chain link mesh and rock bolts b) 5 mm shotcrete layer, chain link mesh and rock bolts.

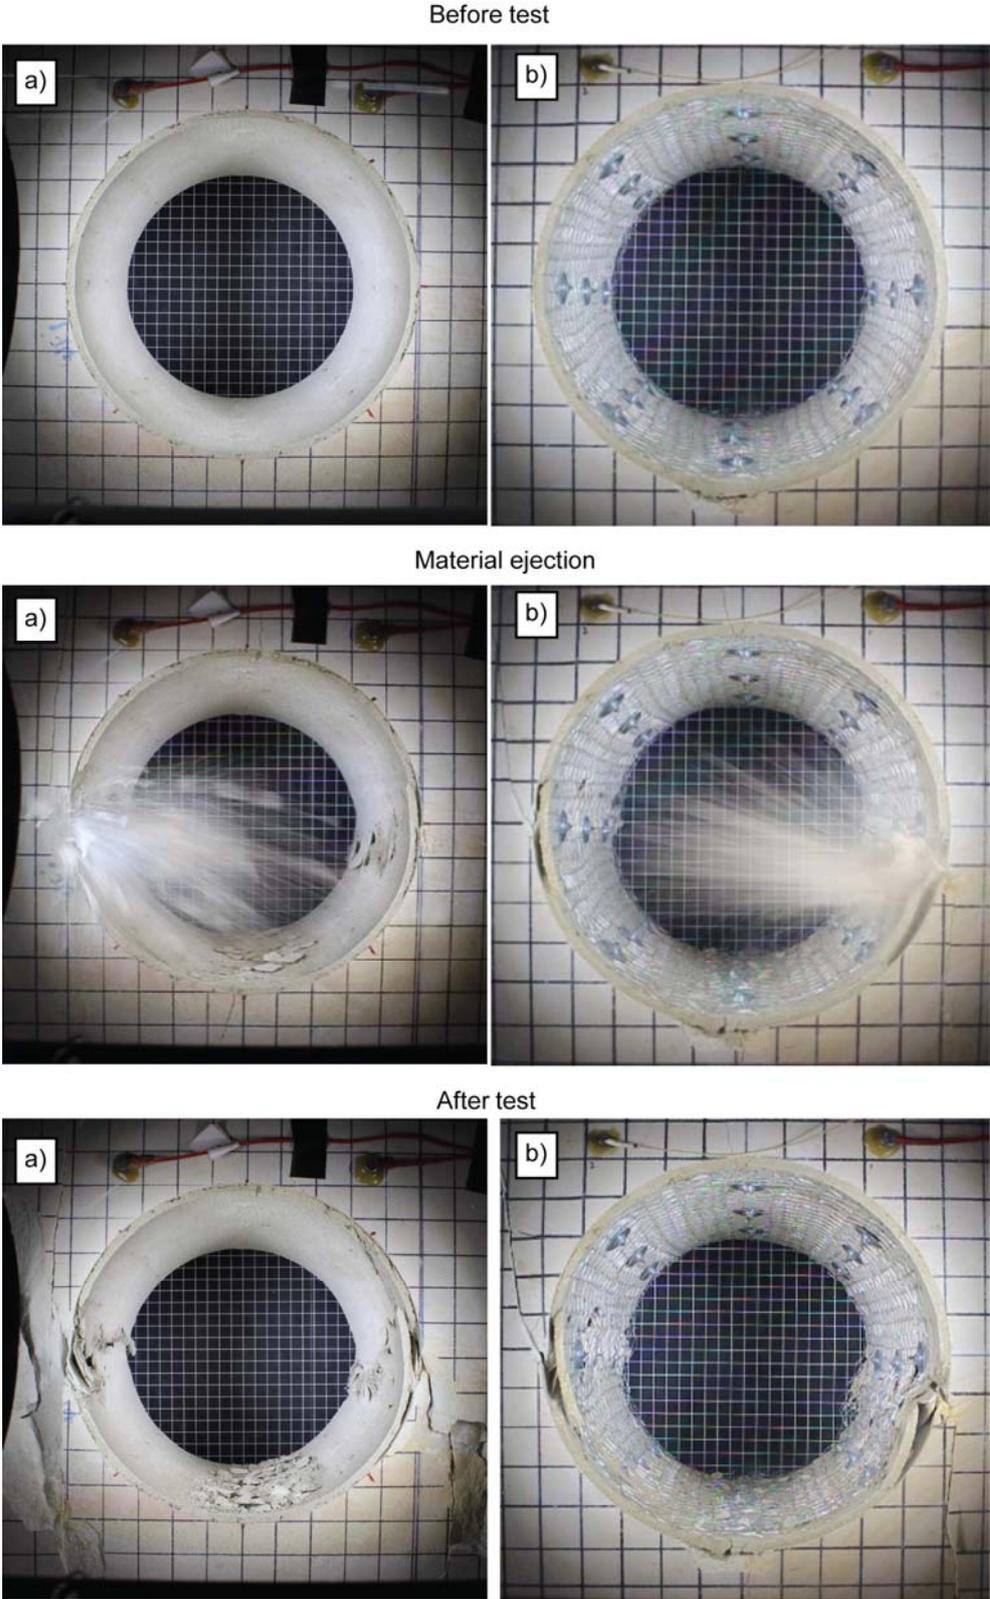
Figure 8.33 Failure mechanism in different mesh position a) mesh exposed (Specimen No.8) b) mesh embedded (Specimen No.11).

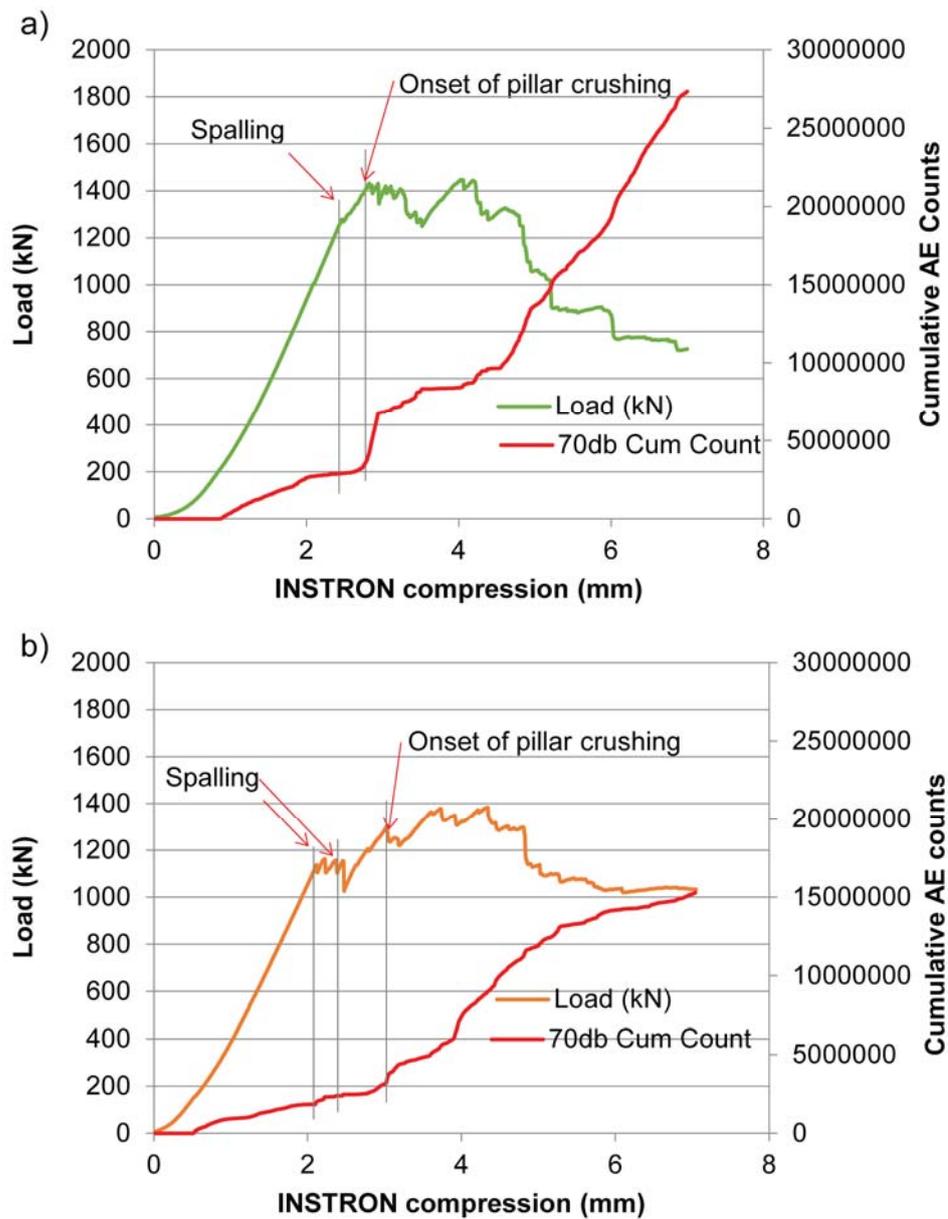
Figure 8.35 Load displacement curve a) mesh reinforced b) mesh exposed.
