Western Australian School of Mines

**Scaled Down Tunnel Testing for Comparison of Surface Support
Performance**

**This thesis is presented for the Degree of
Doctor of Philosophy
of
Curtin University**

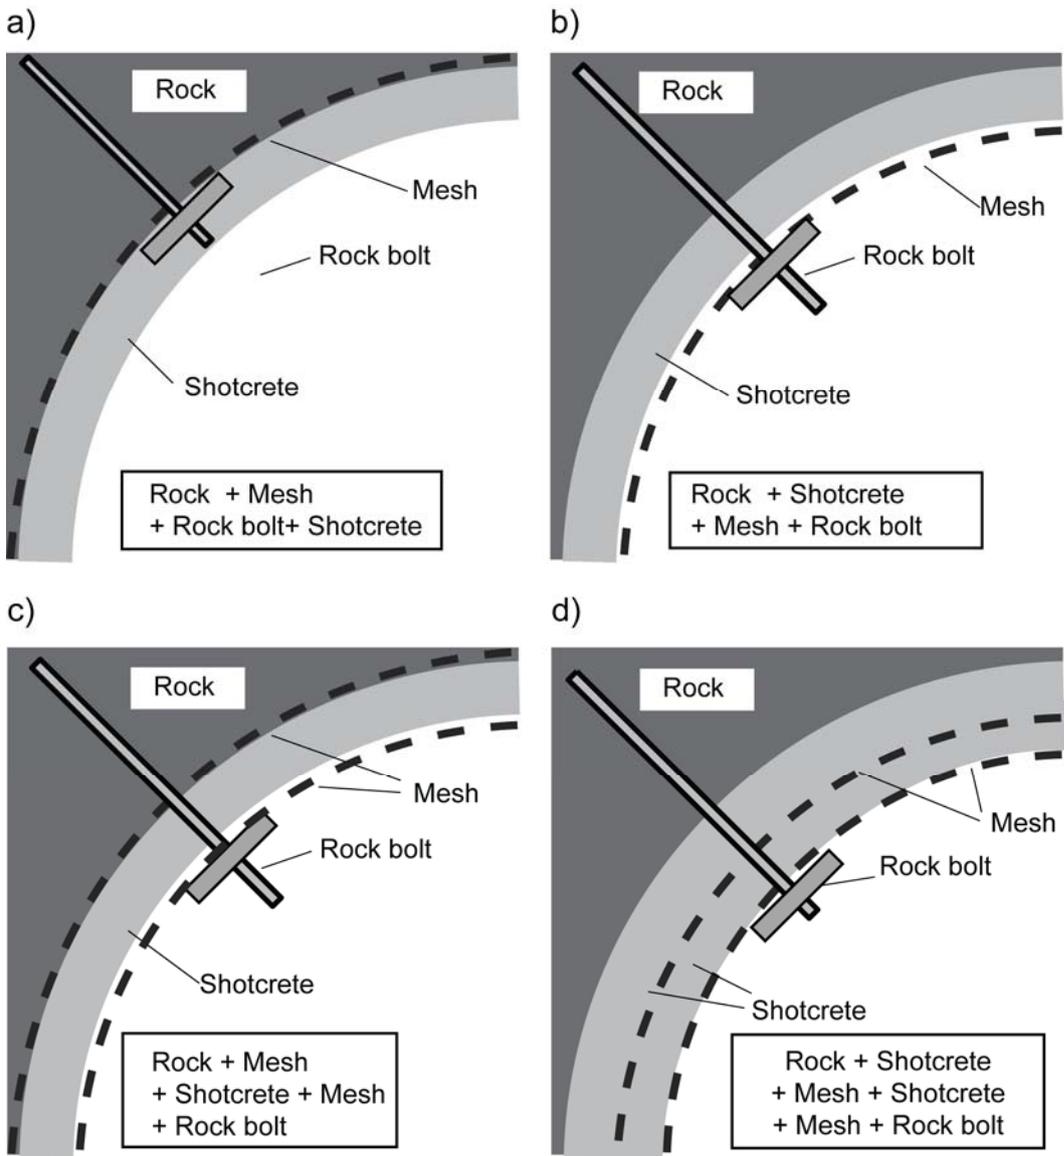
Figure 8.36 A comparison of ground support schemes a) mesh, shotcrete and rock bolt b) shotcrete, mesh and rock bolt c) mesh, shotcrete, mesh and rock bolt d) shotcrete, mesh, shotcrete, mesh and rock bolt.

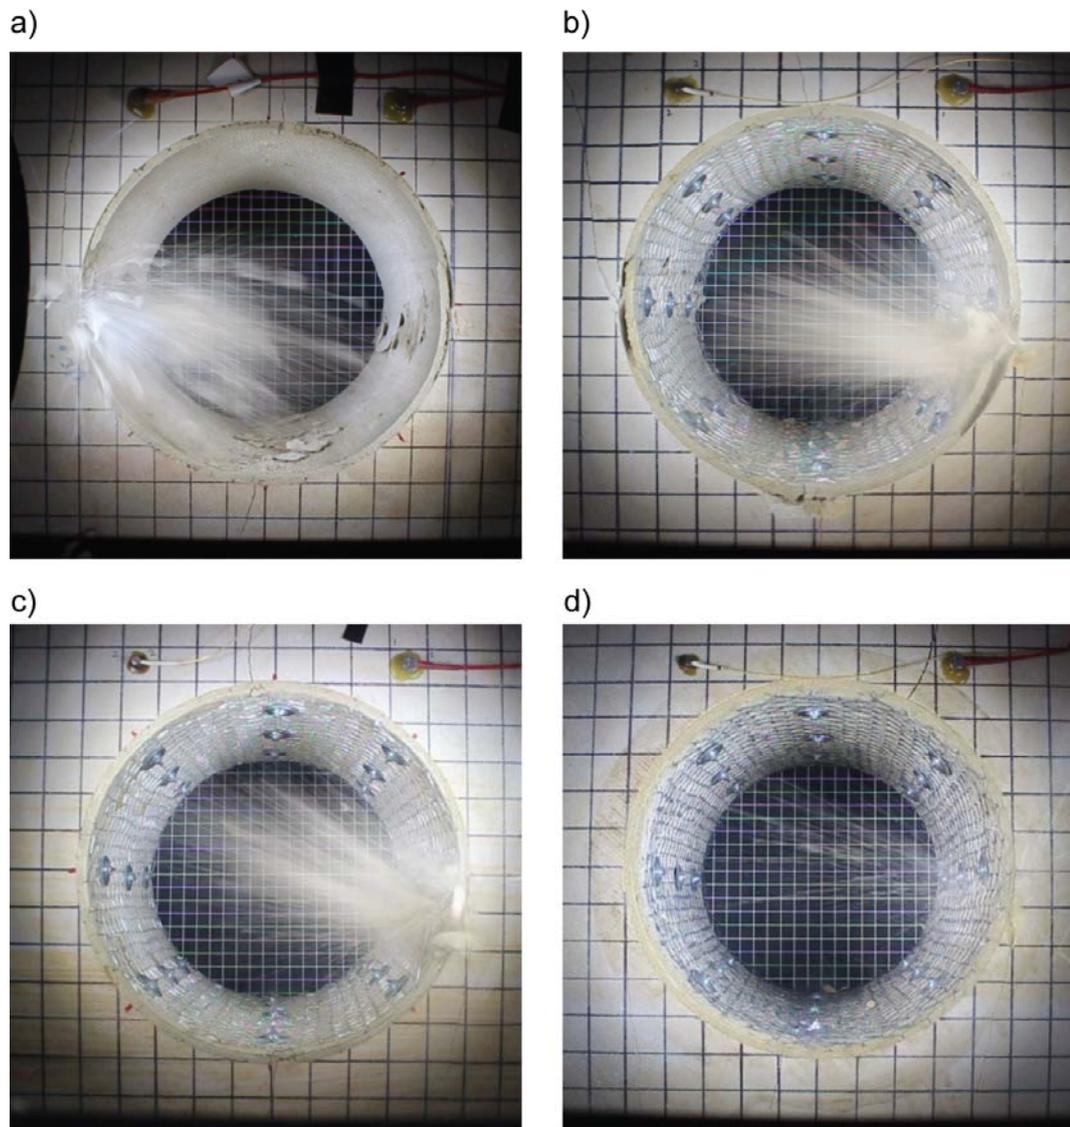
Figure 8.37 Material ejection at spalling failure a) mesh, shotcrete and rock bolt b) shotcrete, mesh and rock bolt c) mesh, shotcrete, mesh and rock bolt d) shotcrete, mesh, shotcrete, mesh and rock bolt.

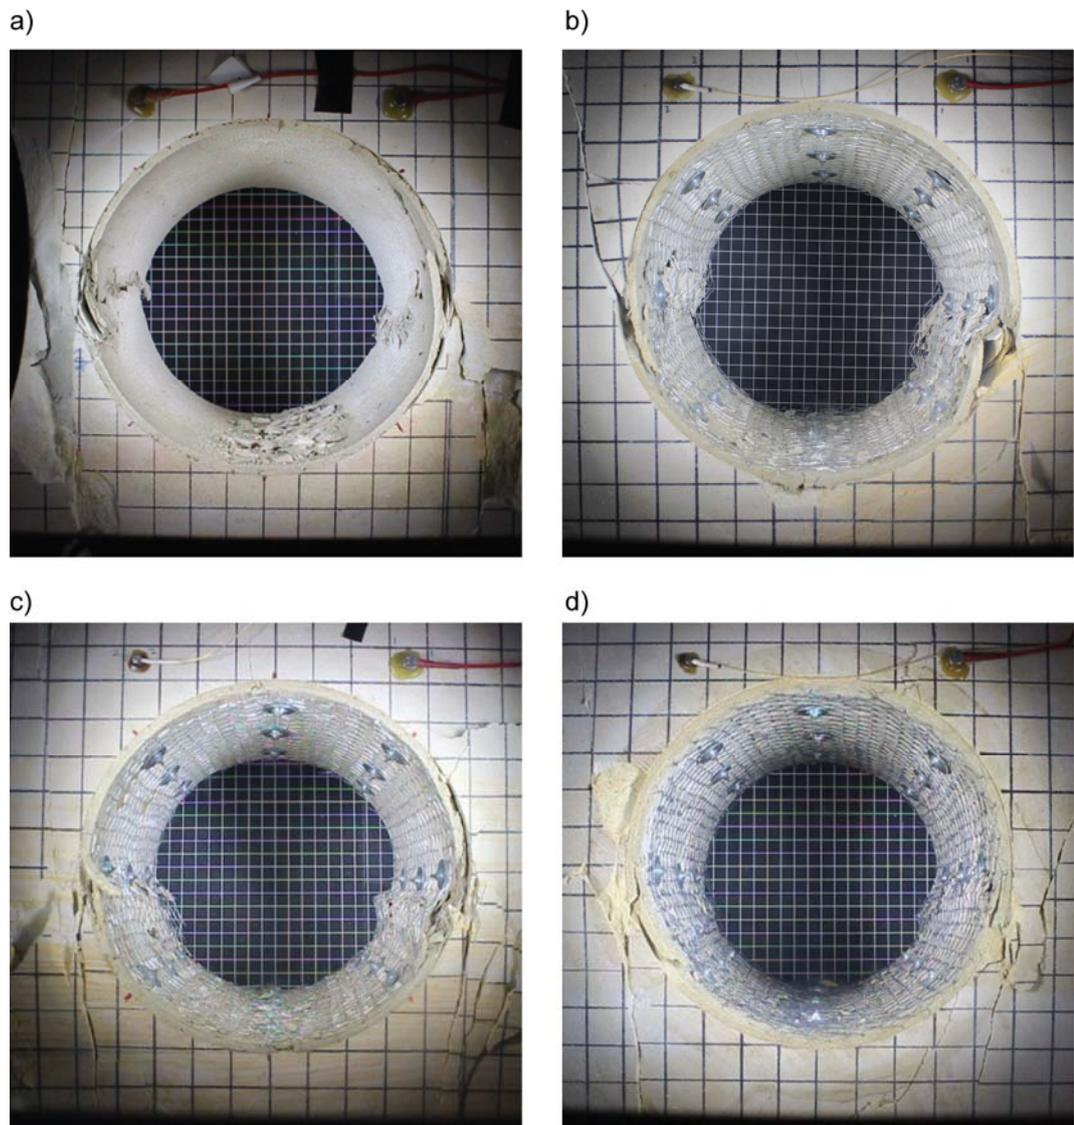
Figure 8.38 Ground support performance following tunnel failure a) mesh, shotcrete and rock bolt b) shotcrete, mesh and rock bolt c) mesh, shotcrete, mesh and rock bolt d) shotcrete, mesh, shotcrete, mesh and rock bolt.

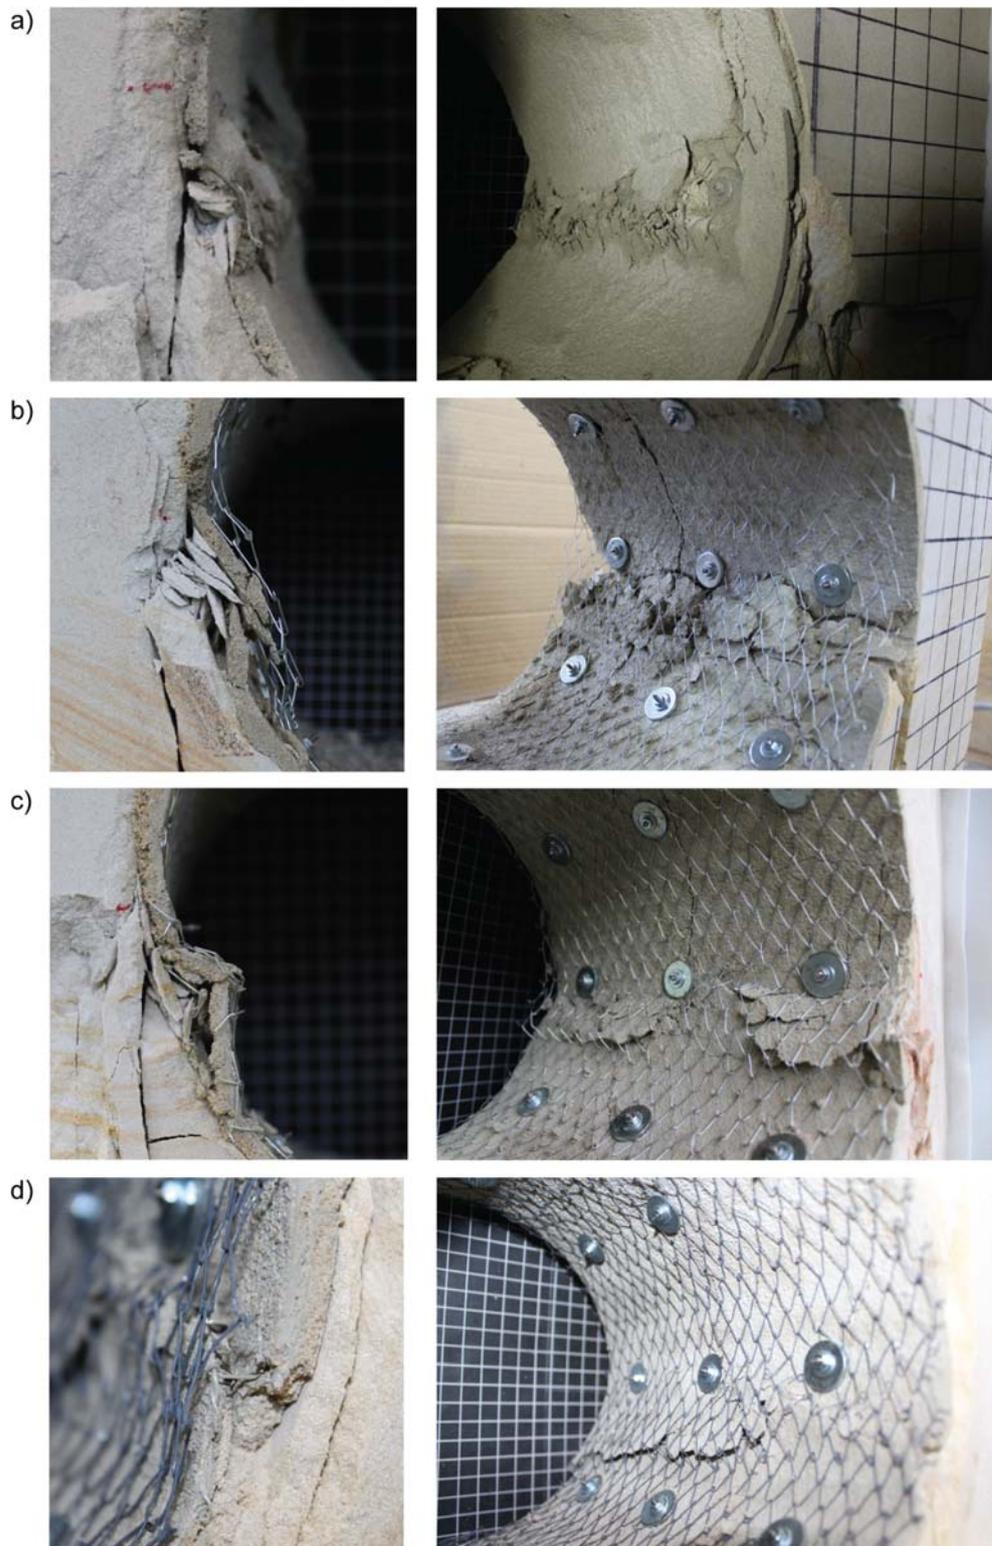
Figure 8.39 Tunnel sidewalls after failure a) mesh reinforced shotcrete b) mesh exposed shotcrete c) mesh embedded and mesh exposed shotcrete d) mesh reinforced shotcrete with mesh exposed.

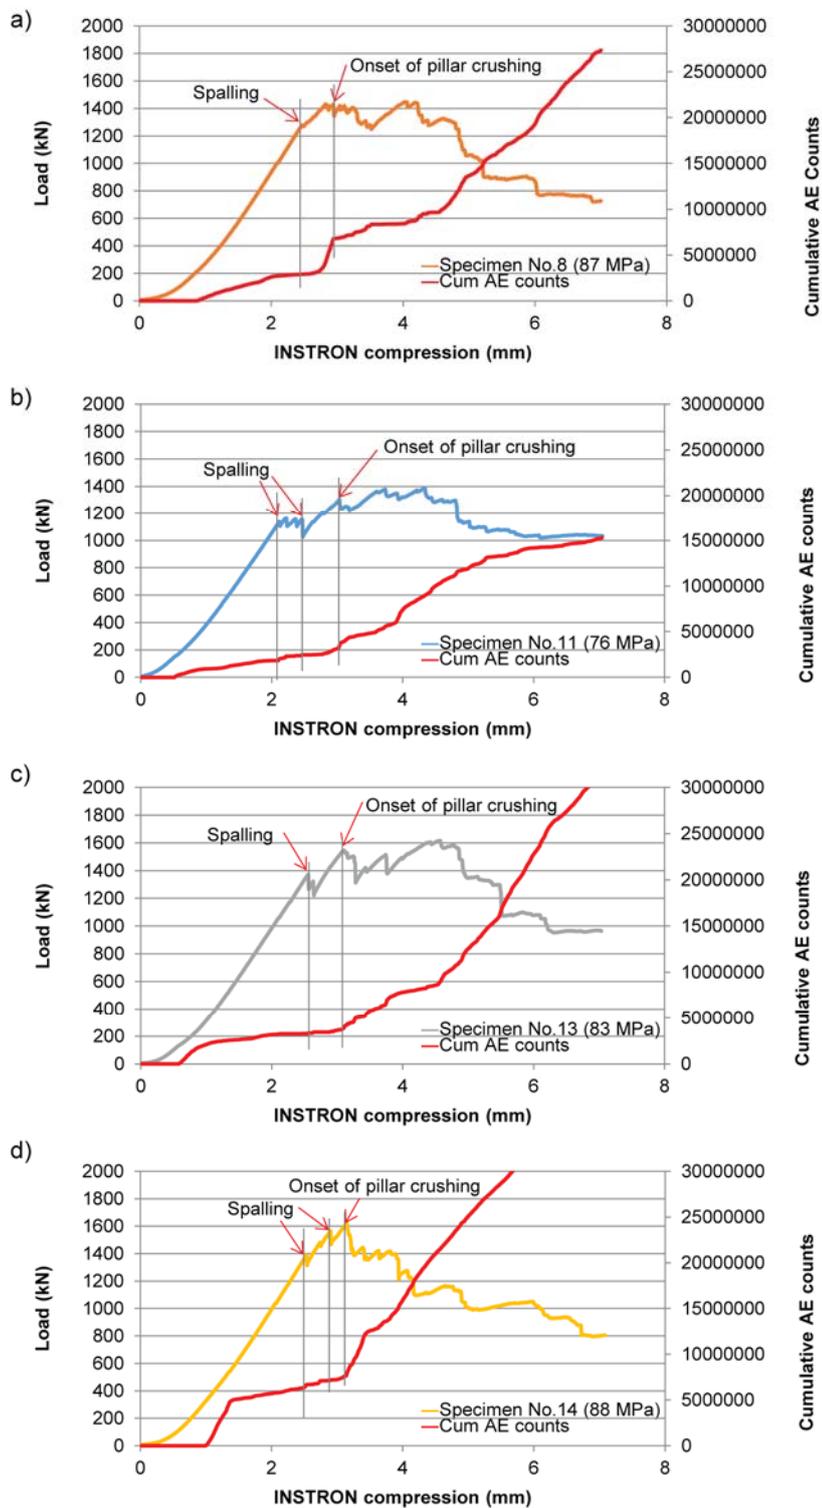
Figure 8.40 Load-displacement curves for different ground configuration tests with AE data a) mesh reinforced shotcrete b) mesh exposed shotcrete c) mesh

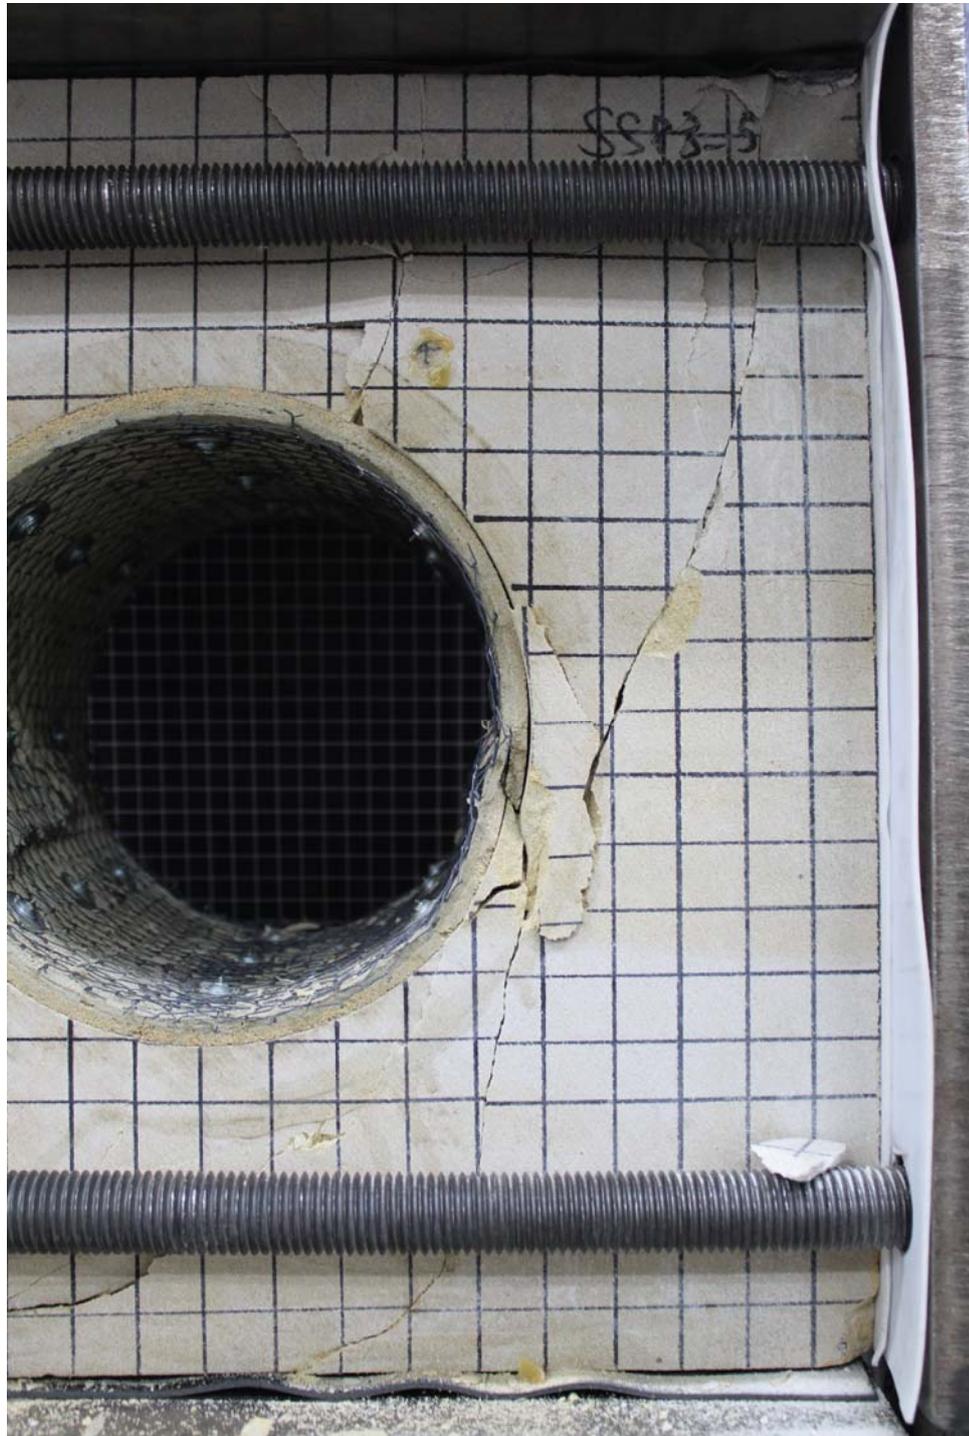
Figure 8.41 The shear failure on the pillar (Specimen No.14).

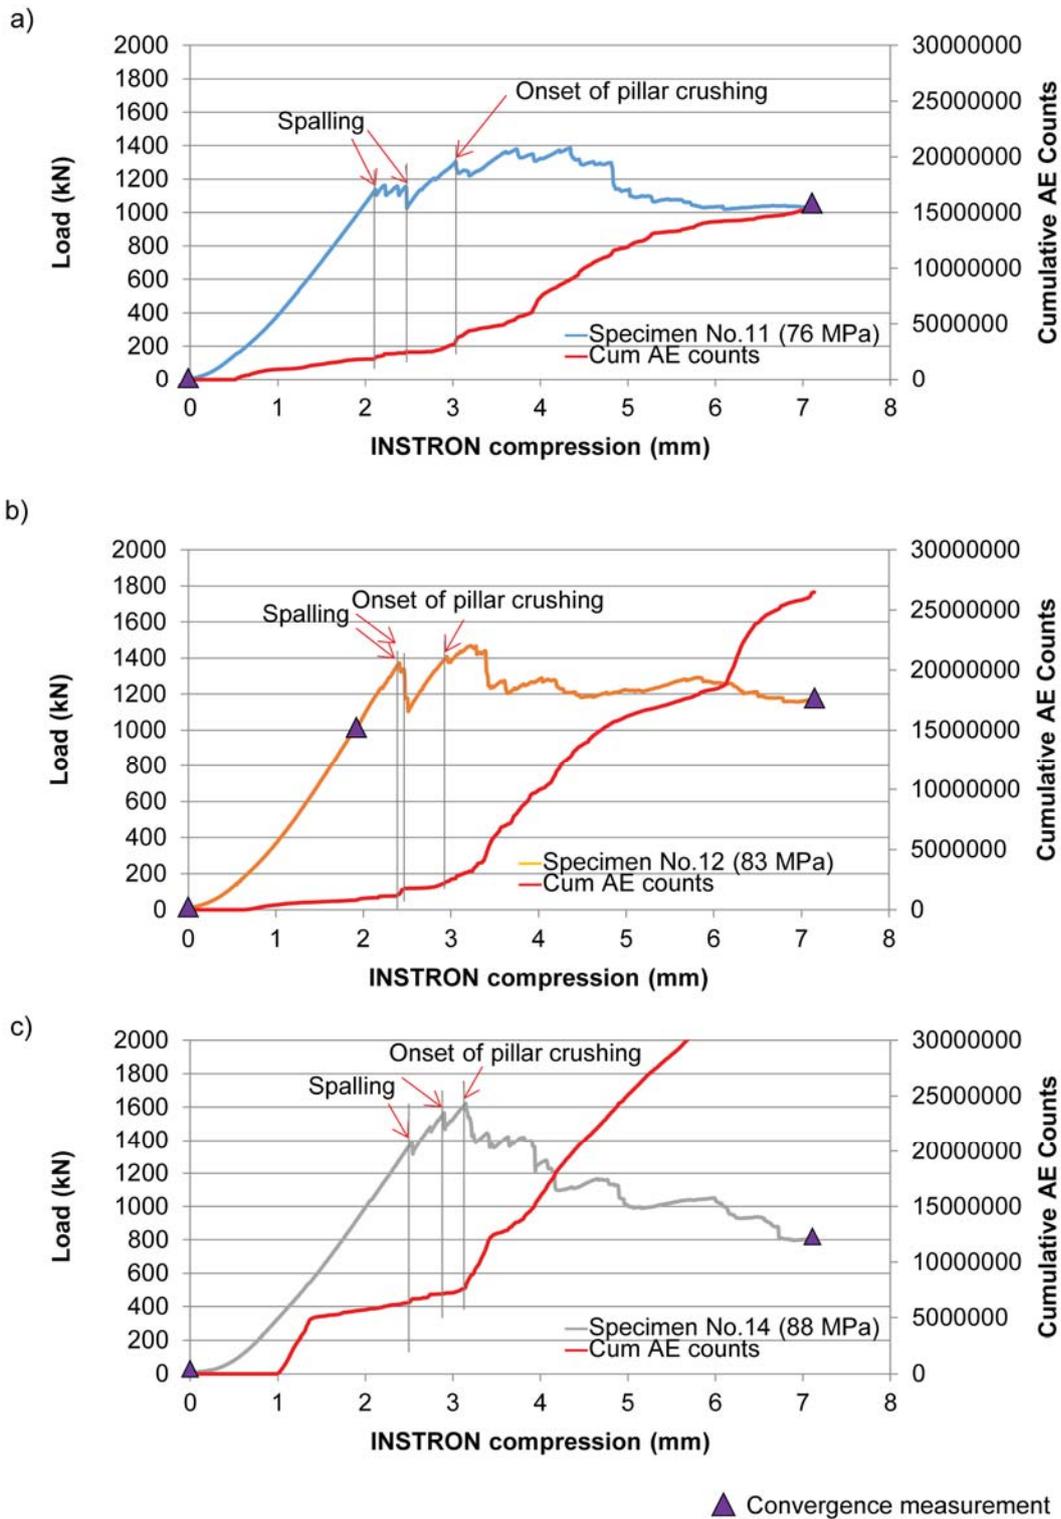
Figure 9.1 Stain measurement point of a) Specimen No.11 b) Specimen No.12 c) Specimen No.14.

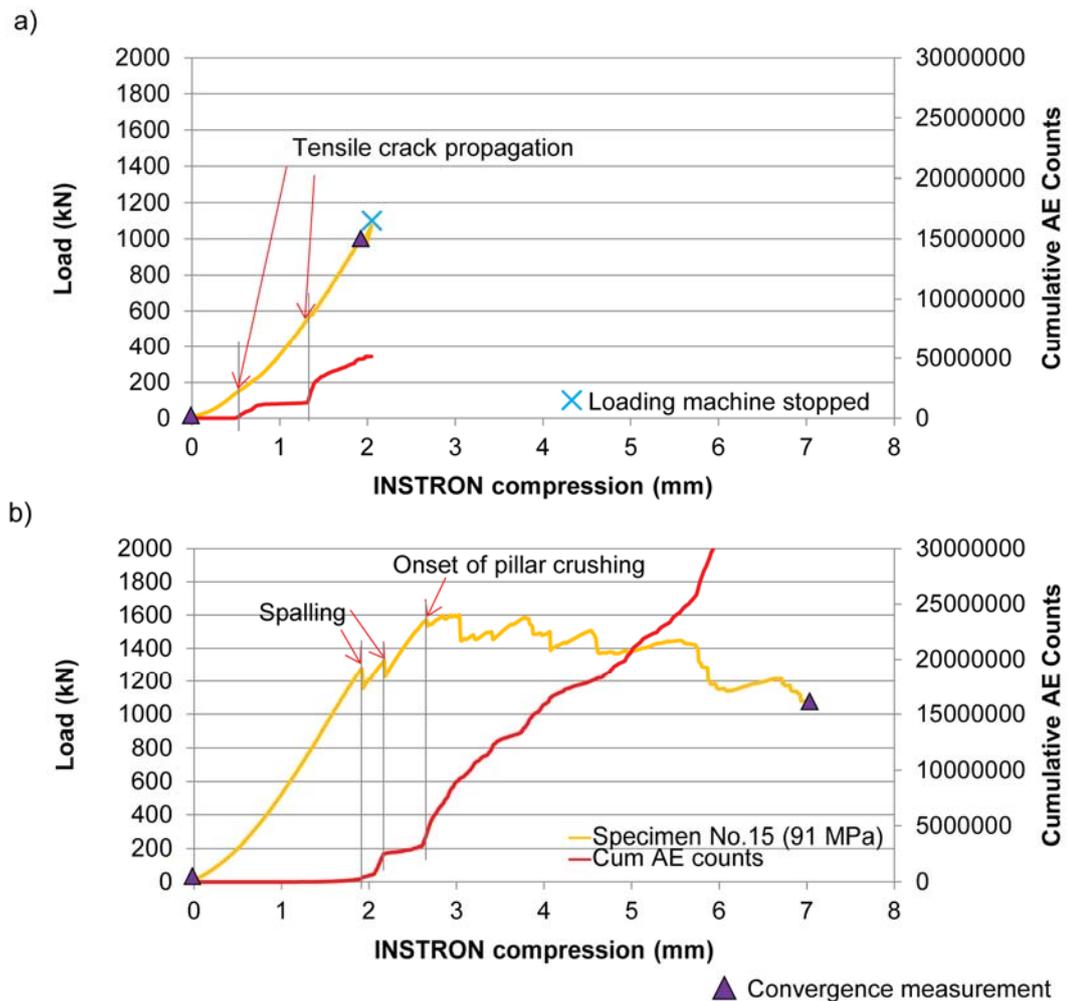
Figure 9.2 Strain measurement point of Specimen No.15 a) the first loading b) the second loading.

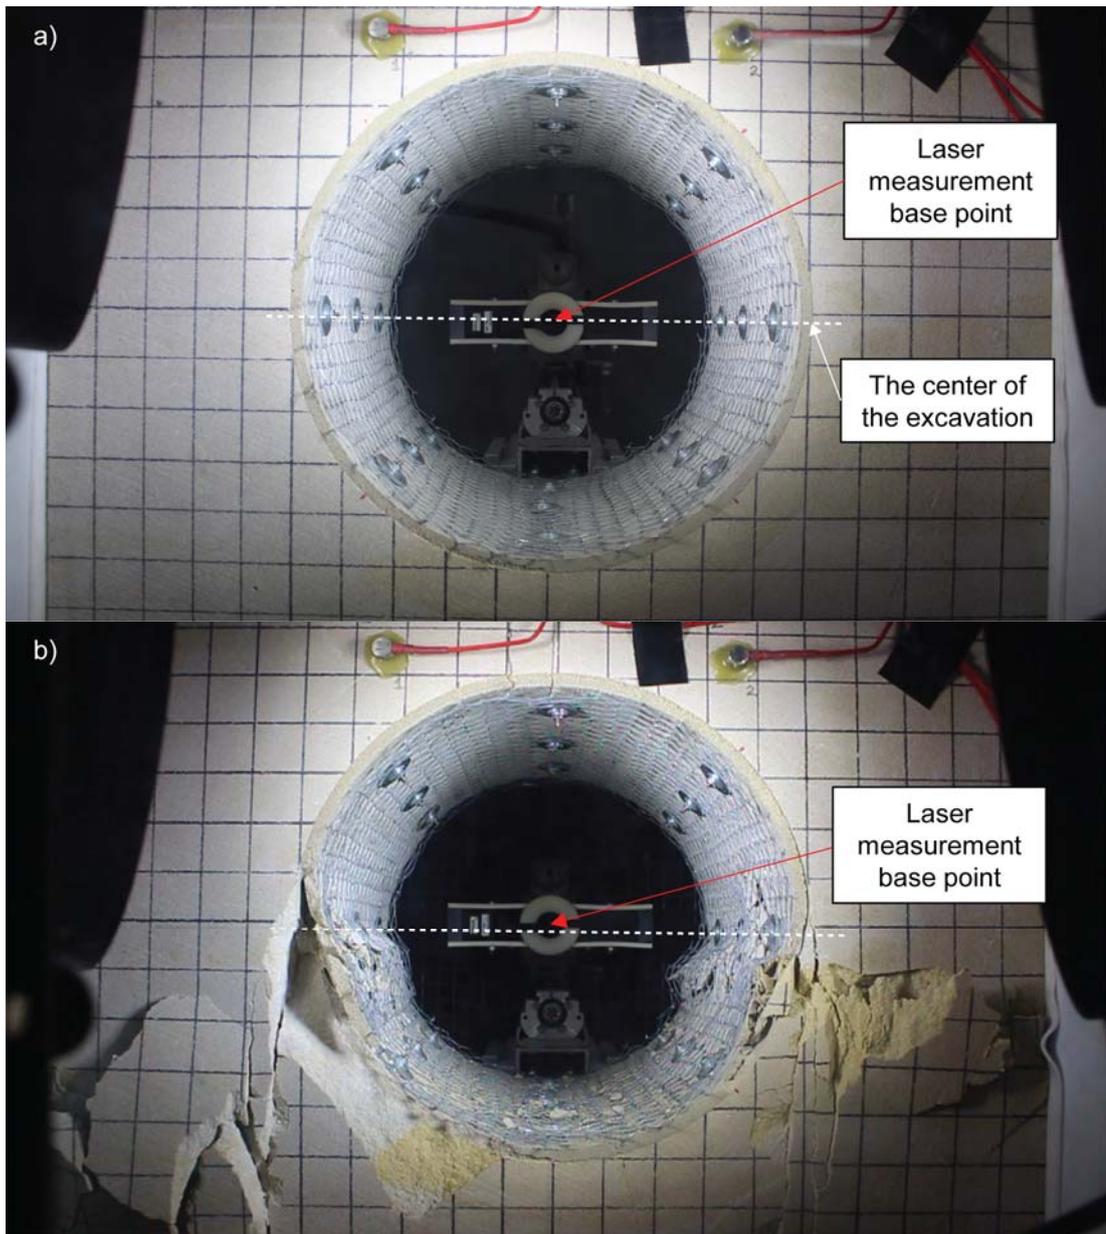
Figure 9.4 Strain measurement by the laser scanner a) before loading b) after failure.

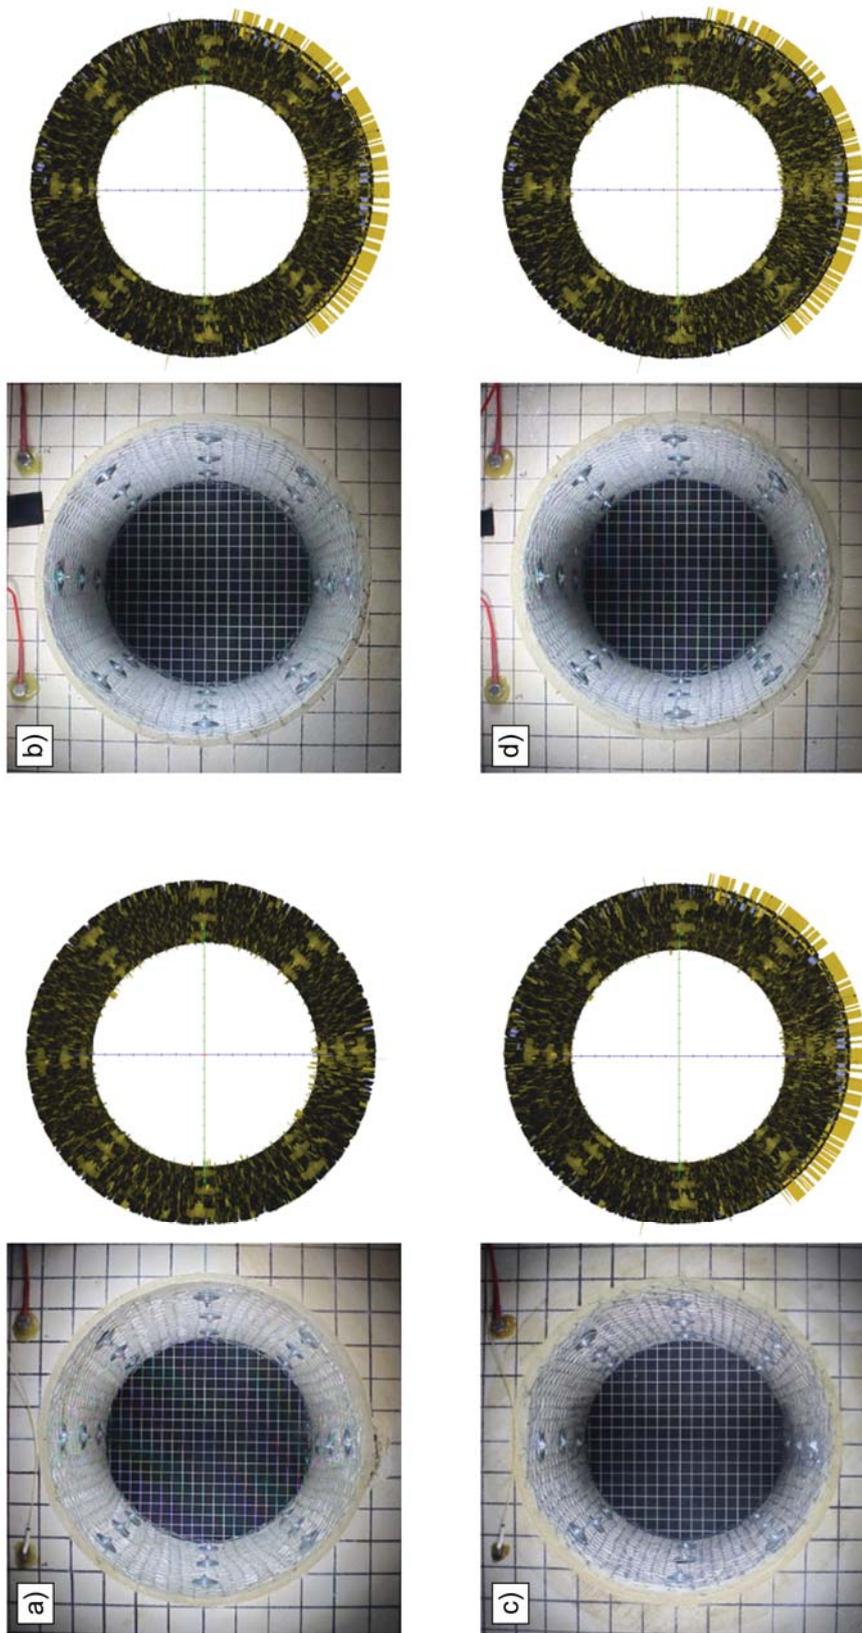
Figure 9.8 Excavation surface and 3D views by laser scanning before testing a) Specimen No.11 b) Specimen No.12 c) Specimen No. 14 d) Specimen No.15.

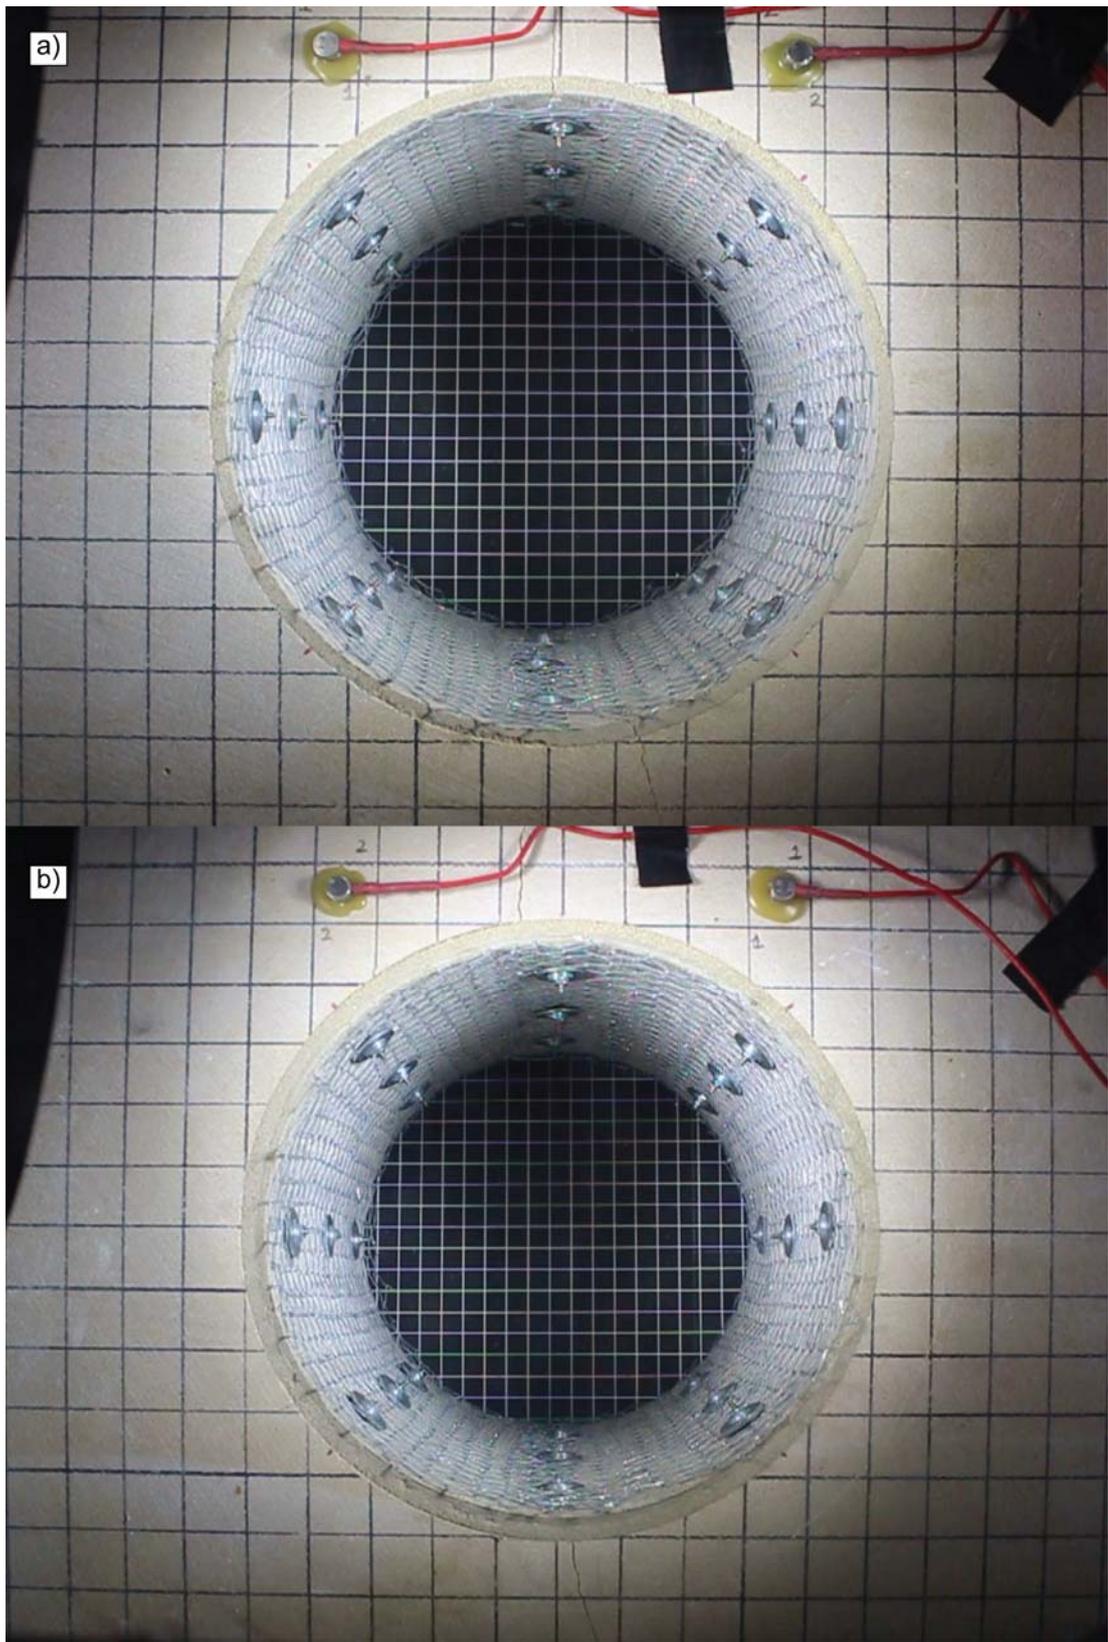
Figure 9.11 Specimens before spalling a) Specimen No.12 b) Specimen No.15.

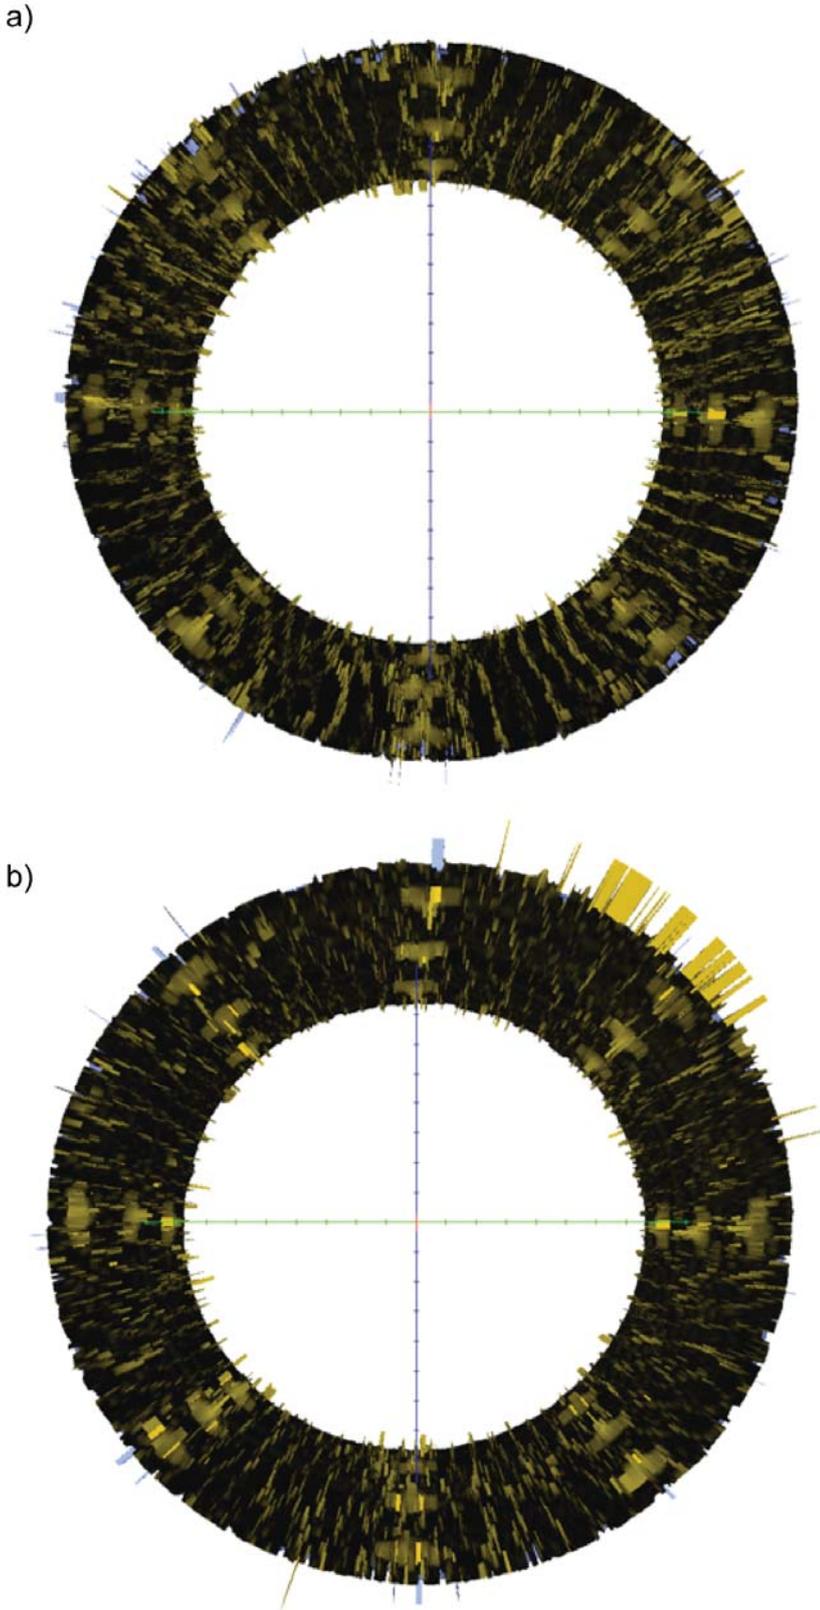
Figure 9.12 Three dimensional views before spalling.

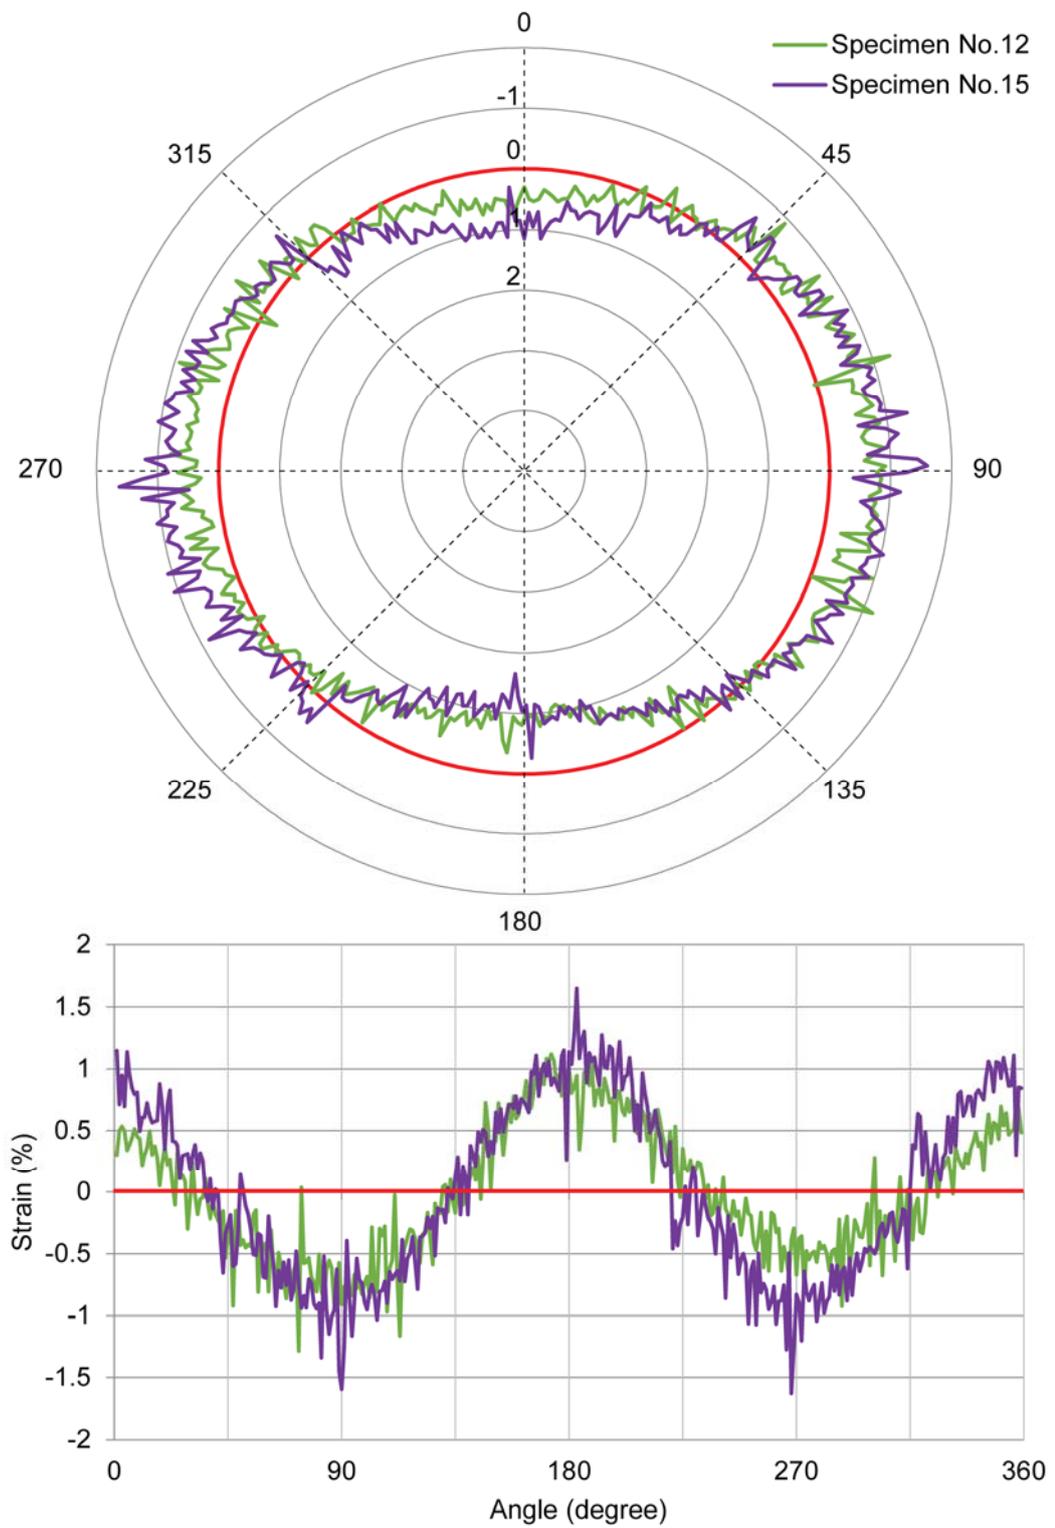
Figure 9.13 Average strain profile before spalling.

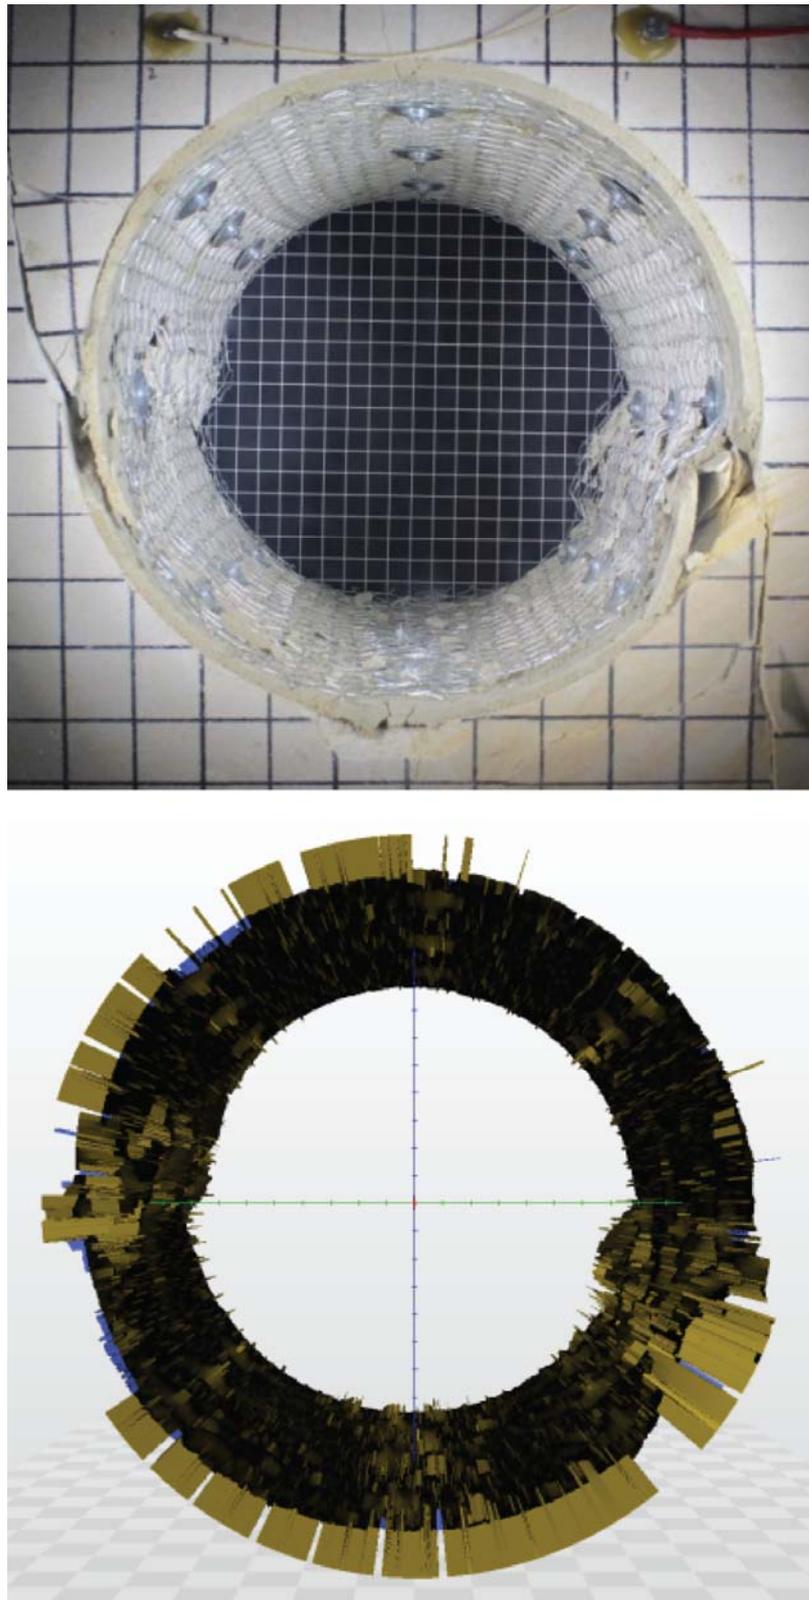
Figure 9.14 Comparison of 3D view and excavation surface after failure of Specimen No.11.

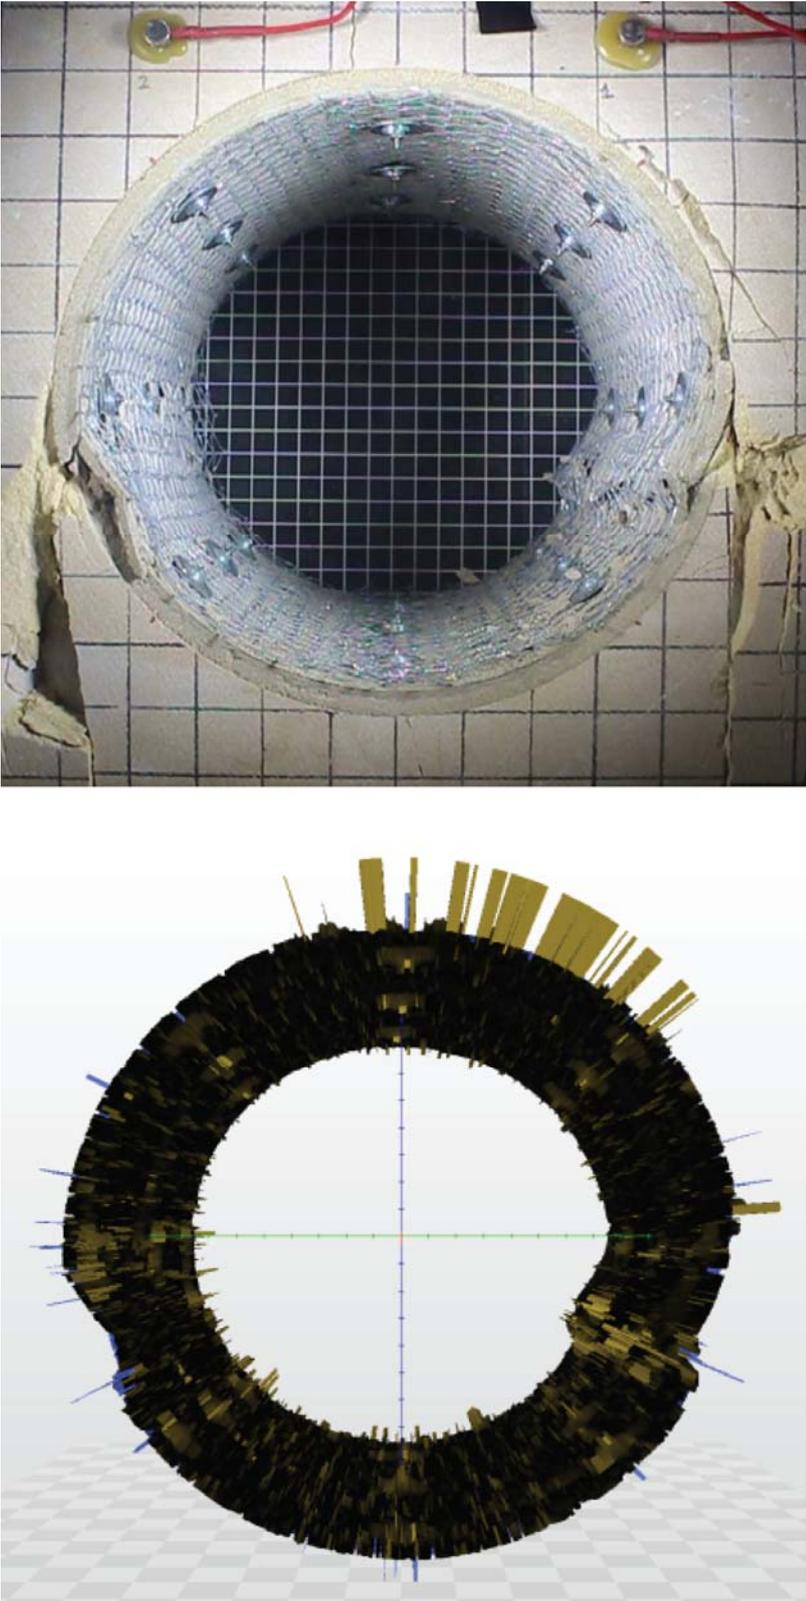
Figure 9.17 Comparison of 3D view and excavation surface after failure of Specimen No.15.

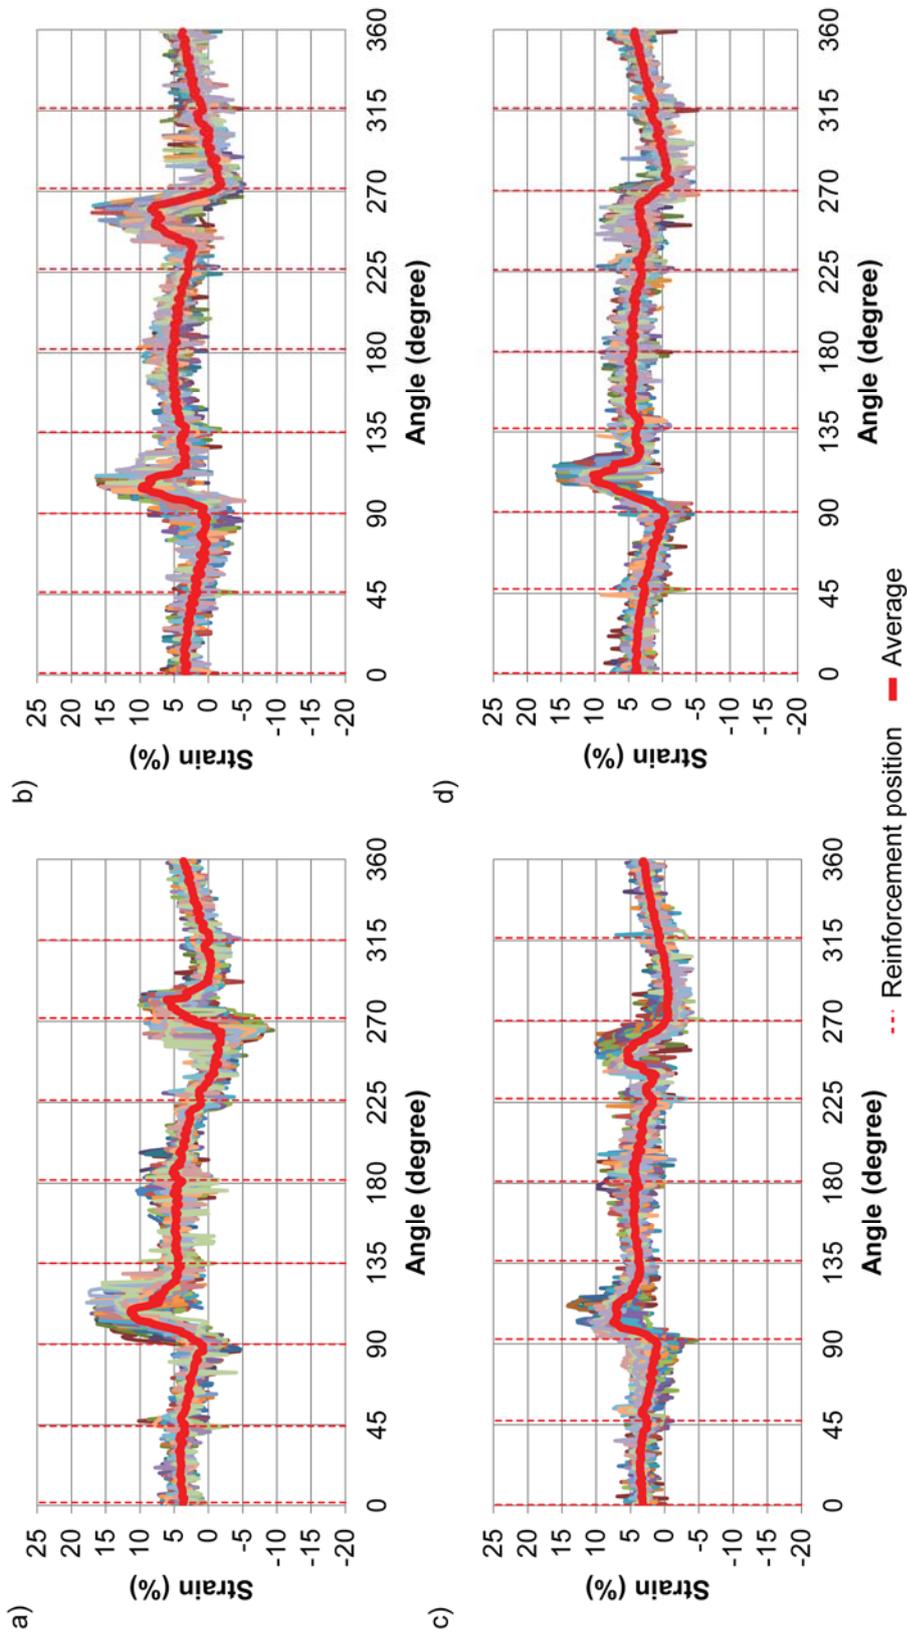
Figure 9.18 Strain profiles after failure a) Specimen No.11 b) Specimen No.12 c) Specimen No.14 d) Specimen No.15
