Western Australian School of Mines

**Scaled Down Tunnel Testing for Comparison of Surface Support
Performance**

**This thesis is presented for the Degree of
Doctor of Philosophy
of
Curtin University**

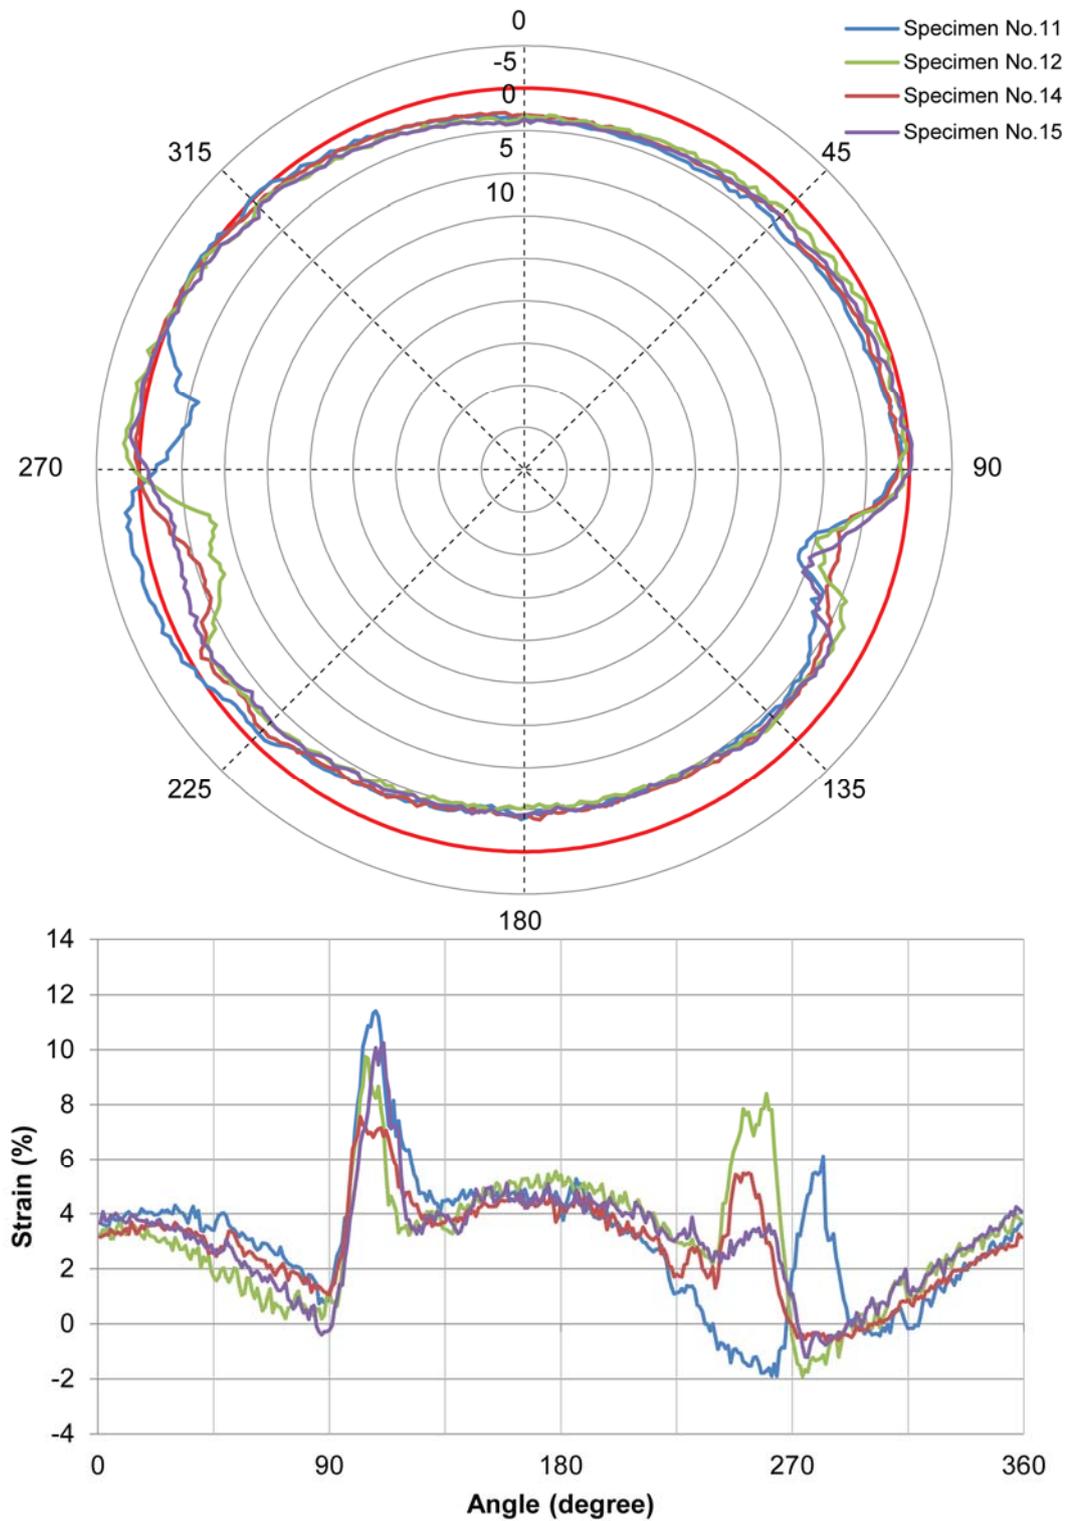
Figure 9.19 Combined average strain profile after failure.

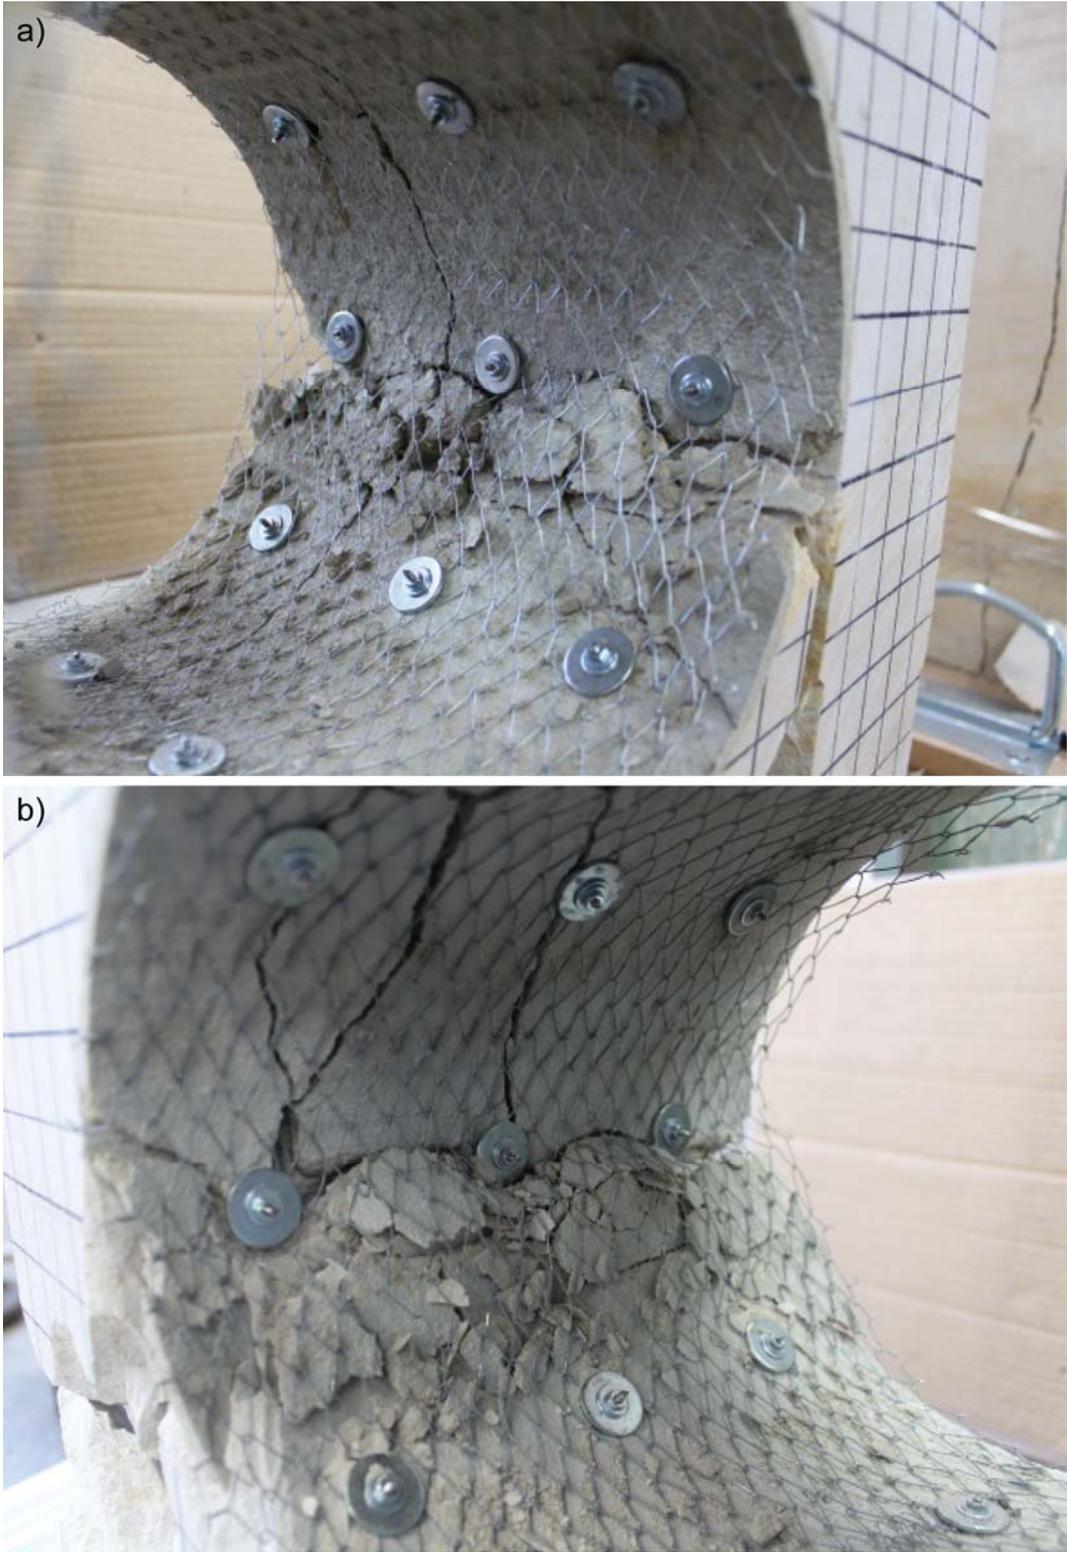
Figure 9.21 Excavation surface with a single layer after failure a) Specimen No.11
b) Specimen No.12.

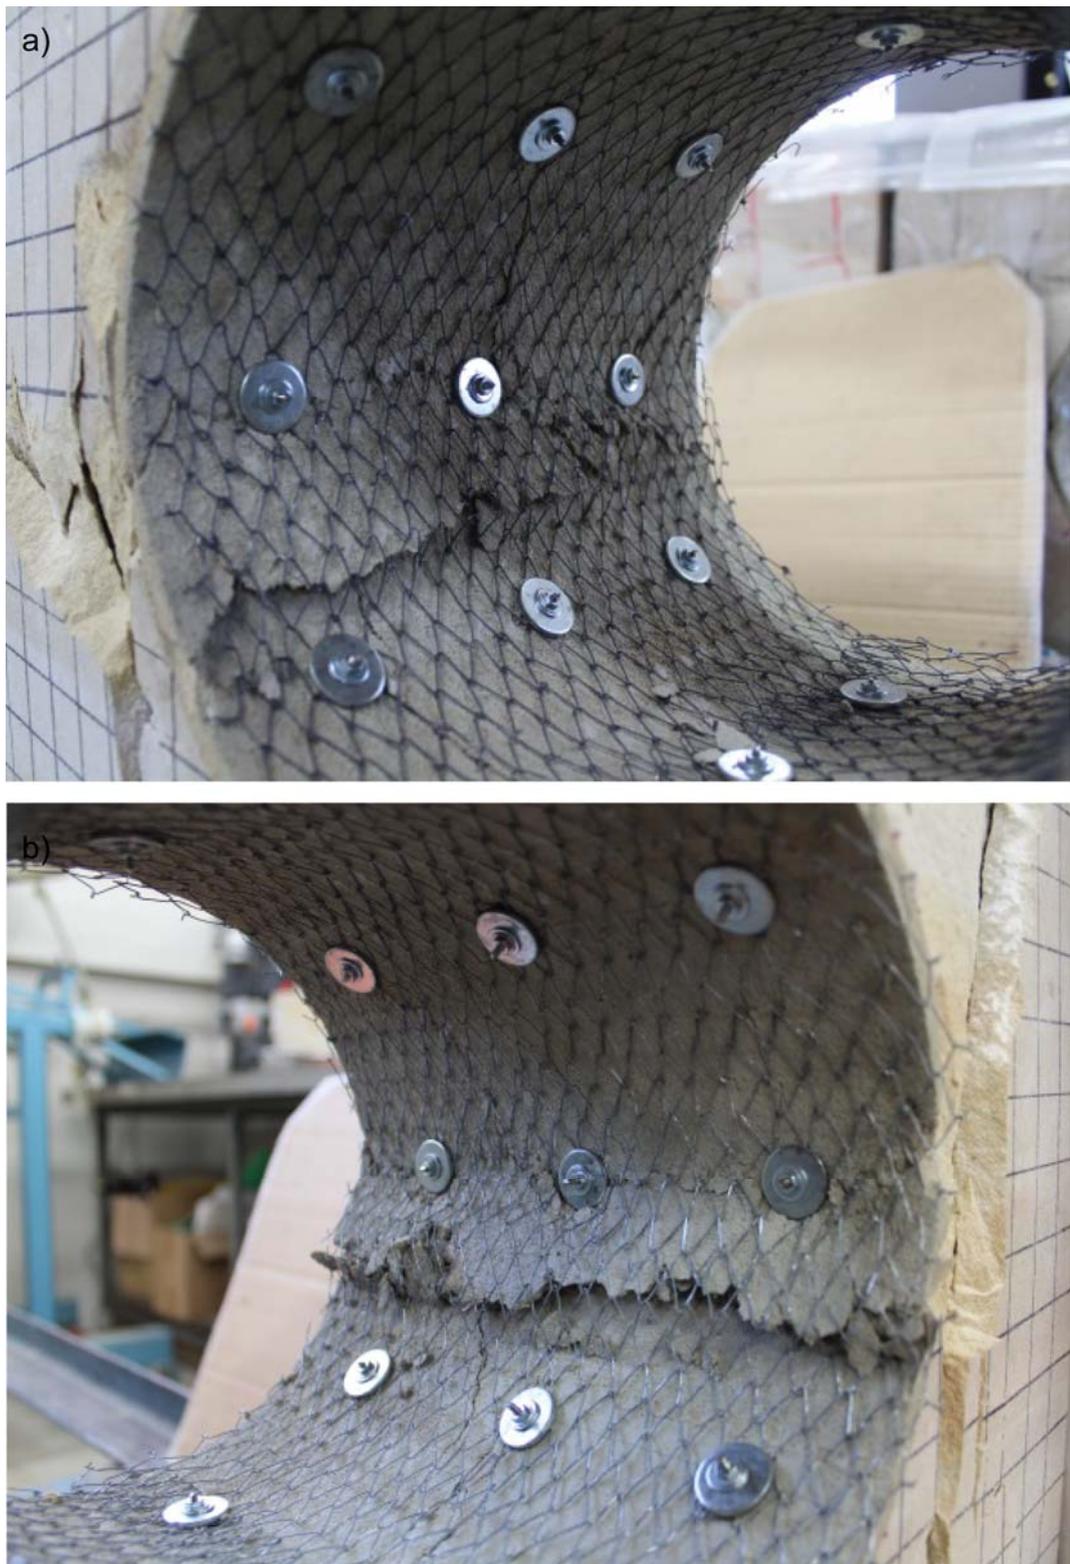
Figure 9.22 Excavation surface with a double layer after failure a) Specimen No.14 b) Specimen No.15.
