**Cracking of Concrete, its Healing and Simultaneous
Monitoring**

This thesis is presented for the Degree of

Doctor of Philosophy

Curtin University

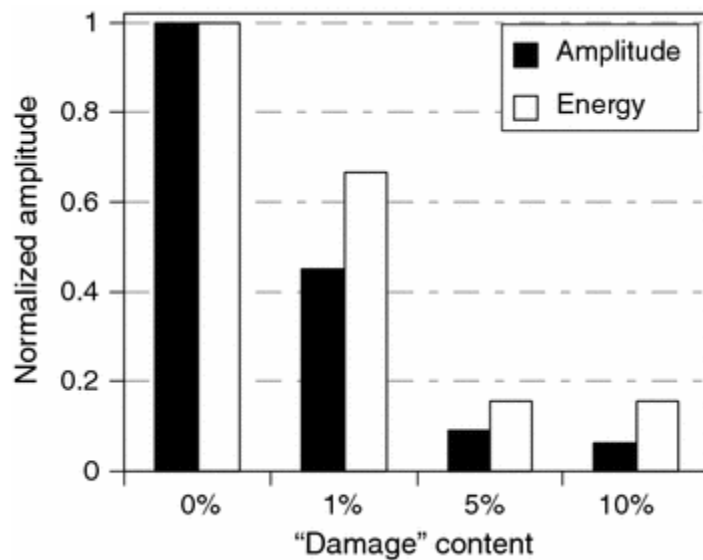
Figure 2.7: Amplitude and energy for different damage content [92]

ultrasonic waves. They reported that pulse velocity (Figure 2.6) had very slight difference, however the amplitude and energy of waveform varied significantly with different damage percentages (Figure 2.7). Kaur et al [20] created damage in the form of cracks of different widths and observed slight change in arrival time, but significant change in attenuation was observed (Figure 2.8).

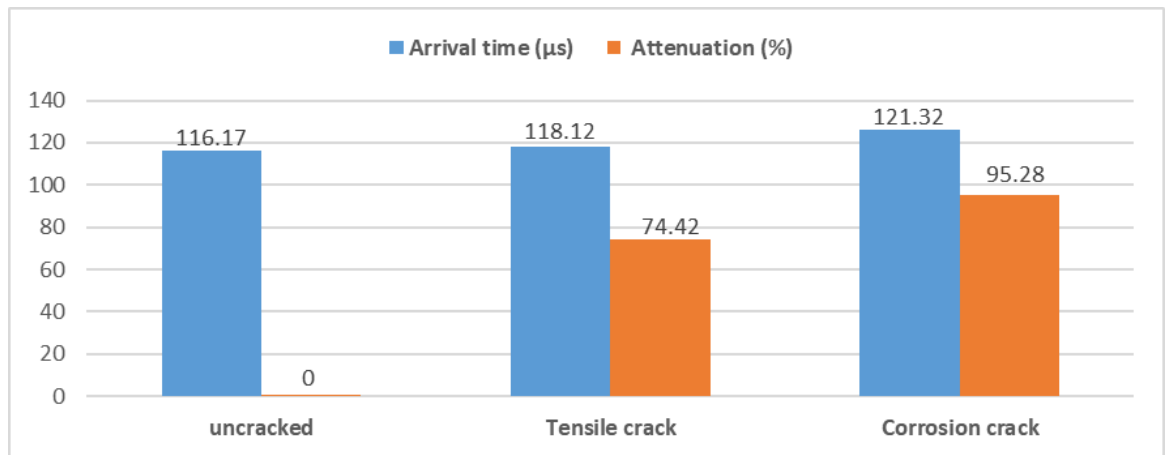
Figure 2.8: Arrival time and attenuation for different cracks [17]

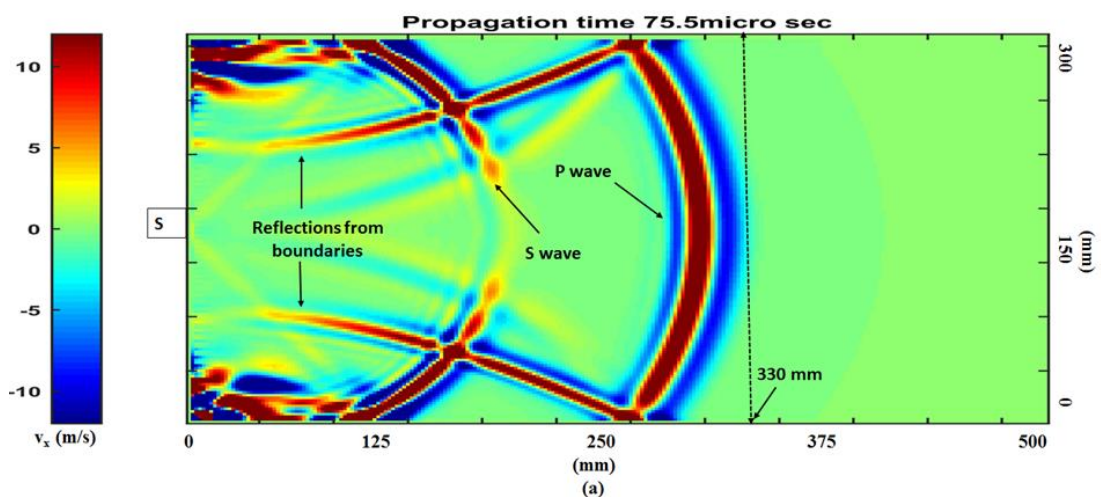
Figure 3.7: Wave propagation through (a) pristine specimen (b) fully cracked specimen (c) soft material in the cracked region. [Stress wave form: Gaussian]

Figure 3.7a shows the wave propagation in pristine concrete. P wave is clearly discerned as the fastest moving wave in the medium. S wave and reflections from the nearby boundaries can also be located in the figure. To validate the model the wave velocities are determined from the simulation. According to Fig. 7a, P wave travels 330 mm in 75.5 μ s. Thus, the velocity of propagation of P waves is 4370 m/s which agrees closely with 4400 m/s as mentioned in table 1 and obtained velocity in Section 4.2.

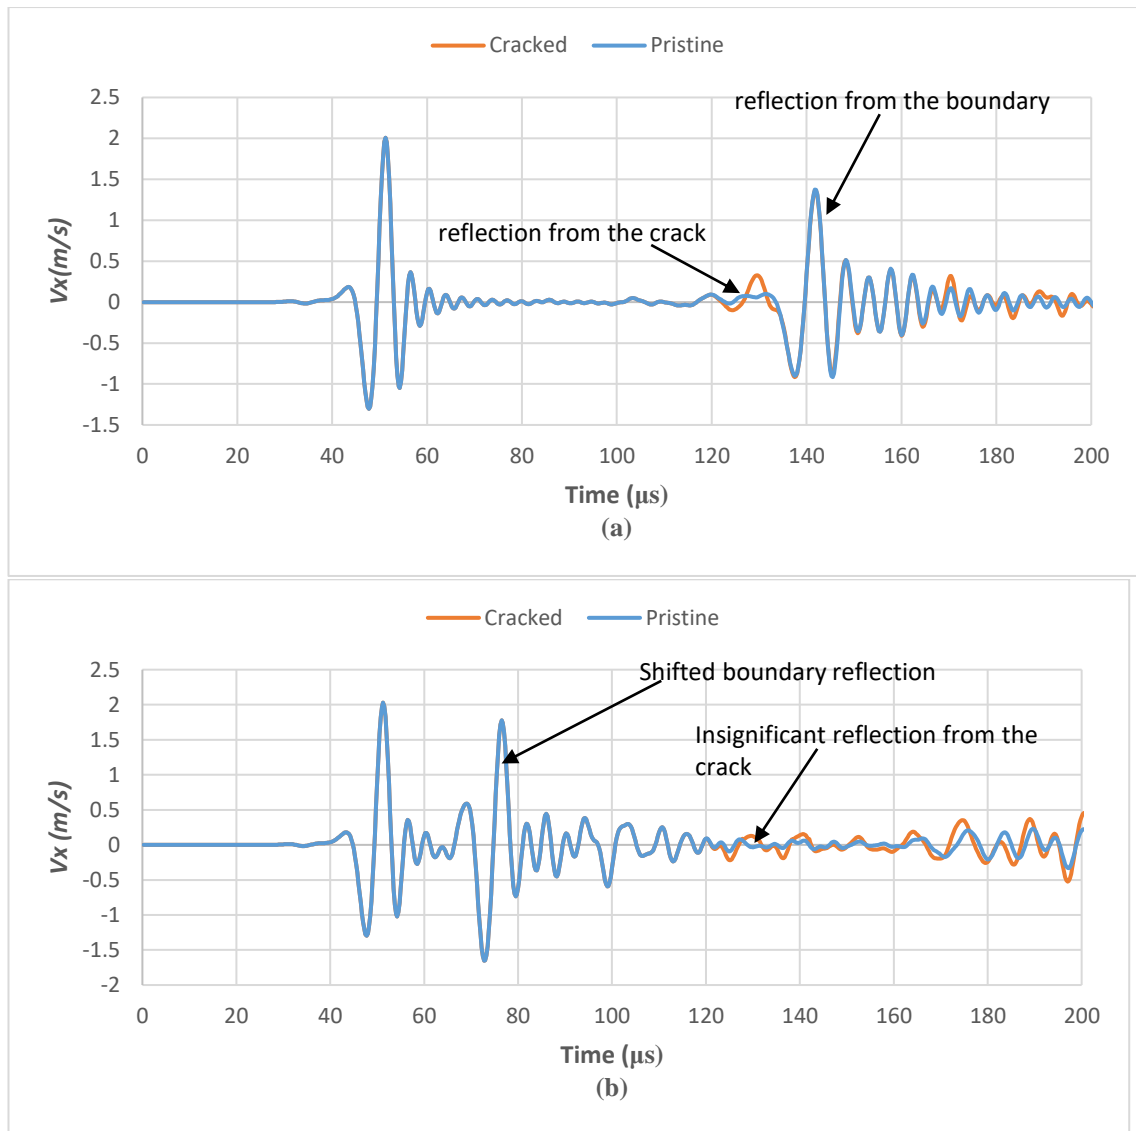
Figure 3.8: Reflection analysis at location R2 for the specimen with dimension of (a) 500 mm x 300 mm and (b) 500 mm x 150 mm

In order to obtain the location of the unhealed portion, reflected waves for a fully cracked specimen is recorded at the location R2 (Figure 3.7b). The distance between S and R2 is 20 mm. As the velocity of the P wave and location of the crack are known to be 4400 m/s and 250 mm respectively, the reflected wave from the crack can be calculated from the distance velocity relation. Figure 3.8a shows additional peak due to the reflection from the crack. However, for the original dimension of the specimen i.e., 500 mm x 150 mm, information about the location of crack gets lost among dominating multiple reflections from the top and bottom boundaries of the specimen as shown in Figure 3.8b. The results for both cases are very similar, and it is difficult to extract any significant information about crack location from these graphs. Based on simulation results, it can be said that the near field effect and the secondary signals generated due to the reflections from the boundaries, dominate the waveform and no significant difference between the pristine and the damaged specimens could be discerned. Also, the assessment of the location of damage through reflection is strongly dependent on the geometry of the specimen.

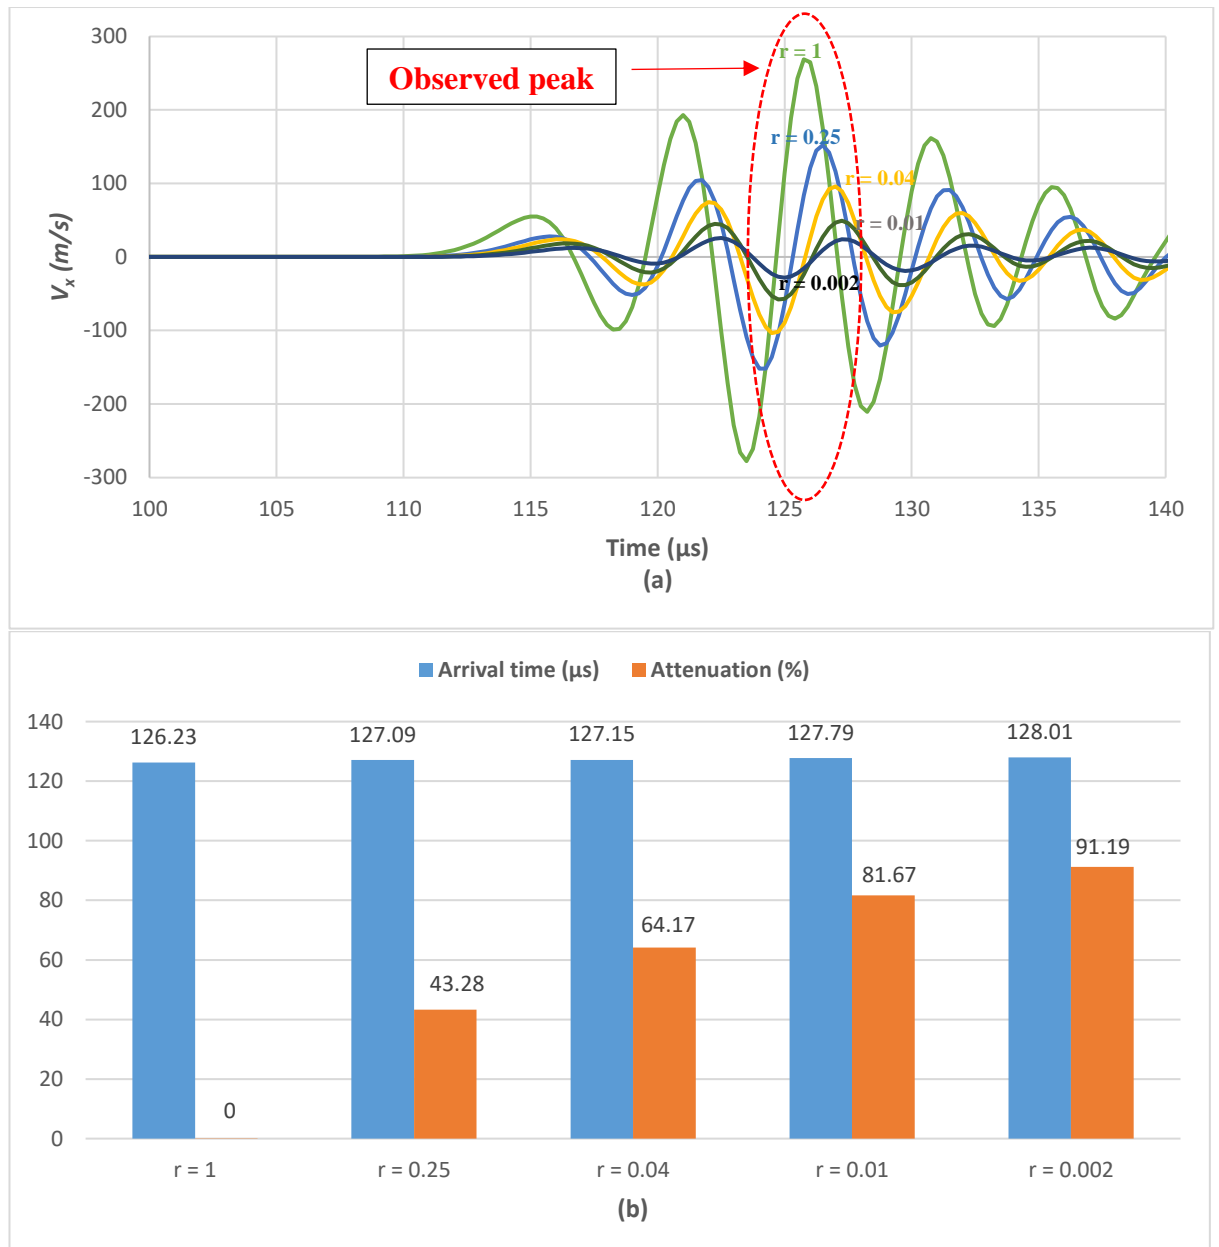
Figure 3.10: (a) V_x vs propagation time plot showing time history of the transmitted wave (b) Variation of arrival time of first peak and attenuation in the third peak

while the arrival time remains relatively unaltered, the attenuation reduces sharply with healing. This simulation demonstrates that in experiments, monitoring signal attenuation during healing is likely to be more effective than change in the arrival time. However, for a reliable experimental data on attenuation, ensuring proper coupling of the transducers with the substrate is essential.

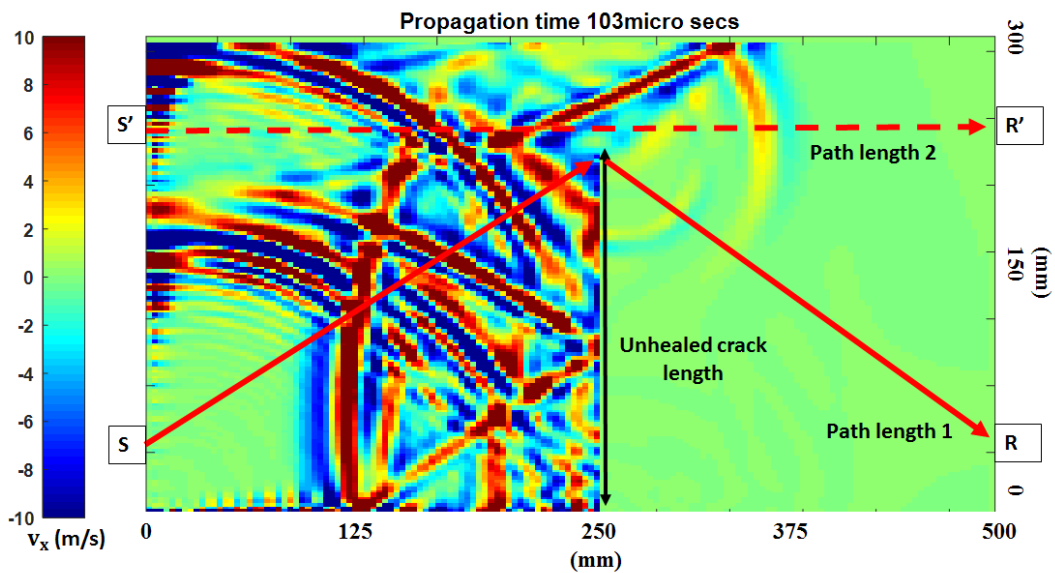
Figure 3.11: Wave propagation through partially filled cracks [Stress wave form: Gaussian]

This section investigates the partial healing of a crack. Figure 3.11 shows a snapshot of wave propagation for a case where only the top one-fourth of the crack is healed, but the rest of the crack is not treated. The snapshot of the propagation of the wave at 75.5 μ sec shows that the transmission happens only through the healed portion. Two transducer positions, S-R1 and S'-R1' have been investigated. It can be noted that the S-R1 configuration is in the unhealed portion, while S'-R1' is in the healed portion. Evidently, the path length in case of S-R1 is considerably longer than that in case of S'-R1'.

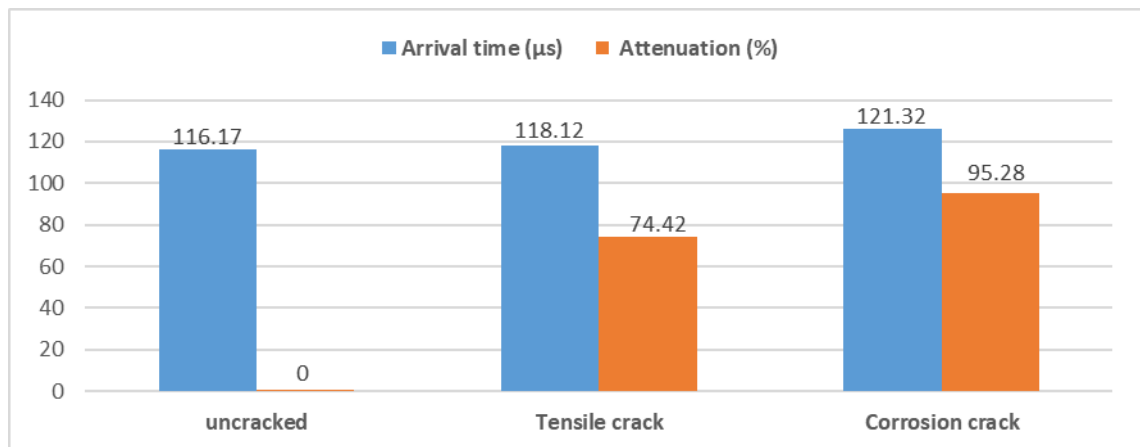
Figure 3.15: Bar graph showing variation of arrival time (largest peak) and attenuation for signals in transmission mode

For clear representation of the transmission signals, the arrival time and the attenuation variation of the largest peak are plotted as shown in Figure 3.15. It is noted that while the arrival time remains relatively unaltered, attenuation is greatly affected. Similar variations are observed in numerical study as well. These results corroborate well with the results obtained by Suaris and Fernando [50] in which attenuation of waveform was found to be more sensitive to the crack growth than wave velocity.

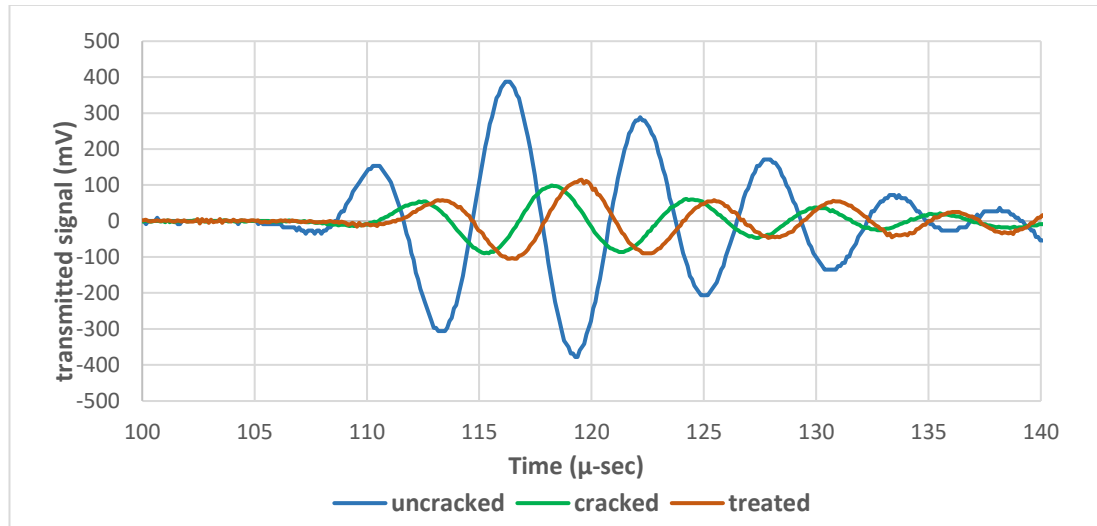
Figure 3.16: Tensile cracked specimen: before cracking (uncracked), after cracking (cracked) and after the grout treatment (treated).

Figure 3.16 presents the ultrasonic signals before cracking (uncracked), after cracking (cracked) and after the grout treatment (treated) for tensile cracked slab specimens. A gain of 40 dB was maintained for all the readings.

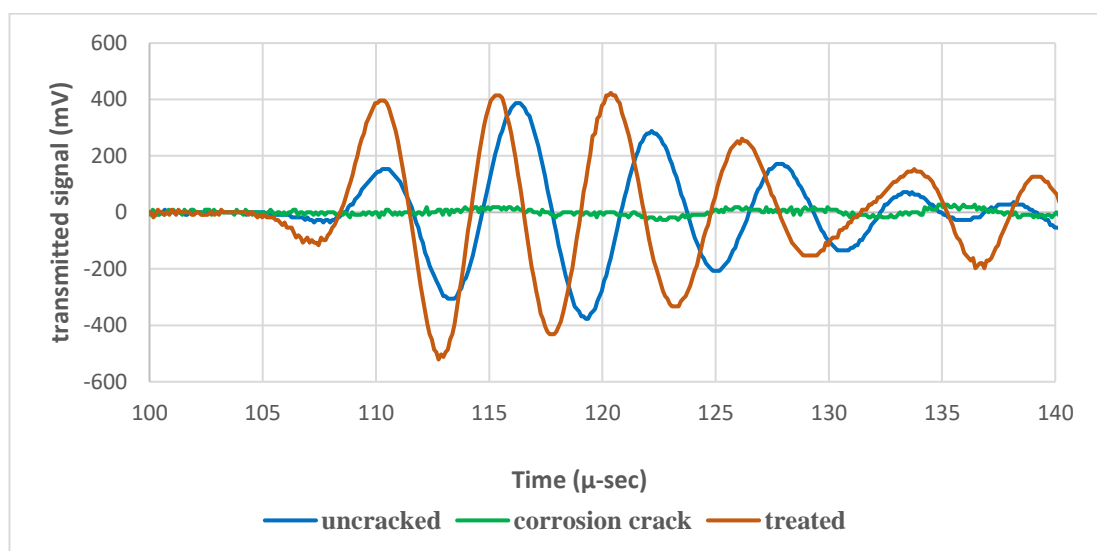
Figure 3.17: Ultrasonic transmission through corrosion cracked specimen: before cracking (uncracked), after cracking (corrosion crack) and after treatment (treated).

Figure 3.17 presents the ultrasonic signals before cracking (uncracked), after cracking (cracked) and after grout treatment (treated) for the corrosion cracked specimen. A gain of 40 dB is maintained for the specimens before cracking and after treating with grout. For the cracked specimen before treatment the signal recorded at 40 dB was below the noise level. Thus, a gain of 60 dB was applied for the cracked specimen.

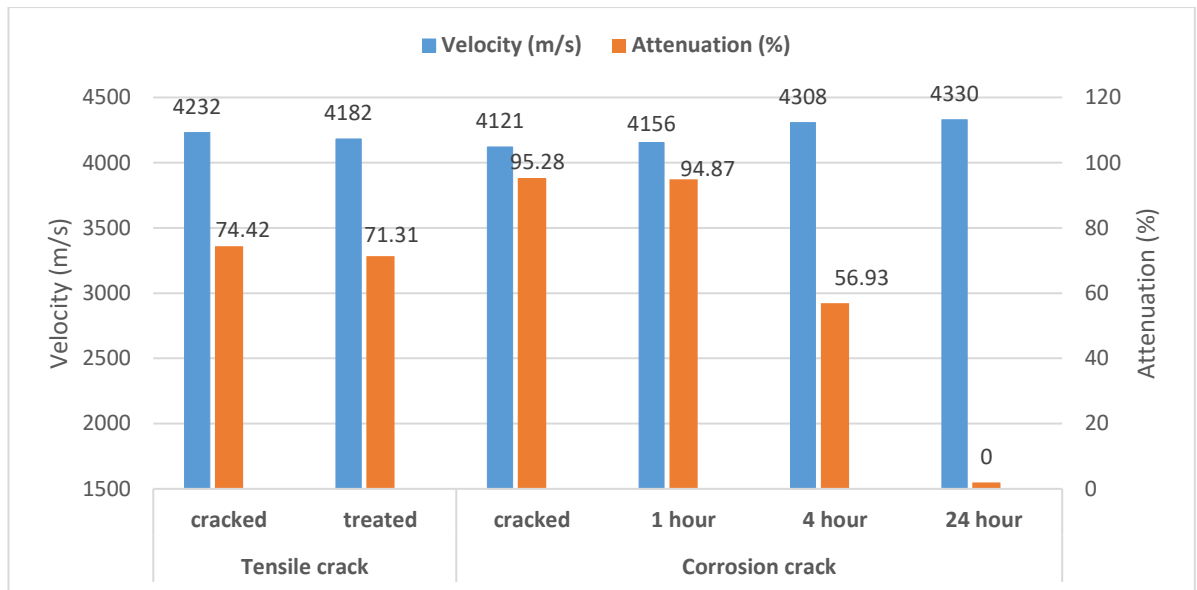
Figure 3.18: Velocity and attenuation variations for tensile and corrosion crack before and after treating

Figure 3.18 illustrates the effect of the treatment in the two crack types. In case of the tensile crack, the treatment resulted in a marginal shift in the wave velocity or wave attenuation. Thus, the present grout was unable to penetrate the thin crack. Significant reduction in attenuation could be seen in the corrosion crack specimen after healing of the wider crack caused due to corrosion. To a lesser extent, the velocity had increased too. Clearly, the voids were filled with the healing material leading to a significant recovery in the signal strength. Thus, evidence of recovery of the specimen due to the treatment could be seen. These results reveal that monitoring signal attenuation during healing is likely to be more effective than change in the arrival time/velocity. This experiment demonstrates that it is possible to discern healed cracks from the unhealed cracks using the present ultrasonic technique.

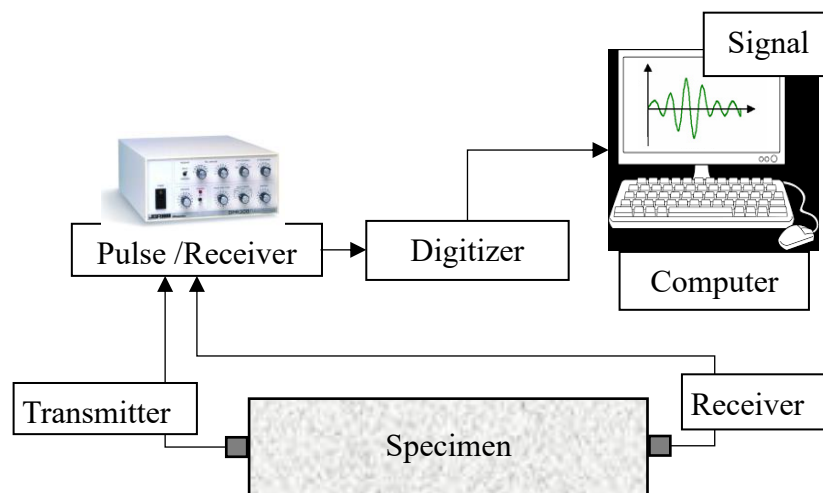
Figure 4.4: Set-up for ultrasonic data acquisition

Ultrasonic technique was used for recording pulse transmission through the crack at designated points. The experimental set-up for ultrasonic data acquisition is presented in Figure 4.4 **Error! Reference source not found..**

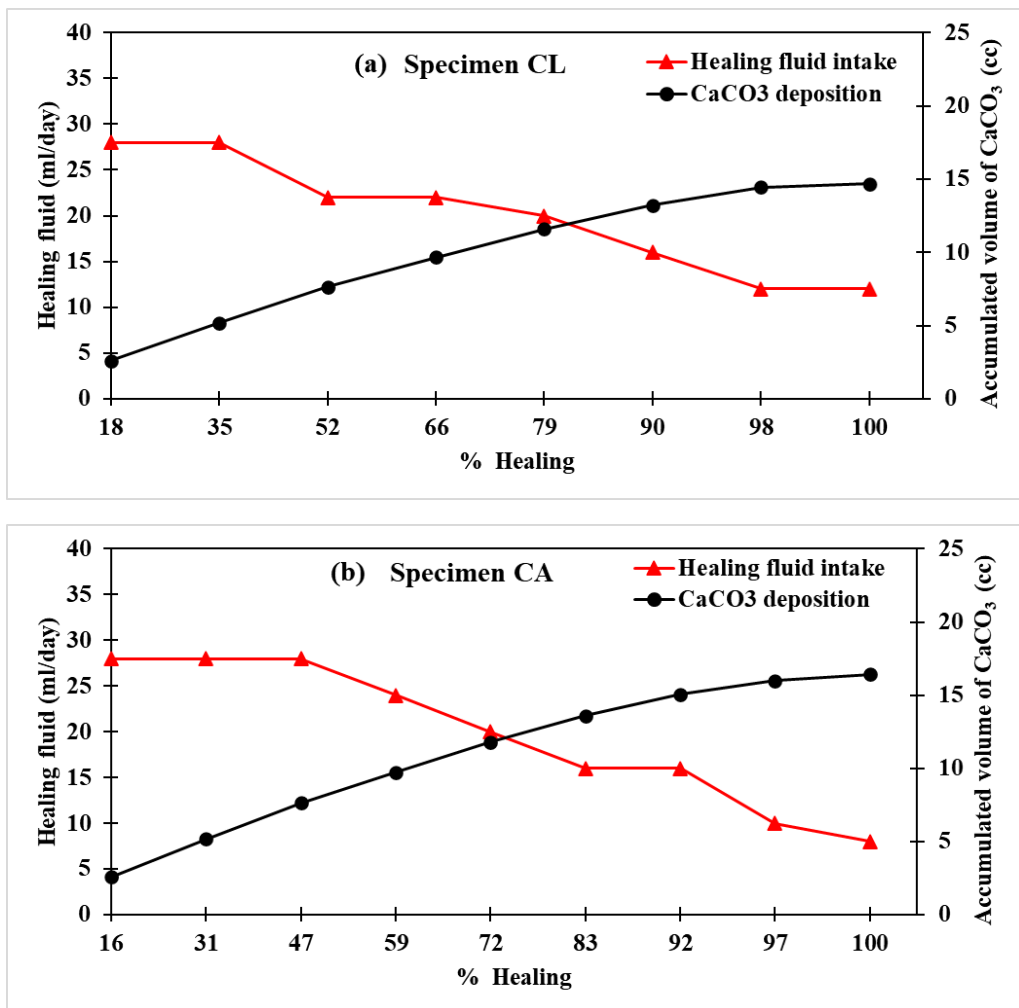
Figure 5.8: Rise in volume of calcium carbonate and reduction in fluid intake with progression of healing.

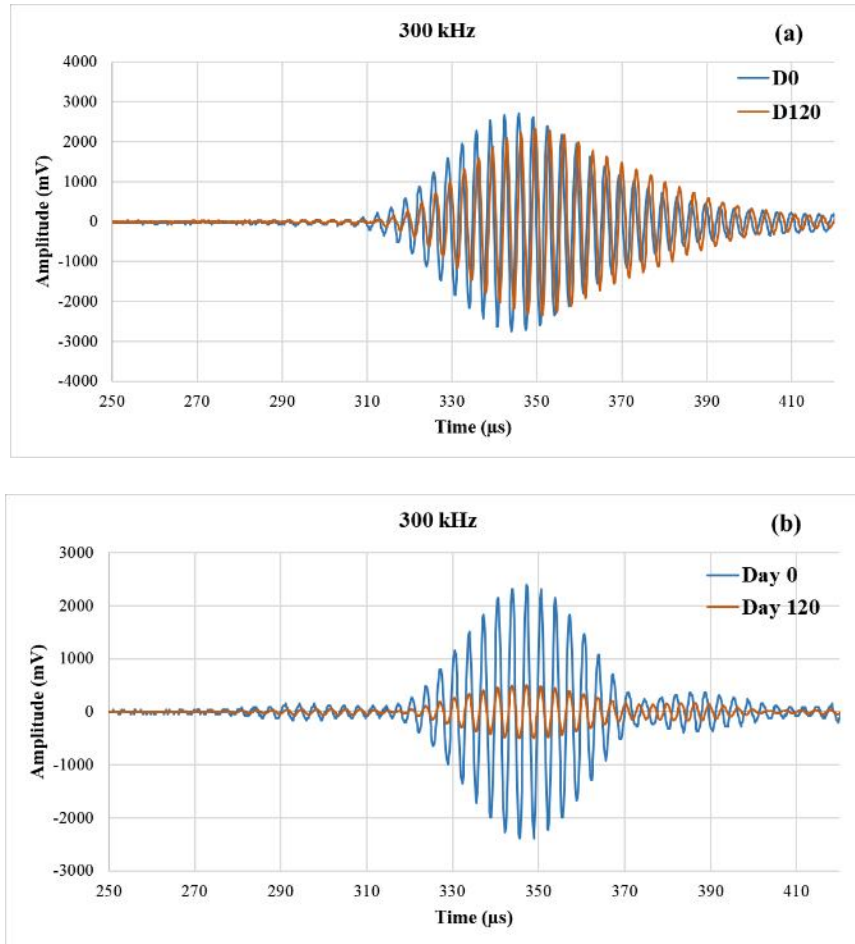
Figure 6.7. Time domain signals for (a) UD and (b) D specimens for day 0 and day 120.

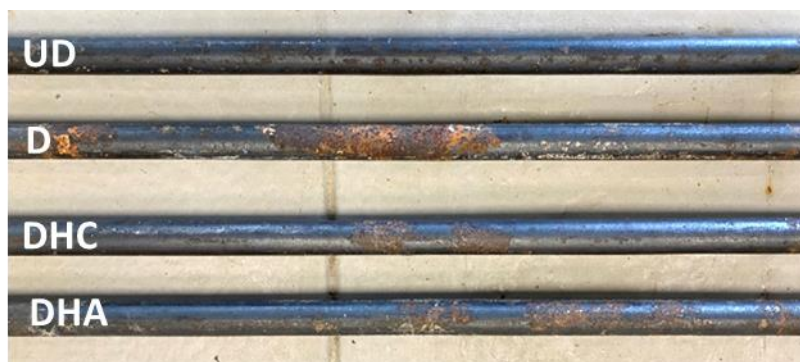
Figure 6.10. Visual inspection of rebar

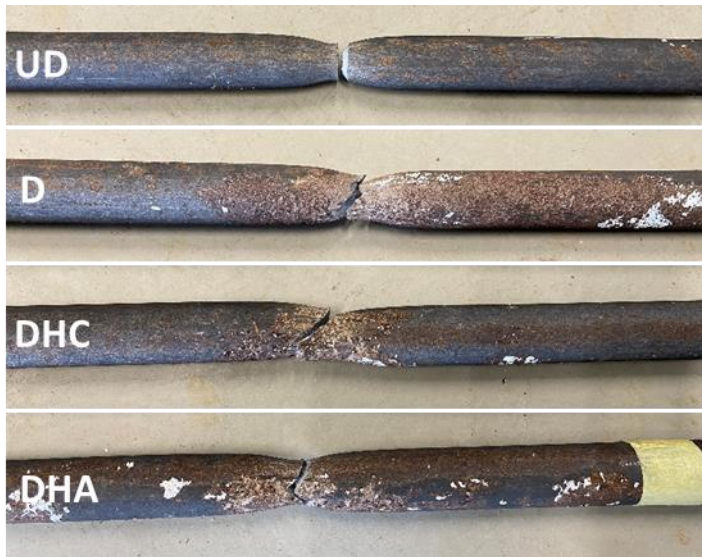
Figure 6.11. Fracture morphology for all specimens after tensile testing
