# Imaging Australia's first naval loss

THE 2018 PHOTOGRAMMETRIC SURVEY OF SUBMARINE HMAS AE1

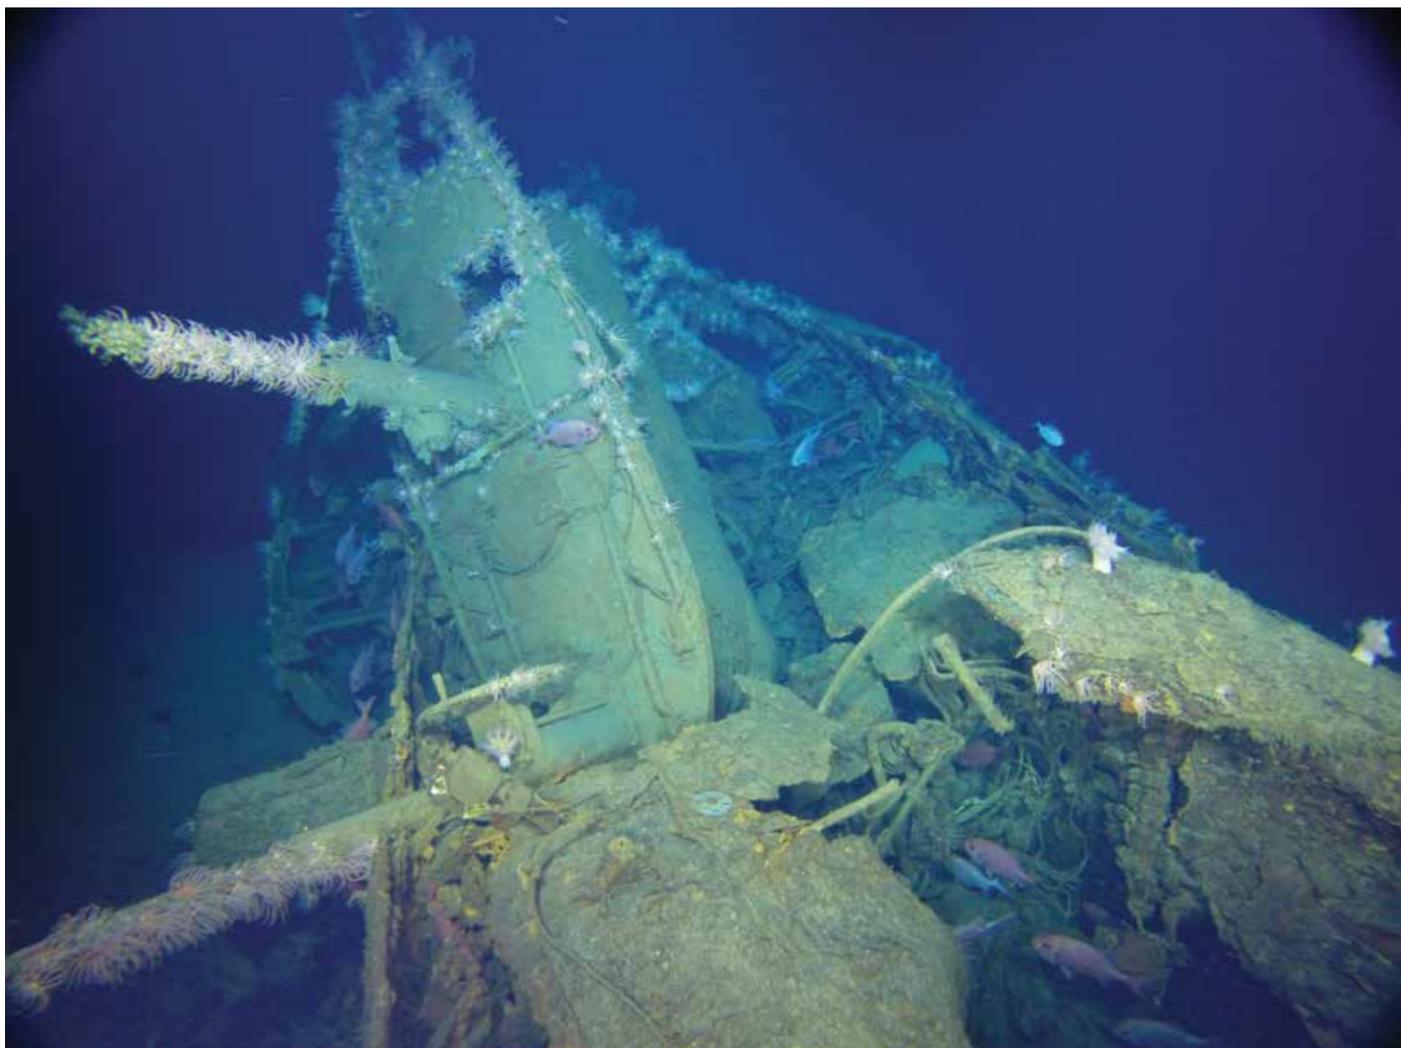
03

The same camera was among the equipment that captured photogrammetric imagery of the Second World War shipwrecks HMAS *Sydney* (II) and HSK *Kormoran* in 2015.
