Breakout Capacity of Headed Anchors with Delayed Installation

Synopsis: The objective of this research was to evaluate the impact on concrete breakout capacity of anchors in tension due to delay in the installation using the puddle-in technique. The puddle-in technique is the process of installing an insert (anchor) into fresh concrete once the surface has been finished. The installation was delayed by up to 160 minutes. Another installation method, pre-installation, is the attachment of the insert to the formwork or reinforcement before the concrete has been poured.

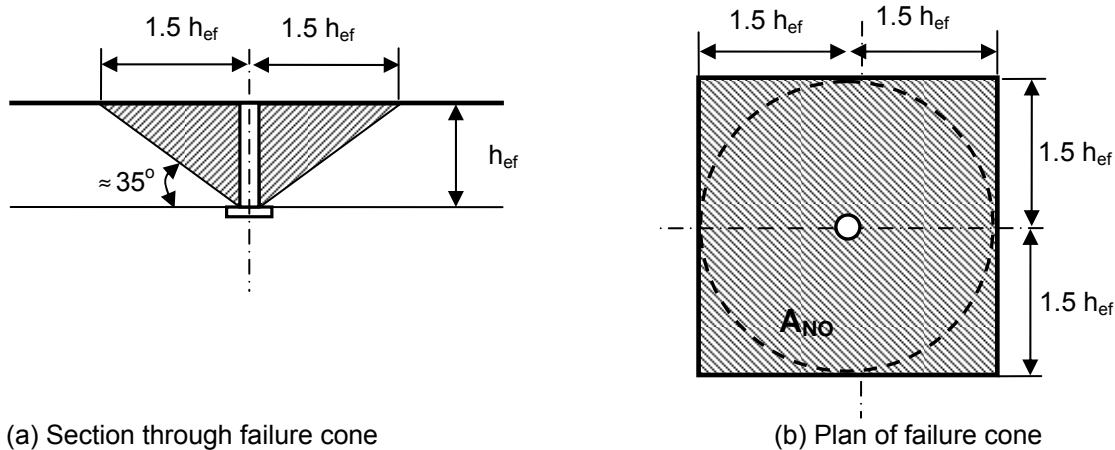
The CCD approach is based upon an idealized concrete failure cone that has an angle of inclination of 35 degrees between the failing surface and the surface of the concrete member. This angle corresponds to the observation that the horizontal extent of the concrete breakout surface is approximately three times the embedment depth. The projected failure of the concrete cone breakout is simplified to a rectangular plan of area $(3h_{ef})^2$. The idealized concrete breakout cone is shown in Figures 1(a) and 1(b) (7).

Figure 1. Idealized concrete breakout cone.

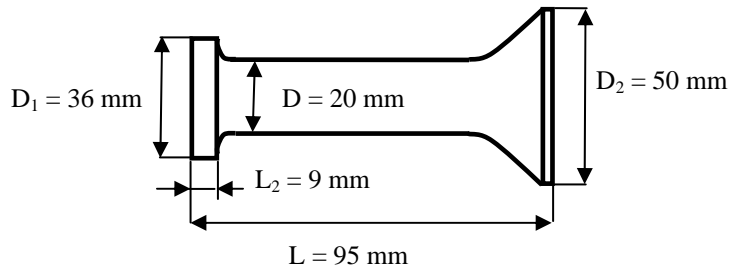
The anchors used in this investigation are a proprietary lifting product. The anchors tested were a headed anchor with a length of 95 mm as shown in Figure 2(a). The anchors were fitted with a plastic recess former, as shown in Figure 2(b), giving an effective embedment depth, h_{ef} , of greater than 95 mm (if the recess former was flush with the concrete surface h_{ef} would be approximately 103 mm, even greater if the recess former were below the concrete surface).

(a) Schematic of headed anchor used in research

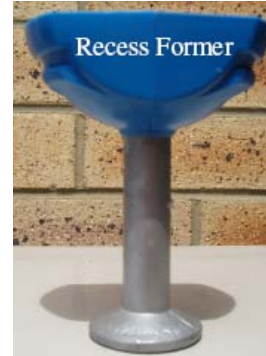
(b) Recess former and anchor

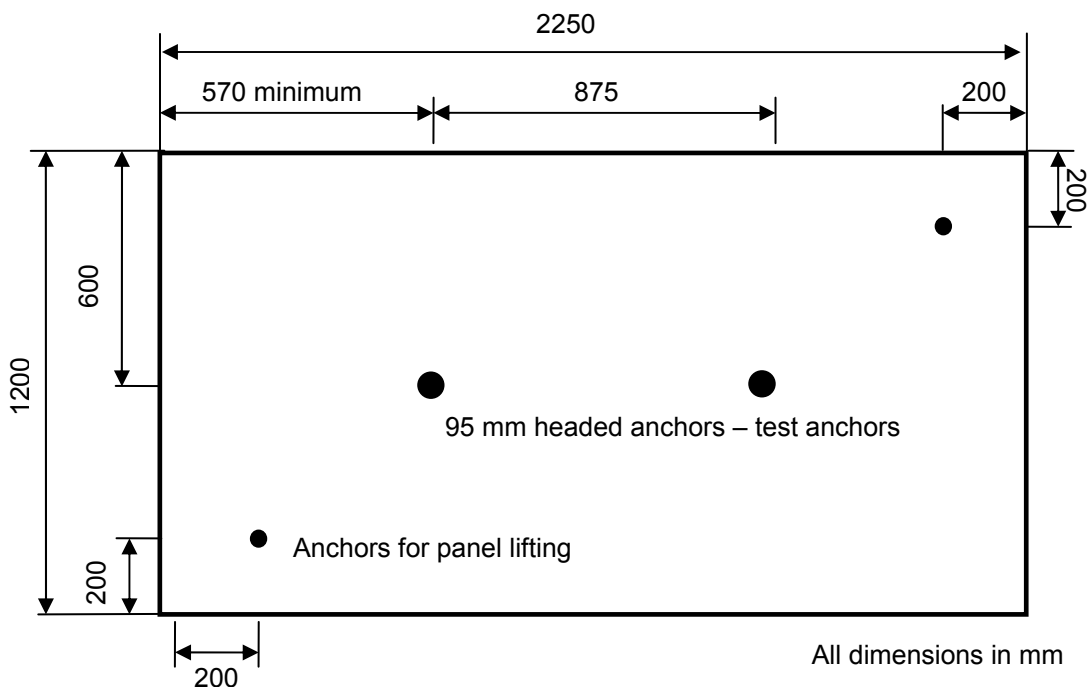
Testing of the anchors was undertaken using panels with two anchors embedded in each concrete panel. The panels were fabricated in the Curtin University Civil Engineering Laboratories. The width of the panel and spacing of the anchors was chosen to avoid the influence of edge distances and/or anchor proximity on the failure cone. The panels were 2250x1200x250 with the anchors spaced 875mm apart (Figure 3). For concrete pours 1 and 2, two such panels were cast and for concrete pours 3 and 4 four panels were cast in one 9 m long casting bed using timber separators for the panels. Lifting inserts (1.3t anchors) were cast into the panels to enable removal of the panel after testing. Their locations were generally in diagonally opposed corners to prevent interference with the concrete break out cone of the test anchors.

Figure 3. Panel dimensions and anchor locations

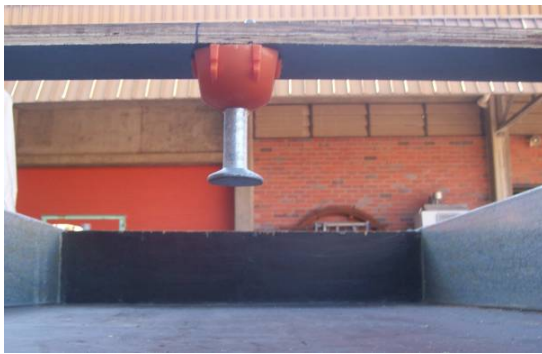
The anchor installation techniques used in this research were pre-installed installation and puddle-in installation. Pre-installed anchors were secured in position by attaching them to a timber slat suspended across the formwork as shown in Figure 4(a). The method of installing a puddle-in anchor is a gentle up and down motion of the anchor into the concrete after the concrete has been vibrated and screeded. Puddle-in installation occurs immediately after the concrete surface has been screeded. In this research, the time at which the anchor was installed after finishing the concrete was extended. As the slump decreased to zero with increased delay, anchor installation became more difficult. The anchors were tapped in with a rubber mallet until the recess formers were flush with the finished concrete surface. For the highly delayed anchor installation the anchors required considerably more effort to install and the anchors were hammered into the concrete with high frequency blows of the rubber mallet.

(a) Preinstalled anchor before casting

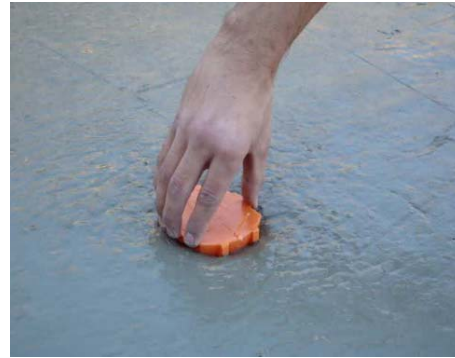
(b) Puddle-in technique

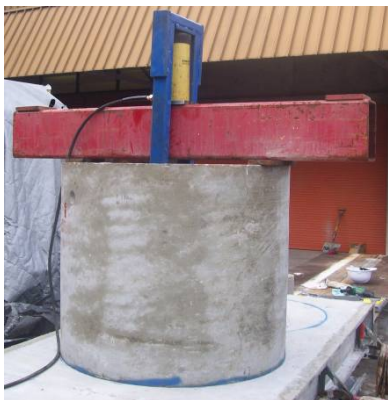
The principle of the testing procedure is to self react the jack off the specimen to reduce the need for a hold-down system. A 250x150RHS spreader beam is positioned on a 1030mm diameter concrete liner (spreader cylinder), 44mm thick and 900mm deep for the 20 tonne jack to be centered on top as shown in Figure 5(a). A custom made loading frame built specifically for this test is placed on the jack ram and connected to the anchor via a lifting clutch (Figure 5(b)).

(a) Elevation showing spreader beam and jack

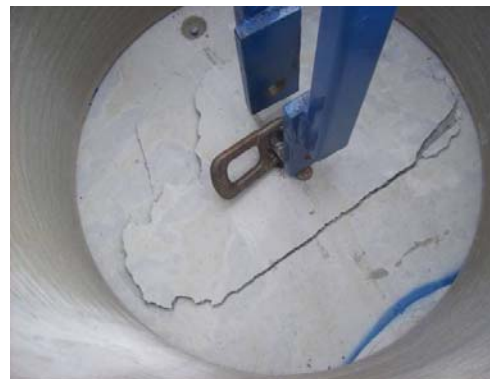
(b) View into liner showing lifting clutch

The expected failure load for anchors in tensile load conditions at ultimate loading is a breakout prism, i.e. a concrete cone failure. All the failure modes were brittle concrete failure, with no prior cracking of the concrete surrounding the anchor. The failure angle of the concrete breakout cone was determined to be an average of 25 degrees. It was found that a considerable shift of angle occurs; the angle of failure is relatively steep with an average of 27 degrees at the base of the cone before it becomes shallow with an average of 15 degrees. The concrete cone failure surface was a truncated circle with one face of the concrete cone at the surface being straight (Figure 5(b)). This failure pattern was consistent with failures observed in previous research (1,2).

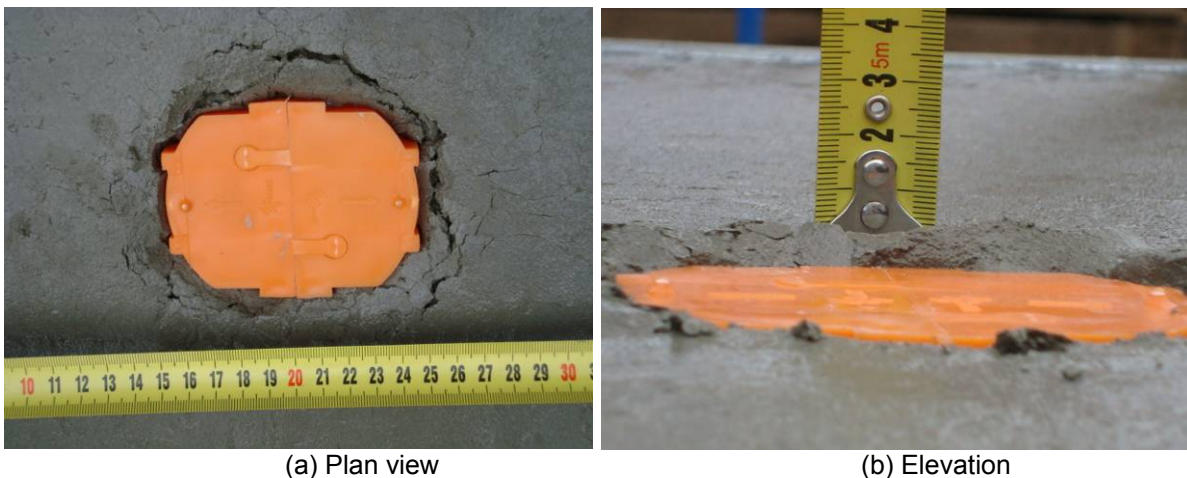
During anchor installation, radial ripples in the concrete surrounding the anchor were observed. This disturbance was observed for all puddle-in anchors, with no delay or with delay. It was observed that the later the anchor was installed; the disturbance radius and ripple depth increased. In some cases the disturbance of concrete around the head of the anchor was visually significant as shown in Figure 6(a) and the ridges of the concrete surface were of the order 0.5mm high as shown in Figure 6(b) for the anchor of pour 2 (test 8) which was installed after 150 minutes delay.

Figure 6: Surface disturbance around anchor void former

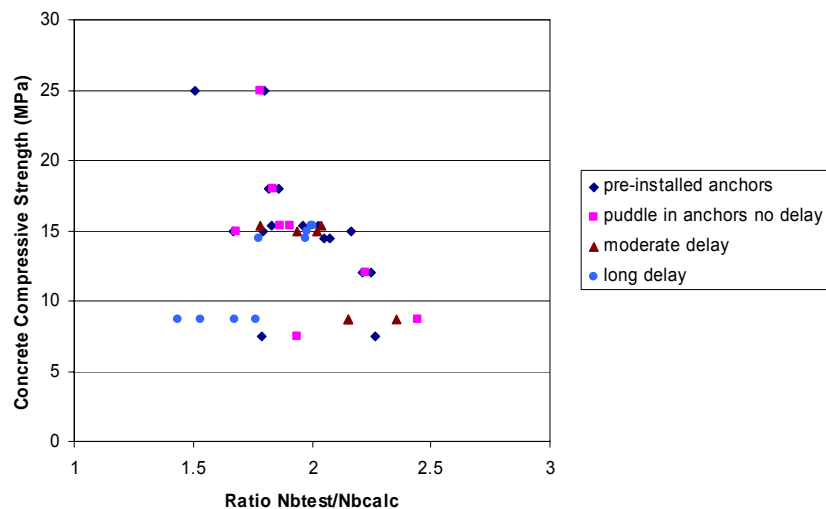
The complete data for the current research and previously published research is shown graphically in Figure 7. Note that pre-installed anchors and non delayed puddle in anchors are plotted separately, however, they form one group defined in this paper as no delay anchors. There is a greater scatter in the data for lower strength concretes. This is reflected in AS 3850 which states that testing should be done at greater than 15 MPa.

**Figure 7. Ratio of Test Concrete breakout load to Calculated Concrete Breakout Load**
