Experimental study of flexural behaviour of RC beams strengthened by longitudinal and U-shaped basalt FRP sheet

Wensu Chen, Thong M. Pham, Henry Sichembe, Li Chen, Hong Hao

To appear in: *Composites Part B*

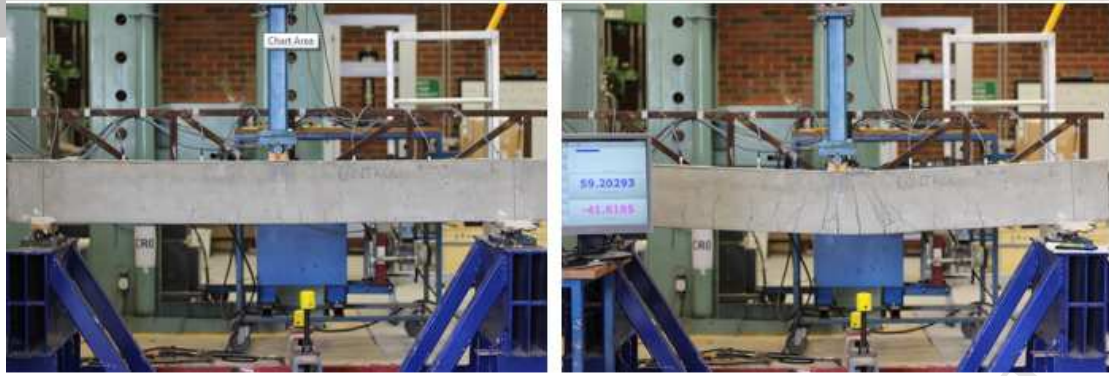
Figure 8 (L) Early crack development of control specimen, (R) Crack development close to failure load of control specimen

194 The control specimen without strengthening experienced a flexural failure with severe
195 vertical cracks. Flexural cracking was symmetrical and hardly any abnormalities were
196 observed, confirming the correctness of the test setup. The cracks first appeared at
197 mid-span and extended towards the supports. They were all visually classified as
198 flexural cracks with no shear cracks appearing at any point during the test. All flexural
199 cracks were propagated vertically from the soffit of the beam as shown in Figure 8.

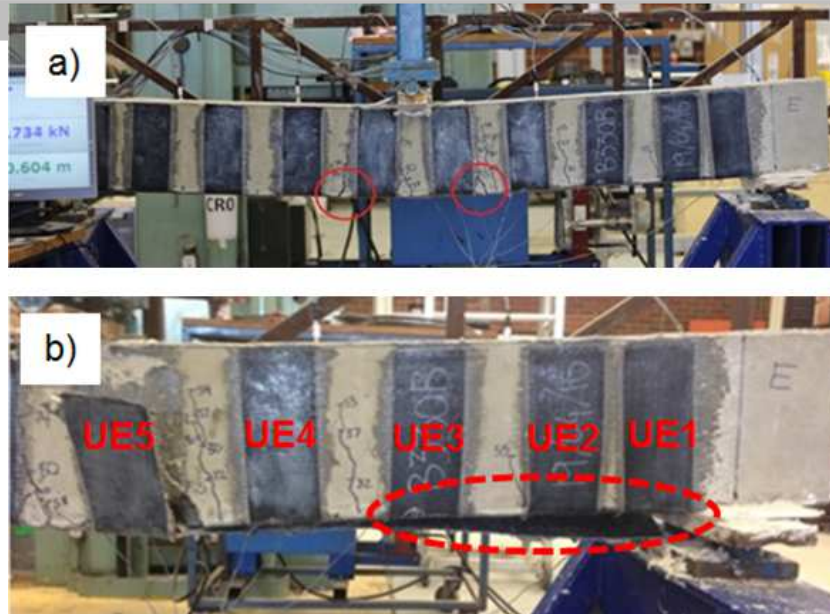
Figure 18 (a) Intermediate crack induced interfacial debonding of soffit strip of B330B; (b) Complete failure of B330B by debonding of soffit strip and rupture of UE1, UE2 and UE3

314 To study the effect of adhesives on the strengthening performance, Beam B330B with
315 the same wrapping scheme as B150B but using SikaDur 330 epoxy adhesive was
316 prepared. As shown in Figure 18, B330B exhibited severe cracking before failure and
317 no shear cracks were observed throughout the test. An ultimate load of 86.53 kN was
318 achieved with a corresponding mid-span deflection of 36.3 mm. These values were
319 close to the corresponding values of B150B. The flexural strength increase was 40.4%

332 At the applied load of 85 kN, B330B experienced intermediate debonding at three
333 separate points along the soffit. Subsequently, UE5 began to debond and UE4
334 ruptured at the edge of the beam. This was followed by explosive debonding of the
335 soffit strip on the right side, resulting in the rupture of UE1, UE2 and UE3. As shown
336 in Figure 19, close examination of cut-outs from the debonded BFRP soffit strip and
337 U-jackets revealed a generally pure adhesive failure at the BFRP concrete interface,
338 leaving minimal damage to the concrete substrate.
