# Study on the GCL's Response to Hydraulic Uplift

**Abstract**—Most of landfill sites in developed countries employ GCL as bottom liners to replace compacted clay liner. However, various water level and direction might be faced by GCL during its operation. These conditions can make the GCL to deform and decrease its hydraulic capability. In this experiment, the GCL was tested with two direction of water flow to see whether any deformation that causes the GCL to lose its hydraulic performance. The results showed that the hydraulic performance of the GCL was constant while facing a water flow coming from above even some area started to be slightly thinner than others. In contrast, the GCL started to uplift, curved and lost its hydraulic performance when the water pressure coming from underneath. The bentonite particles also moved aside from higher hydraulic pressure zone into lower pressure area creating diverse thickness.

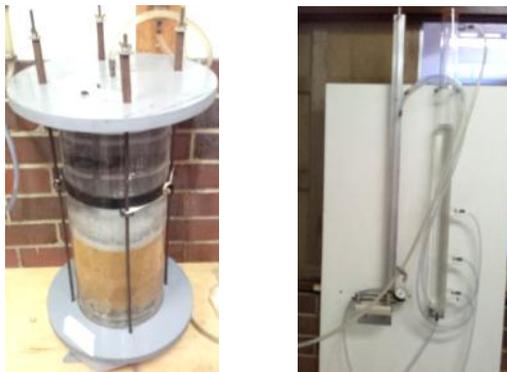
Fig. 1 Experiment apparatus

The main component of the apparatus was a transparent cylindrical cell with 20 cm in diameter and 50 cm in height. The transparent cell provided a chance to monitor any physical alteration of the GCL during the test. A cap with a hole was secured at the top and bottom of the cylinder cell. Each cap was connected to a hose to let the water to flow in and out the apparatus. The hose was equipped with valves to control the water flow (Figure 1).

Two Pressure gauges were also installed in the system to provide water pressure measurement during the test. One of the hose was attached to modified falling head equipment while another hose was directed to a volumetric glass bottle which was used to collect the effluent.

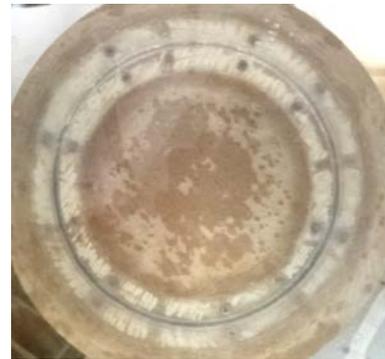
Fig. 2 Sample in the apparatus

The GCL sample was placed inside the permeameter on the top of the subgrade. Silicon sealant was applied around the sample holder's perimeter to secure the sample holder and prevent sidewall leakage (Figure 2). The cap of the apparatus was placed, secured and tighten to prevent any leak. The experiment started a day after to allow the silicone paste to completely dry.

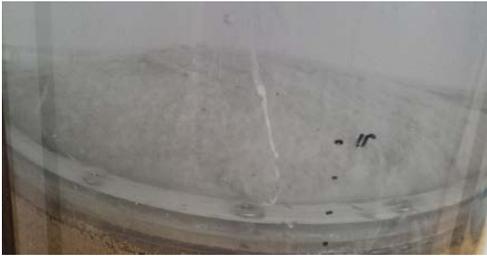
Fig. 3 GCL started to be lifted

During the experiment, the water pressure pushed the sample and the sample started to be lifted at the center and form a curve shape (Figure 3). This condition happened because of the hydraulic uplift pressure was greater than downward pressure. The following calculation explains the differences between downward and upward pressure.

The effective stress at the bottom of the sample was  $-1.933 \frac{kN}{m^2}$  while the water pressure at this area was  $1.14 \frac{kN}{m^2}$ . Summation of force shows that upward force was greater than downward force made the sample to be lifted. Since the edge of the GCL was hold by a sample holder, the GCL started to deform into a dome shape. In this case, the surface of the GCL might be stretched and cracked subsequently the water would flow up through the cracks.

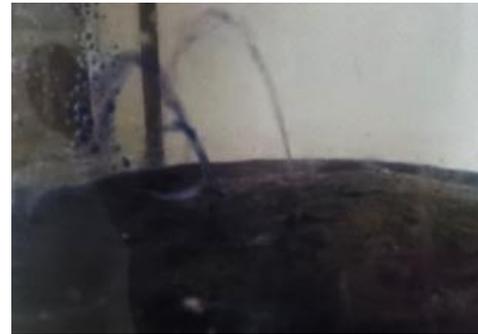
Fig. 4 GCL Failure

The GCL started to fail after undergoing water pressure for 3 days. The water just flowed easily through two small holes on the thinnest area of the sample (Figure 4). The water pressure was fall into 20 kPa in less than 5 minutes and the GCL's sample lost its capability to hold a certain water pressure any longer in 12 hours.

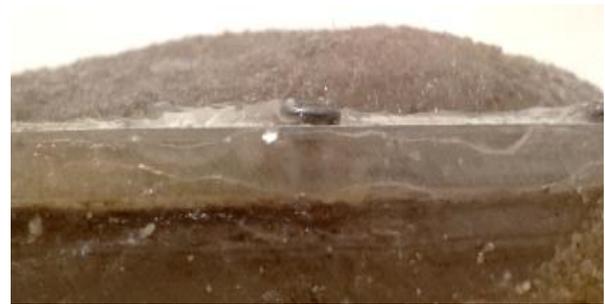
Fig 5. Sample after being tested

An observation of the GCL's sample was conducted by taking the sample out of the apparatus and followed by a thickness measurement. It obtained that the height of the top of the GCL was about 24.7 mm (Figure 5). The sample then was placed on the flat surface and the GCL bottom was leveled on the surface. It was acquired that the thickest area of the GCL was 15.8 mm while the thinner area was 3.2 mm (Figure 6).
