Development and Application of a Relative Displacement Sensor for Structural Health Monitoring of Composite Bridges

Abstract: One of the typical bridge construction types on Australia highways is composite bridge consisting of cast-in-situ reinforced concrete (RC) slab supported by steel or precast RC girders. The slab and girders are connected by distributed steel shear links. The shear links are under constant cyclic loadings during bridge operations therefore may experience fatigue damage besides possible corrosion damage and overstressing owing to increased traffic volume and weight. This paper proposes a relative displacement sensor developed to directly measure the relative slip between slab and girder in composite bridges to detect the health condition of shear connections. The structure, design principle, features and calibration of the developed relative displacement sensor are presented. The design of the sensor ensures that there are no voltage outputs for the tension, compression, bending and torsion effects, but only measures the relative displacement between the two connecting pads of the sensor. The accuracy of the developed sensor in measuring the relative displace

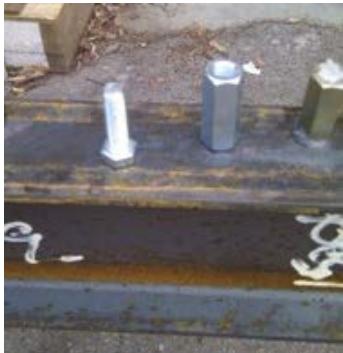
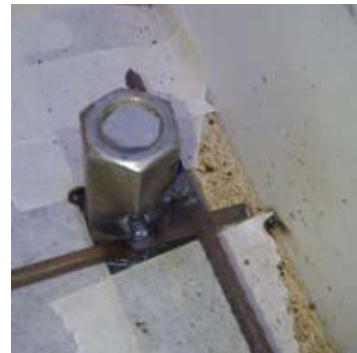
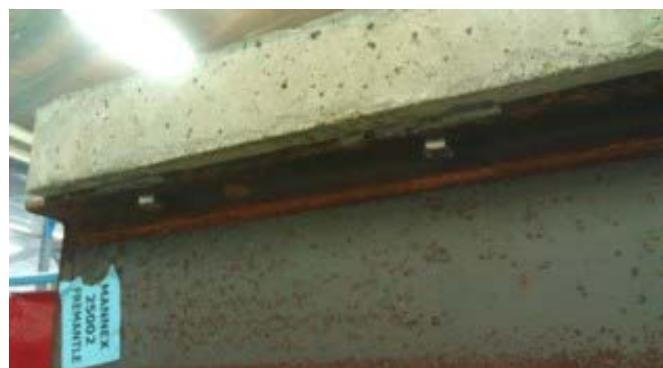
(a) Metric bolt and nut

(b) Bolt screwed into the nut

(c) Plan view of shear connectors

(d) Shear connector in the structure

Figure 7 - Design of shear connectors and composite bridge

located on two steel frames which are fixed to the laboratory strong floor. In this study, the design of shear connectors allows for simulation of the failure of specific shear links as well as for resetting to the undamaged state. Therefore, bolts screwing into metric nuts cast in the slab were used to work as shear connectors. The nuts were welded onto the reinforcement bar in the slab before pouring. Figure 7 shows the design of shear connectors and the composite bridge model. If all bolts are engaged in the nuts and tightened, the structure condition corresponds to the undamaged state. The damage of shear connectors is introduced into the structure by unscrewing several specific metric bolts to simulate the failure of shear links. It may be noted that the bolt is fully unscrewed from the metal nut to simulate the failure of shear link in this study. It is interesting to study the detection problems with partially damaged shear connectors, however, this is difficult to perform in the experimental tests. If a shear link or a bolt in this study is not completely removed, to create relative movement between deck and girder, large shear deformation of the bolt or concrete crushing damage around bolt needs be induced. Such damage could occur in a real bridge under traffic loading, but it is not likely in the lab tests under small loading and vibrations. This is the limitation of the tests. The identification with different damage severities of shear connectors is not conducted in this paper.

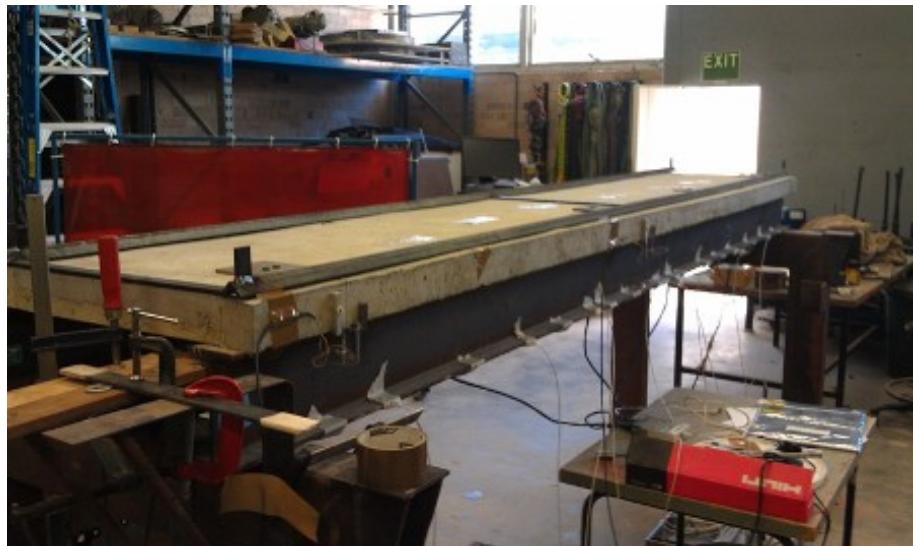
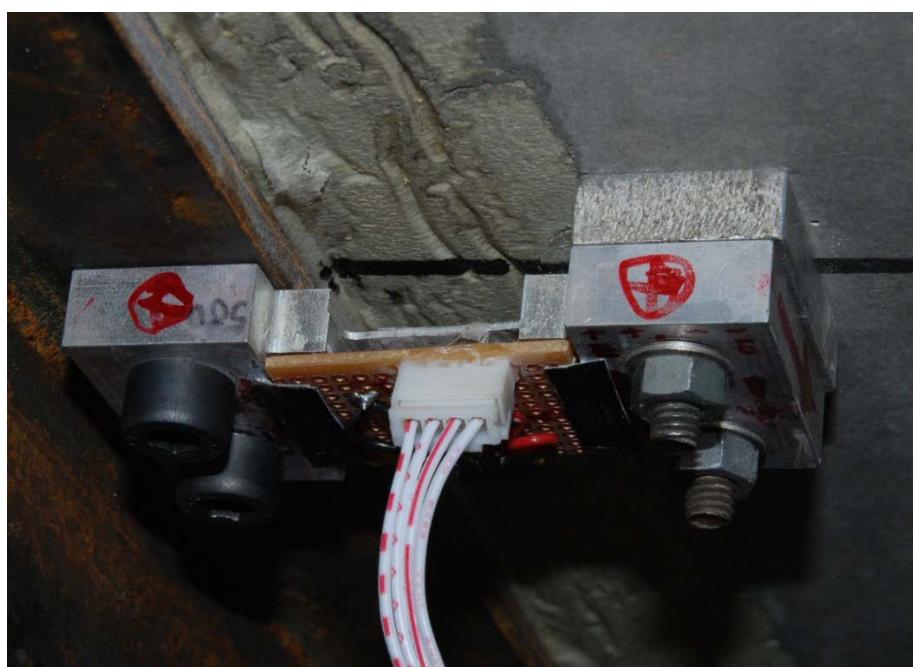
Figure 8 - Experimental setup (a) Composite bridge. (b) Sensor prototype

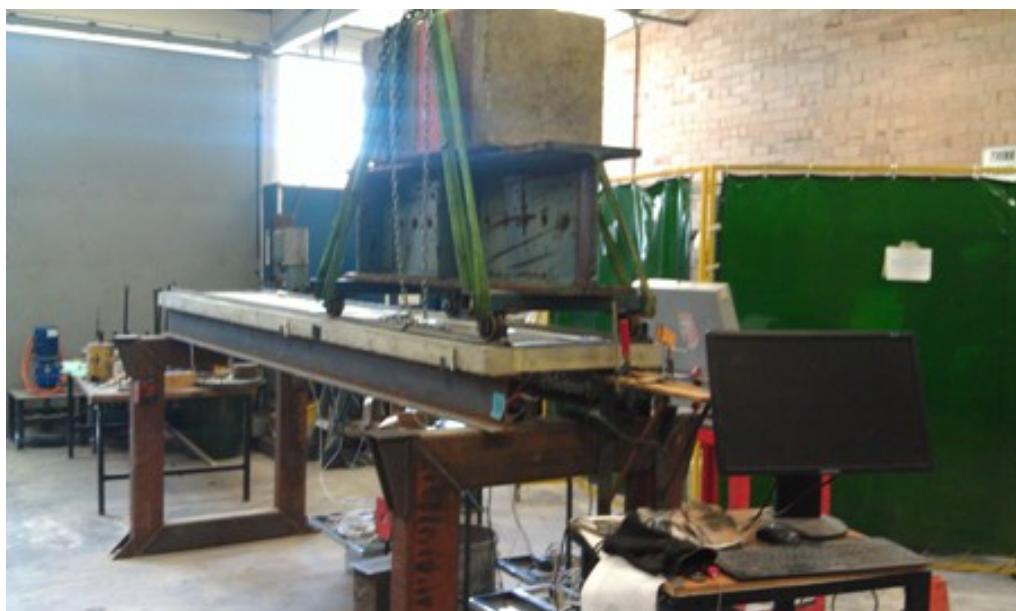
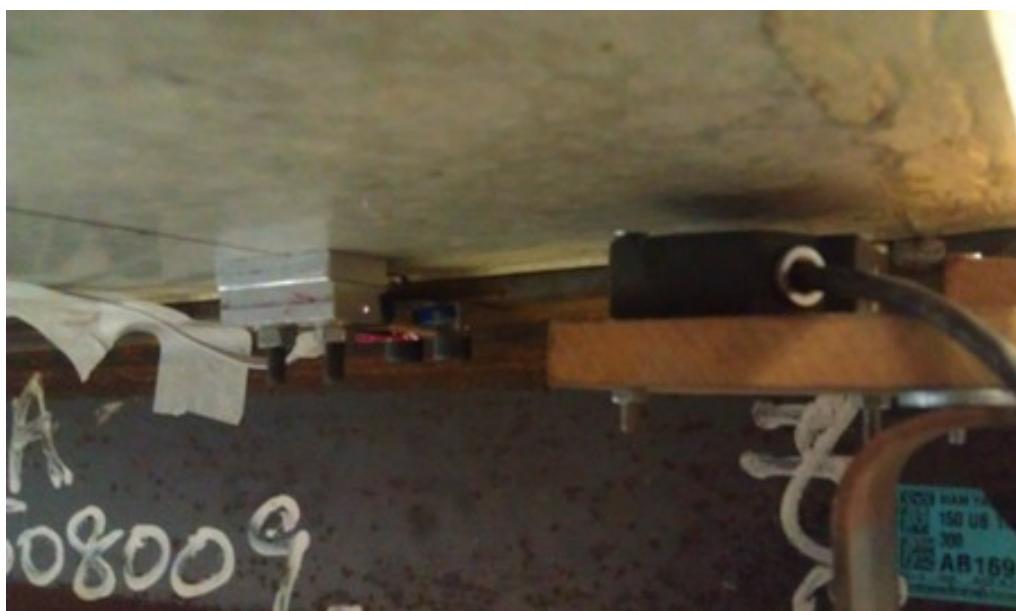
Figure 10 - Experimental test for the accuracy verification of the sensor

A trolley was designed in the laboratory with two concrete blocks placed on it. The trolley was placed on the top of the bridge model as shown in Figure 10(a). Two laser displacement sensors were also installed to target at the two pads of S1, as shown in Figure 10(b), in order to calculate the relative movement between two pads and validate the accuracy of the relative displacement sensor. The difference between the measured displacements from these two laser displacement sensors is obtained and compared with the directly measured relative displacement by the developed sensor.
